Brynele Home Farm W/11/1795

Tir Gofal Farm Visit Historic Environment Report

Report No. 2002/41

REPORT NO. 2002/41
PROJECT RECORD NO. 41691

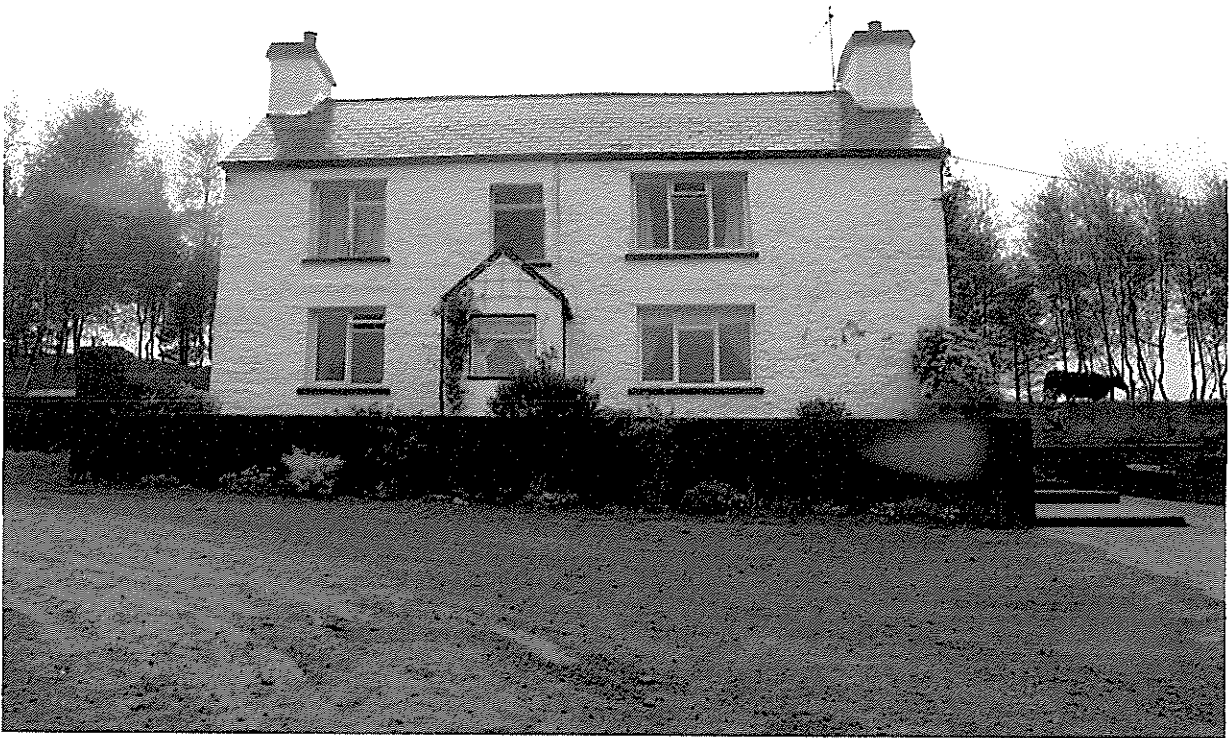
Plate 1 – The farmhouse (PRN 44817) from the south

The farmstead was a minor gentry house which appears to have had its origins in the late 17th century. The earlier farmhouse appears however not to have occupied the site of the present house which is of late 18th-early 19th century character, but is not shown on the Nantcwnlle tithe map of 1839 and so may be a little later and in conservative style. It is depicted on the Ordnance Survey 6" map of 1891 and lies at the north end of the farmyard facing south. It is in the local vernacular, of whitewashed rubble masonry, with two storeys beneath a slate gable roof, and masonry end chimneys. The 3-bayed elevations are asymmetrical, the bay to the east of the central entry being wider, to accommodate a large fireplace; this more than anything else gives the house its early or conservative appearance. Openings are simple and square-headed, beneath lintel-stones. The present gabled porch may be a later addition. There is small, walled terraced yard/garden along the south side of the house.

The farmhouse is not included in the Tir Gofal management agreement as it is occupied as a dwelling.

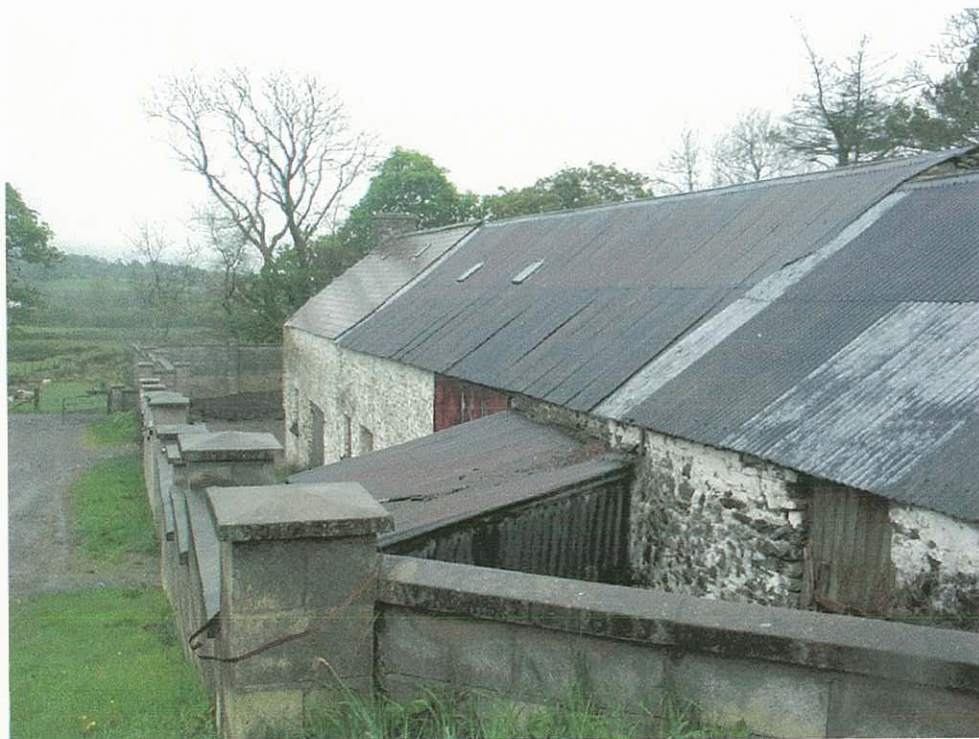
Plate 2 – the cottages/milking parlour (PRN 44818) from the northeast

Long, north-south row of buildings forming the west side of the farmyard. The row comprises four separate buildings, but they now lie beneath a continuous gable roof. All are in whitewashed rubble masonry. The southern building is slated; over the remainder the roof is corrugated metal sheeting. All buildings now comprise a single storey, with a deep loft-space over the southern three, and appear never to have been larger. The southernmost building retains the most original features, including a fireplace and masonry chimney in its southern (gable) wall. The external southeast corner has a pronounced bevel at ground level. Internally, this building is divided into two areas. In the southern half is a domestic room, with the fireplace, and a simple window in the east wall. The northern half is accessed through a large, vehicular entry in the east wall and appears to have been a cart shed. Both openings have segmental masonry heads, and the window has an original slate sill. The remainder of the buildings have been converted. The central two buildings are now a milking parlour (recently disused and used for storage). The stalls, concrete floor and breeze-block divides are mid-late 20th century. However, its east wall retains its central doorway with two flanking windows, similar to those in the southernmost building although the windows have simple lintels. The original form of the north-central building is more difficult to establish and a lean-to corrugated sheet-metal building (formerly a dairy?) has been erected against the east wall. The northernmost building lies higher up the slope and its floor level higher, effectively meaning that the building is lower. It is very simple and has a simple square doorway, its head at eaves level, in the east wall. It may always have been an ancillary building. However, as a whole, the buildings appear to represent a row of tenant/farmworker cottages, of probable early 19th century date. It is depicted on the Nantcwnlle tithe map of 1839. The whole row now lies behind (west of) a north-south breeze-block wall, which obscures them from the farmyard. The buildings are now in fair condition only. The roofs are only just weatherproof, and the roof timbers – which, except in the southernmost building, are probably late 19th – early 20th century – appear damp. Door and window frames are similarly in poor-fair condition, whilst some of the masonry facework in the northernmost building appears loose.

The buildings require sensitive consolidation using traditional materials. Primarily, they need to be made weatherproof. This may involve replacement of some of the roof timbers, and the replacement of the sheet-metal roofing with more sympathetic materials. The loose masonry in the northern building needs to be made good. As the milking parlour has become disused, consideration may be given to removing the breeze-block wall to the farmyard, which cuts the buildings off from the context of the yard.

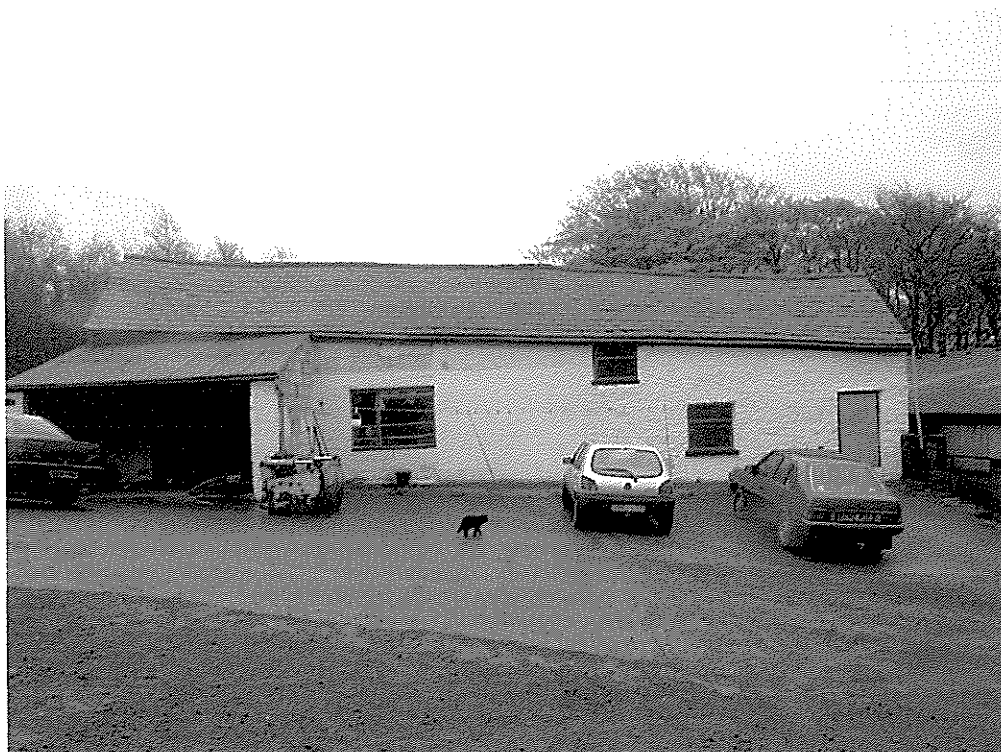
Plate 4 – the ?cow shed (PRN 44819) from the west

North-south rectangular masonry building, forming the east side of the farmyard, which is depicted on the Nantcwnlle tithe map of 1839. It comprises a large ground floor space with a loft over. Much of the northern half of the building, including the west wall, has been rebuilt in breeze-block in the mid-late 20th century, but the slate gabled roof structure appears to be earlier and spans the entire building. There is an original ground floor entry in each side wall, both of which are fairly narrow, and two original ground floor windows lie in the east wall, and one in the west wall. All openings are simple, with square heads of voussoirs or lintels. The loft is lit by a window in the west wall, with its head at eaves level. The original function of the building is now difficult to discern, but the presence of a loft suggests that it was either a stable or – more likely a cow shed, and a wider ground floor entry (or entries) may have formerly existed in the rebuilt northern half of the east wall. The building is in fair-good condition.

Maintain as existing, using traditional materials.
