## **Brithdir W/11/1800**

### **Tir Gofal Farm Visit Historic Environment Report**

Report No. 2002/53

Brithdir  
Tir Gofal Farm Visit Historic Environment Report

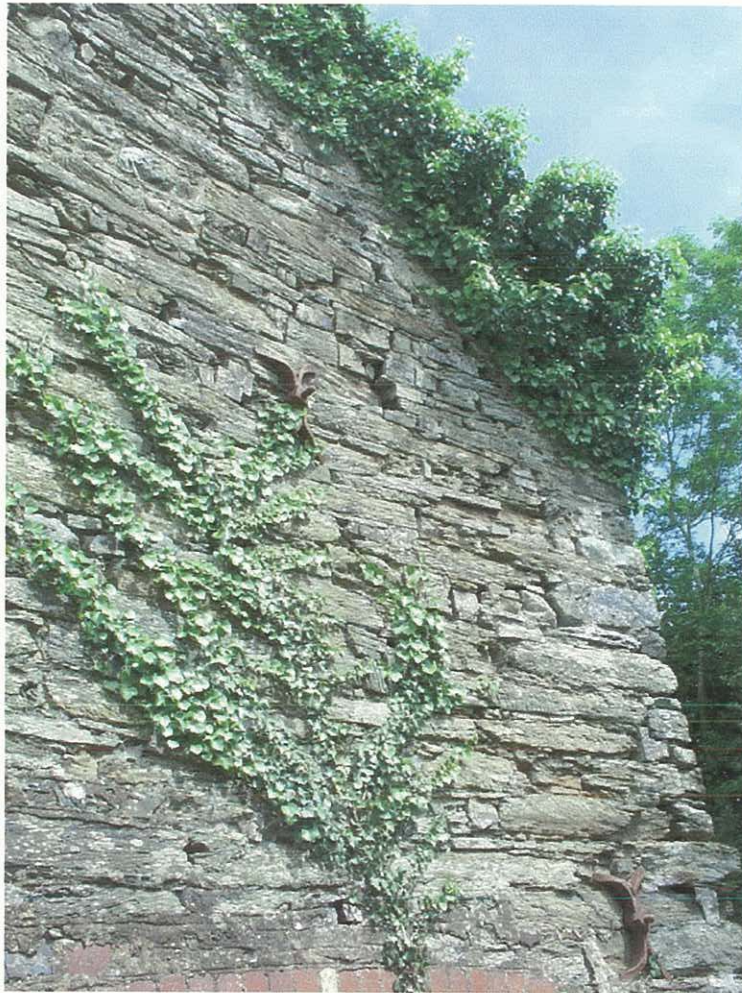
Plate 1 – the cross ties in the south west gable

The current condition of the mill is critical, as the building appears to be under structural strain. The south west gable has 3 iron cross ties, and around these ties the wall appears to be under stress to such an extent as to have caused some stones to have cracked. Mr. Thomas believes these cracks have occurred only recently. Where it is possible to inspect the internal face of this gable wall it shows little cracking and it is possible the wall may be splitting, with the internal face separating from the external (plate 1).

Internally the first floor has collapsed in the central section of the building, and this may be exacerbating the structural problems. The building will no longer be benefiting from the stabilizing influence of the floor structure which helps to tie the walls together.

The south and east sides of the building are very overgrown with ivy, which seems to have taken root from the south side. However, the trunk of the ivy has been cut through but the ivy is still alive and appears to have taken root within the masonry. The ivy is also covering sections of the roof and has penetrated the interior of the structure.

The building evidently suffers from a number of structural faults, and specialist conservation advice should be sought to establish the best method for countering these problems (see the attached list of organisations which may be able to provide conservation advice).

At the very least this building should be structurally stabilized to prevent its' further deterioration. However, in the long term this building also provides a wonderful opportunity for presentation to the public and perhaps a further internal restoration.

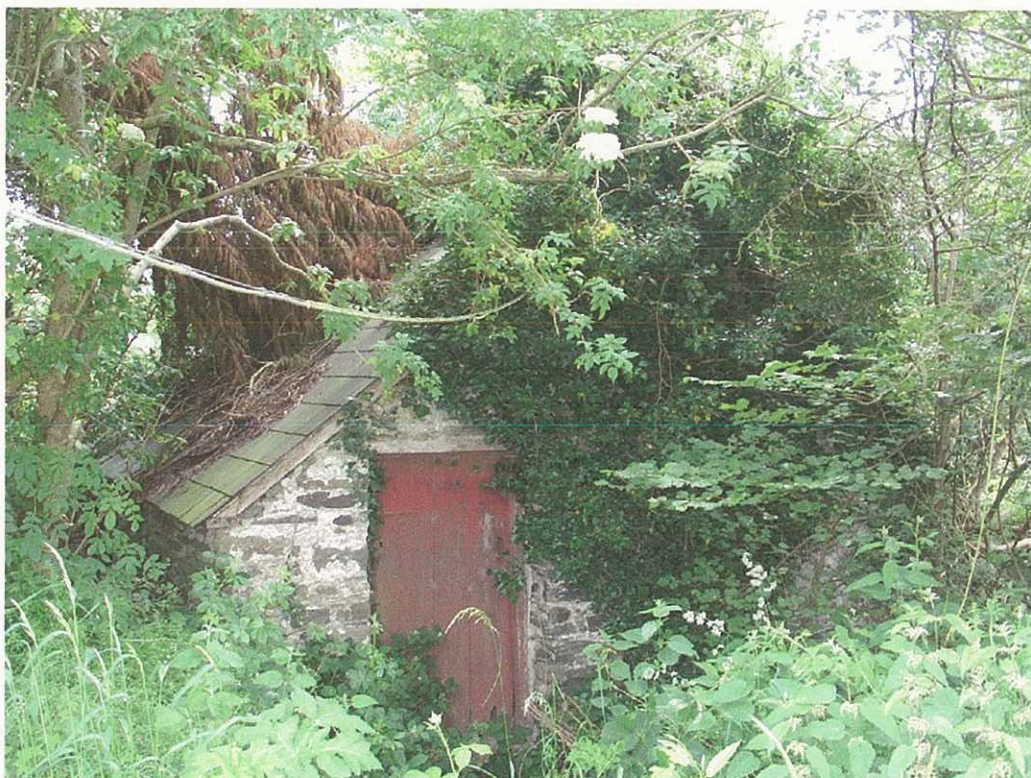
Plate 2 – the former fulling mill (PRN 21369) and electricity generating mill.

This building is currently very overgrown to such an extent that access and further assessment of condition is difficult. Ivy is extensively covering the roof, especially towards the north end (plate 2).

This building is also a significant element in the history of this hamlet, and is worthy of preservation. In order to prevent further damage to the masonry by intrusive ivy growth, the ivy should be cut back and allowed to die, and treated to prevent regrowth. The masonry will then require consolidation in traditional materials in conjunction with the removal of ivy.

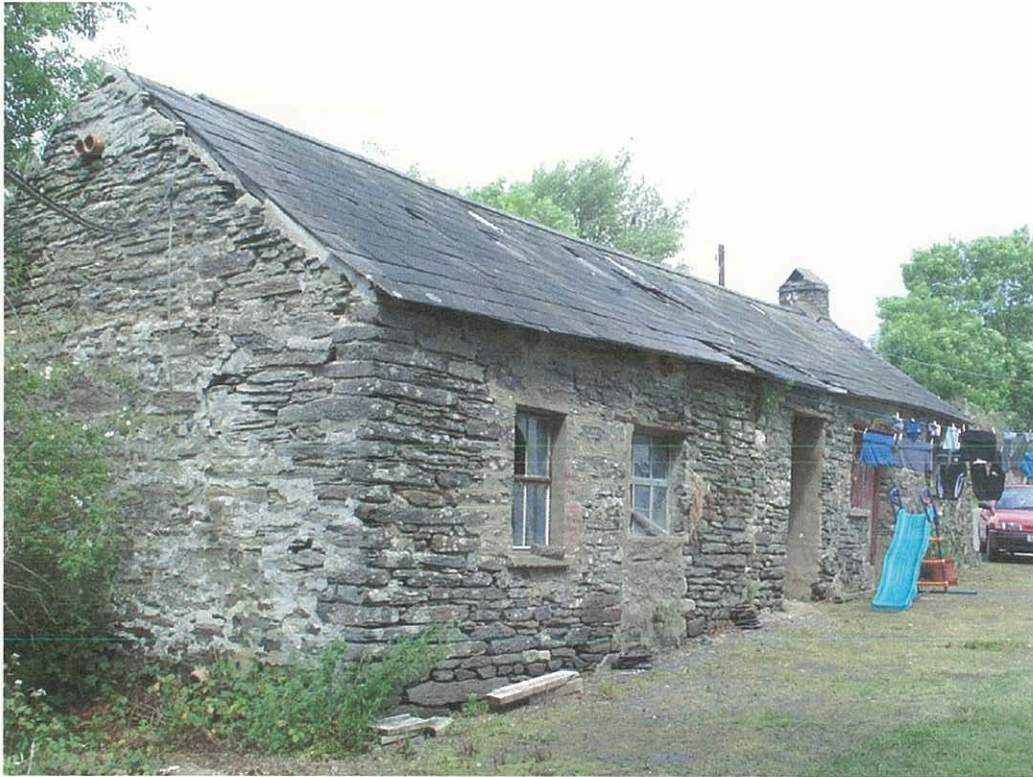
Plate 3 – the former cow shed.

To the north of the farmhouse is a low one-storey cow house with a former kitchen range at the east end with a chimney in the east gable (plate 3). This section was subsequently amalgamated with the cowshed. This building is now used for storage. The slate roof to the building is in a poor condition with some slates missing.

Mr. Thomas expressed his hope to convert this old cow shed into a wood working workshop. The re-use of this building is to be welcomed, and would help to ensure it's continued upkeep. Any repairs or alterations should endeavour to retain the historic fabric and be carried out using traditional materials.

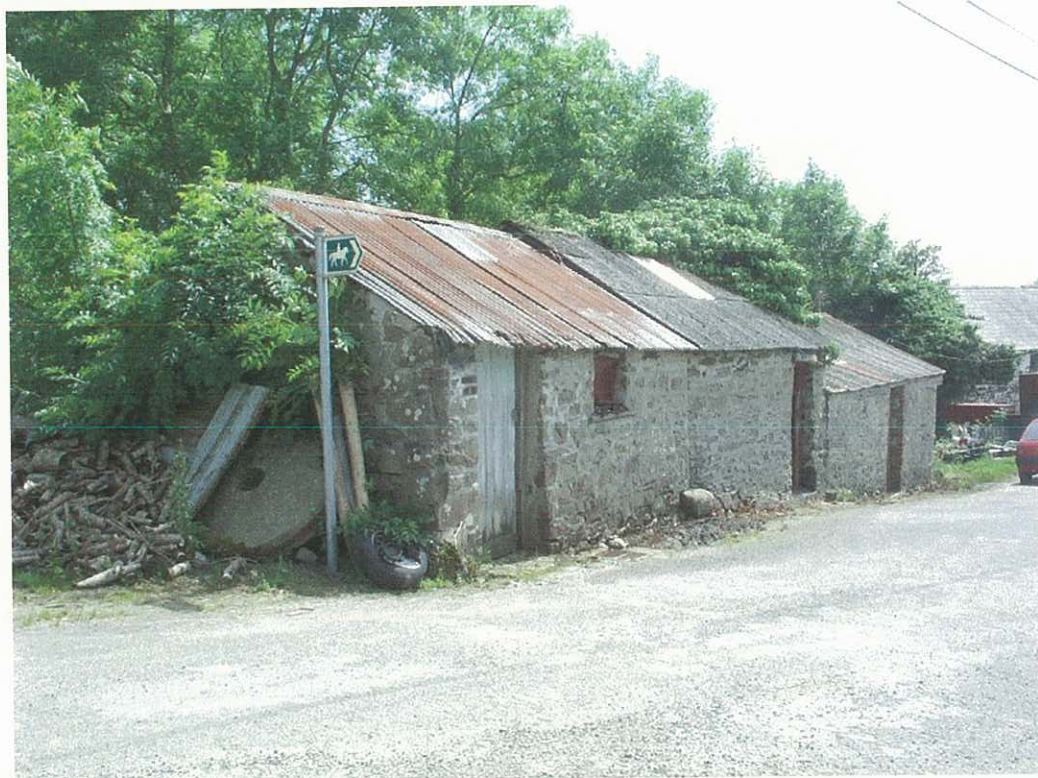
Plate 4 – the former corn drying kiln with Anglesey millstones propped against the near gable end.

To the east of the farm is a long low range of buildings (plate 4). At its southwest end was a former cow shed. The central section used to be a corn dryer, with a chimney at the north east end. The chimney has since been dismantled although the outline is still visible. Mr. Thomas recalls that a mesh floor was used to spread the grain over to dry.

Parts of this range are becoming overgrown with ivy, to such an extent that the ivy is penetrating underneath the roof.

This building forms a significant part of the complex and should be retained. The ivy should be cut back and consolidation of the masonry undertaken using traditional materials.
