TIR GOFAL MANAGEMENT PLAN: HERITAGE MANAGEMENT INFORMATION (HE2)

Ty'n-y-fron farmstead

**Prepared for:
Ynysforgan**

**ACA Report No. 2005/28
Project Record No. 41719**

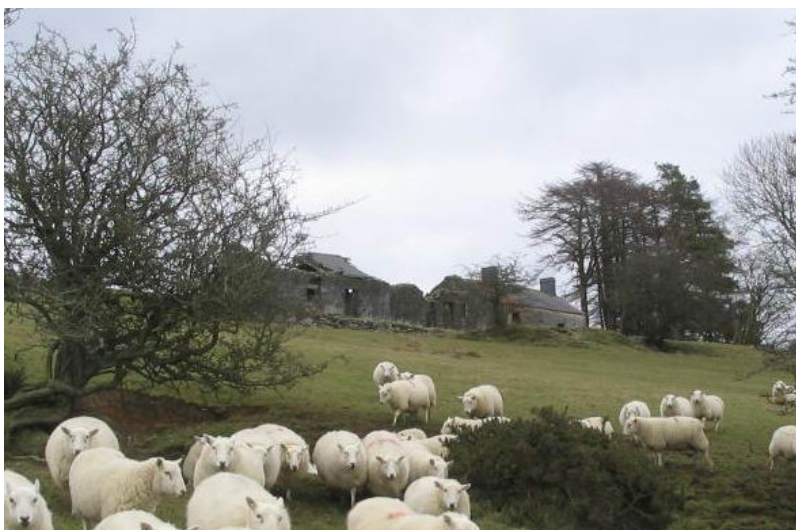
| Name (& PRN) | Period/Site type | NGR | Status SAM/listing | Management required |
|---|---|---|---|---|
| The cottage is redundant and falling into disrepair. Some roof slates are missing but otherwise the building would seem to be in reasonable order. | | | | |

1. Those traditional buildings in a weatherproof and a structurally sound condition must be maintained in a weatherproof condition.
2. Those traditional buildings or parts of traditional buildings that have not been previously modified must be maintained using traditional materials and methods of construction.

3. Characteristics and features which reflect history and function of the traditional buildings identified in this agreement must not be removed.
4. Wherever practicable, repair original features rather than replace them. (Capital Works Option)

5. Repairs should be unobtrusive and make use of appropriate traditional materials and methods of construction. (Capital Works Option)
6. When repair is not possible, replacement features must be modelled on the originals, using the same materials and methods of construction. (Capital Works Option)

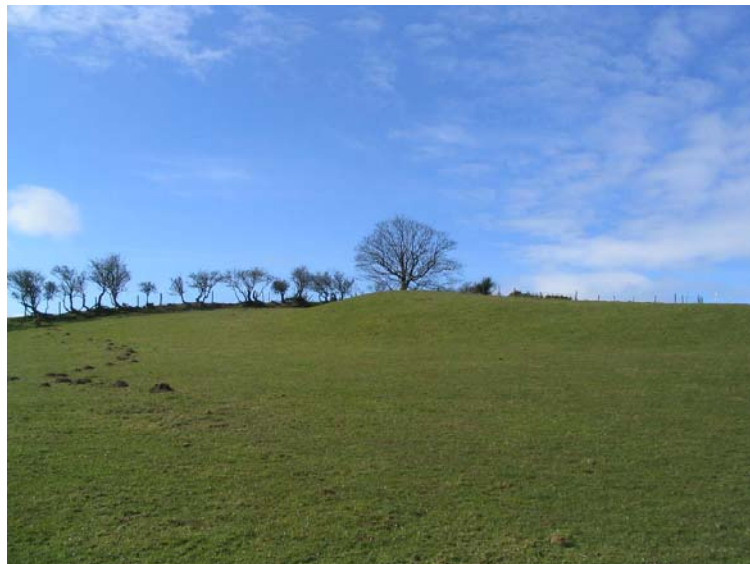
| | Name (& PRN) | Period/Site type | NGR | Status SAM/listing | Management required |
|---|--|---|---|---|---|
| | The defended enclosure consists of a bank 2.7m high enclosing a semi-circular area measuring 60m across internally where it is cut into by a quarry on the northeast side. The annex is surrounded by an enhanced natural slope enclosing a level area of around 100m east-west by 80m north-south. Both areas have been ploughed in the past and there are no internal features visible (WWS 2005 based on DRB 1974). | | | | |
| | Only the semi-circular defended enclosure falls within the Tir Gofal application area. The condition is much as described previously. The site falls between two pasture fields with scrub, mainly gorse established over the western defensive bank. The underlying surface retains a good grass cover with localised patches of livestock erosion. | | | | |

Looking south towards the eastern enclosure rampart.

- Cut back scrub established over the western defensive bank. Remove cut vegetation from the area of the earthworks.
- Graze at a level which will prevent the breakdown of grass cover. Erosion scars on the earthworks should be allowed to recover naturally.
- Monitor mature trees on the earthworks. Consider felling mature trees which are at risk from windthrow.

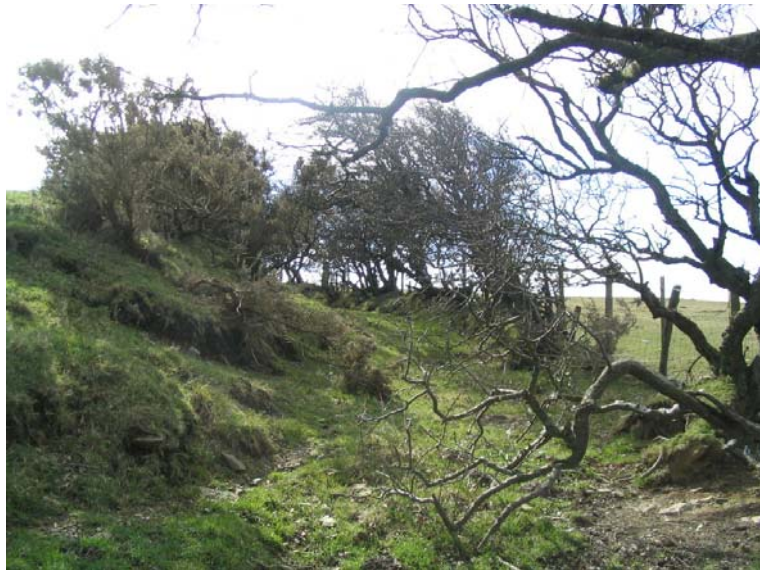
Scrub covers the western bank with localised patches of livestock erosion.

The site falls between two pasture fields with scrub, mainly gorse established over the western defensive bank. The underlying surface retains a good grass cover with localised patches of livestock erosion.

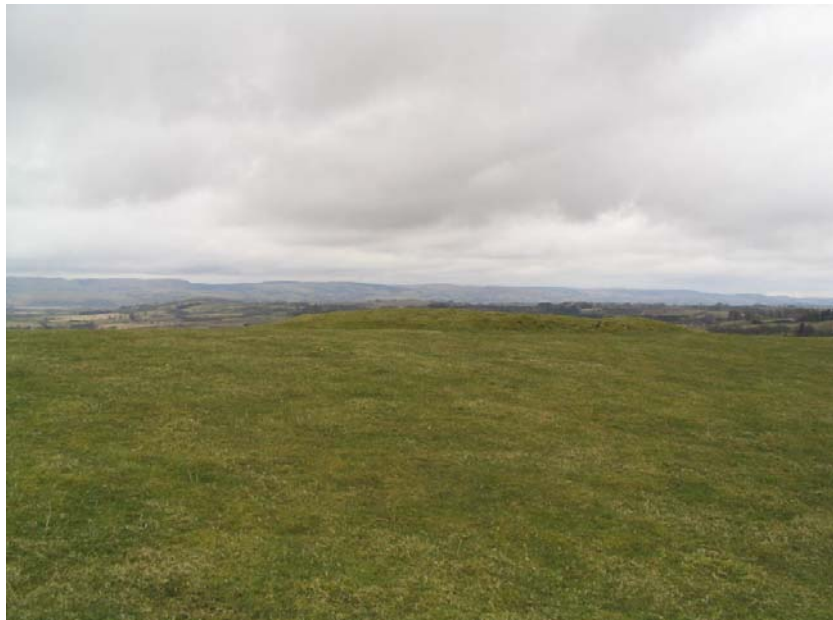
A scheduled ring cairn on the summit of a minor hill. It is well preserved and measures approximately 16m in diameter and 0.5m high, with a dished interior. It consists of small boulders and probably includes field clearance material in its make up.

The condition is improved from that described during previous visits by Cadw Field Monument Wardens which note the presence of sheep scrapes. The monument is now under unbroken pasture with no active erosion present.

Pantcamddwr occupies a prominent position with good views in all directions.

Both round barrows lie within unbroken pasture with no active erosion present. Consider leaving a minimum five metre buffer from the base of the earthworks during any future cultivation in order to protect any associated below ground archaeology.

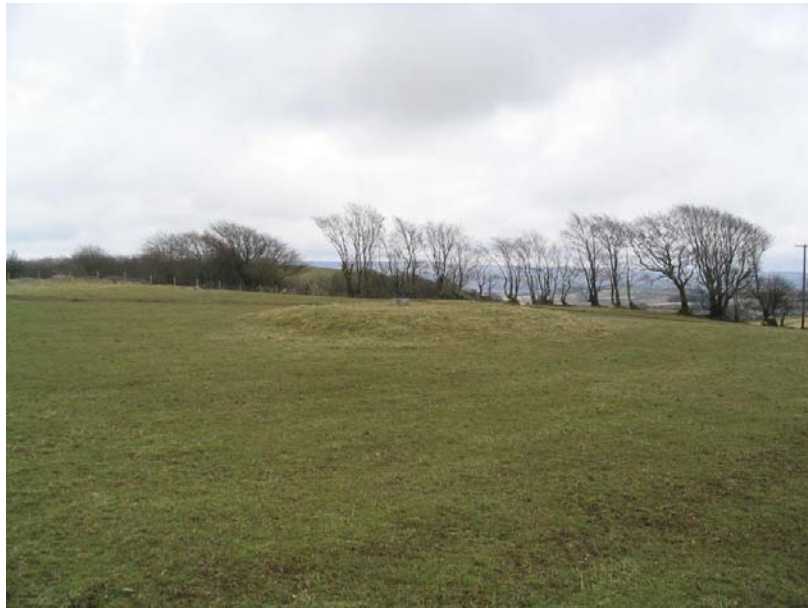
A turf covered round cairn, 11m in diameter and 0.6m high, close to the summit of a south facing slope. The mound is under unbroken pasture with no active erosion.

Ty'n-y-eithin round barrow seen from the north-west.

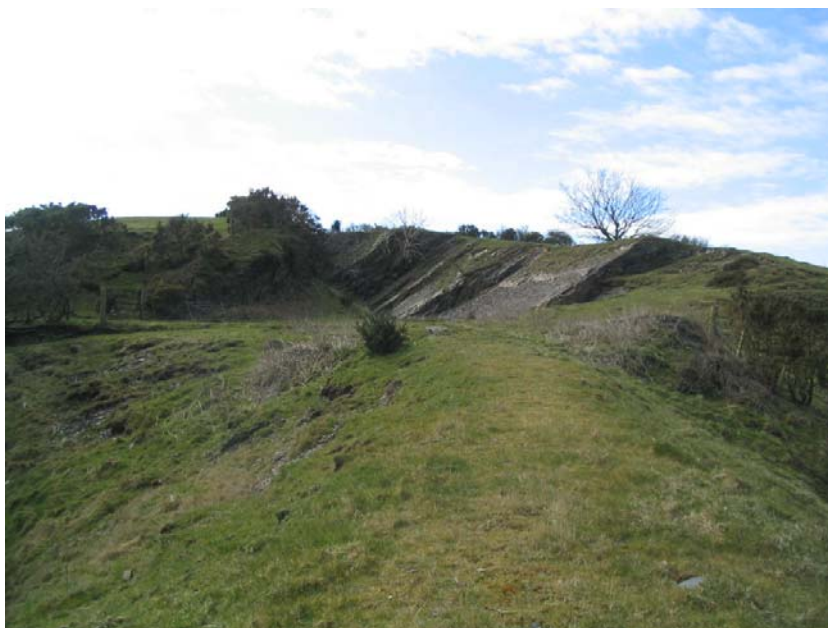
A quarry is shown on the OS 1st edition map of 1888 cutting into the north side of a defended enclosure (PRN 1988). A tramway is recorded running south from the quarry face to serve a spoil tip to the north. It is recorded as Old Quarry and was redundant when the OS 2nd edition map was published in 1905. It is an extensive complex covering some one and a half acres in all. There are no obvious remains of any related structures and the tramway has been dismantled.

Looking south from the spoil tip to the quarry face behind.

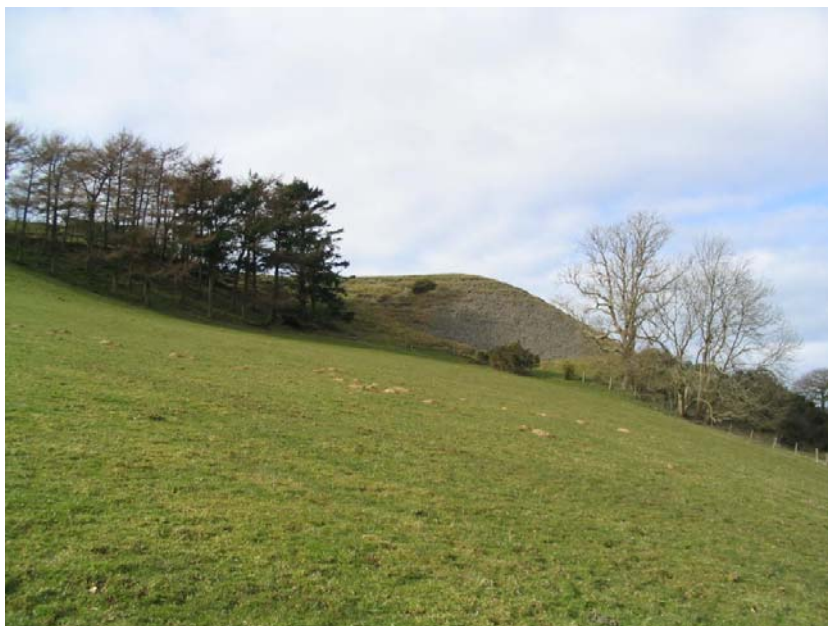
The quarry spoil tip seen in profile.

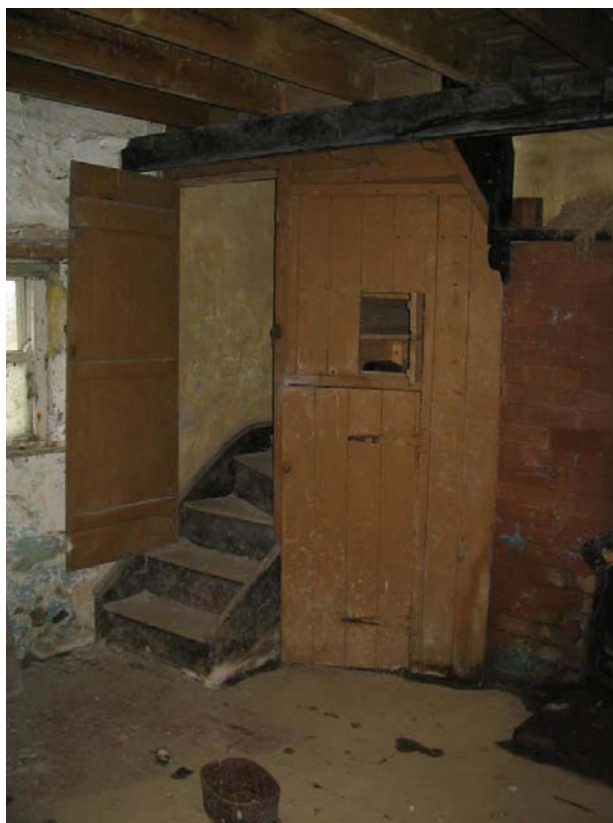
| Name (& PRN) | Period/Site type | NGR | Status SAM/listing | Management required |
|---|---|---|---|---|
| A redundant single storey cottage of probable pre mid-nineteenth century date. It is part of a larger complex including several outbuildings (PRN 53418). The cottage is built of rubble stone, with blue brick end stacks and roofed with slate, although the rough timbers of an earlier roof survive beneath. The door is between two small pane casement windows and there is a small loft light in the east end wall. Internally the cottage is partitioned by boards into two rooms with an annex to the rear. There is a red brick fireplace and chimney breast against the west end wall with dry cupboard and stairs to the left. The loft occupies the space between the roof eaves and extends for the length of the building. | | | | |

The dry cupboard and stairs to the left of the chimney breast.

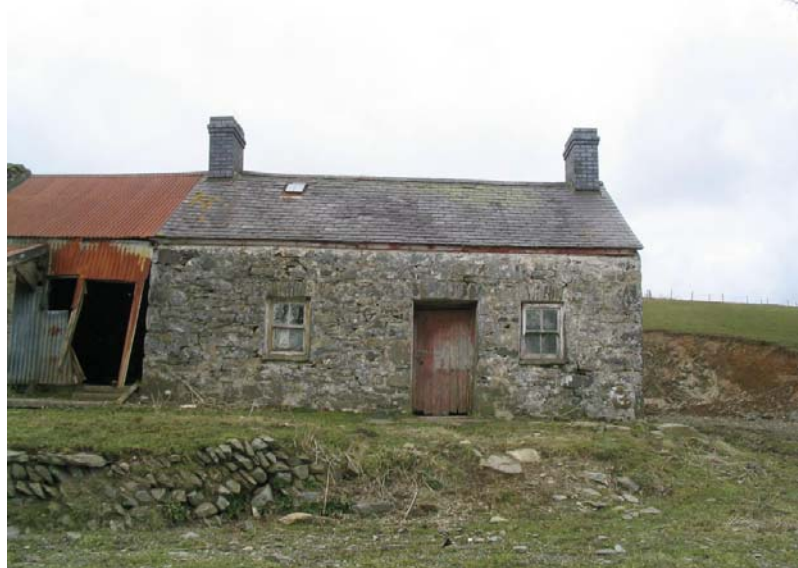
The front (south-facing) elevation of Ty'n-y-fron cottage.
