Tir Gofal Farm Visit Report
Parc Cynog Farm
W/12/2112

REPORT NO. 2002/15
PROJECT RECORD NO. 41722

March 2002

PARC CYNOG FARM
TIR GOFAL FARM VISIT REPORT

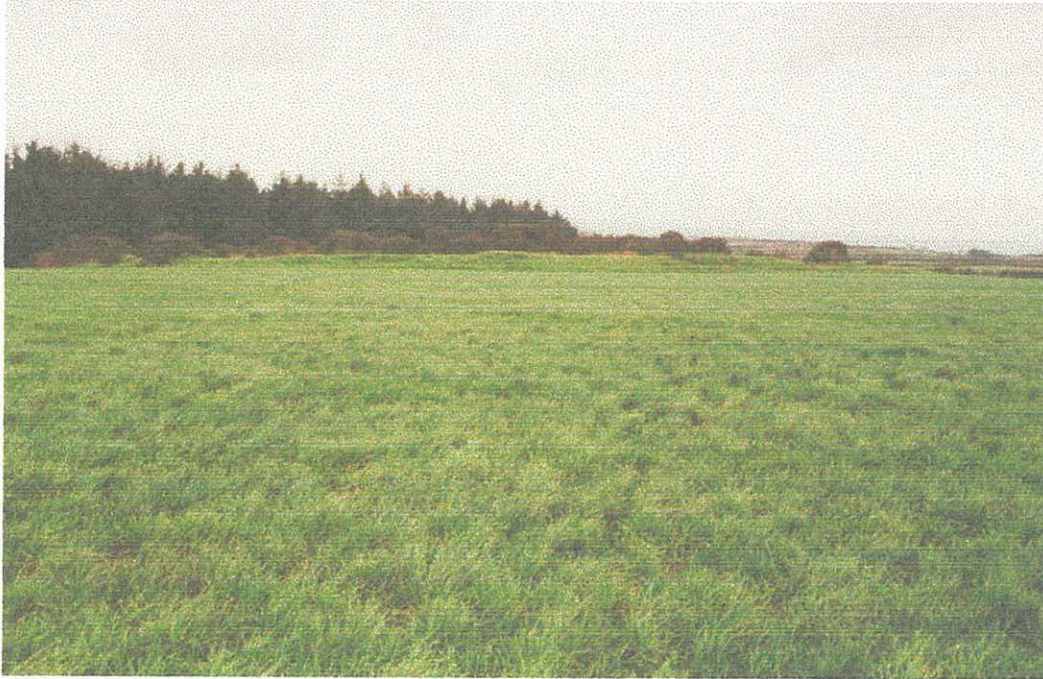
Plate 1 – Iron Age hillfort (PRN 3843)

The Iron Age hillfort lies on the brow of the hill overlooking the valley of Colston Wood to the north with a steep slope to the north west (plate 1). The earthwork encloses a D-shaped area approximately 100 metres across. To the south west there is a double bank and ditch, a single system elsewhere.

This hillfort is currently used for pasture, but also has gorse encroaching extensively over the earthworks and interior of the monument. The gorse should be cut back and treated to prevent regrowth. A light grazing regime should be maintained and erosion by overstocking or vehicle use should be prevented. No ground disturbing activities should take place within the scheduled area.

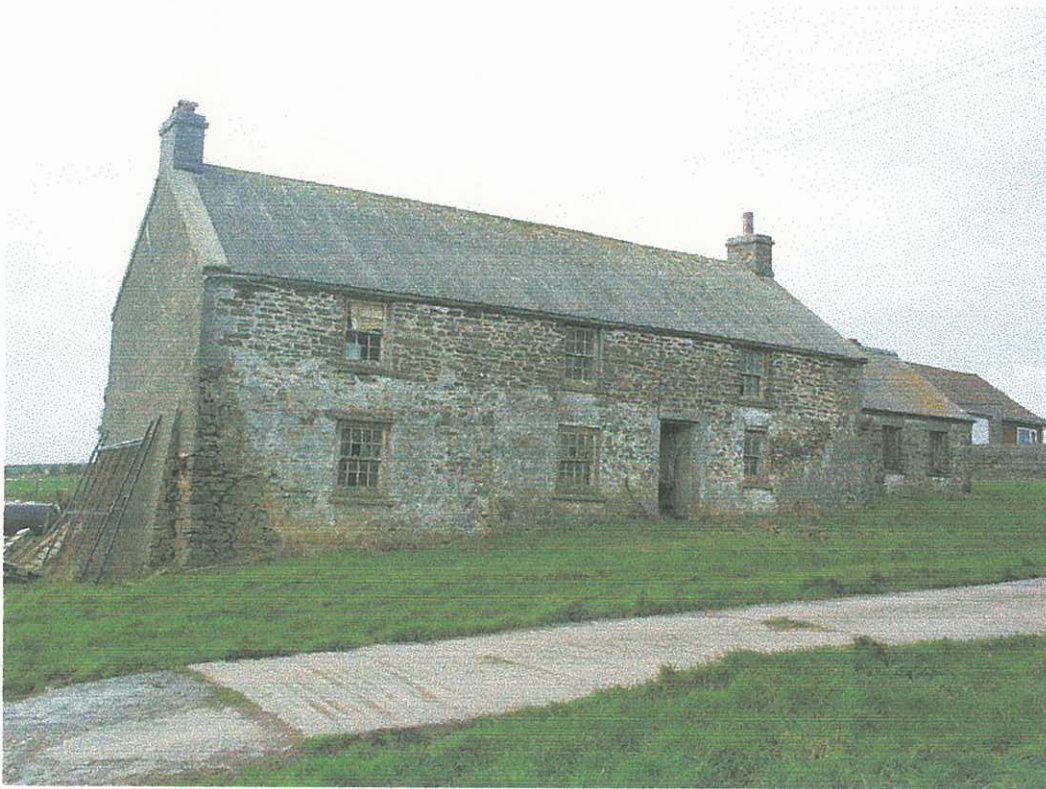
Plate 2 – the uninhabited farmhouse of Parc Cynog (PRN 30537).

The original farmhouse of Parc Cynog appears to be a very interesting building with evidence of various episodes of remodelling and extending (plate 2). The farmhouse appears to have originally consisted of a small one storey structure, at the southern end of the current building. This small building appears to have been extended to the north and subsequently raised to a two storey building. In its' current form the building is two storey, with a stone outshoot to the west and stone chimney stacks positioned at either end. It also has a one-storey extension with pitched roof to the north. It has dressed stone quoins at first floor level and stone watertabling. The roof is pitched, corrugated asbestos. The windows are 8 pane sliding sash to the ground floor (with the exception of the northern window which is 4 pane) and 12 pane sliding sash to the first.

The house has been empty for some time although the farmer, Mr Evans remembers the house was occupied when he took over the farm in 1968. A brief inspection of the interior revealed that some historic fixtures and fittings remain within the farmhouse, such as salting slabs and a stone sink at the northern end of the building and also some wooden shutters still survive at the windows.

This building demonstrates a complex and interesting history which is well preserved within the historic fabric. The farmhouse would undoubtedly be worthy of further archaeological investigation. Mr. Evans hopes that this building will be the subject of restoration, a scheme which would be a very valuable undertaking. It should be stressed that prior to works being carried out on the building a record should be made of the building as existing. Any works carried out on the building should maintain and preserve as much of the historic fabric as possible, including those internal fixtures and fittings such as those mentioned in the description.

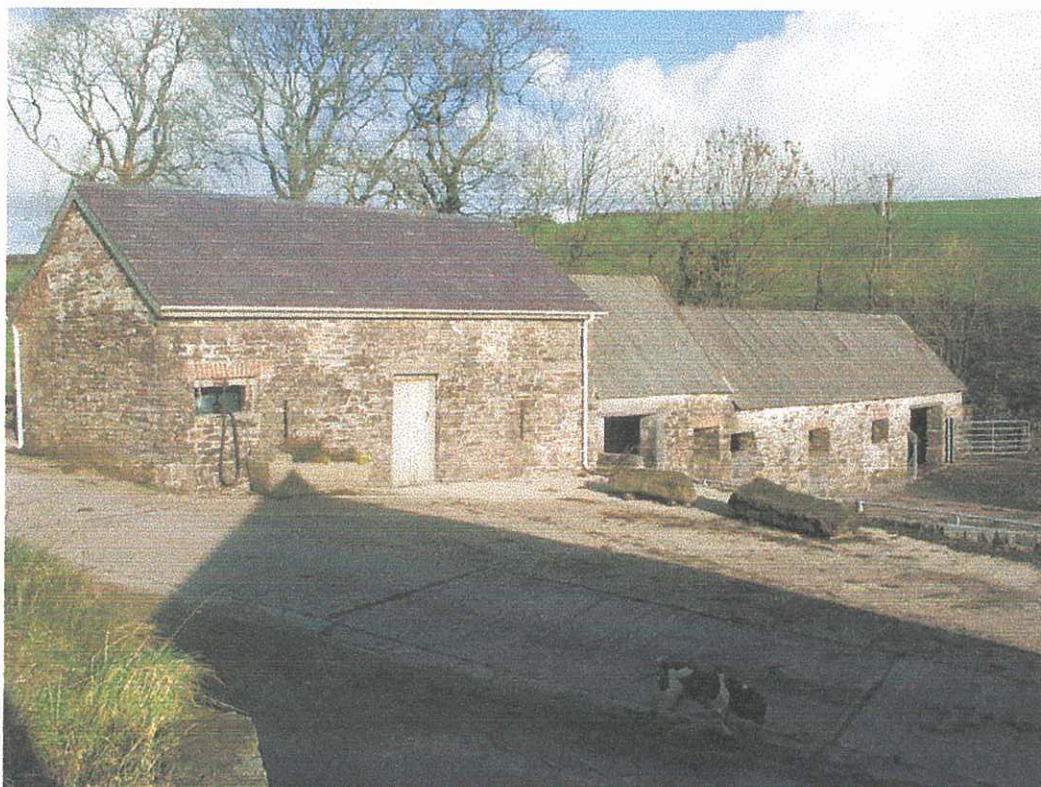
Plate 3 – the range of farm buildings (PRN 44326) at Parc Cynog.

A range of farm buildings at Parc Cynog (Pant glas) are positioned on an north east-south west axis and are composed of three distinct phases (plate 3). At the west end is a one-storey cow byre with a central doorway in the south elevation and two ventilation slits to either side. Further blocked doorways are also visible at either end of the southern elevation. It is constructed out of roughly coursed stone with a pitched slate roof which has been recently renewed. The central doorway and east blocked doorway both have concrete lintels, however the west doorway, which is only partially blocked, has a low brick arch which provides access for an oil pump.

The range of buildings to the east drop in ground level. The middle section has a large entrance inserted into the south elevation and a further doorway and ventilation slit. This section, along with the range to the east, has a corrugated asbestos roof.

These buildings are currently in reasonable condition. They should continue to be maintained in good condition using traditional materials.

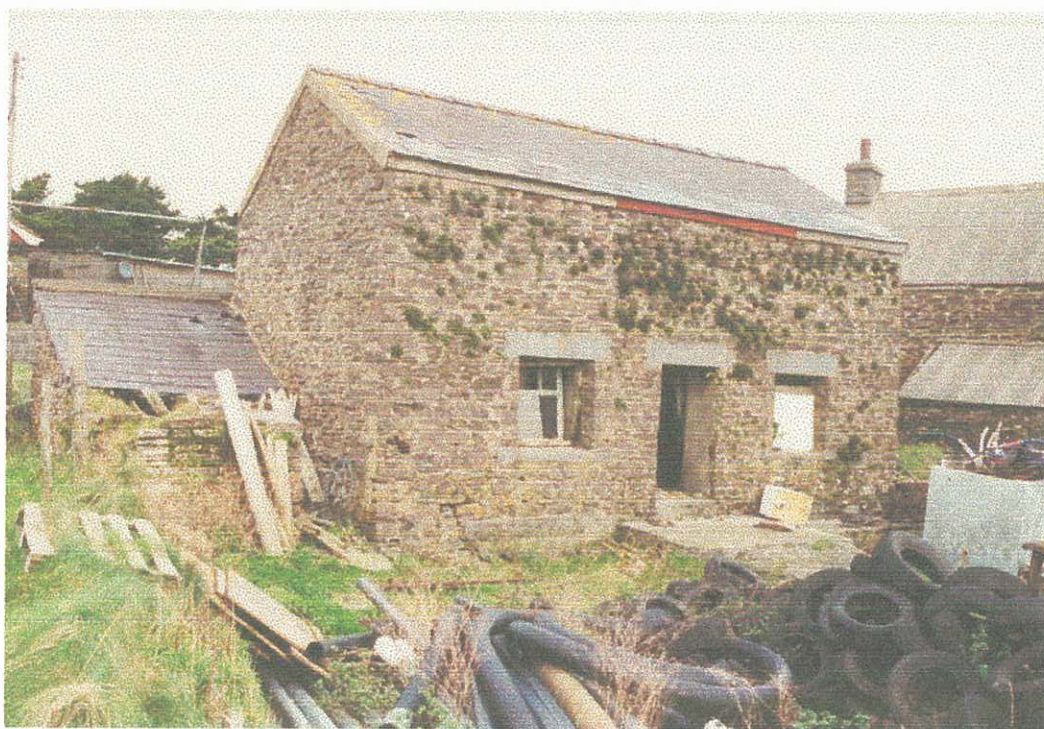
Plate 8 – Stable and adjoining pigsty (PRN 44333 and 44334) at Parc Cynog.

To the west of the farmhouse at Parc Cynog is a stone built two storey stable with a granary above (plate 8). It is constructed out of roughly coursed stone rubble, with a pitched slate roof. The south elevation has a central doorway and a window to either side, all with large stone lintels. External stone steps provide access to the granary at the east end. A few roof slates have slipped, otherwise the building is in fair condition.

The roof to the stable should be repaired and made watertight and the masonry repointed using traditional materials.
