Tir Gofal Farm Visit Historic Environment Report

REPORT NO. 2002/29
PROJECT RECORD NO. 41743

April 2002

NANTHENFOEL
Tir Gofal Farm Visit Historic Environment Report

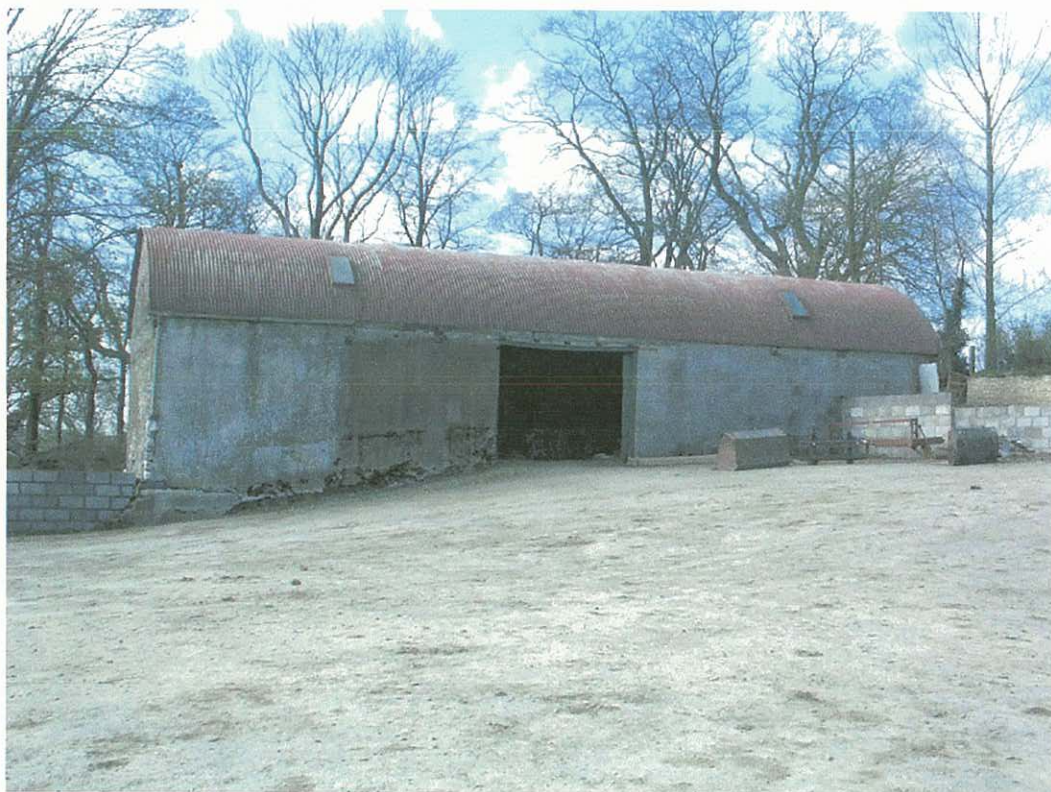
Plate 1 – the north elevation of barn (PRN 44562).

To the south side of the farmyard is a barn approximately 20 metres long by 6 metres wide, orientated on a north west by south east axis (plate 1). The barn is constructed from slate rubble roughly coursed and bonded with a lime mortar mix. The north east elevation has a large double doorway inserted in the centre and to the north of this entrance it has largely been rebuilt in breeze block. The roof was originally a pitched slate roof which apparently collapsed and was subsequently replaced with a round topped corrugated iron roof. An original opening survives in the form of a ventilation slit in the south east gable wall. A doorway is positioned in the north west facing gable to provide access to a first floor granary. Along the south west side of the barn is a stone lined wheel pit (PRN 44566), however no associated machinery survives. The barn is currently in a stable and watertight condition.

The barn should continue to be maintained in a stable condition using tradition materials and preserving the historic fabric as far as possible.

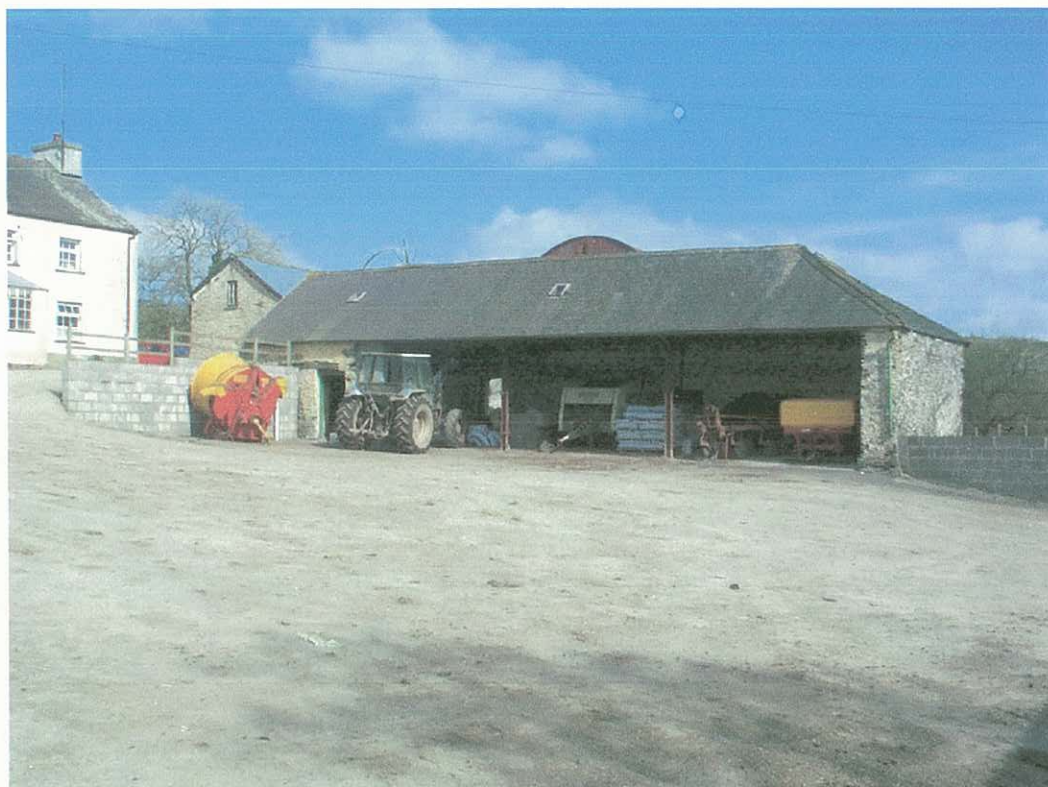
Plate 2 – the former cow shed (PRN 44563), now converted into a machine store.

To the north of the farm yard, parallel to the barn (PRN 44562) is a cow shed (plate 2). The basic building construction is similar to that of the barn, i.e. slate rubble roughly coursed. The cow shed has subsequently been altered to accommodate machinery. Consequently the south east elevation has largely been removed and steel struts and an RSJ now support the roof. The roof is pitched, covered with slate and is hipped at the south east end. At the north east end is a first floor granary accessed by a door in the gable end. The north east elevation has a two doorways and a small square opening at the north end presumably lighting the ground floor room. For the most part the building is in a stable condition, although some roof slates have slipped on the north east side and some areas of masonry are beginning to collapse.

The roof of the cow shed requires repairs in some areas where roofing slates have slipped and the masonry to the north east side also requires consolidation. All repairs and further maintenance should be carried out using traditional materials.

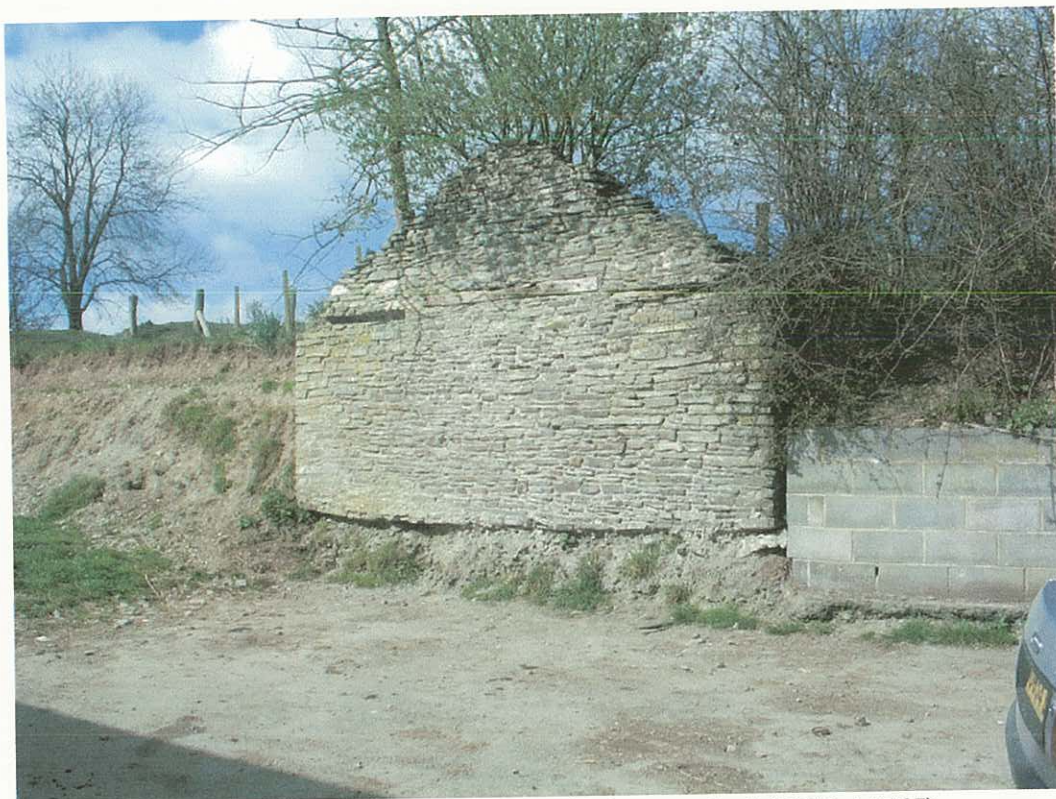
Plate 4 – the surviving north west gable end of a cart shed (PRN 44565).

The north west gable end of a cart shed still survives to the rear of the farmhouse (plate 4). Mr. Williams removed this building some time in the 1970's. Apparently it originally butted up to the farmhouse. The gable survives to its full height and is of similar construction to the other farm buildings. The gable has no foundations and the ground level to the south east has been reduced, consequently the underlying soil is eroding and undermining the masonry.

Ideally the gable wall should be retained as a visible historic feature. This would require works to stabilize the structure. However, in the event that no funding is available to consolidate the structure and it becomes unsafe then an archaeological record should be made in advance of any demolition work.

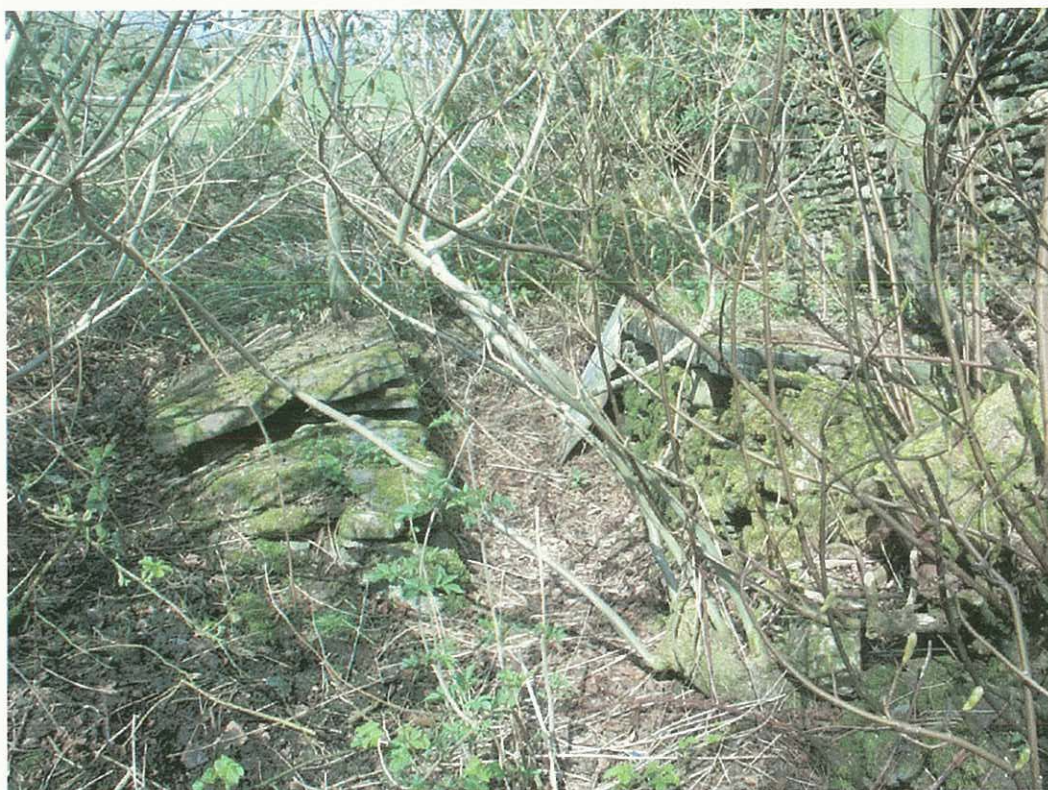
Plate 5 – the stone lined wheel pit (PRN 44566) to the south west of barn (PRN 44562).

To the south west of the barn (PRN 44562) are the remains of a stone lined wheel pit 1 metre wide and 0.8 metres deep (plate 5). The pit is constructed out of slate rubble with massive slate slabs set on either side. Timbers to the north east side are all that remains of the wheel and the associated gearing. Mr. Williams remembers using the water wheel on one or two occasions with little success. Apparently the quantity of water which could be collected in the holding pond was insufficient to drive the water wheel. The wheel pit survives intact although quite silted up and overgrown with young saplings which are becoming established within the masonry.

The intrusive vegetation, which is becoming established within the wheel pit, should be cut back and allowed to die before removal. The masonry should then be consolidated.

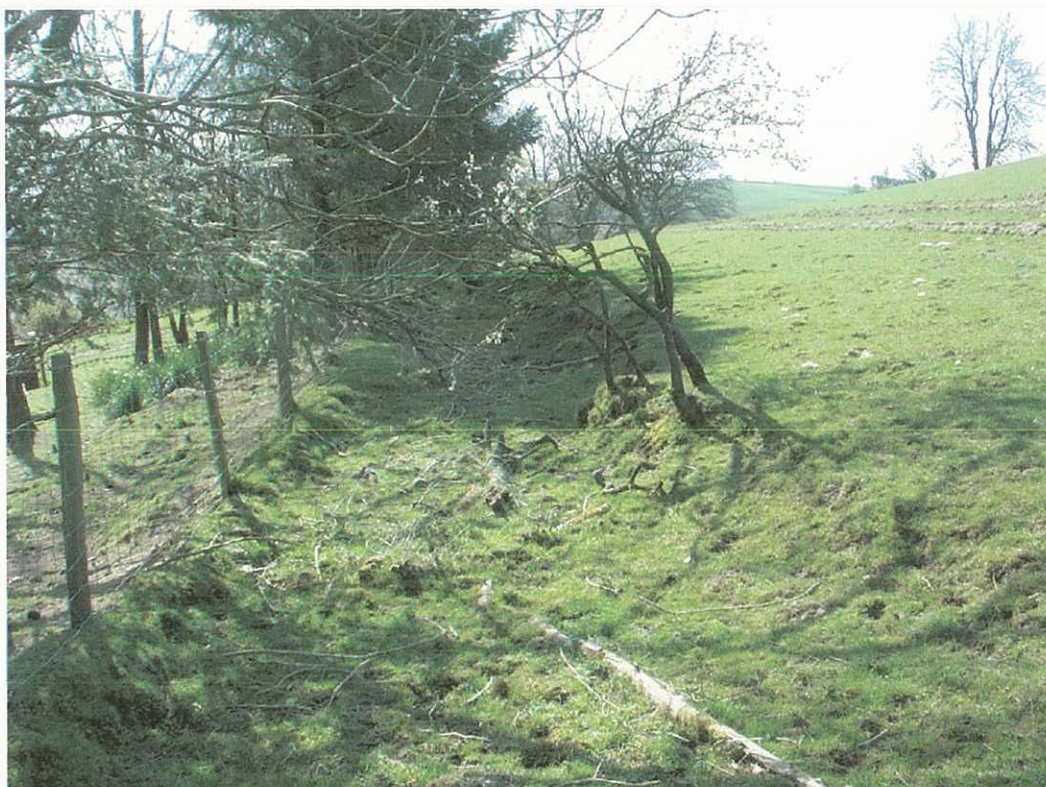
Plate 6 – the water leat (PRN 44567) running south from the holding pond (PRN 44568).

The route of this leat is shown on the 1st and 2nd edition Ordnance Survey maps of 1891 and 1906, and it can still be clearly identified on the ground running along the fence line of the field to the north west of the farmhouse (plate 6). It survives as a depression approximately 0.4 metres deep and between 1.5 and 2 metres wide.

This water leat should be retained as a visible historic landscape feature.

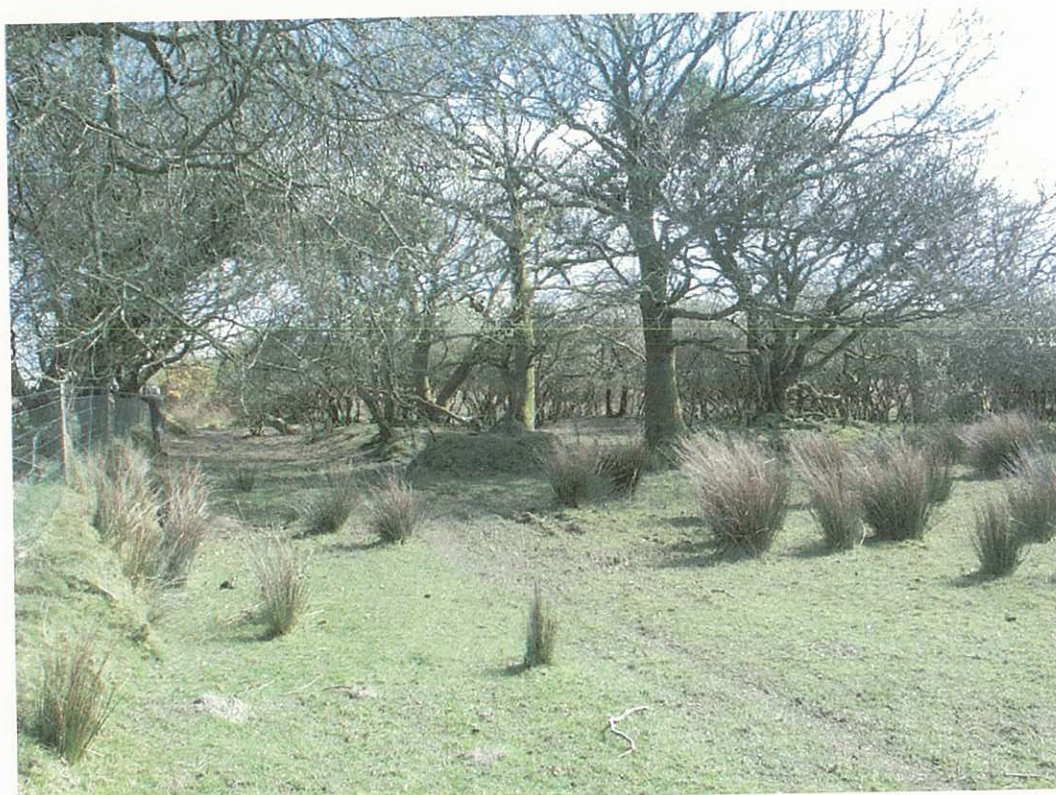
Plate 8 – the remains of the enclosure (PRN 44570) from the west side.

This enclosure is not identified on the Tithe map of 1843 and is only shown on the 1st and 2nd edition Ordnance Survey maps of 1891 and 1906 as a three sided enclosure at the north end of the field boundary. Three sides of the enclosure survive as low earth banks no greater than 0.4 metres high and 2 metres across with overgrown hedgerow trees upon them (plate 8). The interior of the enclosure is very overgrown with thorn trees and the ground surface eroded by sheep that use the enclosure for shelter.

There may well be sensitive archaeological remains surviving below ground level within this enclosure. It is therefore advised that no ground disturbing activities take place in this area. It is also recommended that the dense scrub is thinned out to enhance the visibility of the site.

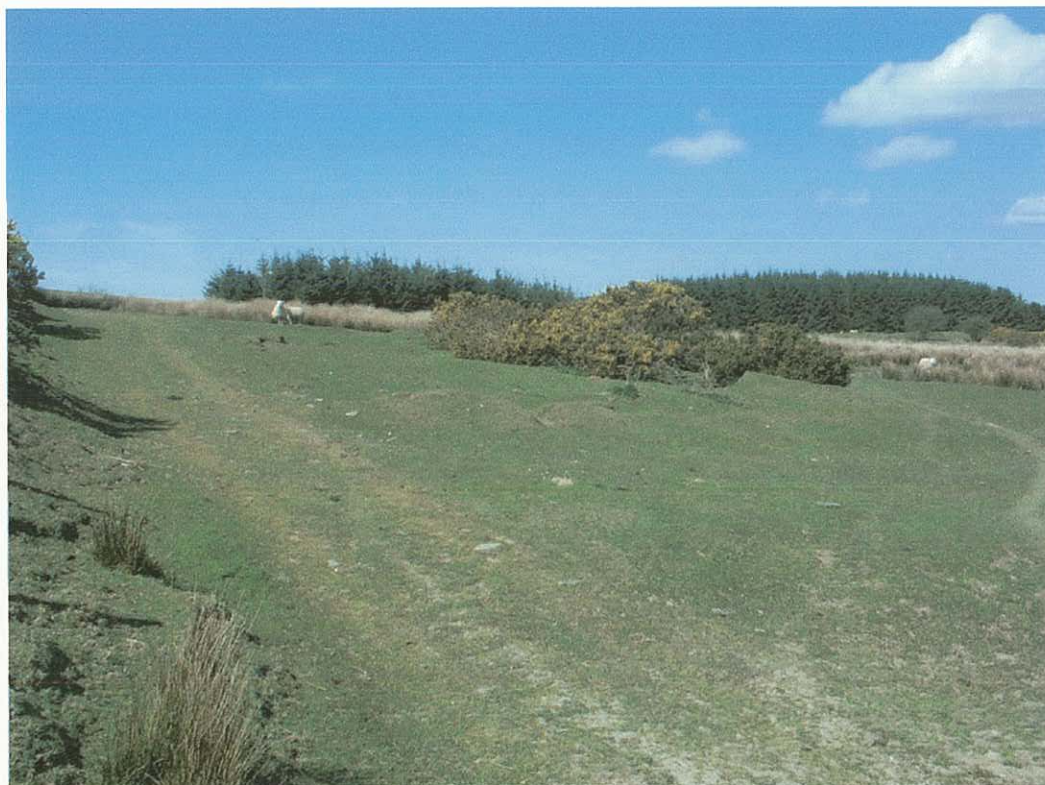
Plate 9 – the remains of an enclosure (PRN 44573) looking north.

A rectangular enclosure is situated to the north east side of an existing field boundary. This enclosure is not recorded on any of the early maps, suggesting that it pre-dates them. The enclosure is defined by low earth banks approximately 2.4 metres across and 0.3 metres high (plate 9). The interior of the enclosure has some raised areas which may indicate the position of buildings or other structures. This may have been a small settlement site of a similar nature to other settlements identified on the farm holding.

The enclosure is partially covered with gorse, but otherwise appears to be in a stable condition.

There may well be sensitive archaeological remains surviving below ground level within and adjacent to this enclosure. It is therefore advised that no ground disturbing activities take place in this area. The gorse which is encroaching on the north corner of the enclosure should be monitored and cut back if it becomes invasive.

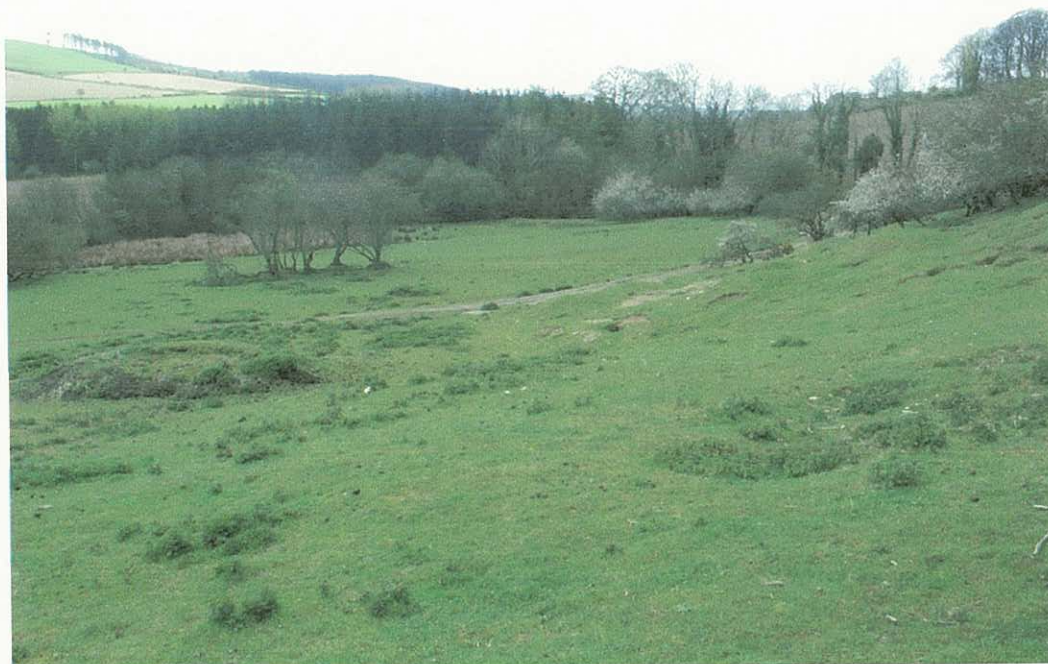
Plate 10 – the site of enclosures associated with the former settlement (PRN 44576).

Currently there is little visible evidence to suggest that a settlement was located in this area. A possible level area to the west of the surviving hedge line would indicate the position of the building recorded on the 1st edition Ordnance Survey map. To the east of the hedge line other levelled areas and the fragmentary remains of a boundary bank may suggest the outline of various enclosures or yards (plate 10).

Although there are few visible remains of the settlement of Nanthenfoelfach there may well be sensitive archaeological remains surviving below ground level. It is therefore advised that no ground disturbing activities take place in this area.
