Pwllau'r Eurych W/12/2298

Tir Gofal Farm Visit Historic Environment Report

Report No. 2002/43

REPORT NO. 2002/43
PROJECT RECORD NO. 41760

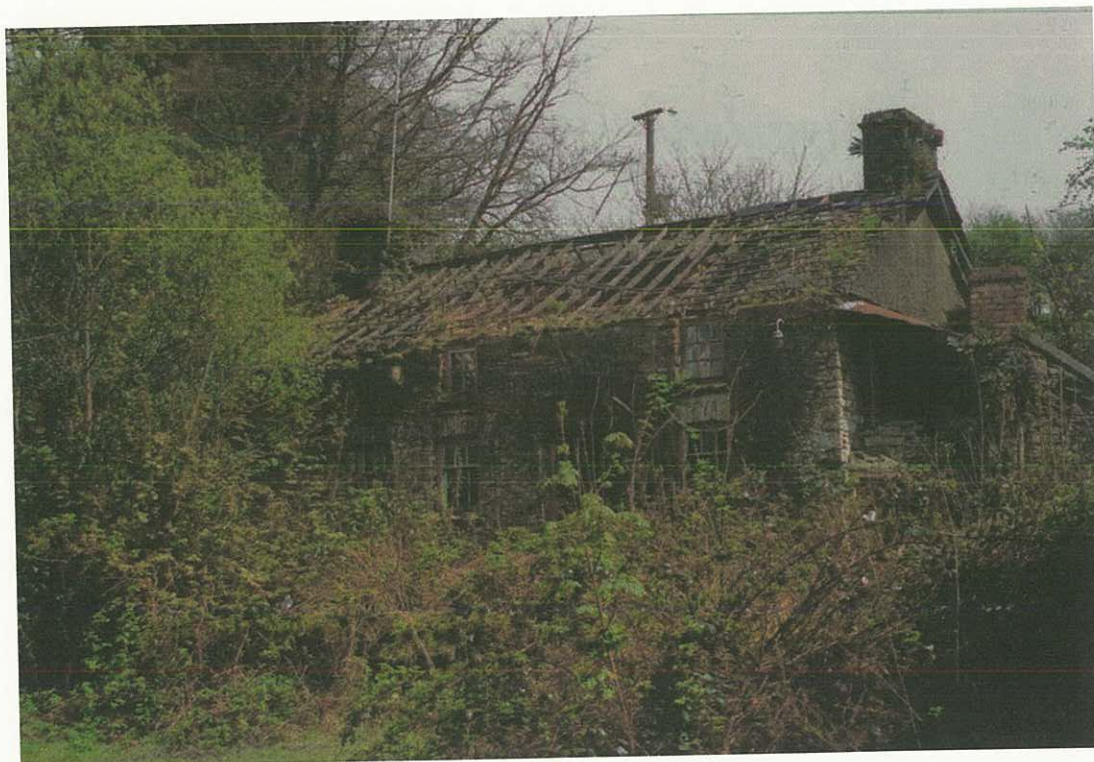
Small farmhouse, probably dating to the eighteenth century and abandoned in the later twentieth century. Now partly ruinous but retaining most architectural features. The front ground floor window frames are particularly interesting.

This farmhouse is built on a wall-fronted platform cut into the lower slope of the hillside and raising it above the trackway. Only partial access to ground floor and exterior could be made. The building is aligned north-south with the front door to the west. Walls are constructed of stone and bonded with lime mortar and the frontage at least is covered in a number of coats of lime wash. Final coat is white but had been ochre at one time. The quoin stones of the building are larger than the wall stones. The front door is no longer attached but the doorframe is *in situ*. The doorway is located slightly towards the south of the building and gives access straight into the main room. Two front windows of nine panes, with the upper three in a horned sash, light the main room, with another similar window into the south smaller room. The lower windows and front door have brick vousoirs in a very slight arch. There are two upper front windows. The one to the south of the door has nine panes and is side-hinged. The other to the north is smaller, of four panes and side-hinged. Both of the tops of these upper windows are at eaves level. The glass in nearly all of these front windows is intact. The roof appeared to have been stripped of slates; nearly all of the rafters and some of the battens are still in place along with some ceiling boards. There are chimneystacks at either end of the main roof, the one to the north has TV aerials: both are in poor condition.

The immediate surroundings of the house are overgrown with scrub that was becoming quite established.

PRN 37624 Pwllau'r Eurych, view NE

In the short term the surrounding area should be cleared of scrub; the roof timbers need to be treated and made good and then a temporary roofing put in place; the interior made safe and cleared of rubbish. In the long term, repair and reoccupation would ensure the preservation of the building. Before any major repairs, a full photographic survey should be made and archived. However, if re-occupation cannot be achieved, then the building should be cleared and recorded by drawings and photographs. There can be little hope of this farmhouse surviving unless it is repaired and re-occupied.

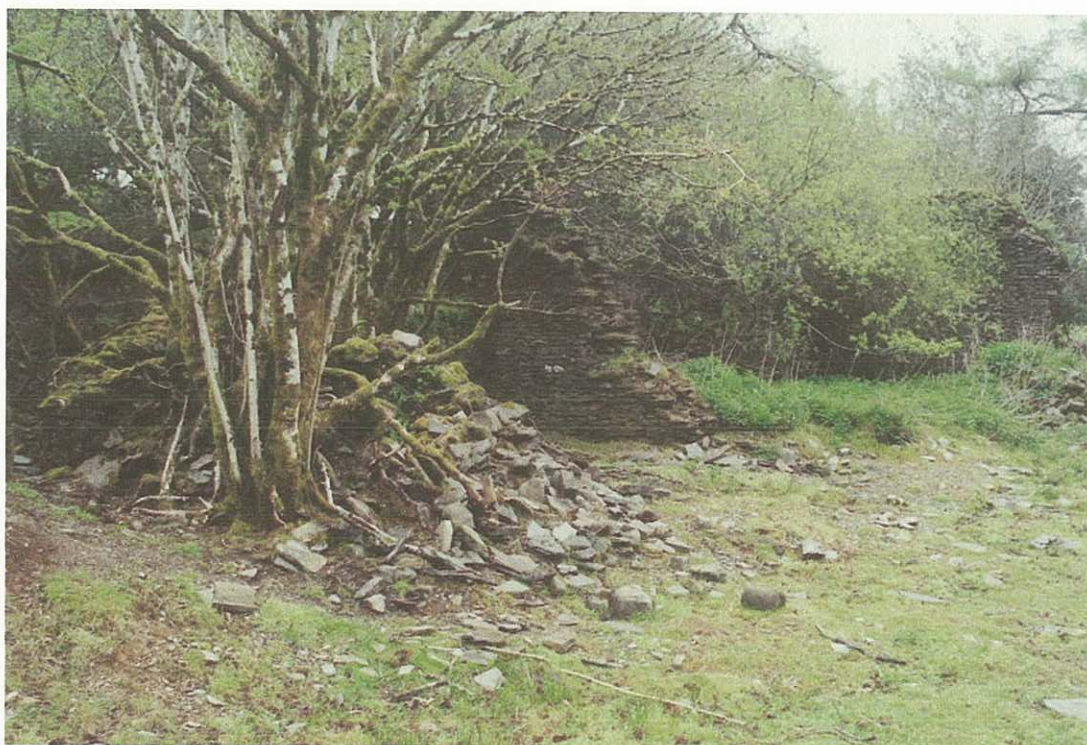
Longhouse farmstead ruin. Probably dating from the eighteenth century. The back wall, end walls and dividing walls stand to almost their original heights and retain some architectural features. The front wall has been destroyed, and scrub trees are taking hold of the structure and surrounding the ruin.

This longhouse is oriented east-west with the front to the south where there appears to be the outline of a garden. The walls are made of flat stones and appear to be lime mortar bonded. The main dwelling room, at the east end, is c 8m long. Its pine end wall is 0.6m wide, stands to c. 4.5m high and contains a flush fireplace. The north wall stands up to 2m high and 0.55m wide and contains a window aperture 0.9m wide near the centre of the room. At the west end of this room there are the remains of, possibly, an inglenook fireplace against a wall 0.6m thick and c. 4m high. Immediately to the west of this there is a doorway 1m wide in the north wall. This mid section is approximately 11m long and could be the remains of the byre. It appears to be contemporary with the dwelling. Butted against the west end of the byre is a single cell c. 2.5 m wide; this gave access to another cell c 1.5m wide through its west wall, the north wall of which is set in from the main wall line. The south wall of this latter cell is also set further back than the probable line of the front wall. The walls of these western two cells are constructed of more rounded stones.

PRN 37626 Bennoeth Farmstead, view E

Remove and clear trees and scrub from around walls. Carefully cut leaving roots in place. Treat stumps to prevent re-growth

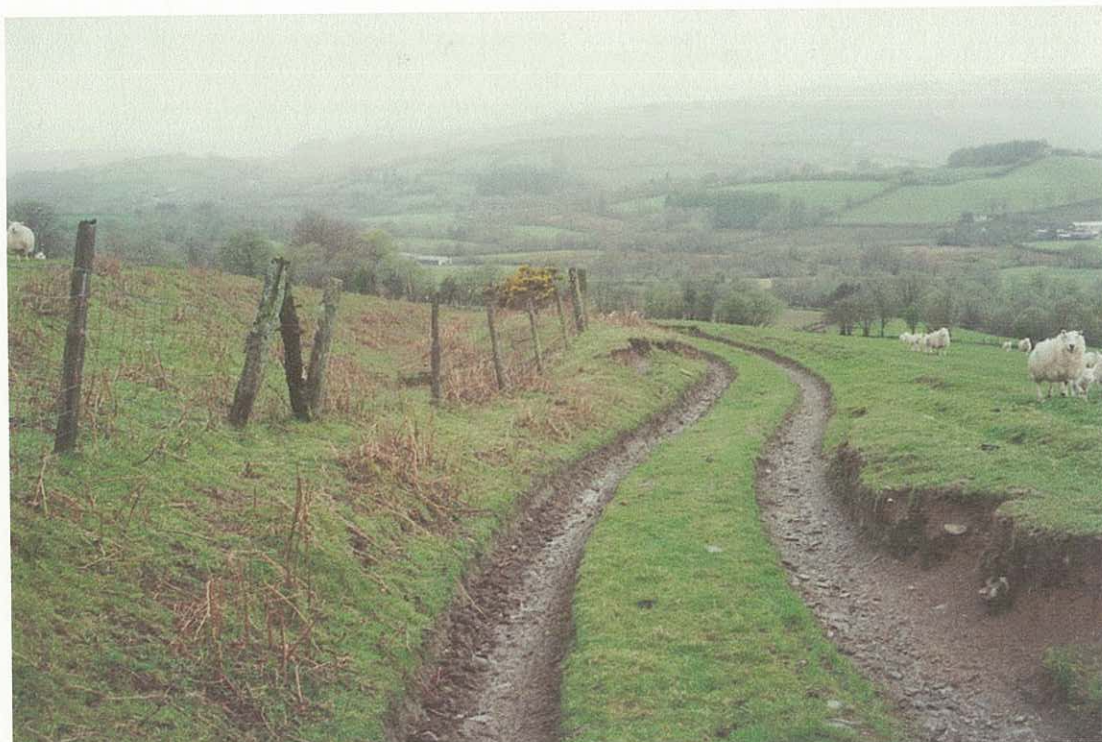
Trackway noted from the Ordnance Survey, drawings 1811-2 sheet 187. The trackway leads from or past the former farmstead of Bennoeth/ Pennoeth to the minor road connecting Llansawel to Esgerdawe. The lower part is more metalled without a central ridge and is well used from west of the modern farm buildings to the road. The mid section has larger stones forming the surface and a central ridge and is partly re-routed around an abandoned sunken section that indicated a lot of use in the past (photo, left of current route). The upper sector may have been un-metalled. The trackway is now little used.

PRN 37631. Note sunken way left of fence, view W

Retain current nature of middle and upper sectors of trackway east of modern farm buildings.

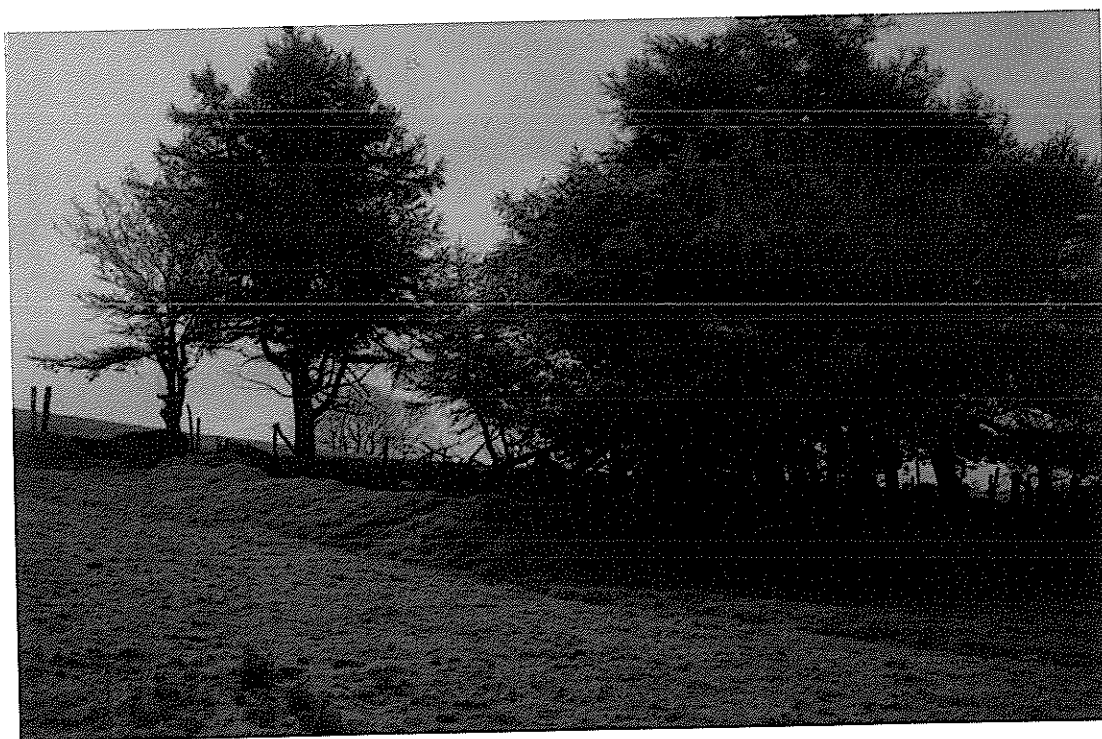
Probable site of a small barn, rather than a cottage, as indicated on Ordnance Survey 1890 map. Building not on Ordnance Survey 1907 map. Trapezoid enclosure in west corner of field. Enclosure approximately 30m x 18m, earth banks 0.75-1.0m high. No surface evidence within small enclosure, now a small tree plantation.

PRN 37632 Enclosure, view E

Avoid ground disturbance in southwest corner of enclosure. Maintain enclosure boundaries etc.

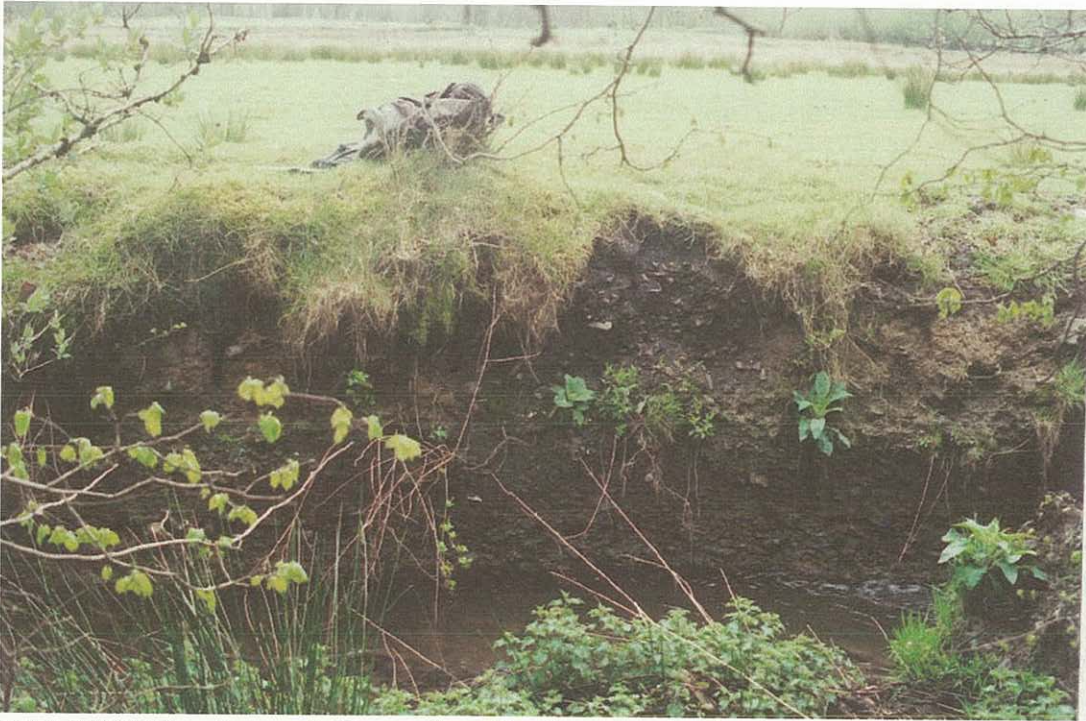
Small burnt mound. Semi circular, of 8m to 9m diameter and c. 0.5m high maximum. Cut on the southwest side by meander of small stream that has created a vertical bank at this point. In the top of this bank there is an exposed 0.4m depth of very dark charcoal rich soil and fire-cracked stone. There were several larger mounds in this field and the adjacent field to the northeast; although most probably natural, these could also be burnt mounds.

PRN 44885 Burnt mound. Exposed section in stream bank, view E

It is recommended that the mound should not be disturbed in any way. However, it should still be grazed to discourage large plants establishing themselves and causing root disturbance. The stream erosion needs to be monitored and if it continues then archaeological sampling and/or excavation may be appropriate.

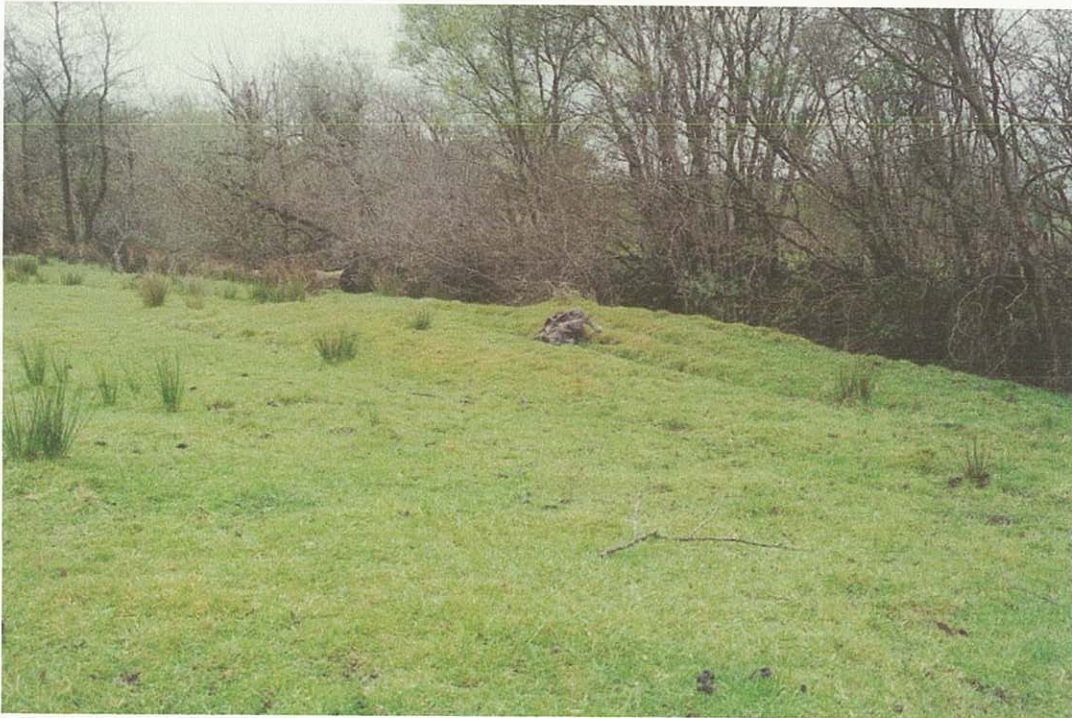
PRN 44885 Burnt mound. view SW

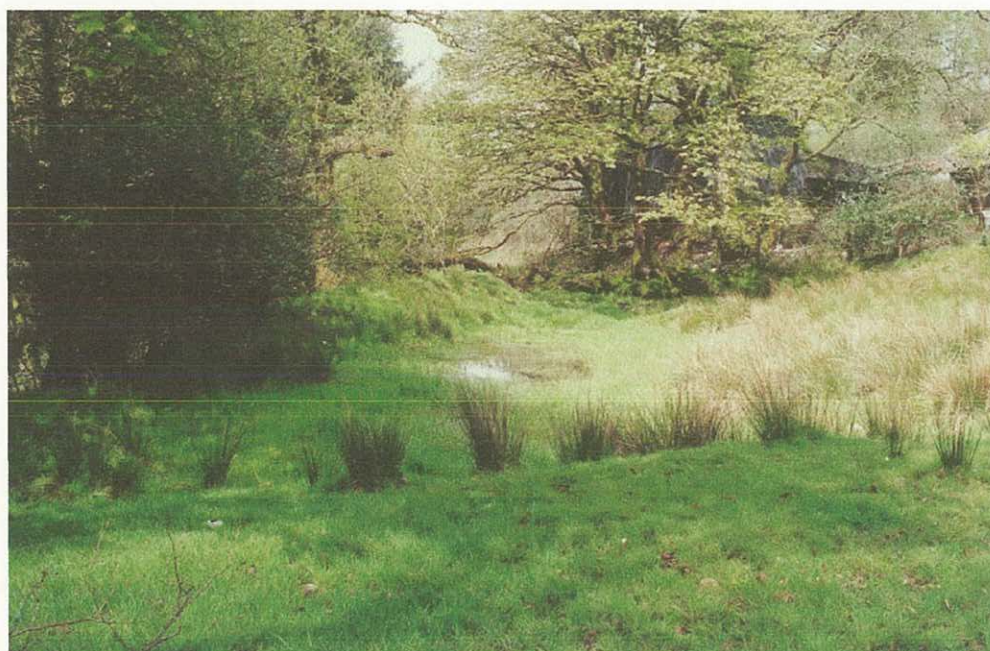
Small dam or earth bank, in fair condition, associated with pond PRN 44887 just to the south west of the old farmstead.

PRN 44886 and 44887 Dam and pond, view N

Smallish pond, partly overgrown, associated with dam or earth bank PRN 44886 just to the south west of the old farmstead.

No action necessary but should not be allowed to become overgrown.

No action necessary but should not be allowed to become totally overgrown.

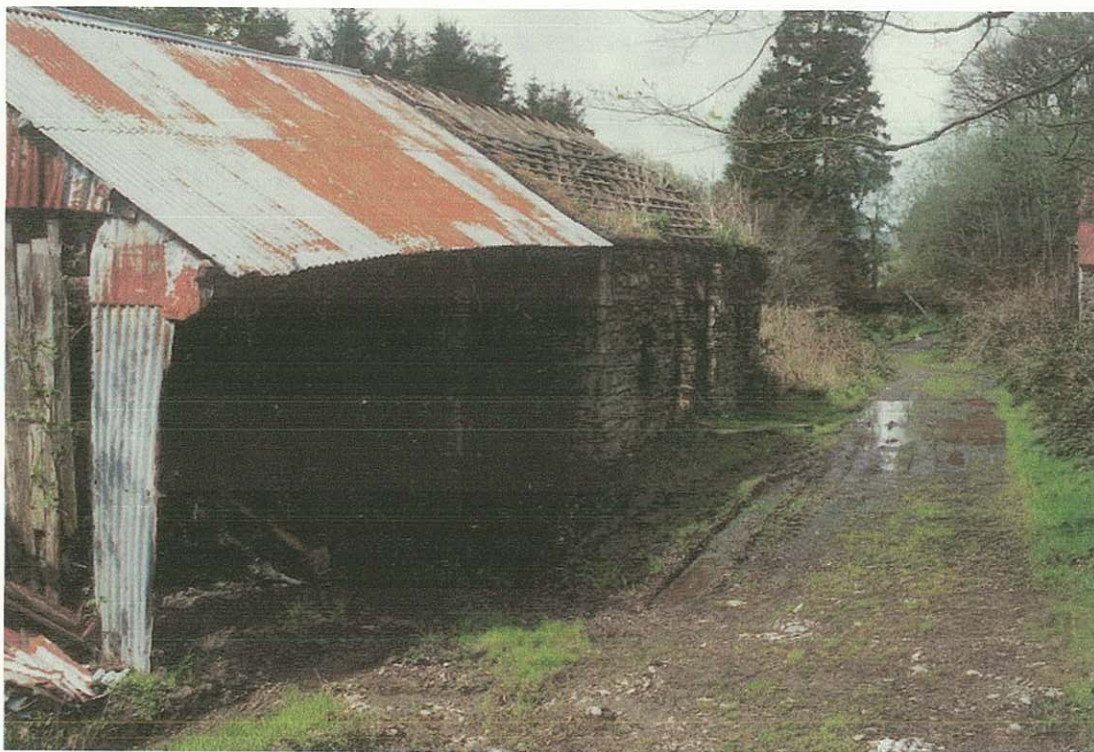
Abandoned stone walled cart shed with double doorways front and rear. Collapsed corrugated iron lean-to to rear, used corrugated iron extension to south.

Stonewalls of cart shed are lime bonded and nearly all intact. There are the remains of double split front stable doors. Vent slits are on either side of the front doorway (east). One vent is below a hayloft hatch in the south wall. There is also one large vent to north of rear doorway (west), another possibly to the south of doorway where a "fume" cupboard? Has been inserted. Roof timbers still remain but no roof covering.

PRN 44888 Cart shed, view NW

The internal areas need to be cleared of debris. The buildings and the old farm machinery need rapid recording, with these records being deposited in an appropriate archive. A secure home needs to be found for the better pieces of old farm equipment. The cart shed should be re-roofed and the walls made good. The extension to the south should be maintained. Dumped rubbish to rear should be disposed of.

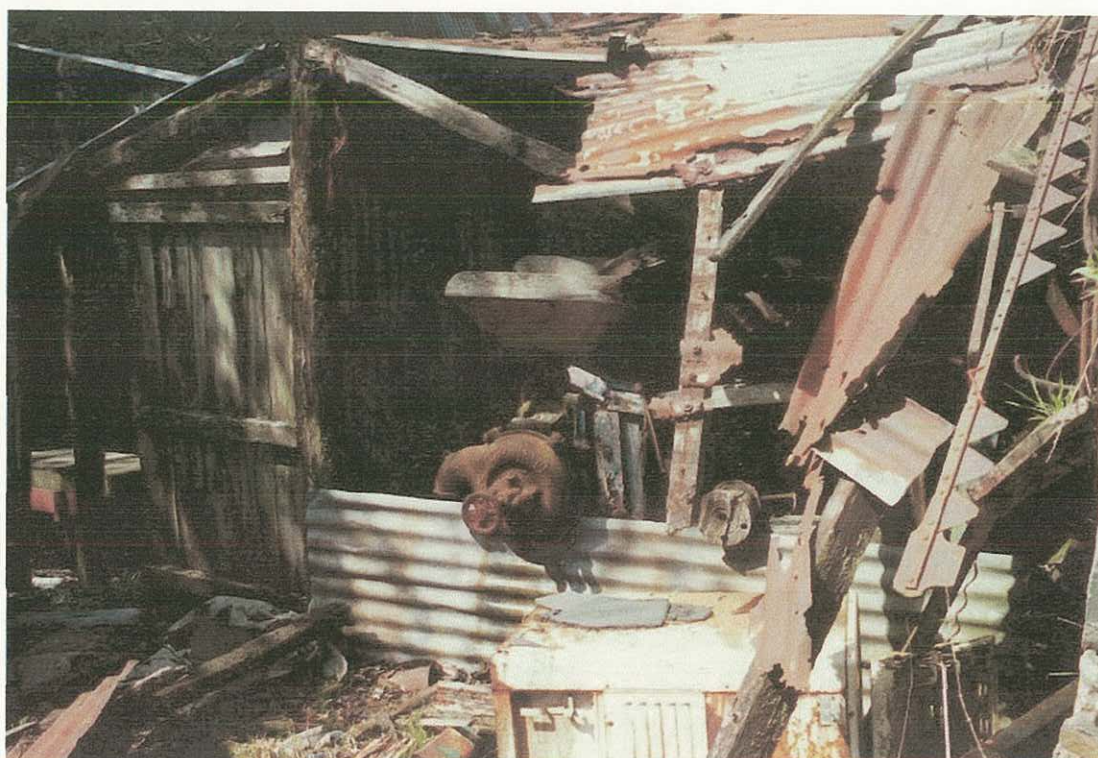
The rear lean-to of corrugated iron has collapsed. There is some farm machinery including a fixed shaft and belt drive wheels. The part of the lean-to to the north of this is still standing and contains old farm equipment.

PRN 44888 machinery to north of rear lean-to for the cart shed, view N

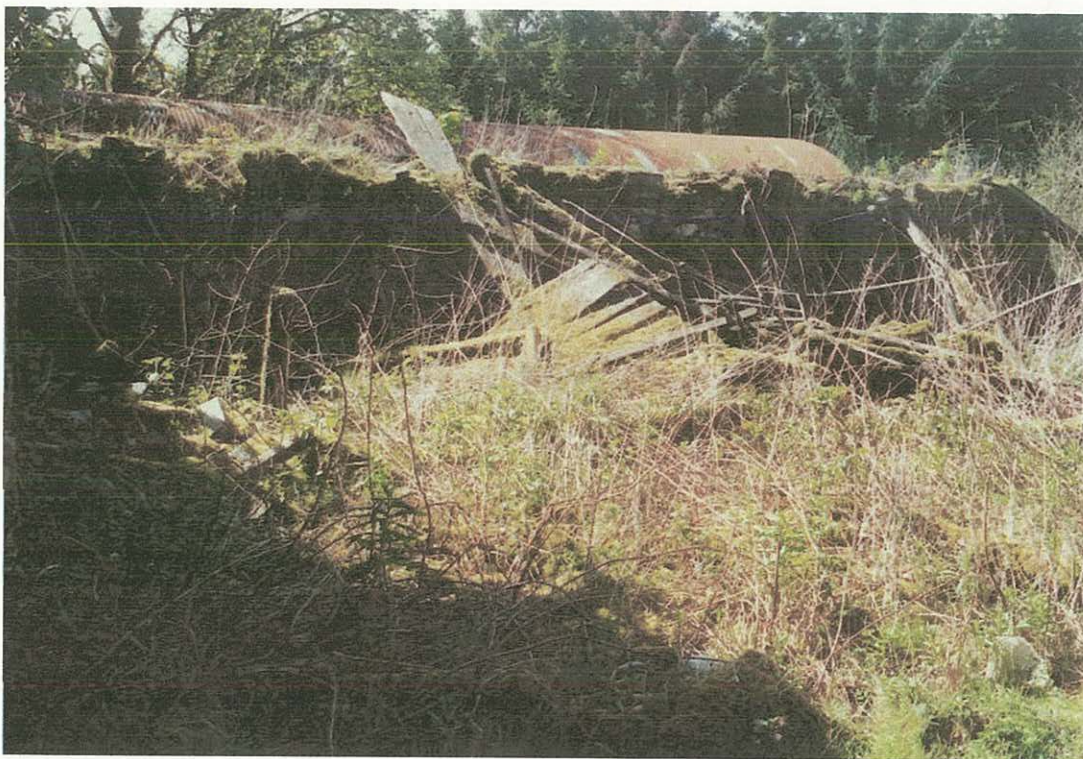
Collapsed shed with intact rear wall. The rear wall is of mortared stone construction with window apertures higher up. The front was probably open fronted pole construction. The whole of the roof has collapsed. A stone built lean-to to rear contains two animal pens to the rear (west). This rear part is still roofed with corrugated iron.

PRN 44910, Shed with collapsed frontage and roof, view W

The collapsed debris should be cleared any internal features below should be left intact if possible but at least recorded. The rear wall needs to be made good and the lean-to to rear maintained.

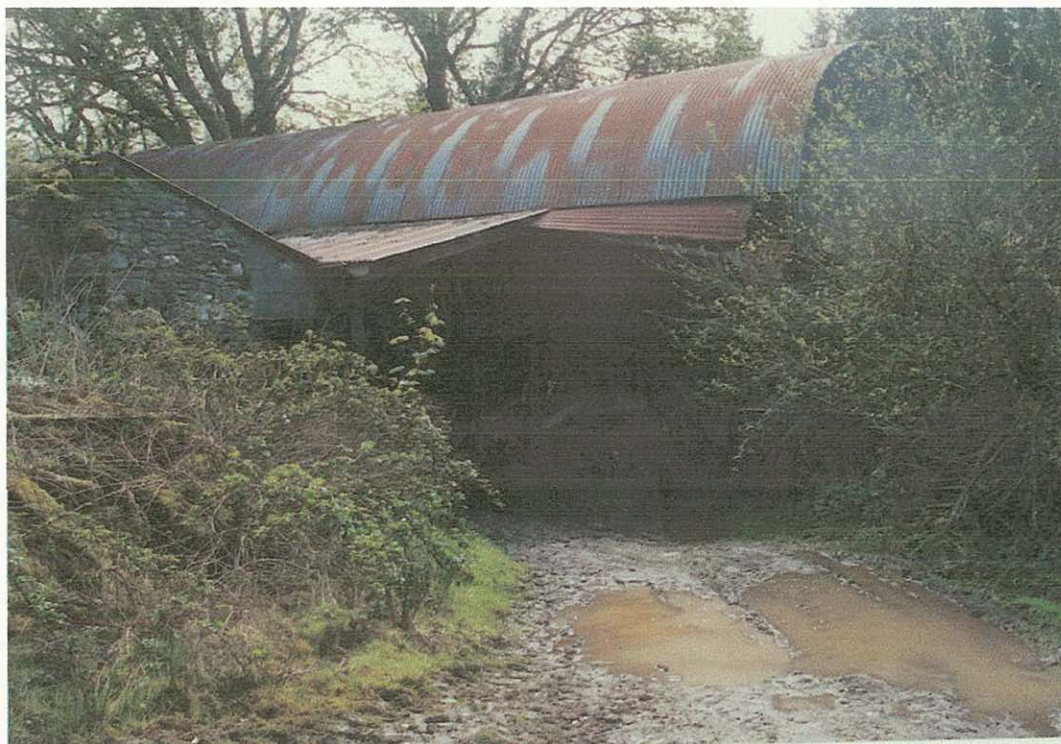
Modern pole barn probably dating to the mid 1900's and still used as a hay and equipment store.

The barn is constructed with re-used railway rails as poles. The rear (west) part is arched roof and a slight inclined roof joins it to the lean-to behind PRN 44910. All of the cladding and roof is of corrugated iron. This is a nice example of this type of barn and still in fair to good condition.

PRN 44911 Pole Barn, view SW

This barn should be used and maintained. If the elevator is no longer used it should be stored or be found a good home.
