Report Prepared for:
Countryside Council for Wales

REPORT NO. 2002/30
PROJECT RECORD NO. 41807

Dolaucothi W/12/2469
Tir Gofal Farm Visit Historic Environment Report

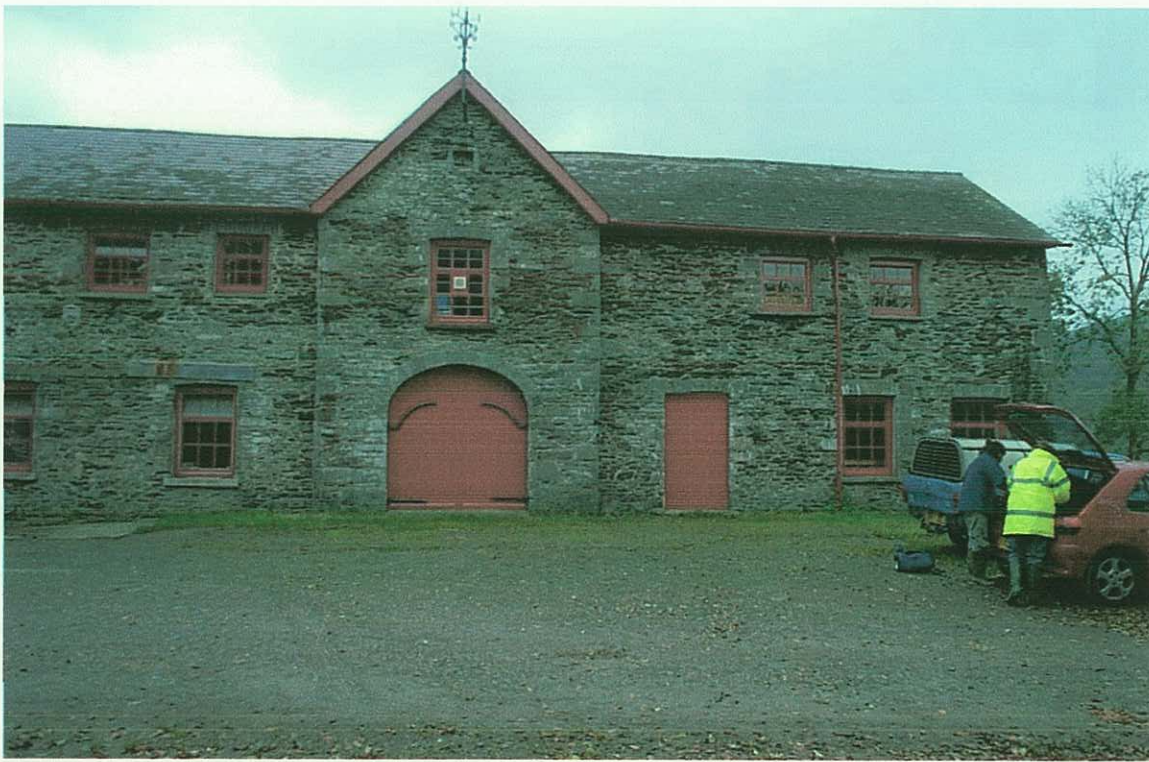
Plate 1 **Southern end of stable range PRN 44462**

The southern end of this range of buildings is used by the National Trust as volunteer accommodation (Plate 1). The interior of this part and the upper floor of the entire range were not visited. This range is not on the map of *circa* 1770 but is recorded on the Cynwyl Gaeo tithe map of *circa* 1841.

Maintain the building in current condition. Care should be taken to prevent damage to the stalls from general wear and tear and from chewing/rubbing by animals (plate 6). Repair to damaged cobbling could prevent further deterioration. This should be undertaken using appropriate materials rather than patching with concrete. Likewise, repair to the lath and plaster could also be undertaken using appropriate materials. Any structural maintenance works should be undertaken using appropriate materials and techniques.

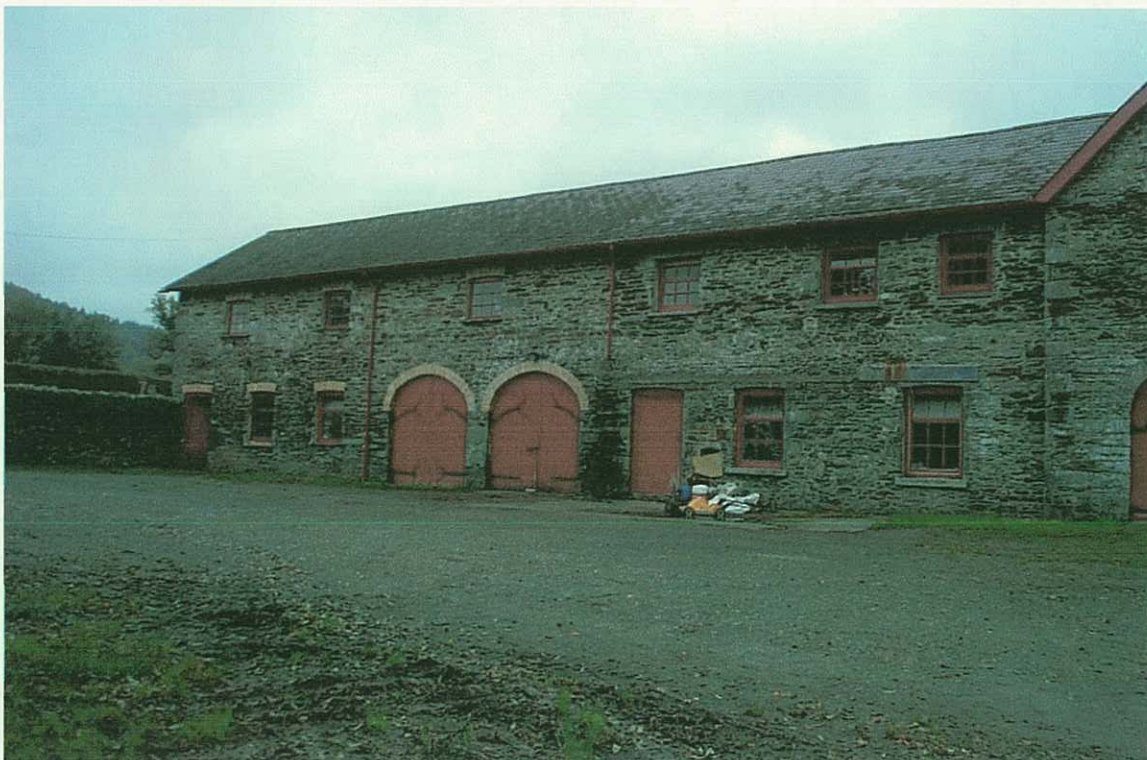
Plate 2 **Northern end of stable range PRN 44462**

For the purpose of this description the interior of the northern end of the stable range is divided in three; the central area with cart-entries, the southern end (plate 4) and the northern end (plate 5). The area inside the paired cart-entries has rendered walls and concrete floor. Moulded detail around the interior of the door and window openings on eastern walls are visible. This section is used as a work shop.

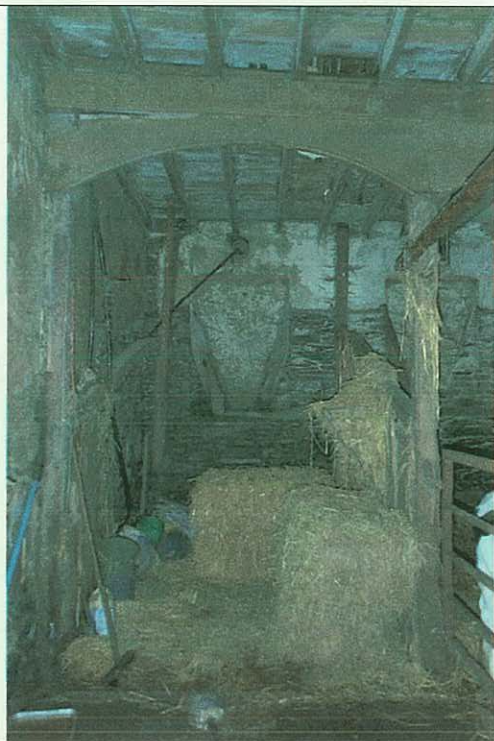
Plate 5

The interior of the northern end of this part of the range is now used as calf housing. The floor is concrete and the ceiling is lath and plaster. The woodwork of the stalls remains in good condition and there are insets for hay mangers on the west wall.

**Plate 5 Northern end of stable
range PRN 44462**

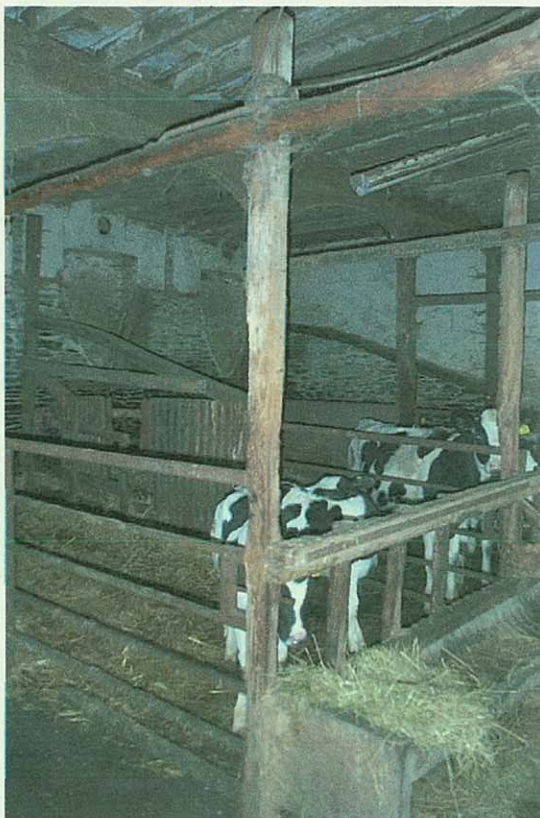
Plate 6

**Plate 6 Interior of northern end of
stable range PRN 44462**

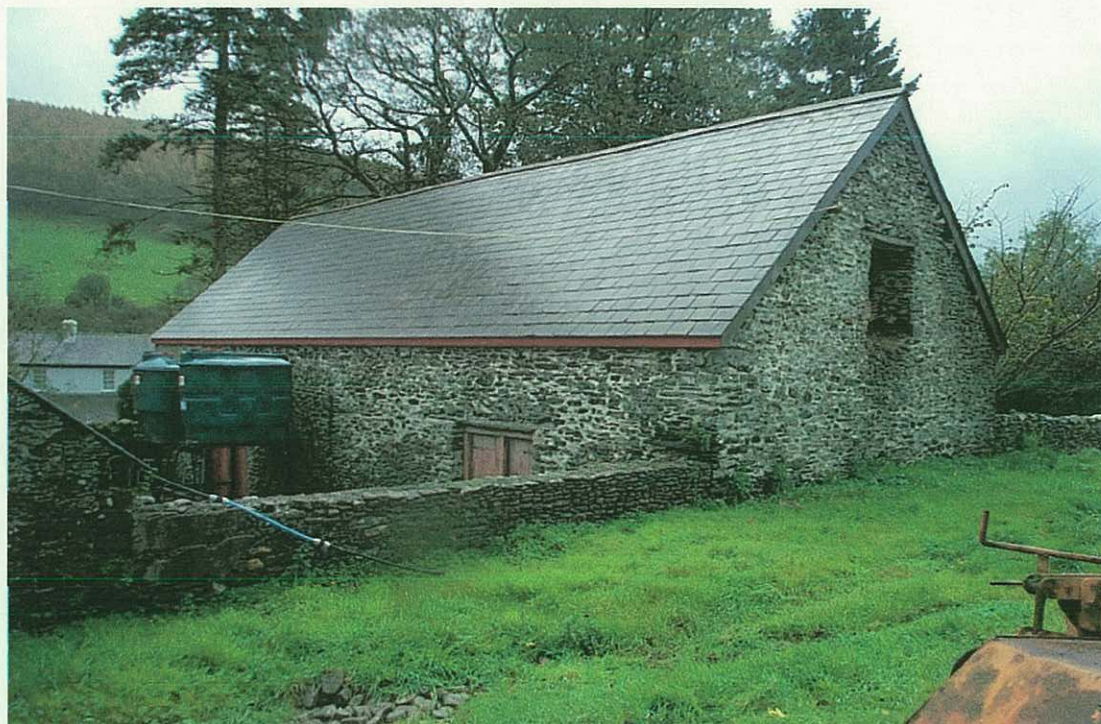
Plate7 Threshing Barn. View of west gable PRN 44463

The threshing barn (plate 7) is directly south of the cart shed and possible tack room (PRN 44464). These buildings have enclosing walls to the east and west to make a small yard with an entrance to the north. Rubble built with slate roof the barn is a rectangular building approximately 18 metres x 6.5 metres. It has large opposed doors to the east with smaller opposed doors to the west. The roof extends over the large door on the south side (plate 7). The barn has a loft door on the west gable (plate 8) and a narrow light on the south side. The building was recently re-roofed. This barn is probably the building noted on the map of the estate drawn *circa* 1770.

The barn should be maintained in its current condition. Any works should be undertaken using appropriate materials and techniques.

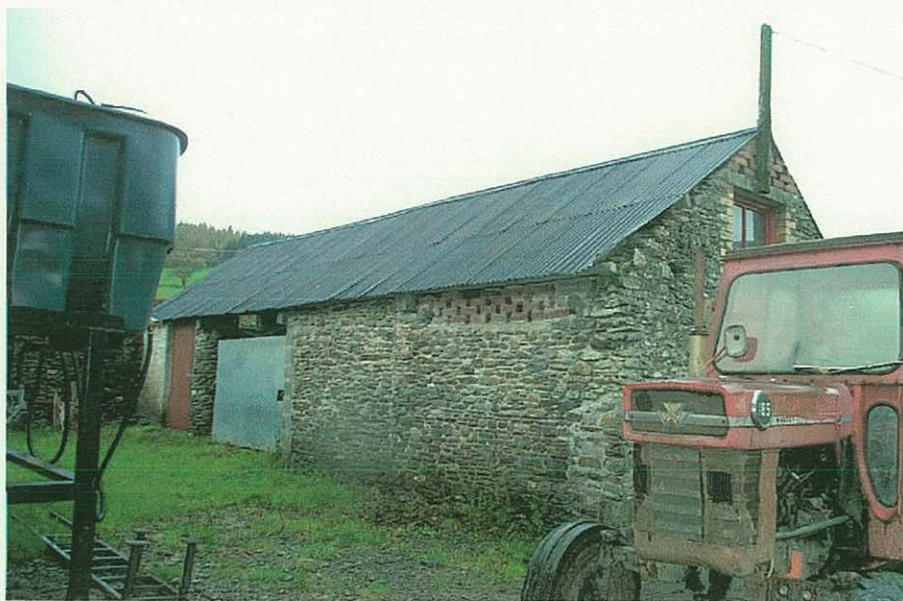
Plate 8 Cart shed and possible tack room PRN 44464

The cart shed and possible tack room (plate 8) are immediately north of the threshing barn. These buildings are not on the map of *circa* 1770 but is recorded on the Cynwyl Gaeo tithe map of *circa* 1841. These buildings have enclosing walls to the east and west to make a small yard with an entrance to the north. Built of rubble, and now with corrugated tin roof, the cart shed has four rounded pillars to the south. The openings between these pillars now have rubble infill. The eastern infill is topped with bricks allowing ventilation. The cart shed currently has a half loft along its length and a window in the east gable. The brickwork around this window suggests that this building may be the same age as the northern end of the stable range. The building has some breeze block repair and also some concrete repair. The cart shed is currently used to house calves. The small room at the north end of the building may have been a tack room for the cart shed. The room has a small door to the south and small openings in the north gable. No internal features were noted. This room is currently used to store old dairy equipment.

The cart shed and possible tack room should be maintained in their current condition. Any works should be undertaken using appropriate materials and techniques.

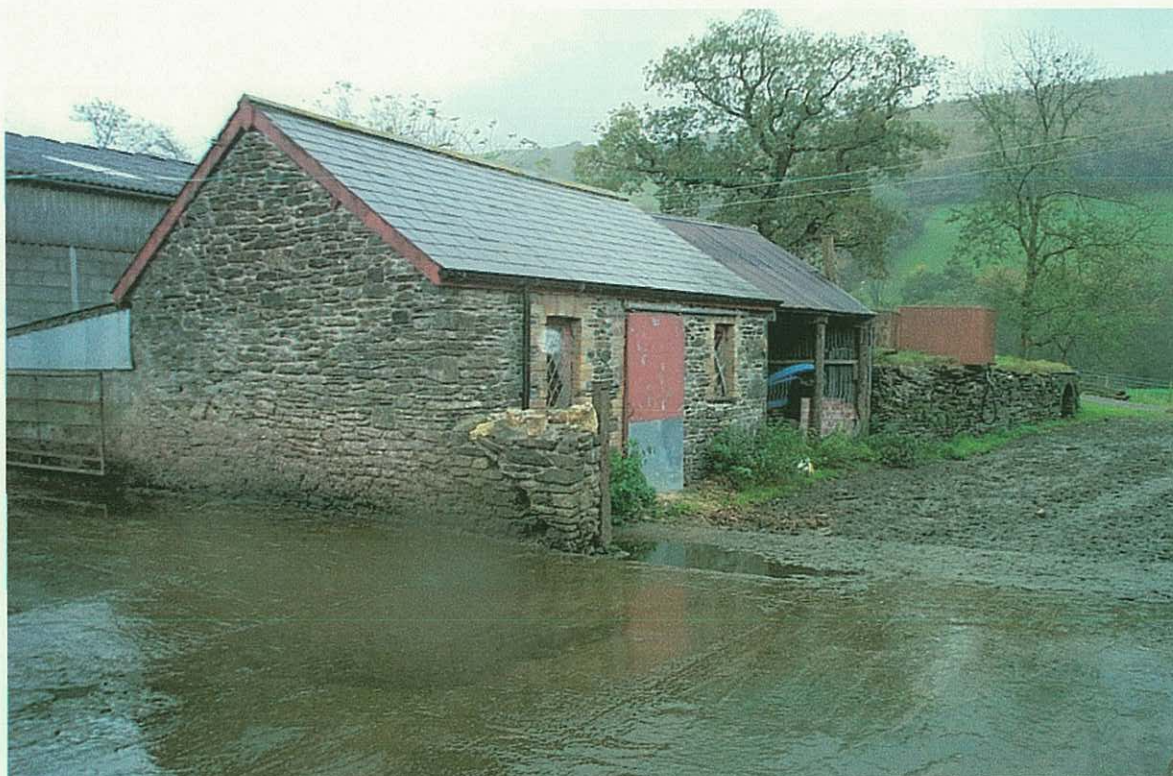
Plate 10 Stock house PRN 44466 with shed PRN 44467 and potato clamp PRN 44465 to right and side wall of poultry house to left PRN 44468.

Rubble built structure (plate 10) with newly slated roof and metal latticed windows, currently with metal sliding door. The stock house is not on the Ordnance Survey map of 1891 but is recorded on the Ordnance Survey map of 1907. Built with the appearance of a small cottage this building appears to be around the same age as the stable range (PRN 44462). The structure appears to be sound but the windows are in poor condition. It is currently used to house calves.

A shed with timber supports and corrugated tin roof is located between the stock house and the potato clamp (plate 10). This shed is not on the Ordnance Survey map of 1891 but is recorded on the Ordnance Survey map of 1907. This is a good example of the continuing change in building materials and techniques to be found on this farm as well as an important example of the maximisation of space within the farmyard. This shed is currently used for storage.

The windows require urgent remedial action to prevent further deterioration and to maintain the character of the building. Otherwise, maintain the structure in its current condition using appropriate materials and techniques.

Maintain this shed in current condition.

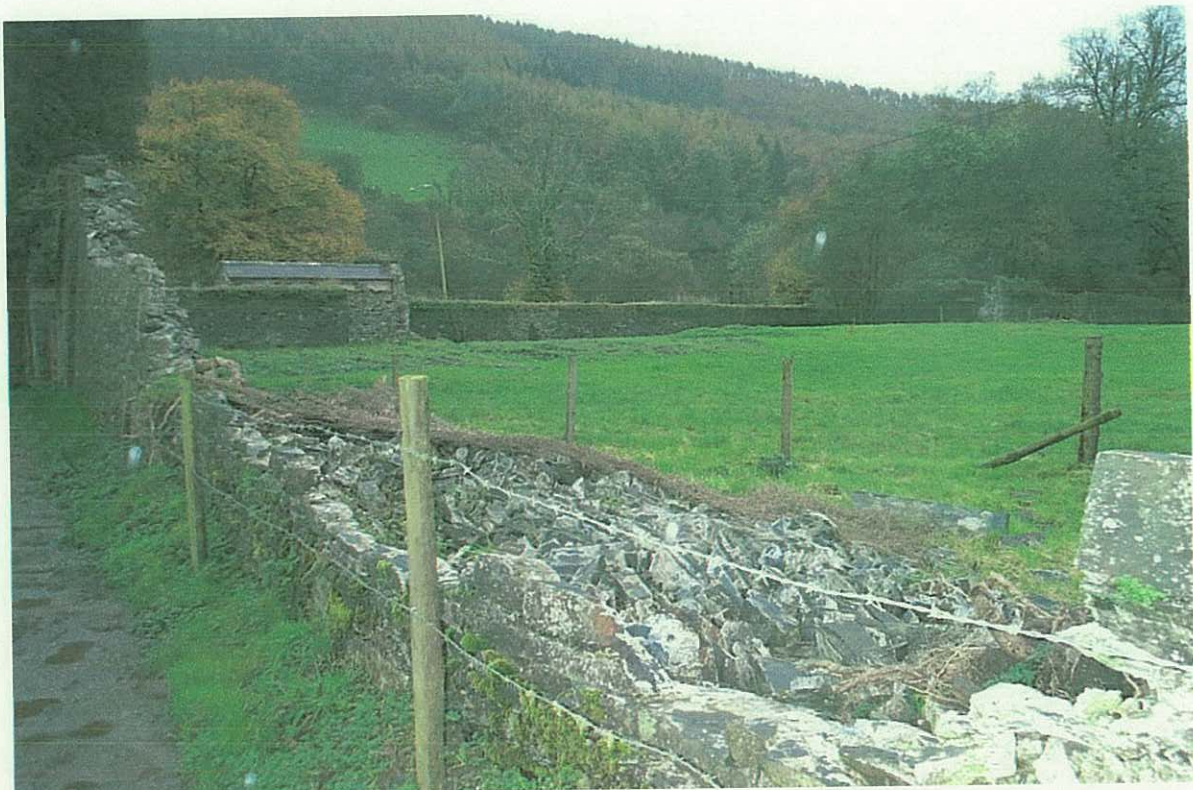
Plate 14 Eastern, collapsed, side of walled garden

There is currently a trench on the east side of the walled garden which appears to be used for draining foul water. In addition, a quantity of scalplings/subsoil has been spread across the north east corner of the walled garden. There is a substantial area of collapse on the north east wall of the garden caused by cutting ivy that had penetrated the masonry. (Plate 14) Other areas of the wall are covered in ivy growth. The south-west wall is supported by brick buttresses of some antiquity (Plate 15).

In order to maintain the walls the ivy should be cut but not removed. At the same time consolidation work should be undertaken to prevent further collapse. A solution should be found to the drainage problem and the trench infilled. No further disturbance should be undertaken without archaeological supervision. The scalplings/subsoil should be removed without disturbing the ground surface.
