Gwarglwydeth

W/12/2367

Tir Gofal Farm Visit Historic Environment Report

REPORT NO. 2002/27
PROJECT RECORD NO. 41808

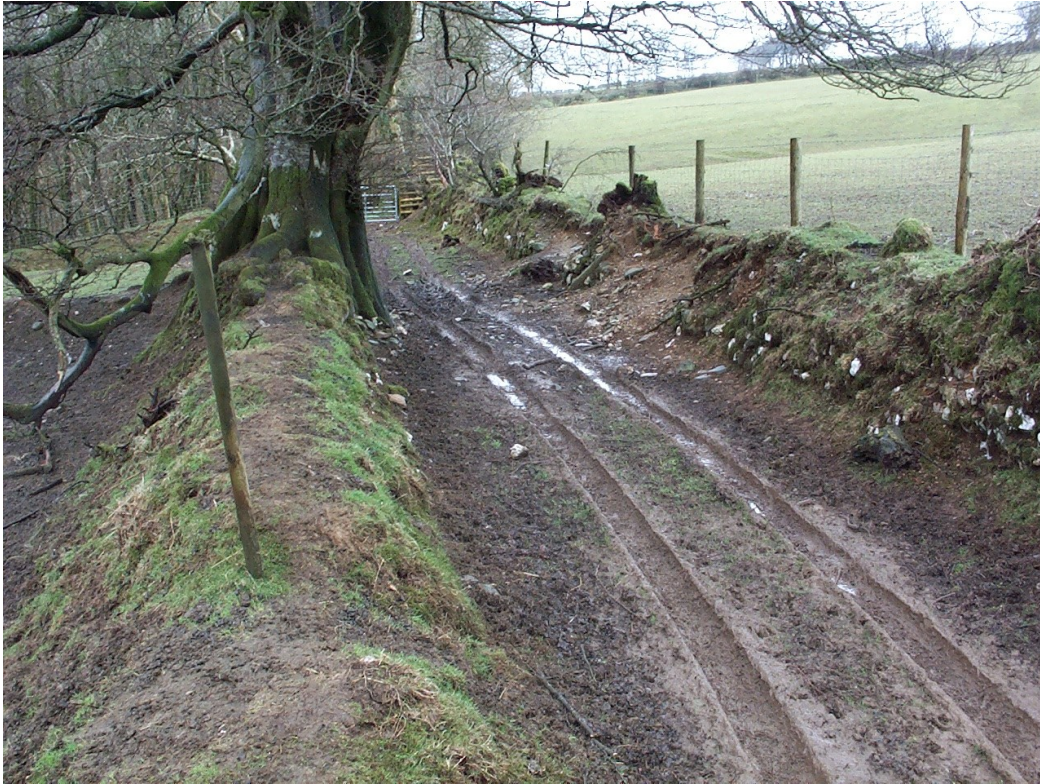
The track, which leads to the enclosure from Perth y berllan house and farm, also survives lined with herringbone stone banks (plate 1). Currently the enclosure is still visible, defined now by low earth banks lined with mature trees. In places the banks are considerably eroded.

Plate 1 – the track which leads up to the enclosure (PRN 44522) from Perth y berllan.

The enclosure is currently used as an area for sheep feeding; consequently the large concentration of animals in the confined space is leading to considerable erosion within the enclosure and of the boundary banks. It is recommended therefore to relocate the sheep feeder elsewhere and to control stock numbers in this area to allow some vegetation to regenerate. The area within the enclosure is likely to contain sensitive archaeological deposits including the remains of the house platform in the east corner. No ground disturbing activities should take place in this area.

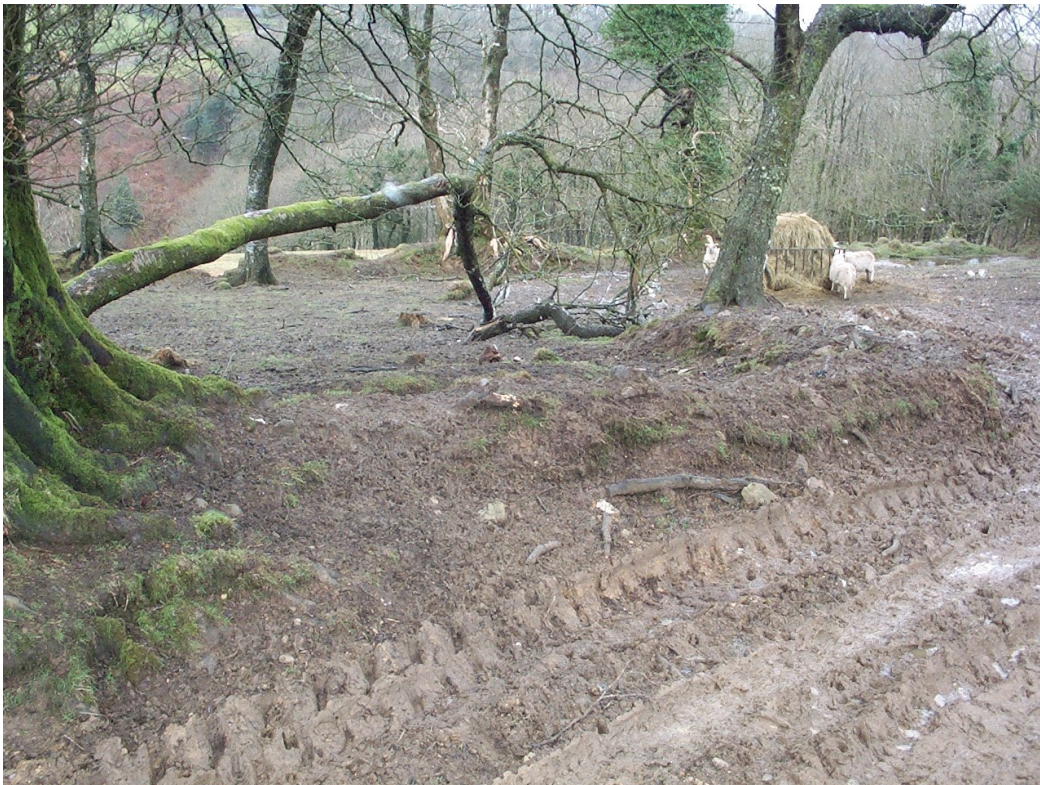
Low stone banks and a general spread of stone also mark the site of the cottage (plate 2). It measures approximately 7 x 3m orientated on a north west – south east axis.

Plate 2 – the enclosure with the site of the cottage in the foreground (PRN 44522)

The enclosure is currently used as an area for sheep feeding; consequently a large concentration of animals in this confined space is leading to considerable erosion within the enclosure and of the boundary banks. It is recommended therefore to relocate the sheep feeder elsewhere and to control stock numbers in this area to allow some vegetation to regenerate. The area within the enclosure is likely to contain sensitive archaeological deposits including the remains of the house platform in the east corner. No ground disturbing activities should take place in this area.

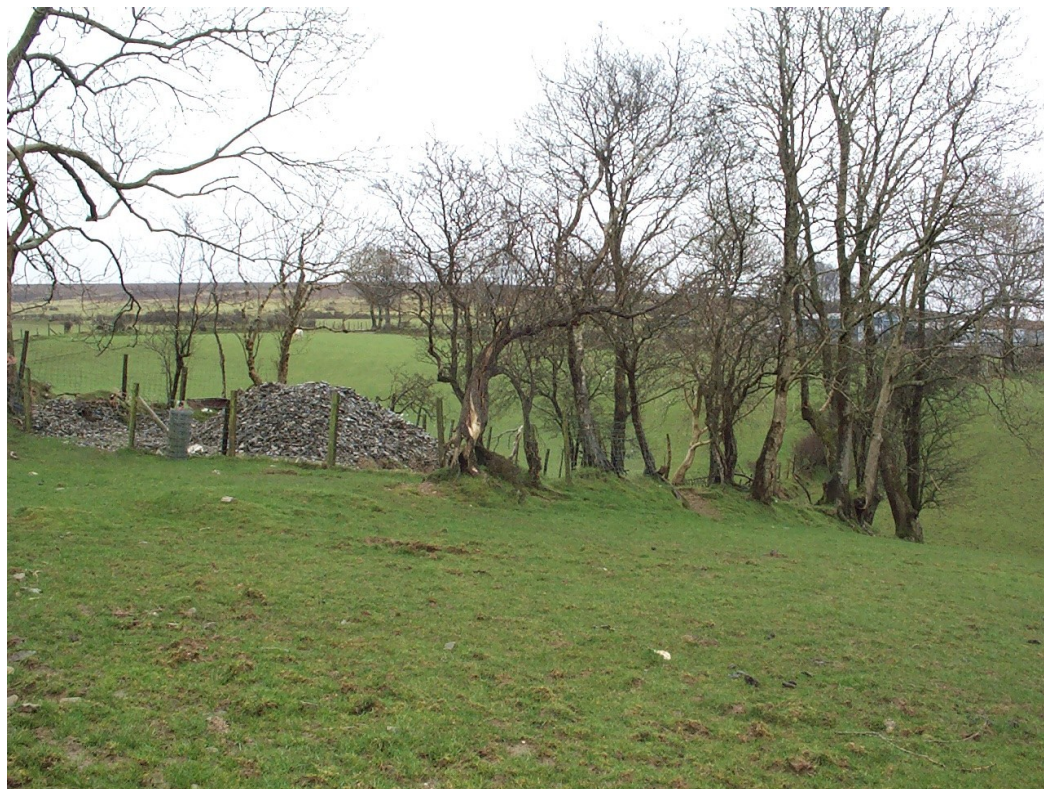
To the north west of the farmstead of Gwarglwydeth is a long rectangular enclosure located in the north corner of the field (plate 3). The enclosure is defined by low earth banks c. 0.6m high, lined with mature trees. The enclosure is first identified on the 1st edition Ordnance Survey map of 1891. Mrs. Evans remembers this as the old orchard. The interior of the enclosure is now devoid of any fruit trees. The enclosure is no longer stock proof except for a small area, which has been fenced off in the centre around a deep disposal pit.

Plate 3 – the site of an enclosure to the west of the farm (PRN 44523)

The low boundary banks of the enclosure should be maintained in a stable condition and retained as a visible feature. It is recommended that no further pits are excavated within the enclosure.

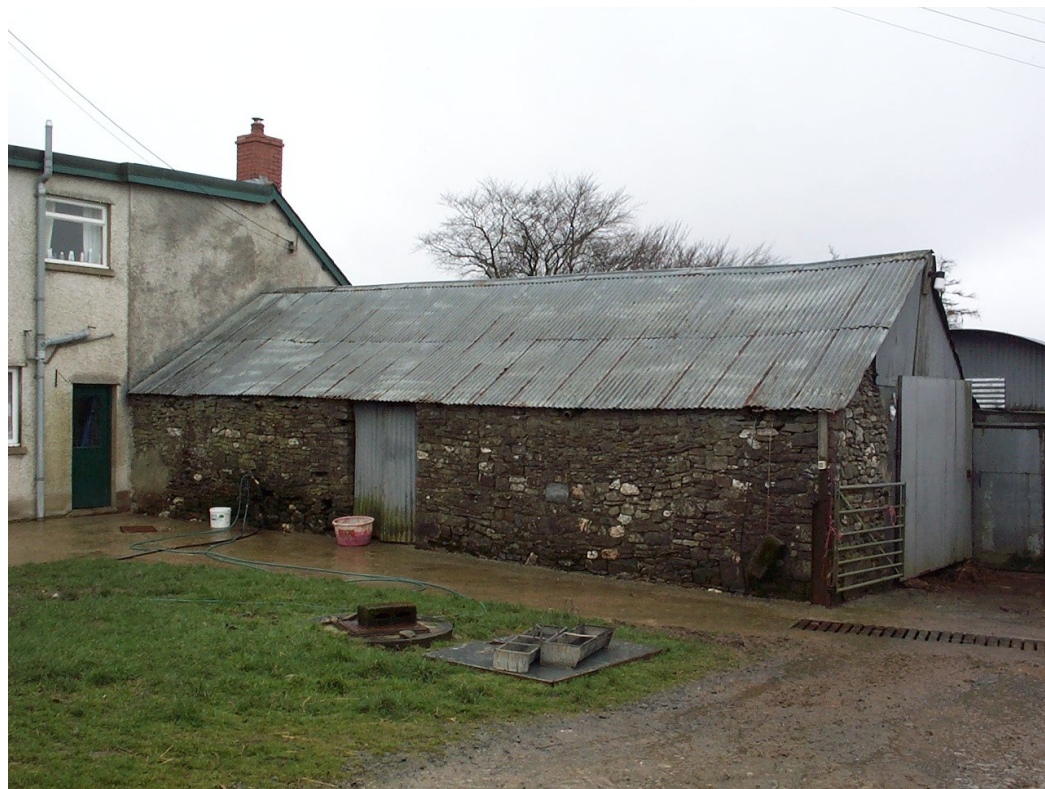
Adjacent to the farmhouse is a cow shed which is constructed in rubble stone work, with roughly dressed quoins (plate 4). The pitched roof is covered in corrugated iron. It has undergone various modifications, including a wide entrance inserted in the north west facing elevation. A blocked window opening is also visible in this elevation. The north west gable end has largely been rebuilt with breeze block. The south east elevation has a lean to constructed against it and a window has been positioned in an earlier doorway, with a stone lintel and concrete sill.

Plate 4 – the cow shed (PRN 44524) positioned to west of the farmhouse.

The cow shed is currently in a stable condition, it should continue to be maintained using traditional materials.

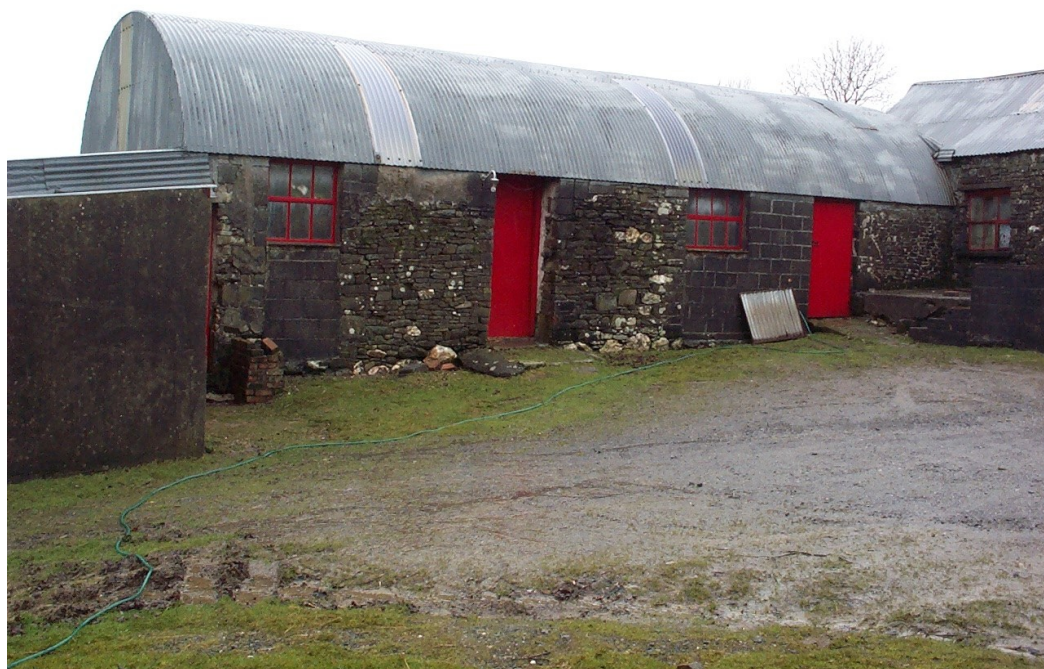
A cow shed is positioned at right angles to the farmhouse and adjoining cow shed (PRN 44524). This is also constructed out of rubble stonework, roughly coursed with a round topped corrugated iron roof (plate 5). There are two doorways in the south east facing elevation, each with cobbling to the front of the stone thresholds. The southern doorway has concrete setting at the base in which is inscribed 1965. Two windows are positioned alternately with the doorways.

Plate 5 – the cow shed (PRN 44525) which is positioned to the north west of the farmyard.

The cow shed is currently in a stable condition, it should continue to be maintained using traditional materials.

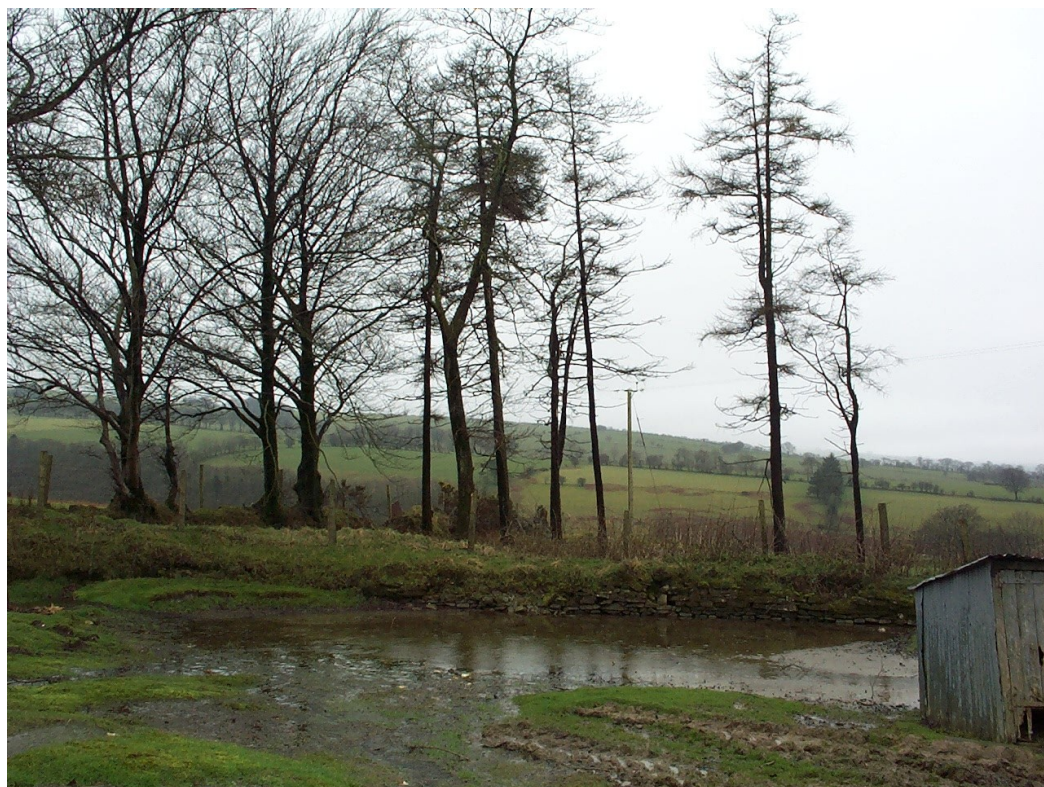
A pond is situated to the south east of the farm (plate 6). This is lined with rubble stonework at the lower, south west side. To the west the pond has been breached and the water level is consequently very low.

Plate 6 – the pond (PRN 44526) to the south of the farmstead.

The pond should be retained; if any works are considered to reinstate the pond archaeological advice should be sought first.

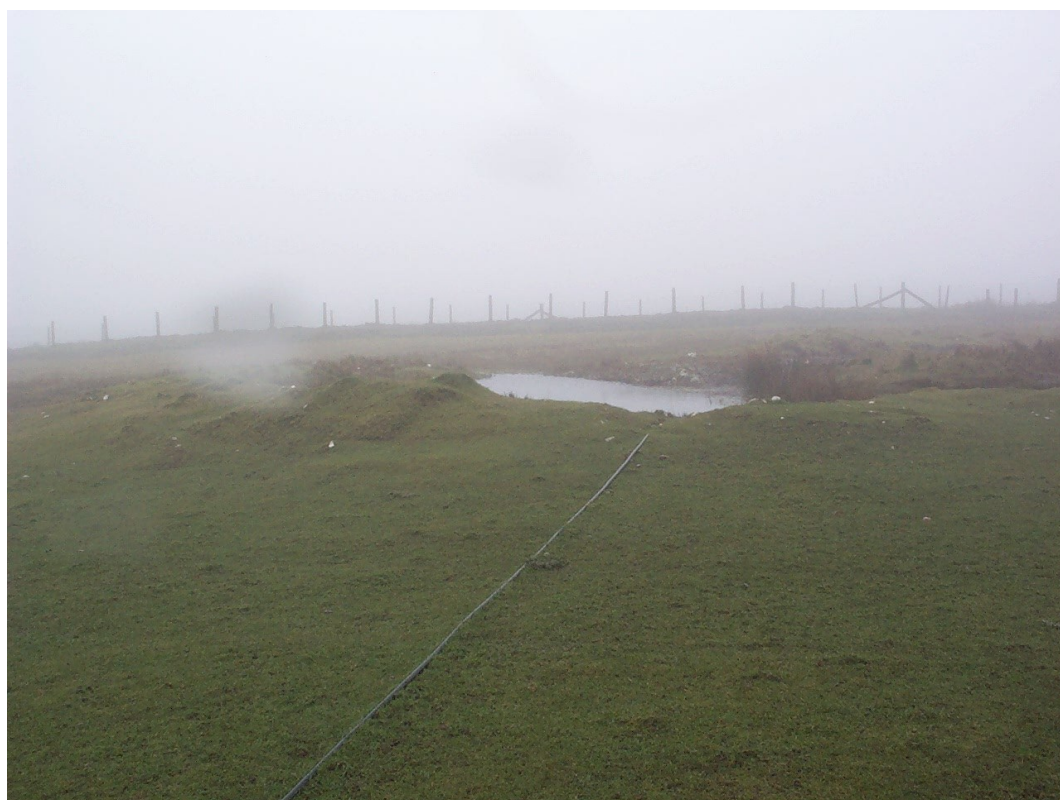
A roughly circular pond, between 9-10m in diameter, is constructed with stone and earth revetment banks to the south west (down slope). The retaining banks are approximately 1m high and 2m wide with stone outcropping on the external faces (plate 7). The pond is fed by two water channels, the first comes from the roadside to the north and the second from a straight channel c.46m in length to the north east which appears to feed from a natural spring.

Plate 7 – the pond (PRN 44528) constructed with stone and earth banks.

This pond should be retained as a visible landscape feature. Archaeological consultation should be sought if any works are to be undertaken on the pond.

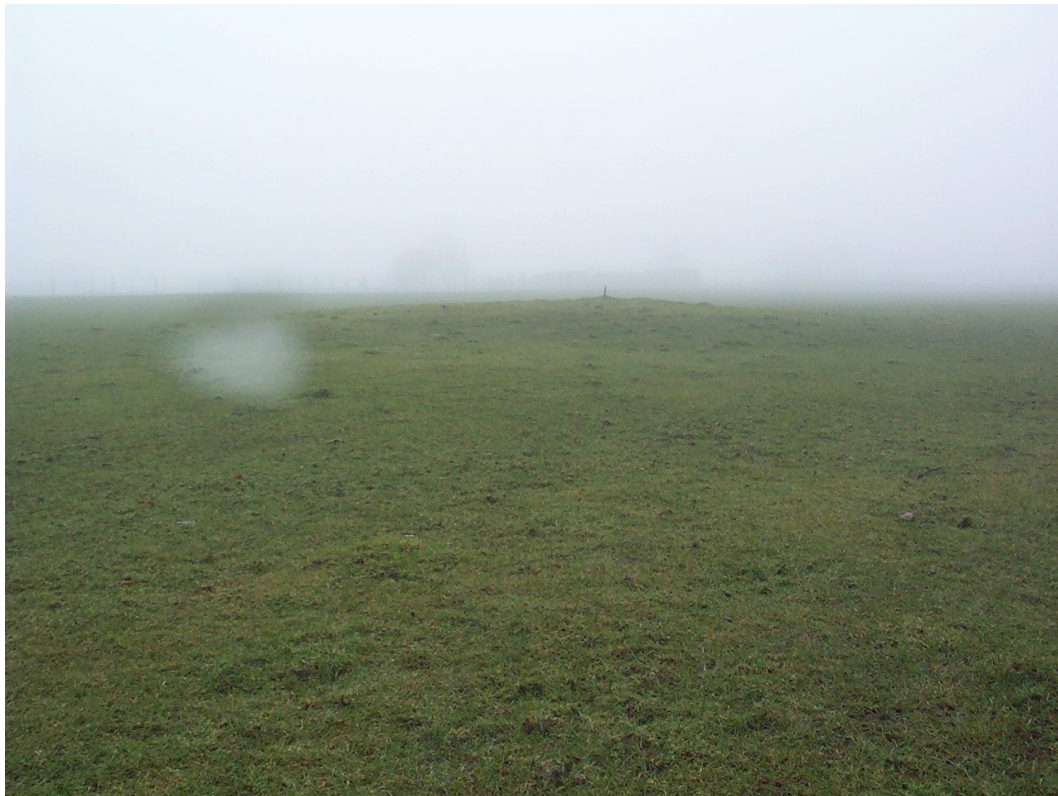
To the west of the pond is a roughly circular mound approximately 0.3m in height and 6.5m in diameter (plate 8). The mound is covered entirely with turf and no stone work was observed. It is unknown what this feature is, it's proximity to the pond and water channel may indicate that it may be a feature associated with their construction.

Plate 8 – low earth mound (PRN 44529) to the east of the pond.

This mound should be retained as a visible landscape feature. No ground disturbing activities should take place which might damage the profile of this feature.

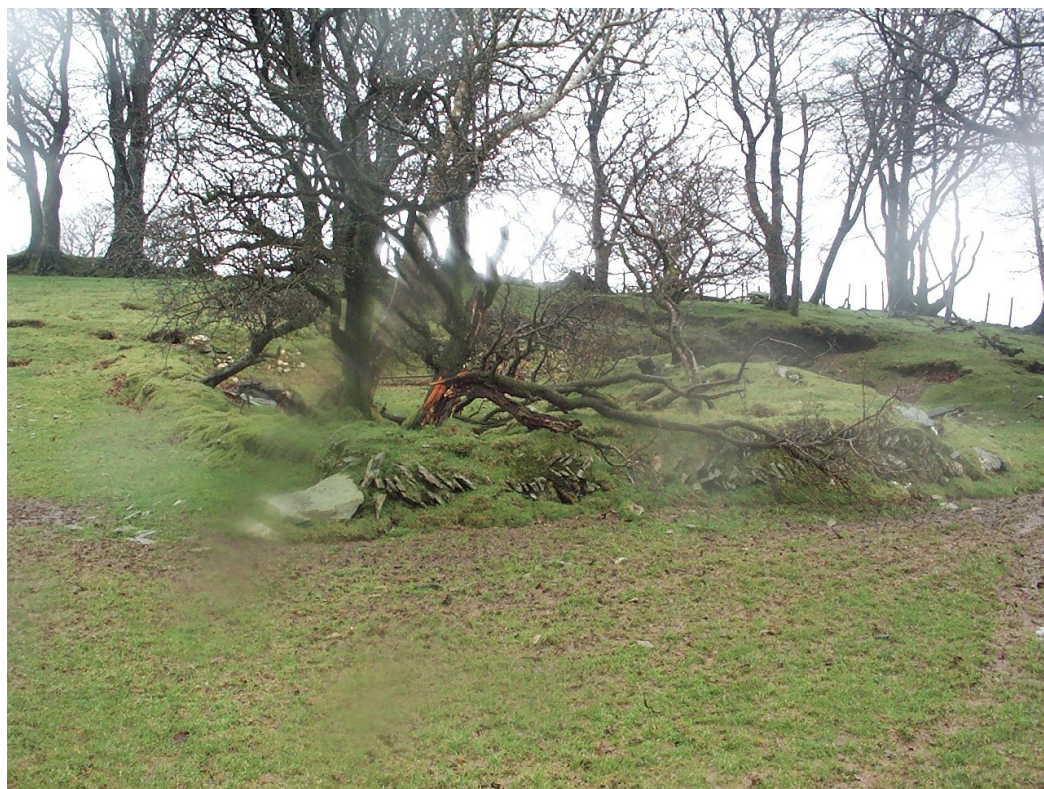
Today the site of these structures appears to have been largely quarried away and the enclosure banks are the only remaining structures (plate 9). The enclosure walls survive to a height of approximately 1m high, 14m long and 6m wide and are constructed out of stone laid vertically on end.

Plate 9 – the vestigial remains of the deserted settlement of Coedllwyndan (PRN 22621)

The remains of this settlement should be retained as a visible landscape feature. No further quarrying or other ground disturbing activities should be carried out in this area.

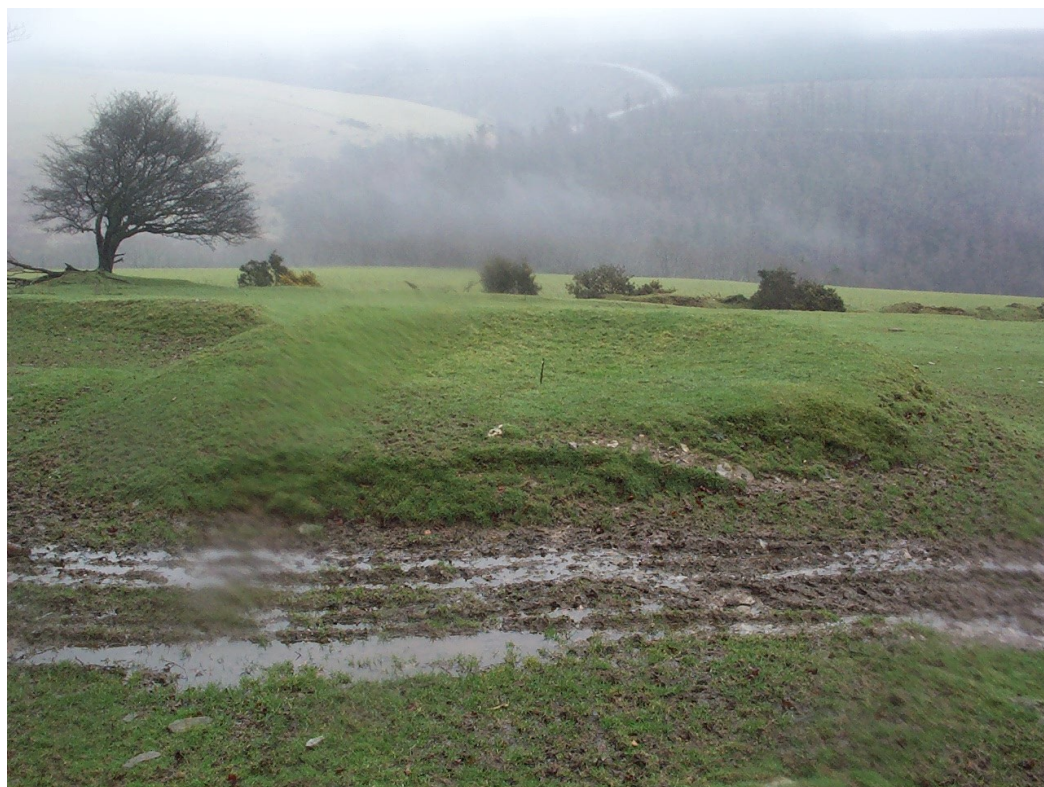
To the south of the enclosure of Coedllwyndan Cottage (PRN 22621) is a roughly circular structure between 5-6m in diameter with stone work visible in the external face (plate 10). The structure is sunken in the centre and is turfed over. This may be the site of horse engine. This structure is currently in a stable condition, although the external edges are slightly eroded by animal tracks to the south east and by vehicle tracks to the north west.

Plate 10 – a mound (possible site of a horse gin?) (PRN 44530) to the south of the settlement of Coedllwyndan.

Placing cut brash or gorse on the eroded areas around the external banks should stop sheep using the tracks giving the grass a chance to regenerate.

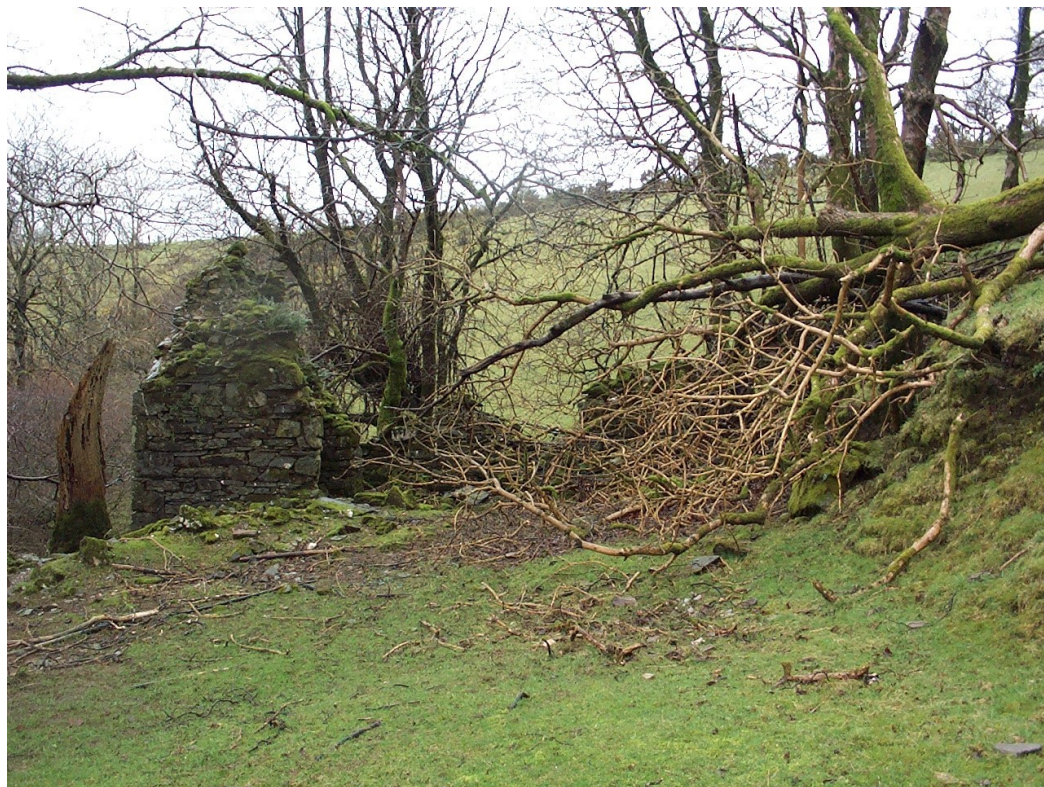
The external walls of the farmhouse survive to a maximum height of approximately 3m at the west gable end (plate 11). The building is rectangular, orientated east to west and c. 7m long. It is constructed from rubble stone built to courses with large quoins. A brick built corner fireplace remains in the north west corner and a small fireplace with a wooden lintel survives at the east end. The remains of the building are threatened by tree fall, and currently a fallen tree lies across the upstanding masonry at the east end.

Plate 11 – the remains of a house at Byrgwm (PRN 44531)

This building is currently threatened by tree fall. The remains of the fallen tree, which lies across the east end of the building, should be carefully removed. A scheme of woodland and vegetation management should be introduced which will help to prevent further tree fall from damaging the structure. Ideally the upstanding masonry of the structure should be consolidated.

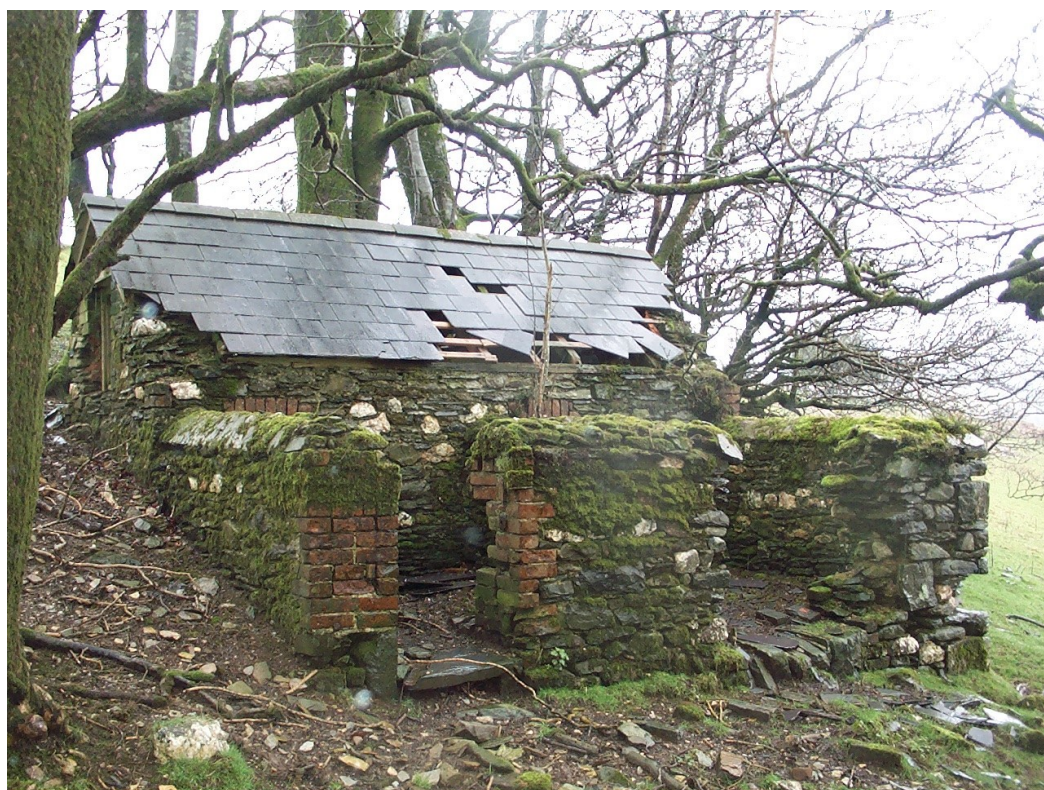
A pair of pigsties are the most intact structures which survive at the deserted settlement of Byrgwm (plate 12). They are constructed out of rubble stone with quartz, roughly coursed, with brick dressings to the openings. Internally the pigsties are divided by large monolithic slabs of slate. The roof is pitched and covered with slate and the ridge tiles are stamped with the name W. Hancock. Some slates have come off the roof and the substantial holes are allowing water to penetrate the structure.

Plate 12 – the pigsties (PRN 44532) at the deserted settlement of Byrgwm.

It is advisable that the roof is repaired as soon as possible and the structure made watertight.

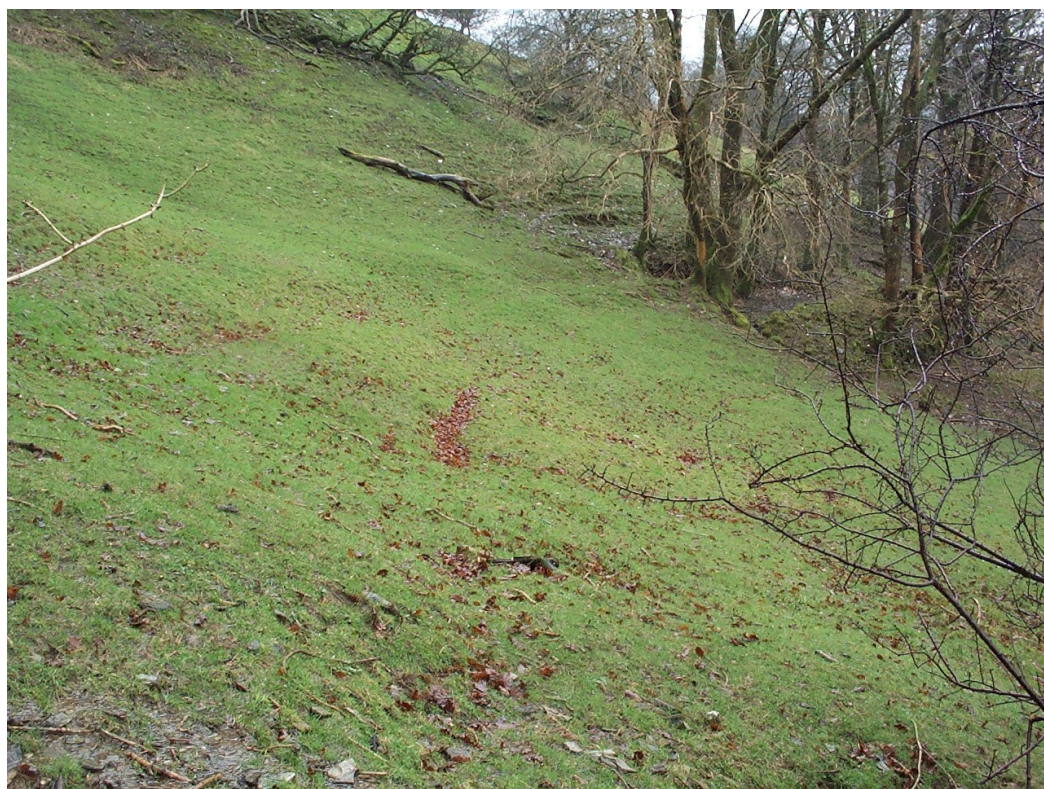
A pond is situated on the steep slope below the farmhouse. It has been constructed with stone and earth banks to the south west and is now encircled with mature trees. It is roughly 13m long and 5m wide. The pond is part of a water wheel complex and to the north west of the structure the line of a leat follows the contour of the slope round to the watercourse at the farm boundary (plate 13). The line of the leat appears on the 1st edition Ordnance Survey map of 1891. To the south east of the pond are the masonry remains of a stone sluice which fed the water wheel (PRN 44533). These features appear to be in a fairly stable state.

Plate 13 – the course of a leat can be seen in the foreground with the pond beyond (PRN 44533).

The pond and the associated sluice and leat are structures which are sensitive to any forms of disturbance. Currently they are in a fairly stable condition. However, the ash trees, which surround the pond, should be carefully managed to prevent tree fall which may damage the pond structure.

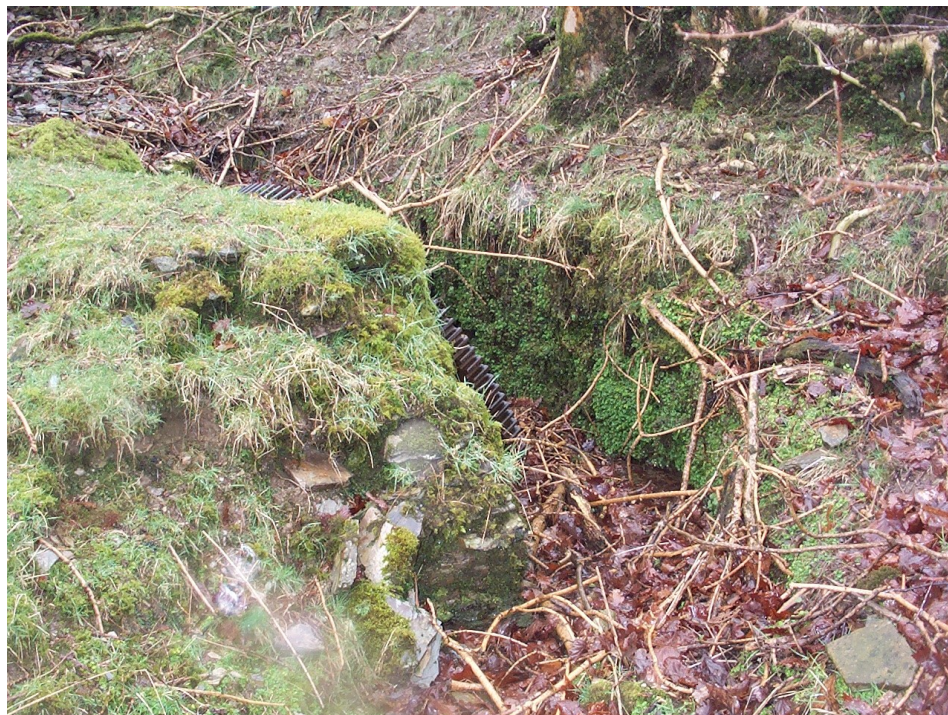
To the south east of the pond is a stone lined wheel pit with the iron wheel gear still surviving (The gear wheel is stamped “William Isaac & Son Carmarthen”). The wheel pit is approximately a metre deep although considerably silted up at its base, however it survives in fairly good condition (plate 14). A mature tree is growing less than a metre from the north east side which may cause damage to the structure in the long term. To the south west of the wheel pit is a slight platform c 15m across however there are no upstanding remains which would indicate the presence of a structure in this position.

Plate 14 – the stone lined wheel pit with wheel gear still *in situ* (PRN 44534).

This structure survives in fair condition at present, which should be maintained. The mature tree growing to the side of the wheel pit should be managed to prevent any damage to the masonry structure.

The area surrounding the wheel pit may contain other features associated with the mill complex, therefore it is recommended that archaeological advice is sought prior to any works being carried out in this area.

This structure survives in reasonable condition at present. However, the mature tree growing to the side of the wheel pit may need to be removed to prevent any damage to the masonry structure. The area surrounding the wheel pit may contain other features associated with the mill complex, therefore it is recommended that archaeological advice is sought prior to any works being carried out in this area.
