Berlouwin W/12/1619

Tir Gofal Farm Visit Report

Report No. 2002/31

REPORT NO. 2002/31 PROJECT RECORD NO. 41817

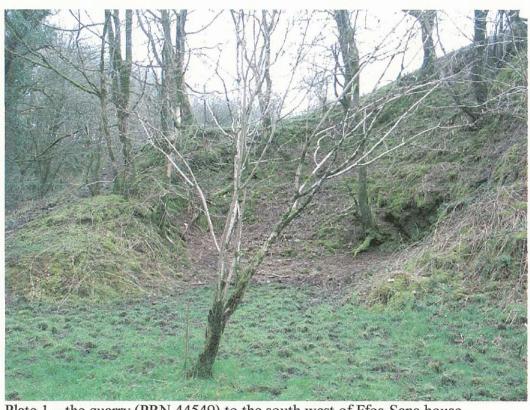
Plate 1 – the quarry (PRN 44549) to the south west of Ffos-Sana house.

This quarry is recorded on the 1st edition Ordnance Survey map of 1891. It survives as a cutting in the natural valley slope down to the watercourse. It is currently clearly visible with some trees and brambles growing on the quarried slopes (plate 1).

The quarry should continue to be maintained as a visible historic landscape feature.

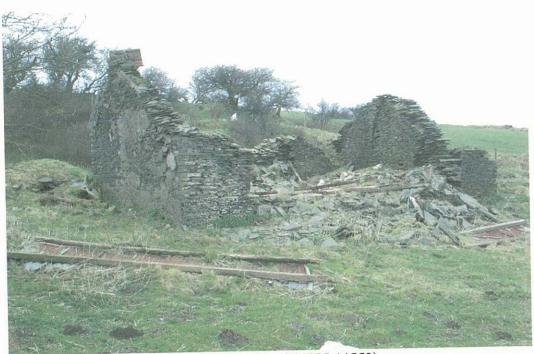
Plate 2 – the derelict cottage of Waun-lwyd (PRN 44552).

The cottage of Waun-lwyd is identified on the 1st edition Ordnance Survey map of 1891. According to Ms Wyllee it has been empty for some 40 years and is now largely ruinous. The building is positioned on a south west to north east axis with the front facing south east (plate 2, page 11). The cottage is constructed out of uncoursed, rough slate and bonded with a lime mortar. The roof appears to have latterly been covered by corrugated iron indicated by the sheeting which lies strewn about.

The remains of the cottage now consist largely of the two gable walls. At the south west end a brick chimney survives, although it has a severe outward lean and the gable will fall before long. Internally at the south west end is a small gable fireplace with a flat stone arch. The cast iron fireplace survives partly *in situ* although the top half has come adrift and lies within the masonry rubble. The gable end has traces of a lime render finish and the sockets for the ceiling joists at eaves level can clearly be seen.

The south east facing elevation has largely collapsed, although there are remains of a window splay and a central doorway. The outline of a wide tapered flue is still visible at the north east gable end although the chimney and wall tops have been lost.

Against the north east gable end are the wall stubs of an outhouse or outshoot, butting up to the gable end.

The south west gable end currently presents a safety issue, as the chimney is in a perilous condition and is causing Ms Wyllee some concern. Unless funding is available to consolidate the gable end, there may be no alternative than to dismantle the chimney and gable top to a secure level. An archaeological record should be made of the affected area prior to this work being undertaken.

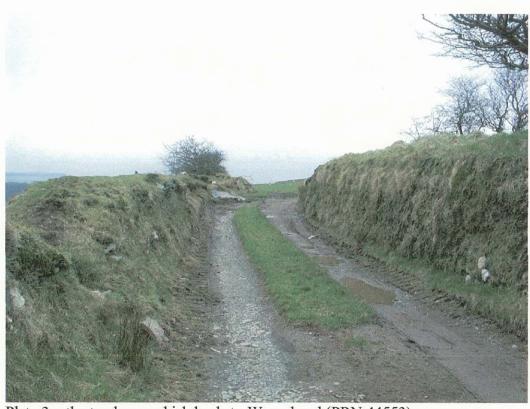
Plate 3 – the trackway which leads to Waun-lwyd (PRN 44553).

To the south east of the derelict farm of Waun-lwyd, is a track lined with substantial stone banks approximately 1.6 metres high and 1.2 metres wide, constructed with vertically laid slate to the north west and horizontally laid to the south east (plate 3). The track leads from the road to the east of the enclosure of Waun-lwyd. To the east of the farmhouse, where the track turns a corner to the north west the southern bank has sustained some damage from vehicles.

The track and associated banks should be repaired and maintained using traditional materials. Due to the sharp angle of the trackway the track provides only limited access and is therefore not suitable for use by large vehicles.
