# **Tir Gofal Farm Visit Report**

**Cae Iago**

**Report Number 2002/5**

CAE IAGO  
TIR GOFAL FARM VISIT REPORT

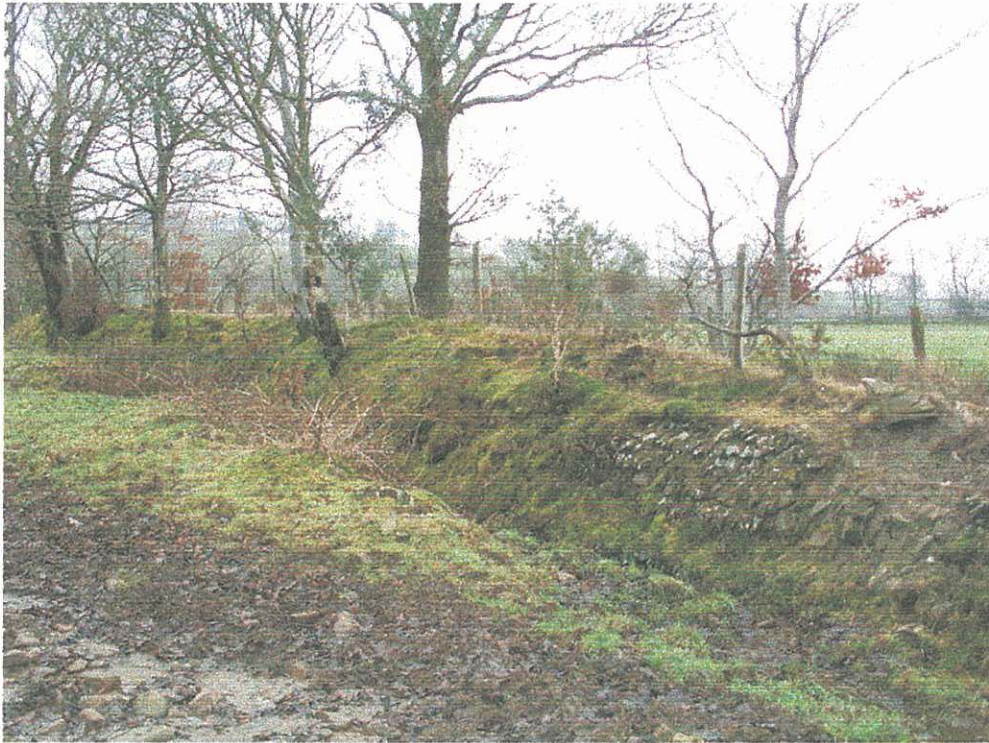
The farm boundaries appear to survive almost intact, as established in the 1st edition ordnance survey map of 1891. The boundaries to the east of the road are well constructed with stone and earth (plate 1). The hedgerows on top are very overgrown and are now largely composed of mature trees. To the north west of the farmstead some boundaries have been replaced with post and wire fencing.

Plate 1 – a stone constructed bank with grown out hedge, to the east of the holding.

The farm boundaries, which form an important historical characteristic of the farm, should be maintained as visible landscape features. Archaeological sites on the holding which require action are detailed below, for other management recommendations see the gazetteer of individual sites.

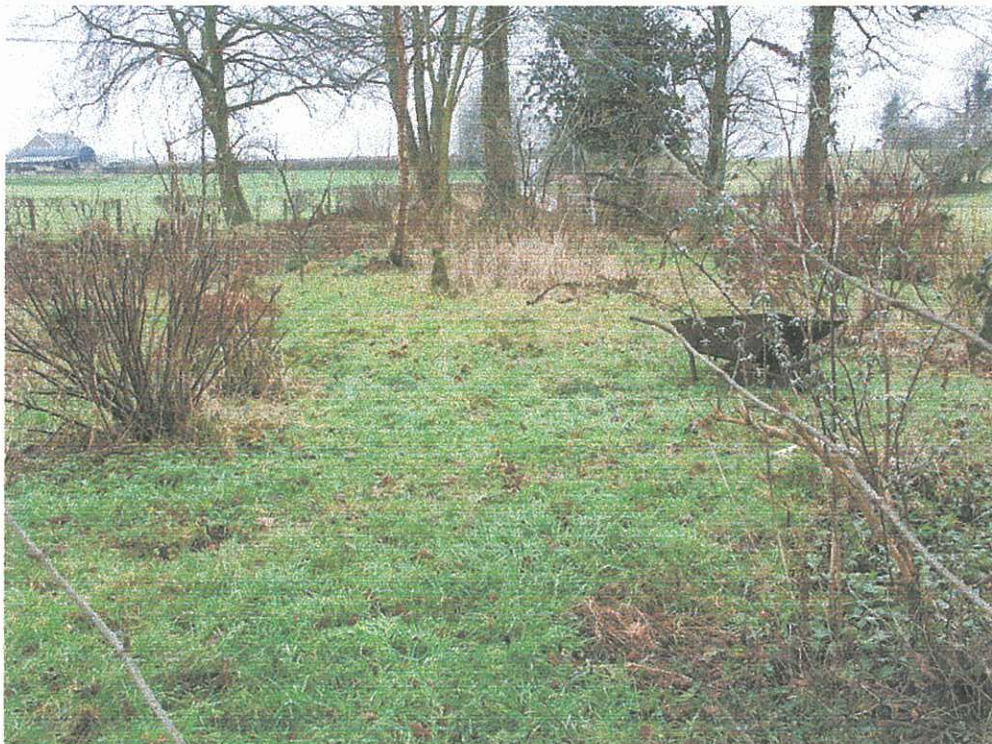
The Roman road which runs from Pumpsaint up the Twrch valley to Llanfair Clydogau is largely perpetuated by the modern minor road via Ffarmers. The line of the road crosses Cae Iago farm leaving the existing road to the south of the farmstead and crossing the Afon Twrch to the north west. The course of the road can only be seen on the ground in the garden adjoining the road, where it is indicated by a rise of about 0.5 metre (plate 2). On the land to the north west of the farm there is no visible trace of the road which has probably been ploughed flat in antiquity (plate 3).

Plate 2 – the line of the Roman road *Sarn Helen* (PRN 3420) looking towards Ffarmers

Although there are no upstanding remains of the Roman road visible in the farm land to the north west of the farmstead, there is a likelihood of buried archaeological remains surviving. Therefore no ground breaking works should be undertaken in this area.

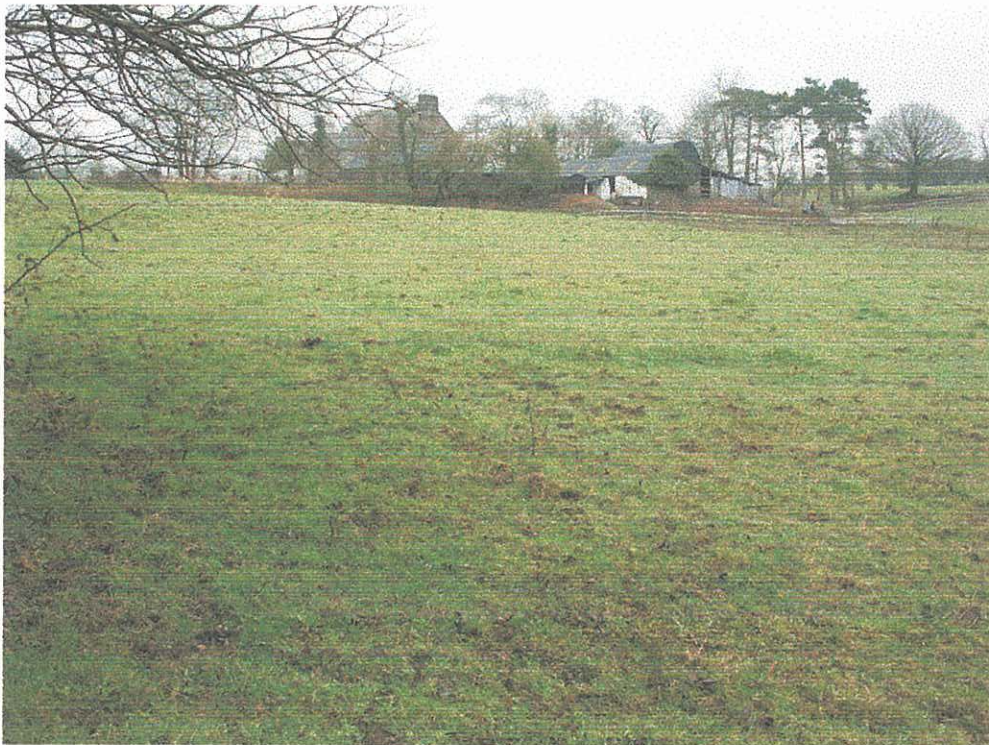
Plate 3 – the route of the Roman road *Sarn Helen* (PRN 3420) crosses this field and through the farmstead of Cae Iago

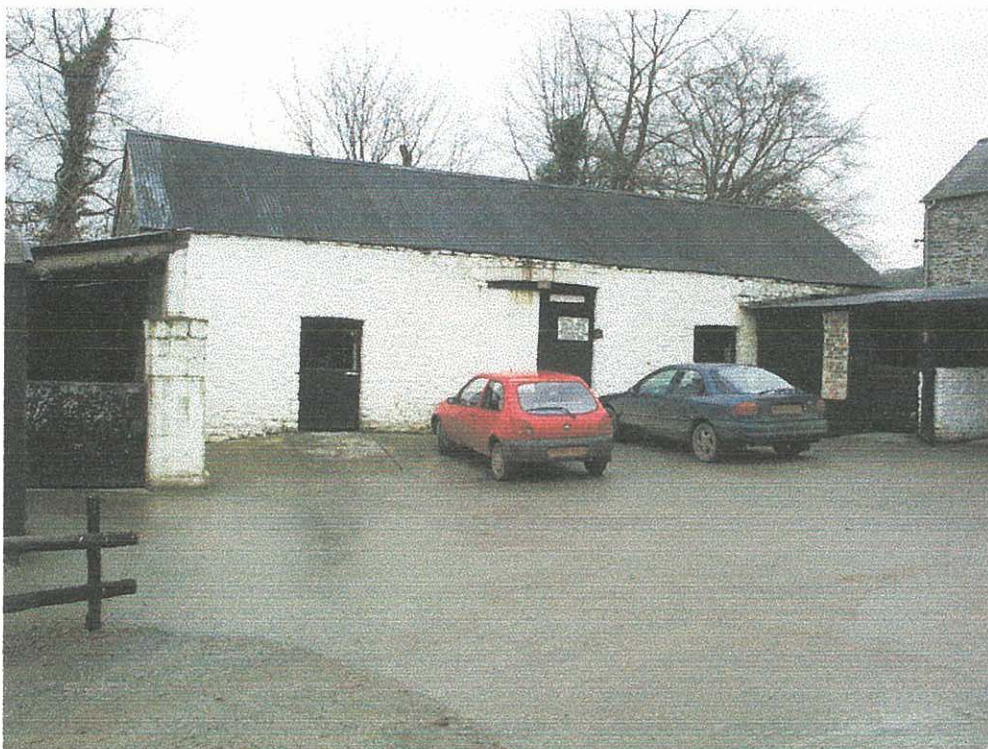
The cow shed to the north west of the farmhouse is orientated north west - south east. It is constructed of roughly coursed rubble walls and stone quoins and has been finished with whitewash. The south west facing elevation has four doorways; the centre left doorway is a semi-blocked cart entrance with a low brick arch (plate 4). The rest are low doorways with stone voussoirs (the east doorway is also blocked). The east gable end has a large square window, shuttered with plank boards, and at the west gable end is a narrow ventilation slit. In the north east facing wall are three blocked ventilation slits, and two small square openings at the east end of the elevation.

Internal offsets in the gable end walls and cut off beams and sockets in the lateral walls suggest that the roof height has been raised. The roof currently has 6 bays. It is constructed with collared trusses with two pairs of trencled purlins and fixed with iron pins. The roof is covered with corrugated iron. The floor is concrete and there are no historic fittings. To the west is a part stone, part breeze block lean-to with a single pitch corrugated iron roof.

Plate 4 – the south west facing elevation of the cow shed (PRN 43946)

This cow shed is in good condition and should be maintained in its existing stable state.

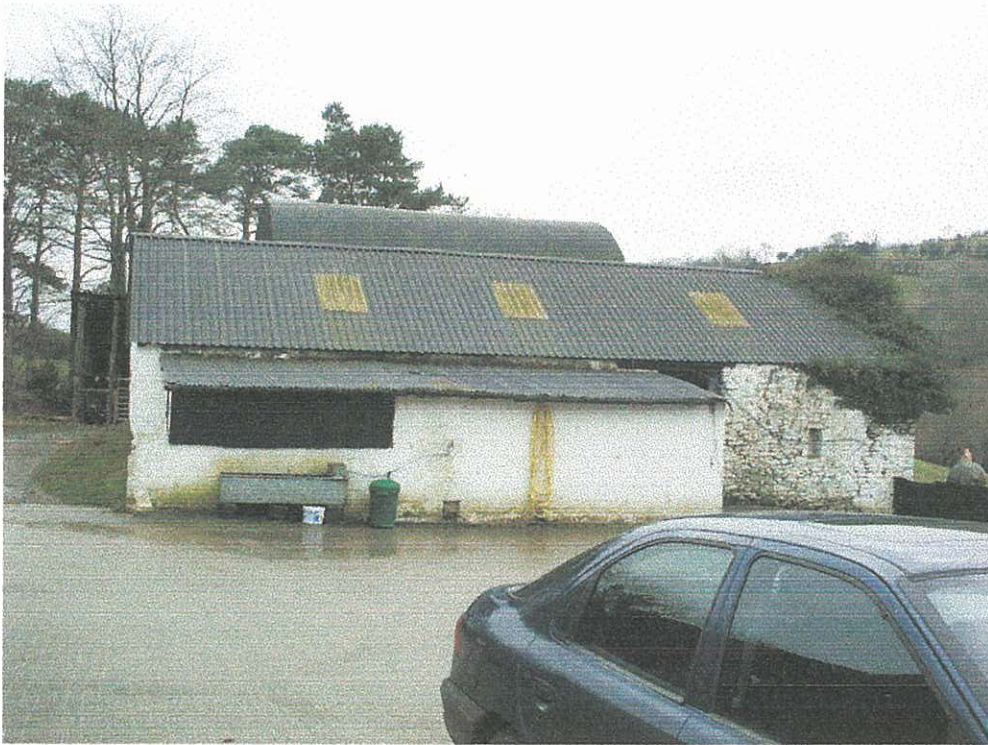
The cow shed to the south west of the farmhouse is orientated north west - south east. It is constructed of roughly coursed rubble walls with stone quoins, and finished with whitewash (plate 5). The north east facing elevation has three doorways, including a full height cart entrance (partly blocked) and an additional small rectangular opening to the west. The south west facing elevation includes an inserted doorway to the east, a central blocked window and a double doorway to the west. The east gable end has a large window. A breeze block outshoot has been constructed along the north east facing wall.

An offset on the interior of the south west facing wall may indicate that the roof height has been raised in this building as seen in the cow shed (PRN 43946). Internally this cow shed has a concrete floor and concrete stall partitions with a feed passage along the south west wall. The roof has 6 bays with trusses of the same construction to those found in the cow shed (PRN 43946) with a square sectioned corrugated iron roof.

Plate 5 – the north east facing elevation of the cow shed (PRN 43947)

PRN 43947 - At the west end the cow shed is very overgrown with ivy and has considerable cracks in the north east facing wall. The vegetation should be cut, and allowed to die back before being carefully removed. The masonry should then be consolidated.

At the west end the cow shed is very overgrown with ivy and has considerable cracks in the north east facing wall. The vegetation should be cut, and allowed to die back before being carefully removed. The masonry should then be consolidated.

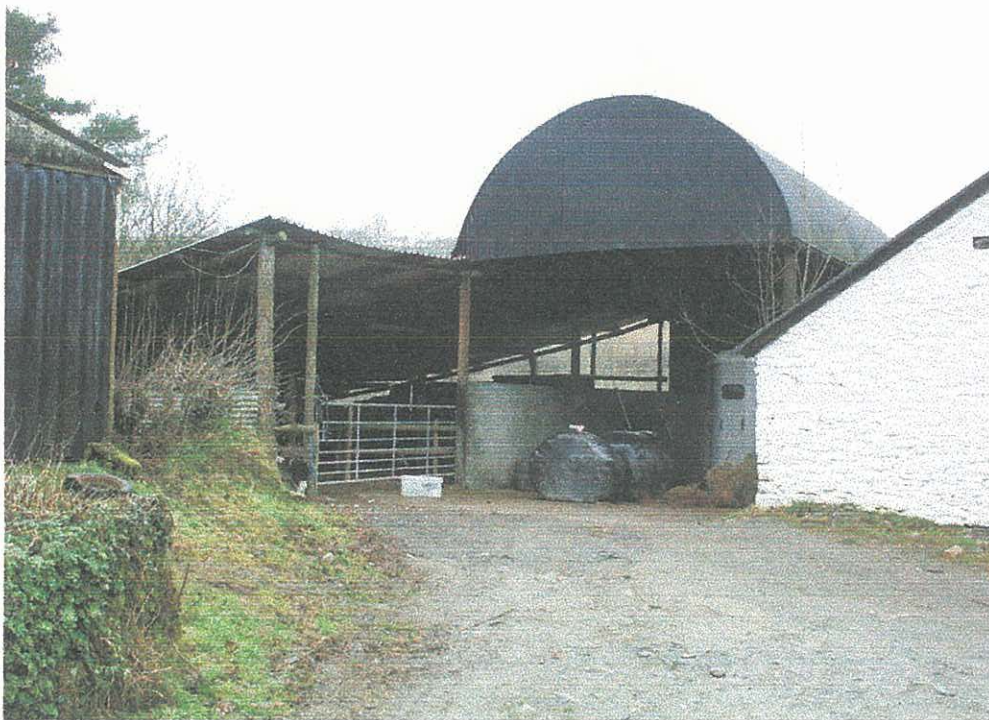
To the south of the cow shed (PRN 43947) is a round topped dutch barn. This is constructed with iron H-sectioned supports and a corrugated iron roof. The sides are open on all but the west, gable end (plate 6).

Plate 6 – the dutch barn (PRN 43948) to the south of the farmyard

The barn is in good condition and should be maintained in its current state.

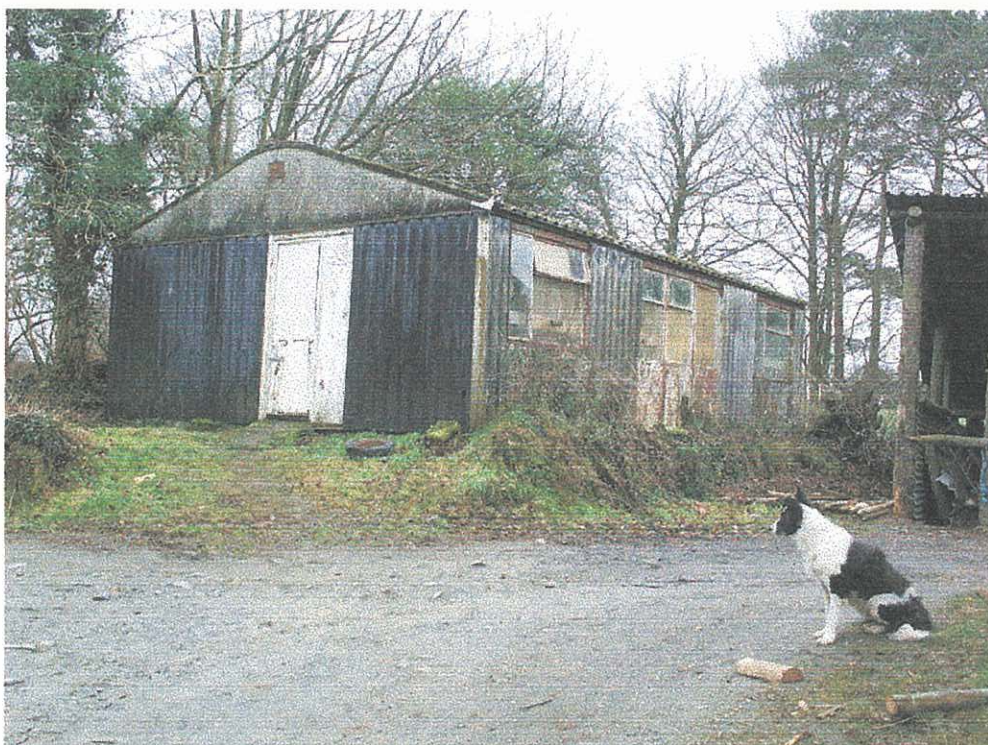
To the south of the farmhouse, orientated on a north east - south west is an asbestos building. This is an Arcon prefabricated house, the first type of prefab built on a commercial scale between 1944 -45. It has square sectioned corrugated asbestos walls and roof (plate 7).

Plate 7 – the Arcon asbestos prefabricated building (PRN 43949)

The condition of this asbestos prefabricated house is beginning to deteriorate. If possible it would be desirable to repair and maintain this building in a stable condition.

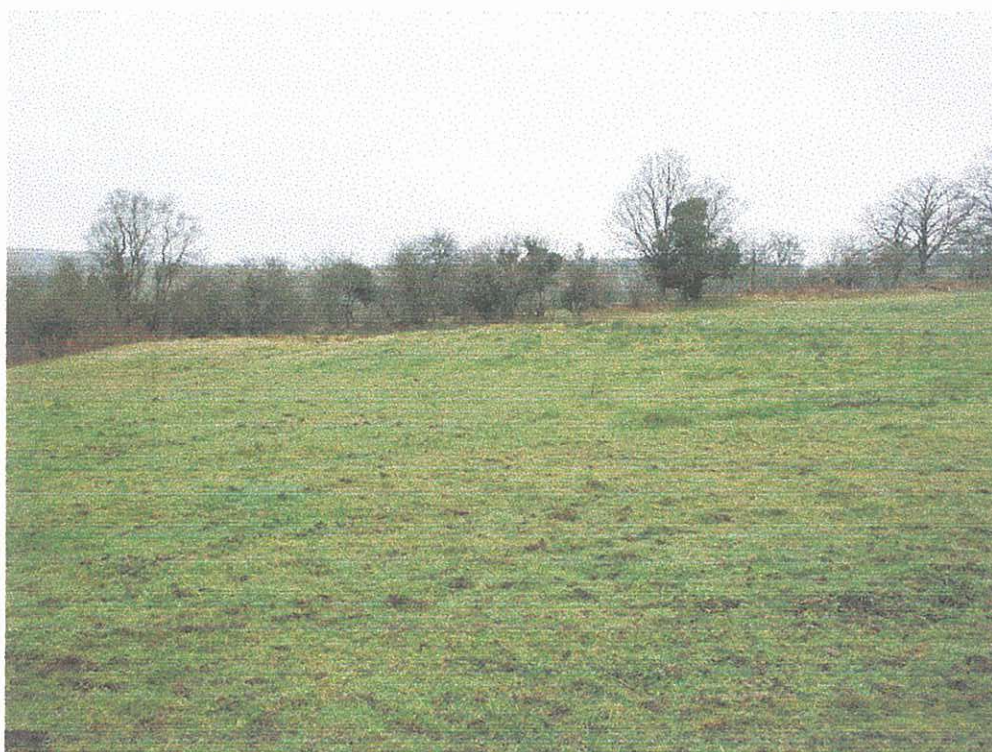
Towards the eastern extent of the holding is a large artificial mound or bank which extends in a north east to south west direction (plate 8). From the north hedge boundary the earthwork extends c. 45m across the field and is c. 10m wide. The bank is c. 1m high and follows the contour except where it is broken towards the centre. This may be the remains of a water management feature associated with the culvert identified to the east (PRN 43952).

Plate 8 – the earthwork feature (PRN 43951) to the east of the farm holding

This earthwork is currently under pasture and is in a stable condition under this management regime. This feature should continue to be maintained in this state.
