**CARMARTHEN CASTLE, DEMOLITION OF NO'S 10-14  
BRIDGE STREET. EVALUATION WITHIN THE SQUARE  
TOWER UNDERTAKEN BETWEEN 21/6/1993 AND 1/7/1993  
AND THE WATCHING BRIEF CARRIED OUT DURING  
DEMOLITION ENDING 9/9/1993.**

**D.A.T. P.R.N. 57 SITE CODE CMC93**

**ARCHAEOLOGICAL REPORT**

**February 1994**

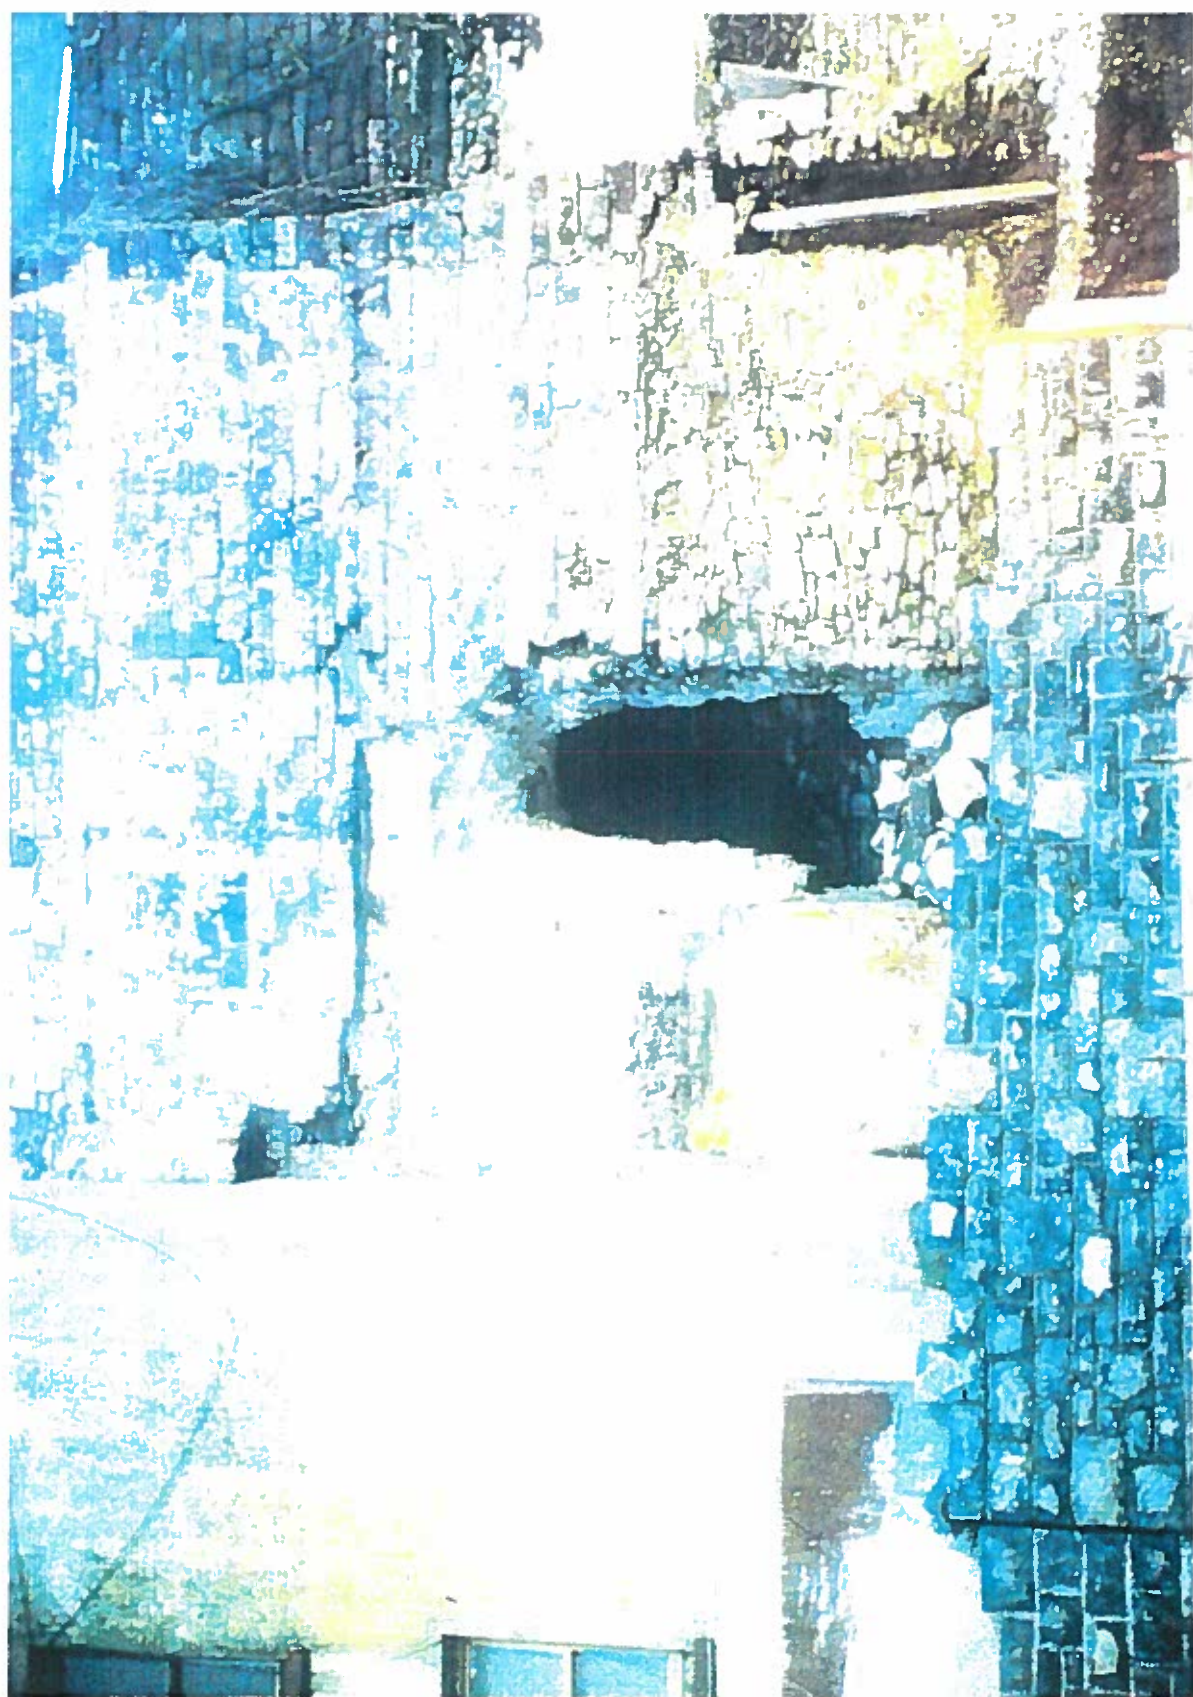
Figure 6

A slide taken when Coracle Way was put through c.1963, looking at the outside of the south wall of the Square Tower, shows an entrance through the wall (Figure 6). As far as can be determined, the height of the top of this entrance is about 93.40 metres site datum, and around 2 metres above the height of the concrete floor on the inside. The interior of the south wall has been well repaired but shows where this entrance is likely to come through.

CARMARTHEN CASTLE, SQUARE TOWER 1963

Both of the cellars of Nos. 11 and 12 Bridge Street were cleaned out by the demolition contractor. These had cobble floors which were photographed before being backfilled almost up to ground level. Towards the rear of No. 12 part of its west wall has been inserted below the footings of the South-West Tower, with a small part of the footings having been straightened. The house on the west side of the Square Tower, No. 10 Bridge Street, appears not to have had a cellar beneath it, but possibly a store leading through the south side base of the Square Tower, as revealed in 1963 (Figure 6).

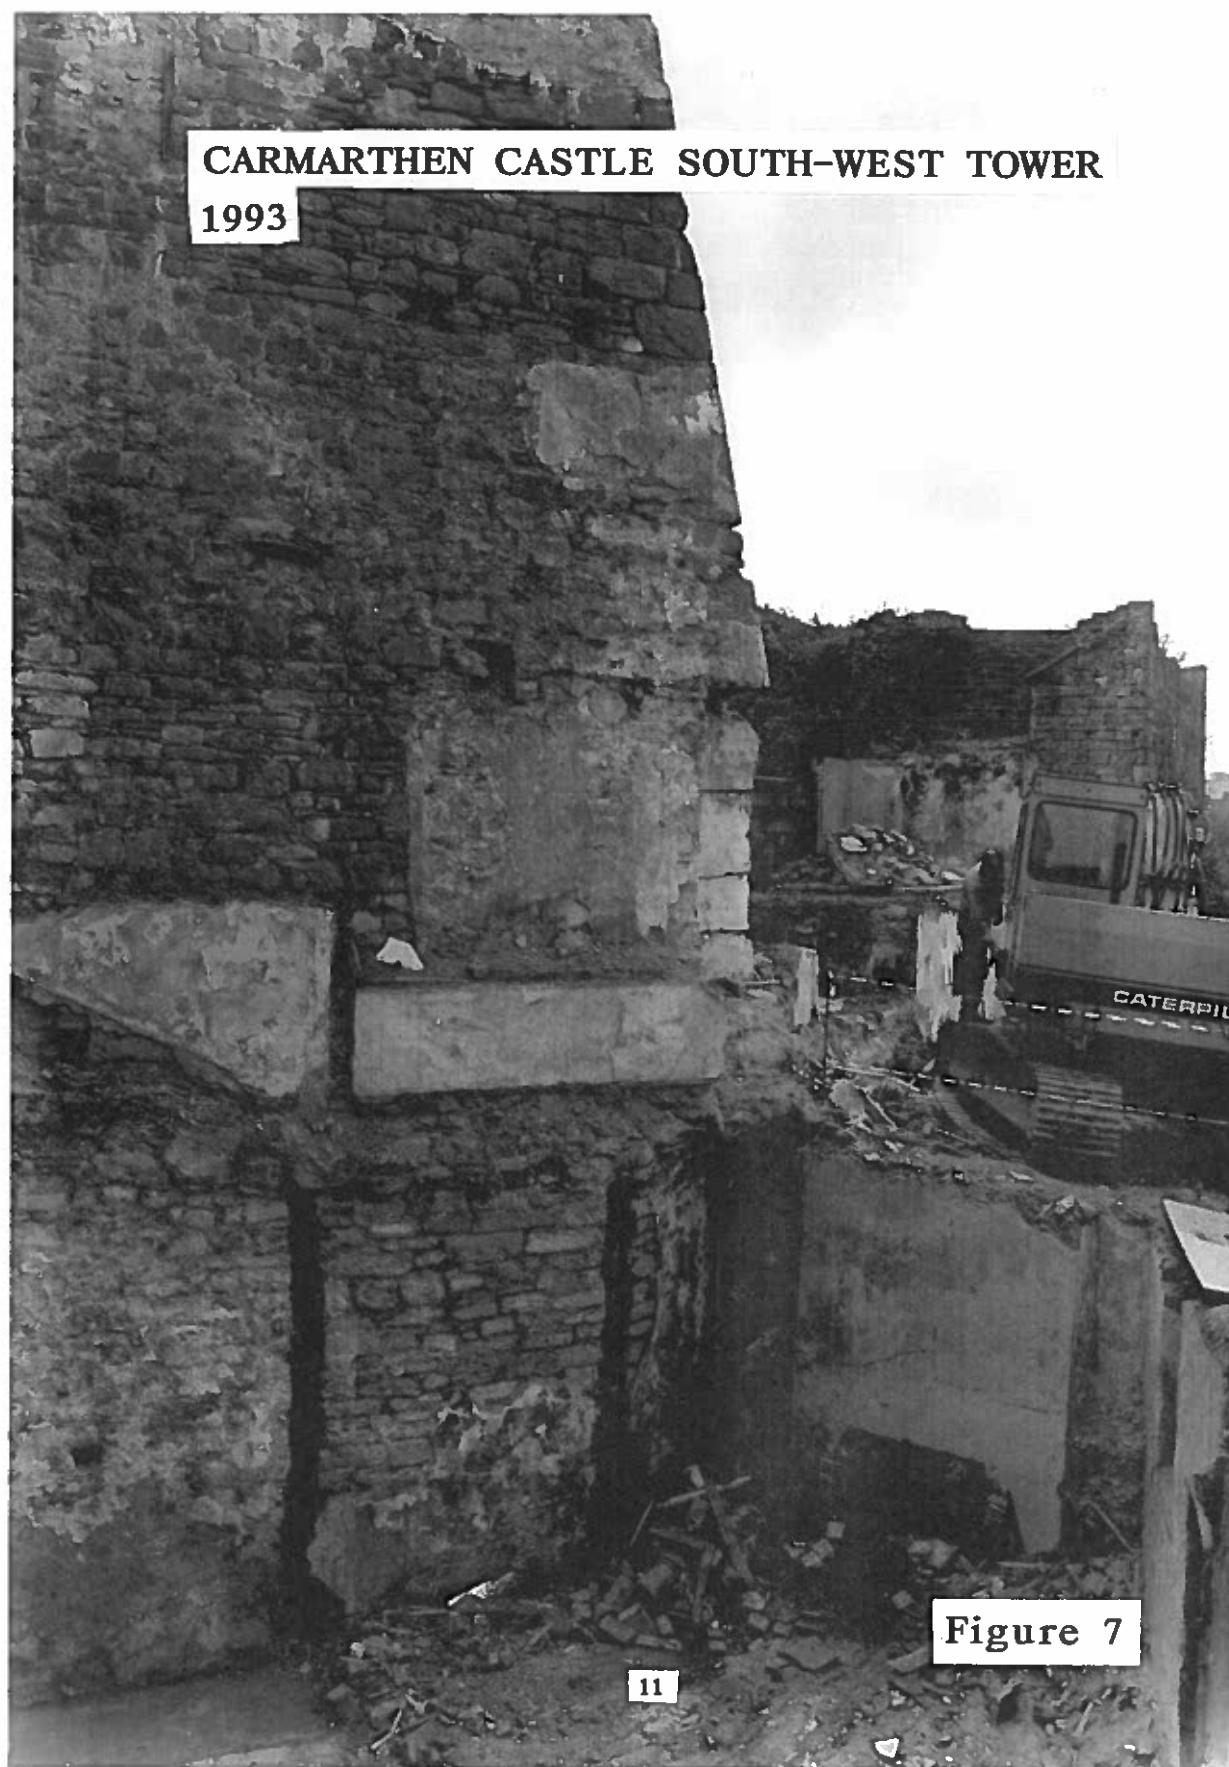
Figure 7

On the outside of the South-West Tower the spur buttress can now be seen. The lower part of this spur has been cut away (Figure 7), to facilitate the insertion of a doorway in the adjacent, now demolished house; it is intended to consolidate this part with core work, so it is sound again, but still revealing and retaining the structural history of the building. The footings of the tower have now been completely uncovered on the south-west side (Figure 6). Part of the south-eastern side of the tower footings are also now uncovered, and a small portion of which was underpinned during the demolition contract.

CARMARTHEN CASTLE SOUTH-WEST TOWER  
1993

Should further work be undertaken on the South-West Tower we would recommend that detailed structural recording is carried out on the affected areas, whether this is just the opening up of the modern blocked doorway or

repointing for consolidation. If, however, the tower is to be emptied of the fill within and the interior and exterior are to be consolidated (the exterior in parts is in urgent need of repointing), then we would recommend that there is a detailed standing building survey programme for the whole tower. Mortar samples from the various phases of the tower should also be taken.

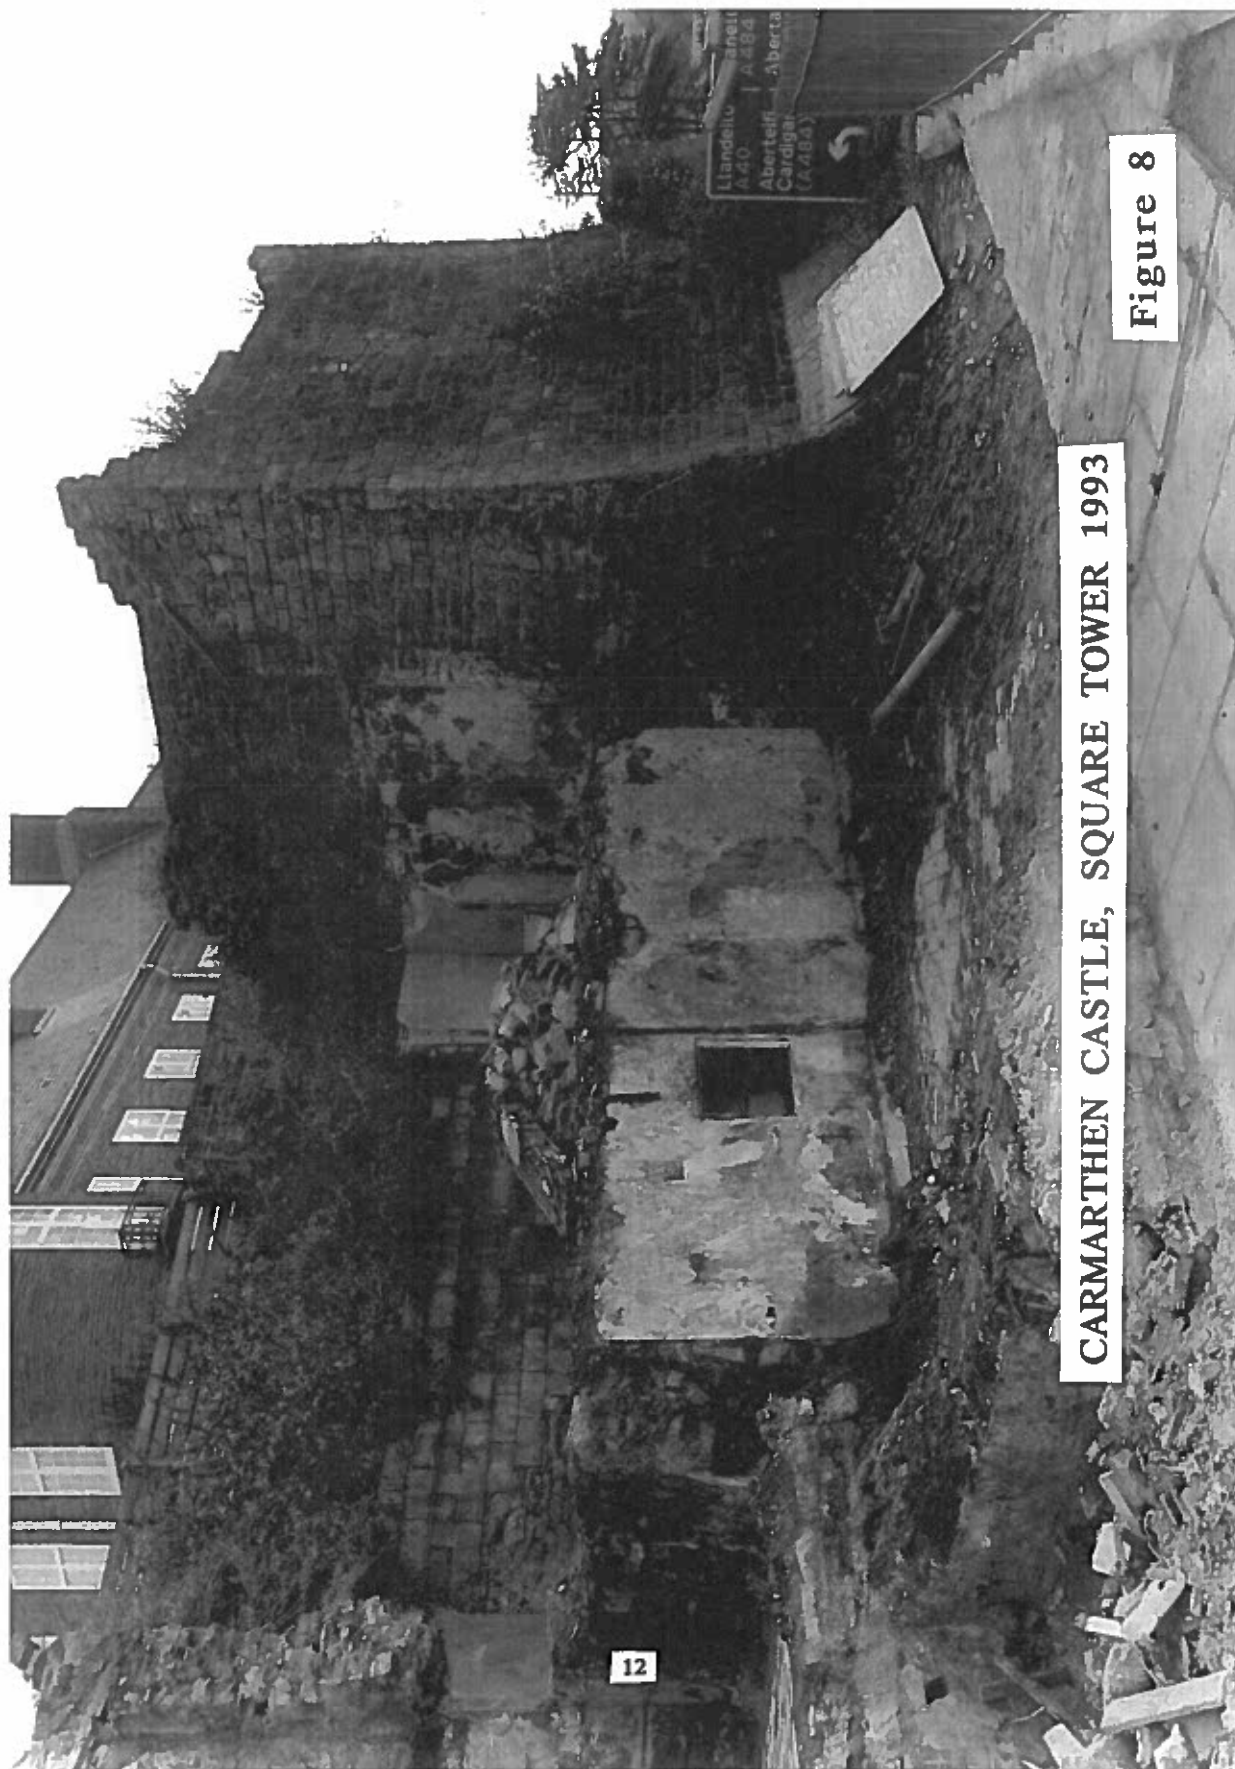
Figure 8

Demolition of the houses further revealed the extent of the refacing of the Square Tower and, along with the construction of a chimney breast into its south-west corner (Figure 8), how much its structure has suffered in the past. The base of the footings in the south-west corner of the tower were uncovered during the demolition and this area was cleaned and recorded prior to it being underpinned. This again demonstrated how shallow the footings are to the tower. On the north-west side of the Square Tower the line of the curtain wall will now be easily visible to the public.

CARMARTHEN CASTLE, SQUARE TOWER 1993

Clearing the house from around the Square Tower confirmed how much of its southern outer face was rebuilt in 1963. Bricks can now be seen behind this face on the western side and we would recommend that they are left in to indicate this refacing. However before work is undertaken on any part of the scheduled areas Cadw's advice should be sought and permission obtained.
