# **SEWER SCHEME BRIDGE STREET CARDIGAN 2000-2001**

**ARCHAEOLOGICAL WATCHING BRIEF PRN 42464**

Report No. 2001/36

Report Prepared for:  
Dwr Cymru

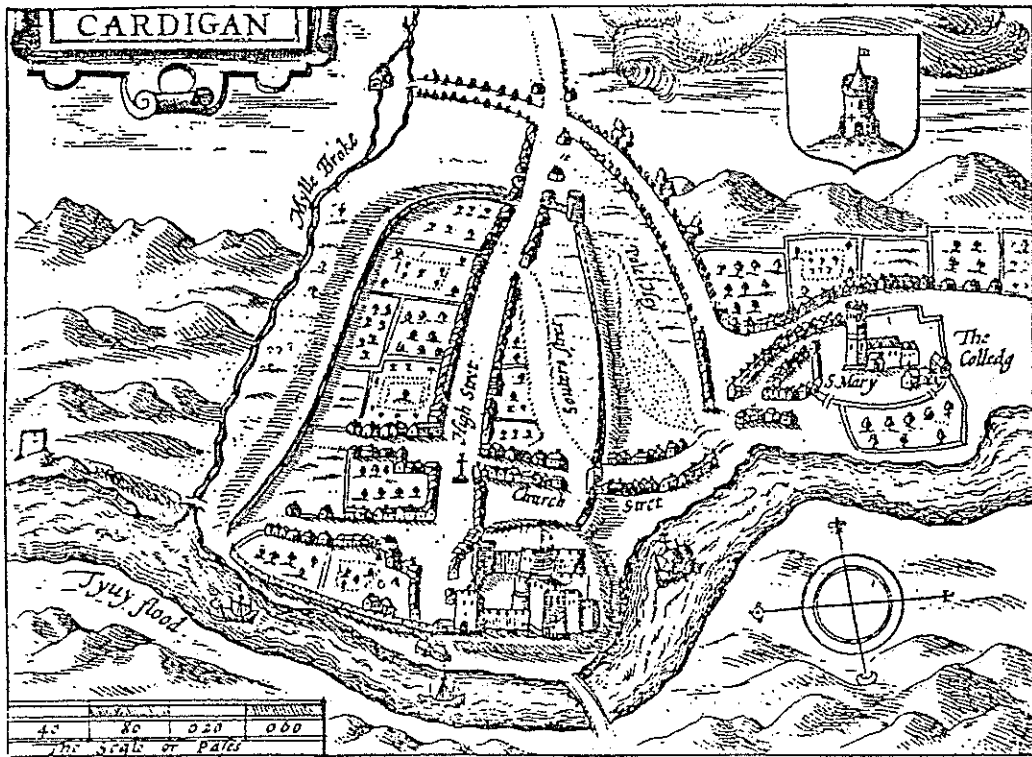
**Figure 2: John Speed's Map of Cardigan 1610**

The area on the west side of Bridge Street, between the new sewer and the house frontages, is so disturbed by service trenches as not to warrant any further investigation. However, the location of the Town Gate may well be on the west side of the new sewer, and adjacent to the castle wall, as illustrated on Speed's Map of 1610.

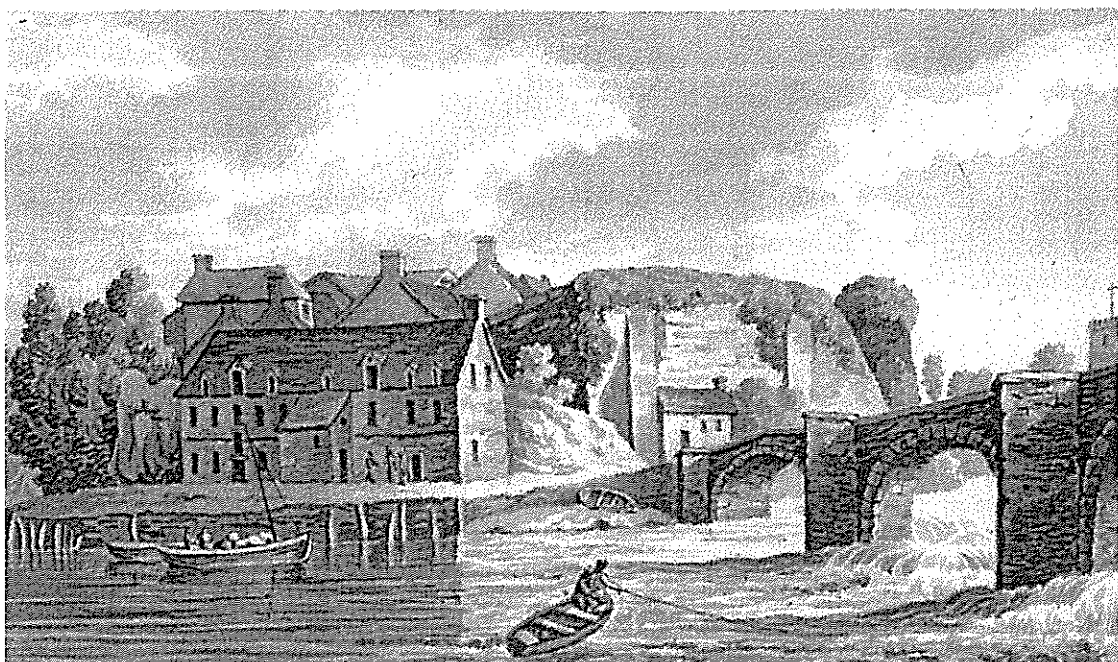
**Figure 3: Print of Cardigan Castle 1748**

The north-south wall encountered in the pumping station trench (Section 4) could relate to later medieval buildings of the Coedmor Estate c.1507, and was probably the west wall of the warehouse illustrated on a print of 1748 (Fig. 3). This is possibly the same structure as that represented on Wood's map of 1834 (Fig. 4). The general impression of the made-up ground in the quay area was that it was relatively recent, possibly the lower make-up being earlier 1900s, with the upper deposit dating to the 1960s.
