ST. ISHMAEL'S CHURCH ROSEMARKET PEMBROKESHIRE

ARCHAEOLOGICAL WATCHING BRIEF

REPORT NO. 2000/53
PROJECT RECORD NO. 42533

**ST. ISHMAEL'S CHURCH ROSEMARKET PEMBROKESHIRE
ARCHAEOLOGICAL WATCHING BRIEF
JULY 2000**

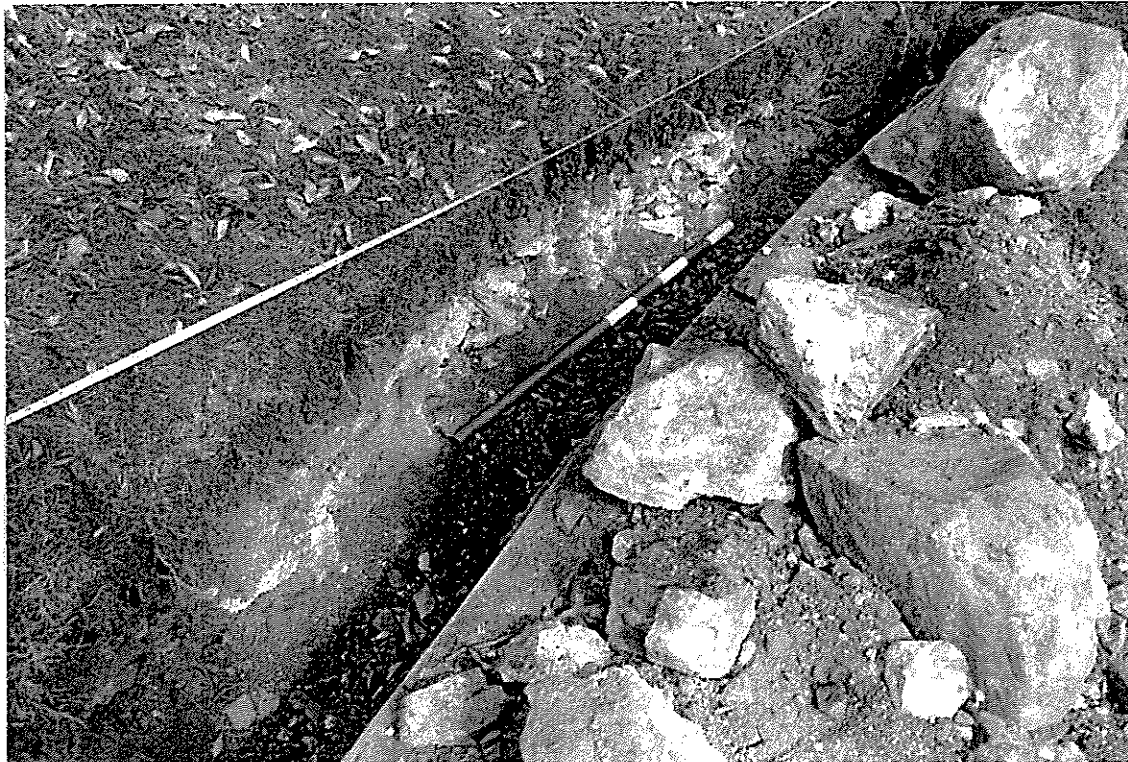
**PHOTO 1: WALL FOUND 9 TO 11 METRES SOUTH OF
CHURCHYARD GATE**

The service trench was fully open by the time of inspection. The trench was 300-350mm wide and 450-600mm deep. It ran along the west side of the path from the north churchyard entrance before turning eastwards c. 1.5m-2m north of the line of the north transept (figure 3). It then ran c. 1m to the east of the north transept before entering the north side of the church (figure 3). The trench sides showed a large amount of disturbed deposits throughout its length, except for a section 9m to 11m south of the gate where a lime mortared wall, or wall footings, probably running east to west, were encountered (photo 1). There may also have been a small amount of undisturbed material on the north side of the wall footings, but this could not be established within the limited confines of the trench. The wall location was plotted and photographed. Bones had been collected by the contractor and these were quantified (see Appendix One). No artefacts were recovered.

The disturbed soils observed are likely all to be the result of multiple grave cuts, with all the later burials below the bottom of the trench. The wall or wall footings are part of the structures shown on the tithe map, probably outbuildings or part of a property boundary wall. This wall was destroyed when the churchyard was enlarged near the beginning of the 1900s. On the north side of this wall there may have been a small amount of undisturbed natural as this later expansion of the churchyard did not have such a high density of graves. The bones recovered were nearly all human and probably are disturbed remains of earlier burials in the upper fills of later graves.

Except for the one probable post-medieval wall, or wall footings there was little disturbance to the archaeology except for the upper fills of graves, by this service trench. The contractor was requested to return all recovered bone to the trench.
