CARMARTHEN CASTLE

PHASE 3 ARCHAEOLOGICAL WORK

Report No. 2004/59

Prepared for TACP and Carmarthenshire County Council

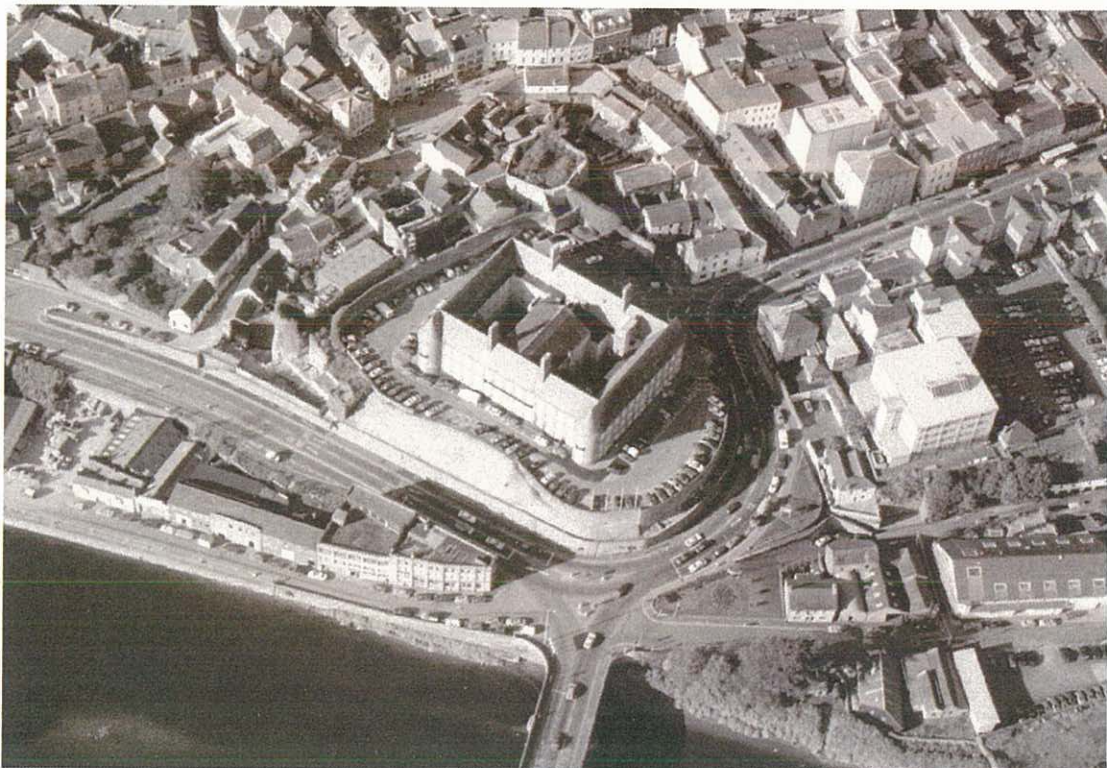
Photo 2 – Aerial photograph of the castle from the southeast, prior to the current works. All the elements discussed in this report can be seen, and the Southwest and Square Towers (© Cambria Archaeology, DAT AP 93-48.2)

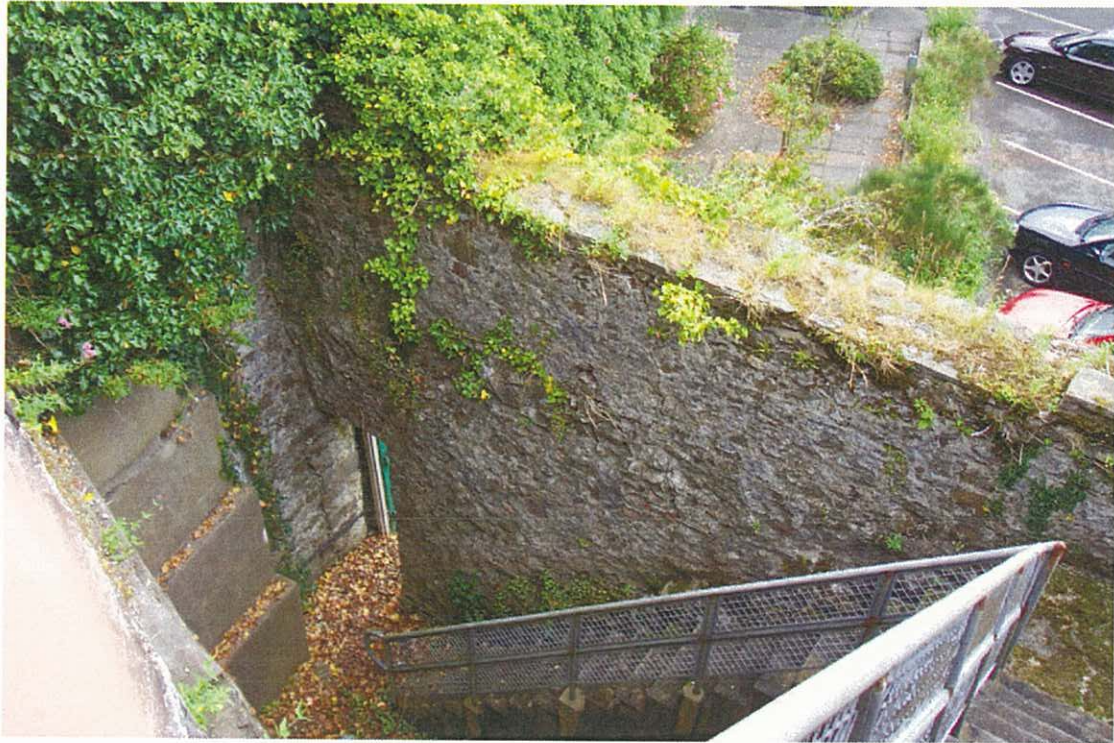
Photo 3 – The interior of the forebuilding, looking down from the shell-keep entry (facing northeast). The stepped concrete revetment, and modern stair, can be seen (see Fig. 3)

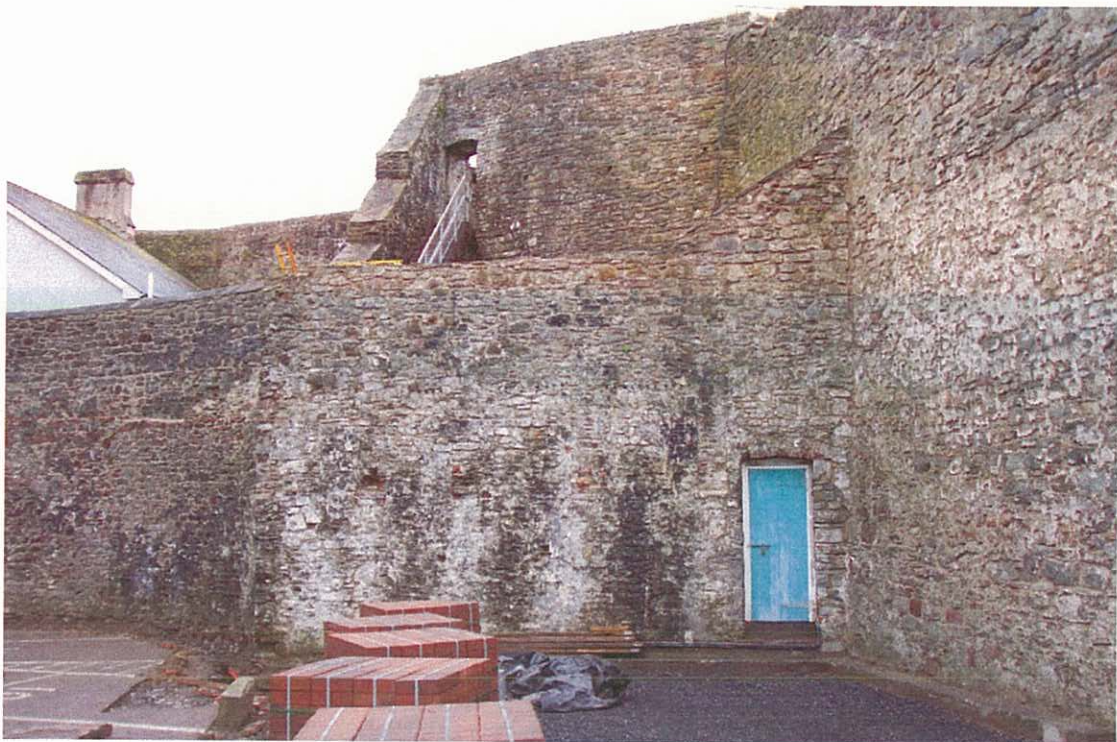
Photo 4 – The exterior of the forebuilding east wall, showing chases for the gaol-phase passage arches. The shell-keep, and its entry, can be seen beyond (see Fig. 4)

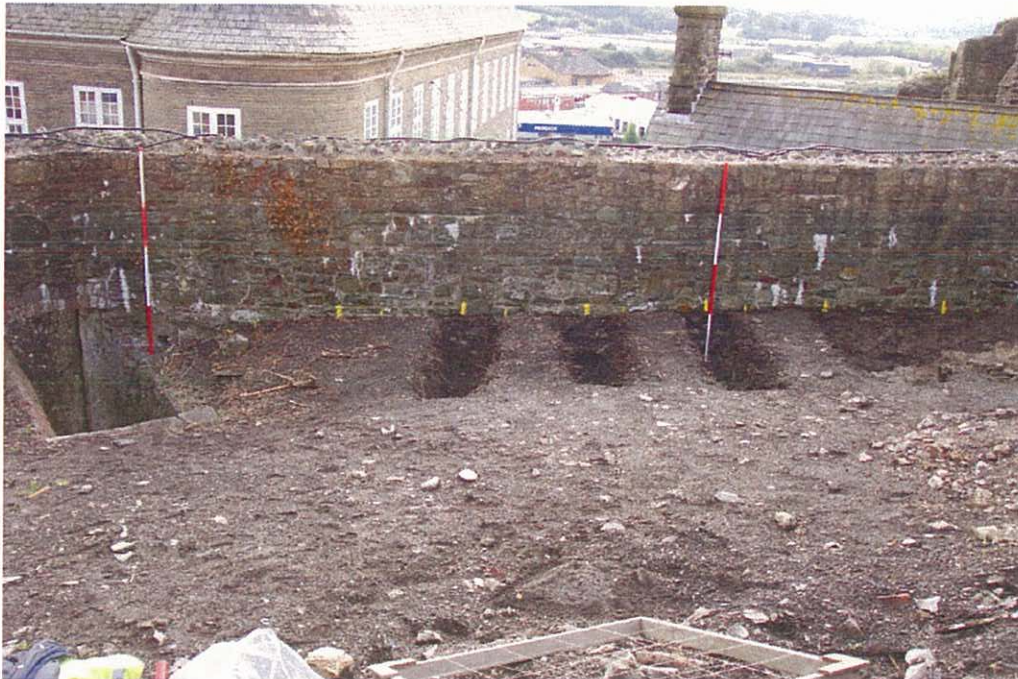
Photo 6 – The decking construction trenches along the shell-keep south wall, facing south. The present shell-keep entry is to the left (see Fig. 5)

The erection of a timber deck walkway around the interior of the present shell-wall, in 2002, entailed the excavation of 40 trenches around the periphery of the motte (Fig. 5, T1 - T40; Photo 6). It is unfortunate that such a damaging method was chosen for the installation of such a slight structure. Each trench was approximately 2m in length, radial to the centre of the motte-top, and averaged 0.4m in width and 0.5m in depth. All trenches were photographed, and every second trench (ie. half of the total number) was fully recorded through drawn sections.

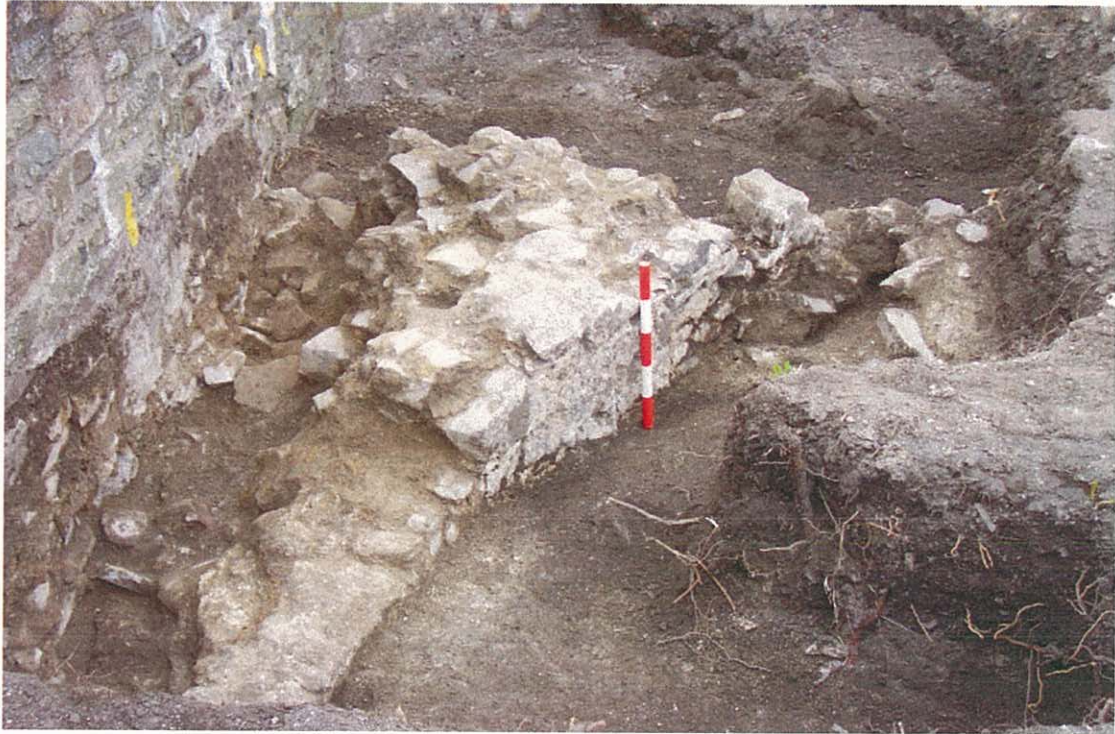
Photo 7 – The inner face of the medieval shell-wall on the south side of the shell-keep, revealed by construction trenches 4–6, facing west (see Fig. 6)

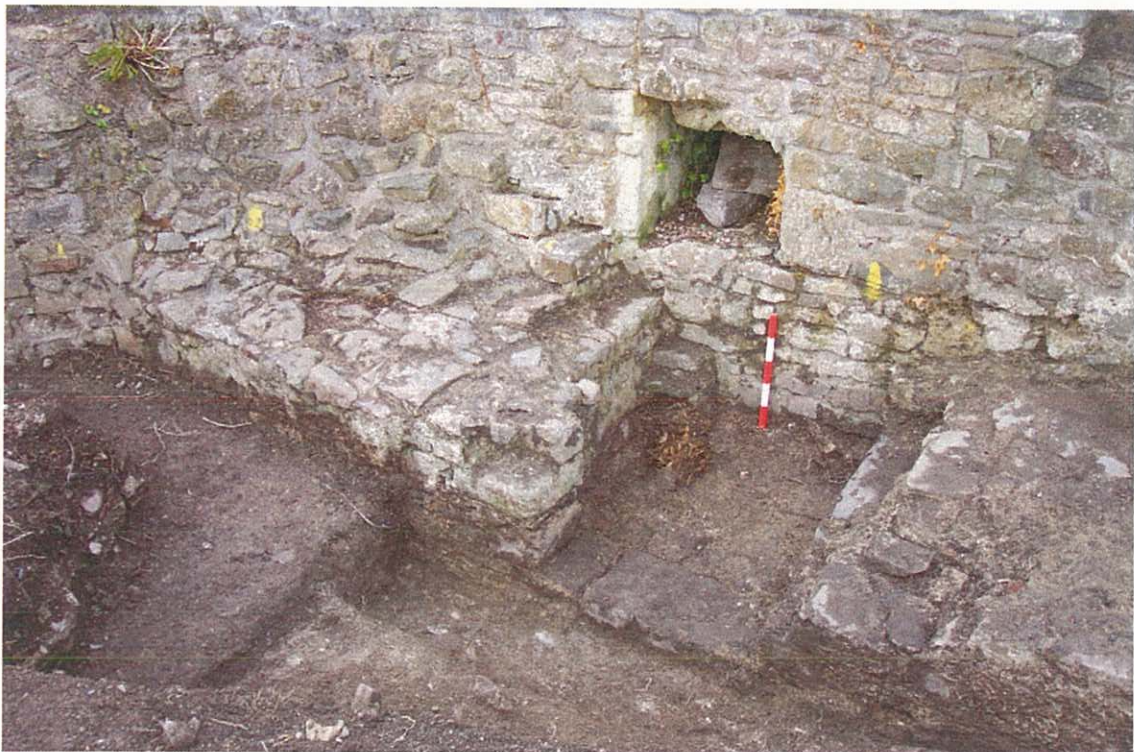
Photo 8 – The inner face of the medieval shell-wall on the west side of the shell-keep, revealed by construction trenches 13–17, facing southwest. The base of the mural stair, and doorway, can be seen (see Fig. 7)

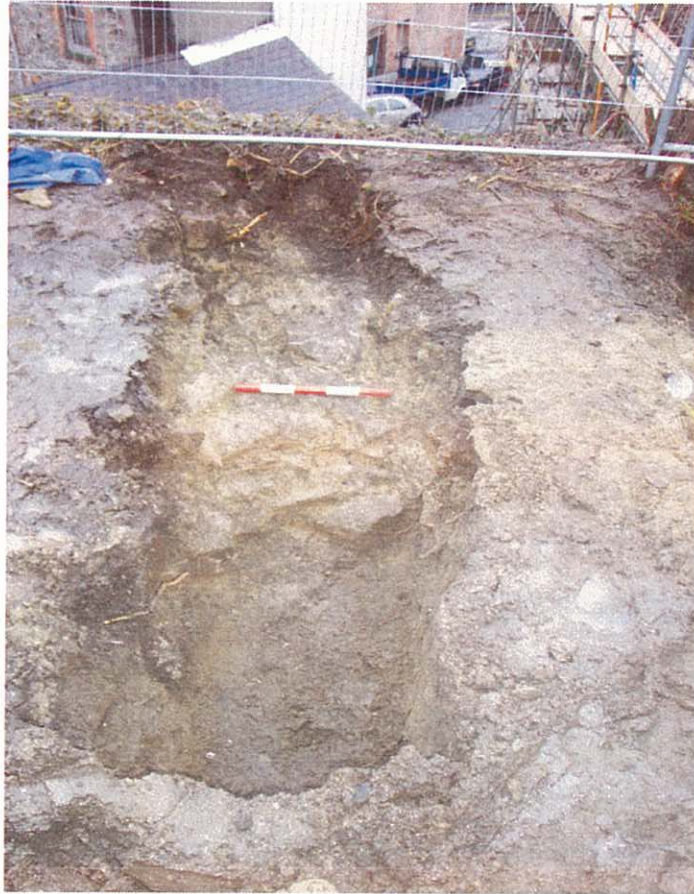
Photo 9 – The inner face of the medieval shell-wall on the east side of the shell-keep, revealed by construction trench 34, facing east (see Fig. 8)

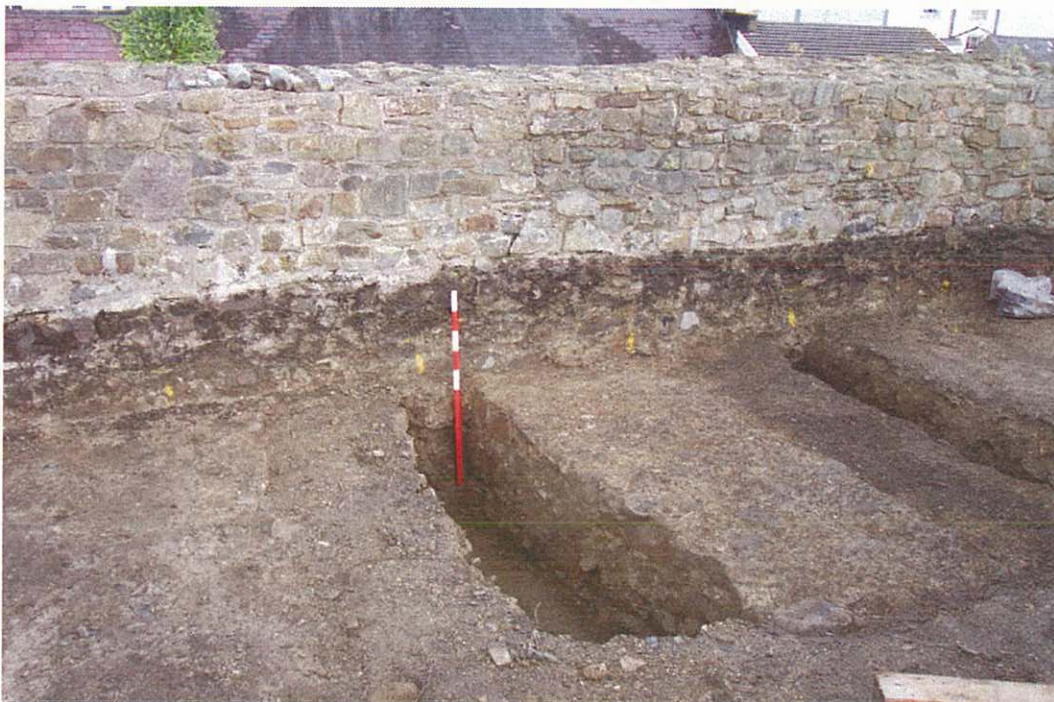
Photo 10 – The ?c.1901 buttresses against the internal face of the northern shell-wall, revealed by construction trenches 27 - 29, facing northeast (see Fig. 8)

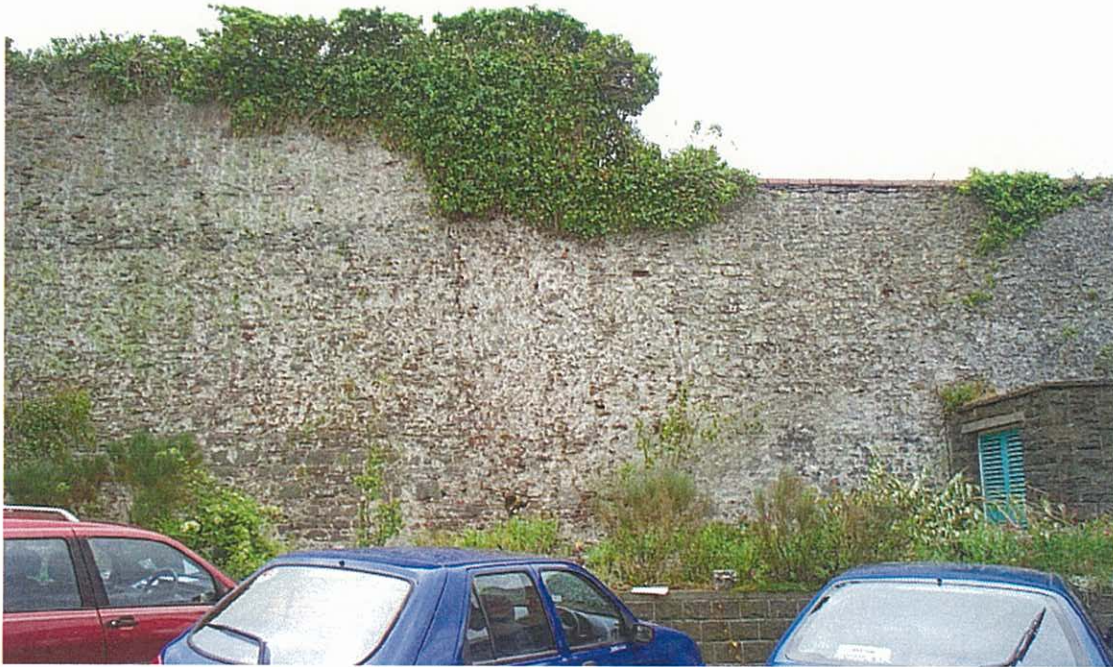
Photo 11 – The south face of the north 'curtain' wall, facing north. The modern electricity substation is to the right (see Fig. 9)

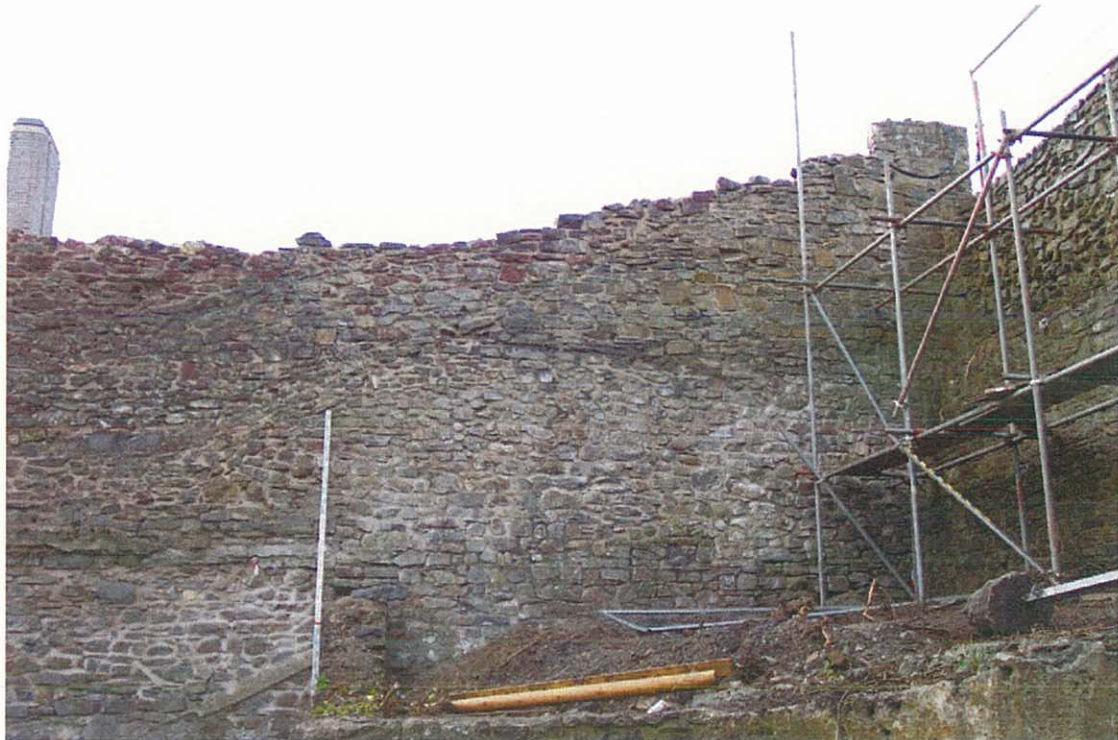
Photo 12 – The north face of the north 'curtain' wall, facing south. The roof-crease of the former cottage, and the cottage garden wall, are at the bottom (see Fig. 10)

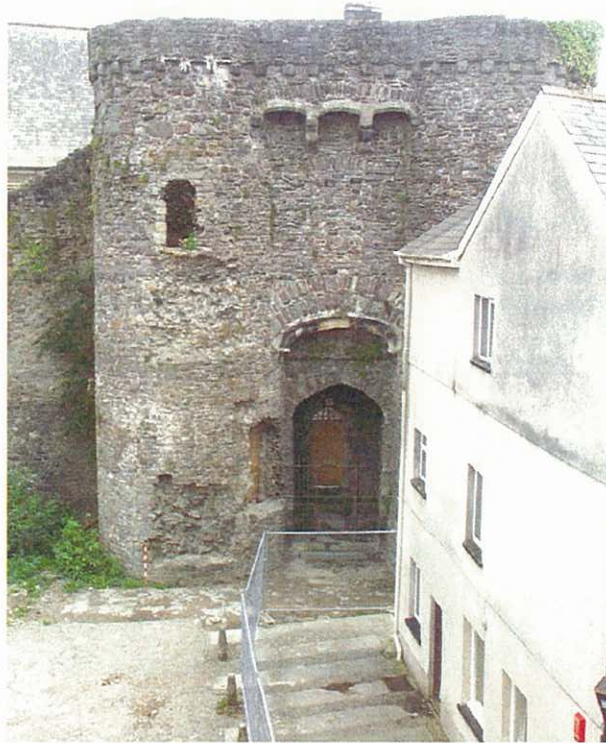
Photo 13 – The gatehouse from the west, before consolidation and excavation (see Fig. 15)

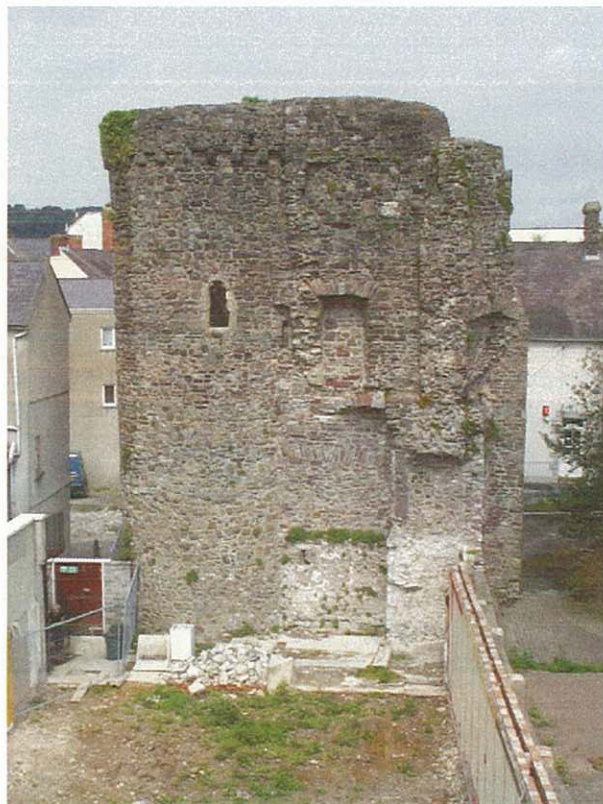
Photo 14 – The gatehouse from the south, after the demolition of the Rugby Club. The truncated west curtain wall, and the remains of the turret in its angle, can be seen, and the large area of robbing and infill in the central lower half (see Fig. 16)

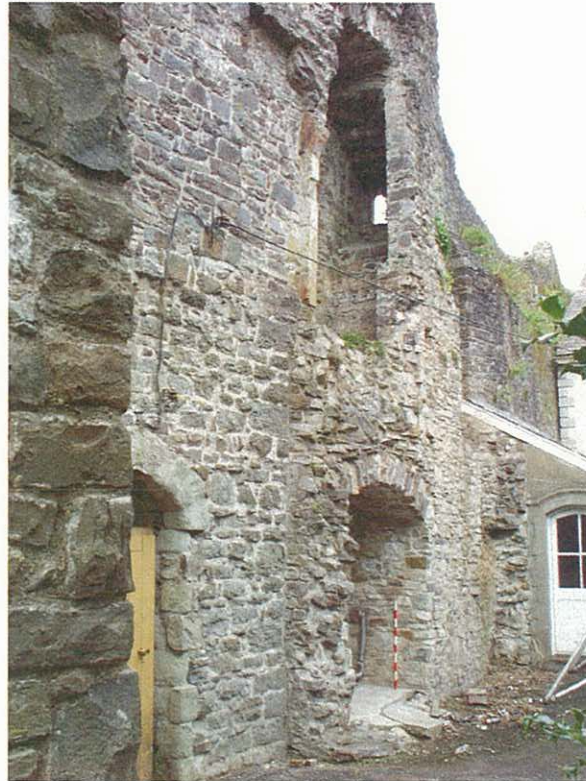
Photo 15 – The gatehouse east face, facing northwest. The gaol-phase infill and entry are to the left, and to the right are the scar of the rear section north wall and the doorway to the west curtain wall-walk (see Fig. 17)

The present gatehouse east wall (Photo 15) represents the internal dividing wall between the gatehouse towers and the missing rear section, but at 1m thick it is the same thickness, at first floor level, as the external walls. Its east face, now external, exhibits a plethora of openings (Fig. 17). The gate passage formerly emerged through this wall, but was partly infilled after 1789, and a new, smaller doorway was inserted (Fig. 17, 1). This has a four-centred surround in yellow oolite. The northern passage side wall can be seen as an area of corework, 0.7m wide, north of this infill (Fig. 17, 2), extending into the yard as some surface slabbing (see Fig. 13). To the north, the east wall face appears to have been external ie. outside the former rear section (see Section 5.1.6). A recess at ground floor level, immediately north of the former passage side wall, is 1m deep, 2.3m wide and 2.2m high beneath a segmental arch (Fig. 17, 3); it is rather wide but may represent a former entry into the north gate tower chamber from the castle interior, later blocked (presumably when the ground floor chambers were infilled). All evidence for the southern passage side wall has been lost on this face of the gatehouse, and no former entry to the south gatehouse tower can be distinguished; this area may then have been extensively re-faced, but see below and Fig. 18, 6.

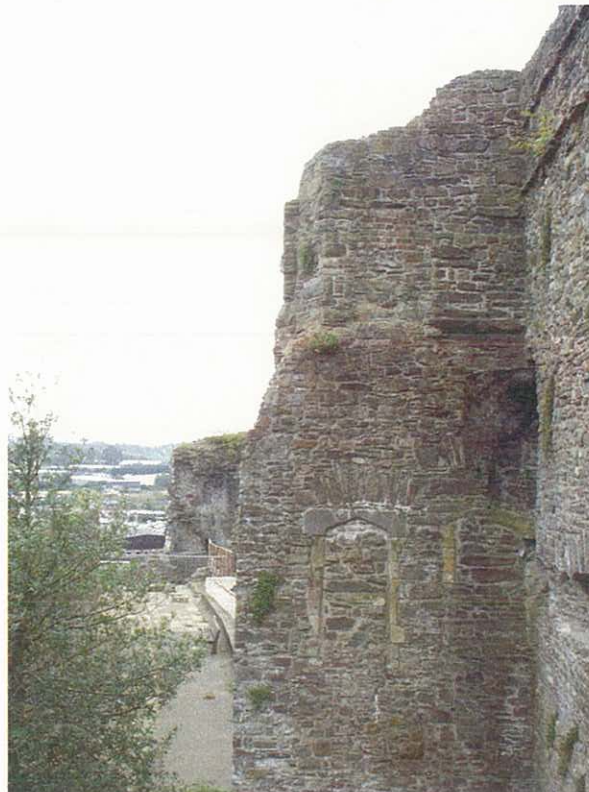
Photo 16 – The remains of the gatehouse rear section south wall, facing south, showing the blocked first floor entries, and secondary entry (see Fig. 18)

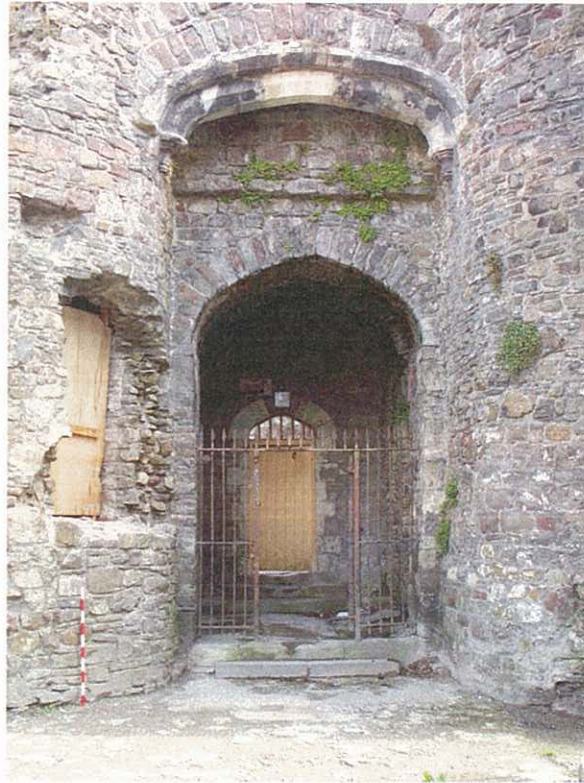
Photo 17 – The gate-passage entry from the outside, facing east, before excavation. The early 15th century dressings can be seen. The flanking opening in the north tower has been unblocked (see Fig. 15)

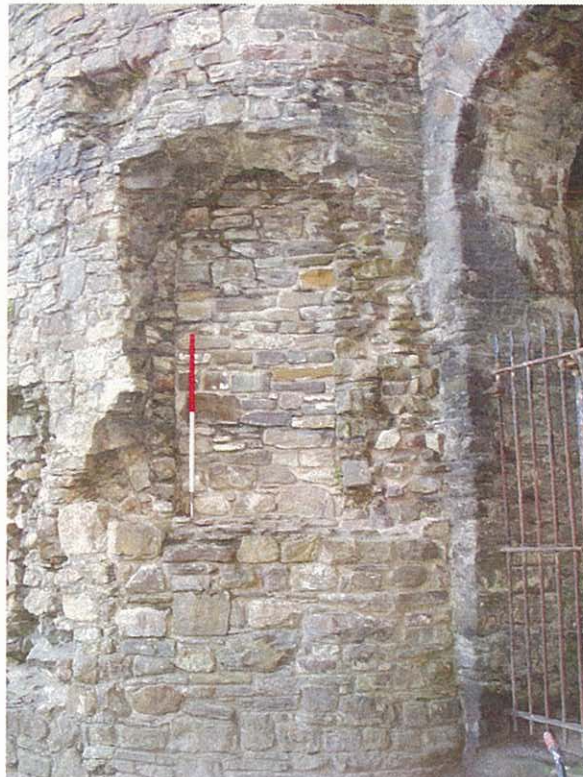
Photo 18 – The opening in the north tower, flanking the gate-passage entry, before unblocking, facing northeast (see Fig. 15)

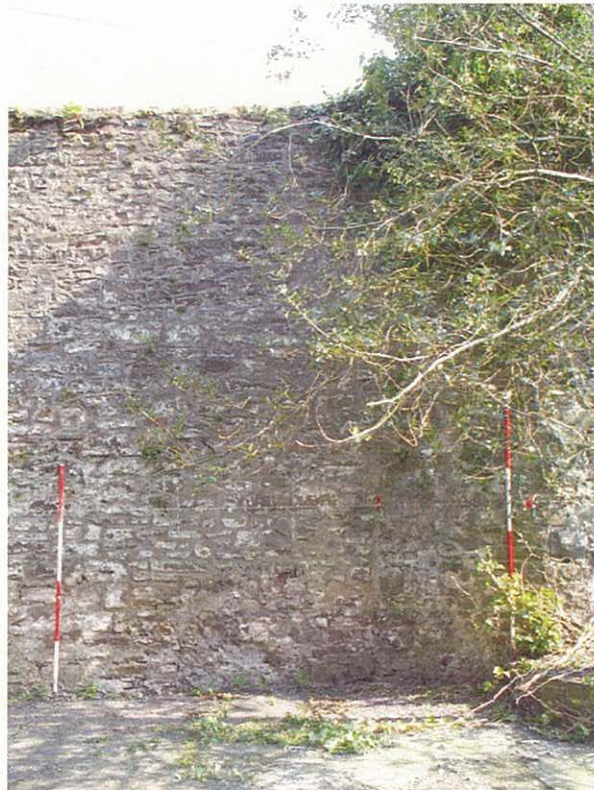
Photo 20 – The gaol wall from the west, showing the joint between the gaol-phase wall (left) and the remains of the southeast corner of the gatehouse rear section (right). See Fig. 33

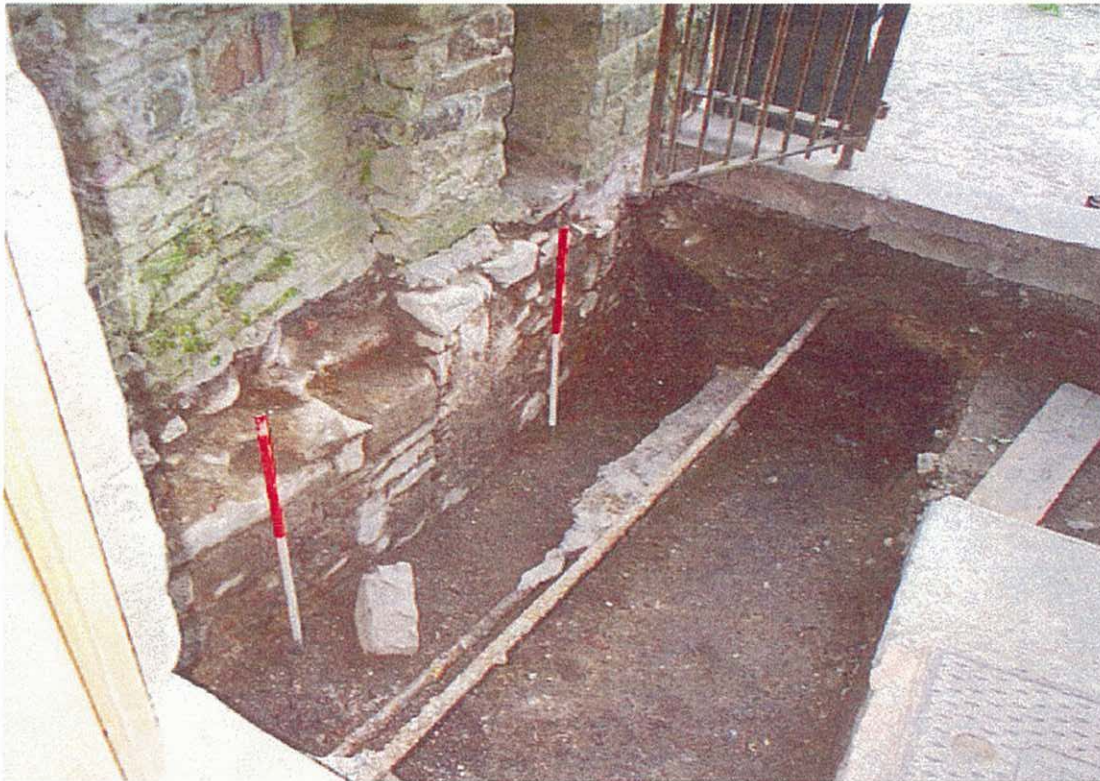
Photo 21 – The gate passage evaluation trench, facing southwest showing the joint in the passage south wall where it forms the side wall of the probable drawbridge pit (see Fig. 19)

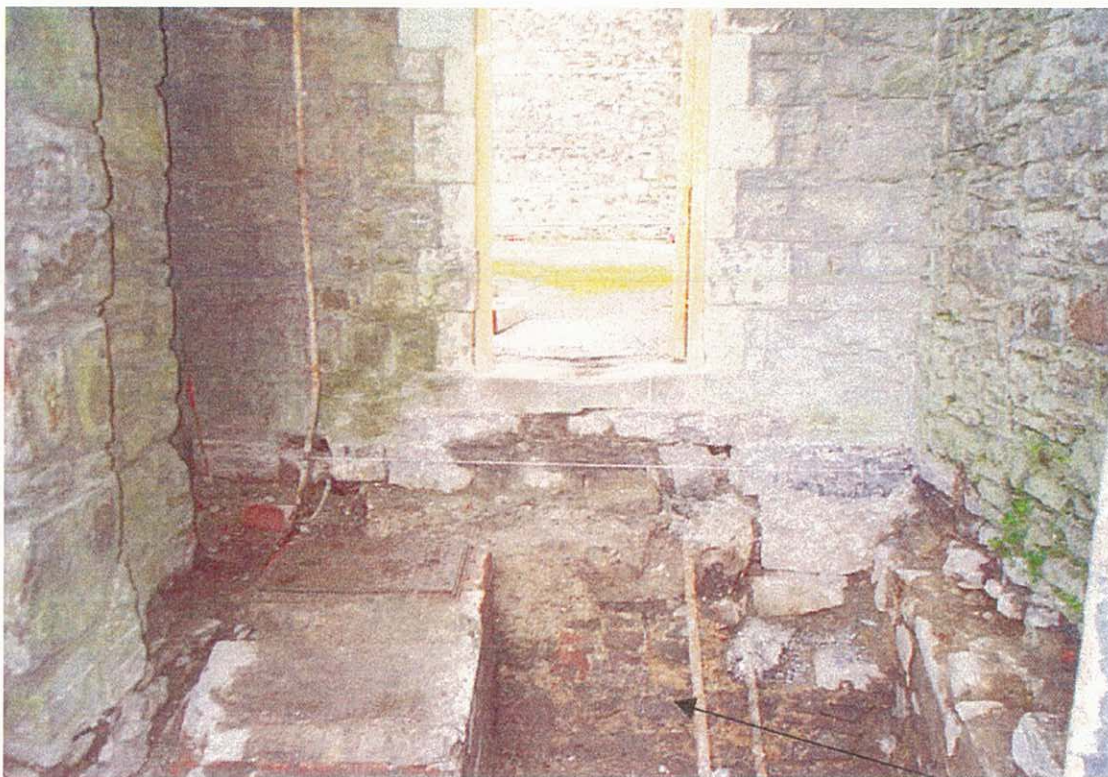
Photo 22 – The gate passage evaluation trench, facing east showing the inserted gaol-phase doorway and infill (see Fig. 20)

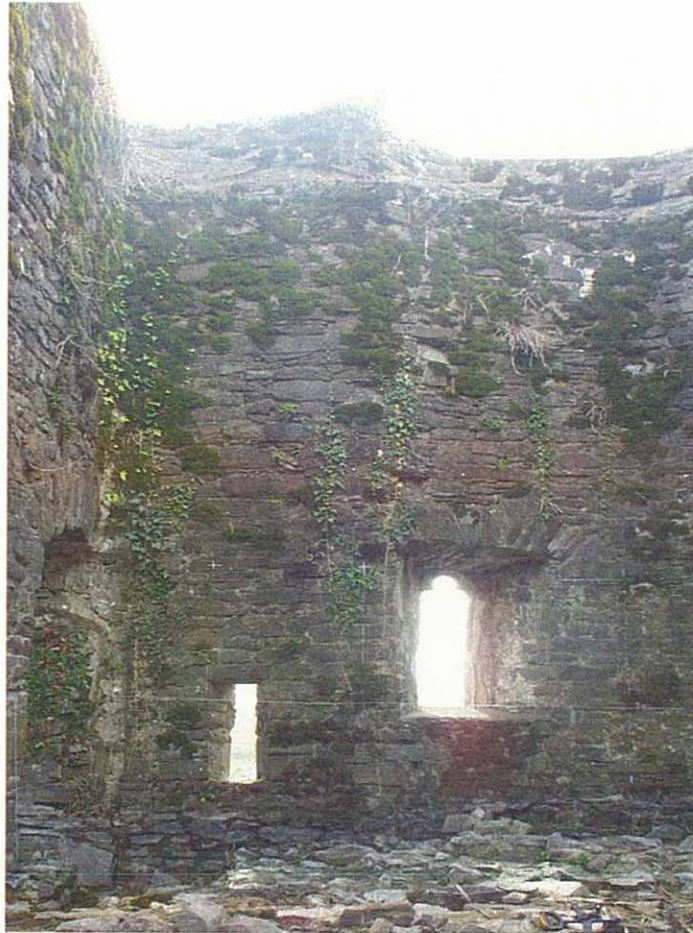
Photo 23 – The gatehouse first floor, facing south, showing the surviving 15th century surround in the window opening, and the top of the ground floor infill (see Fig. 24b)

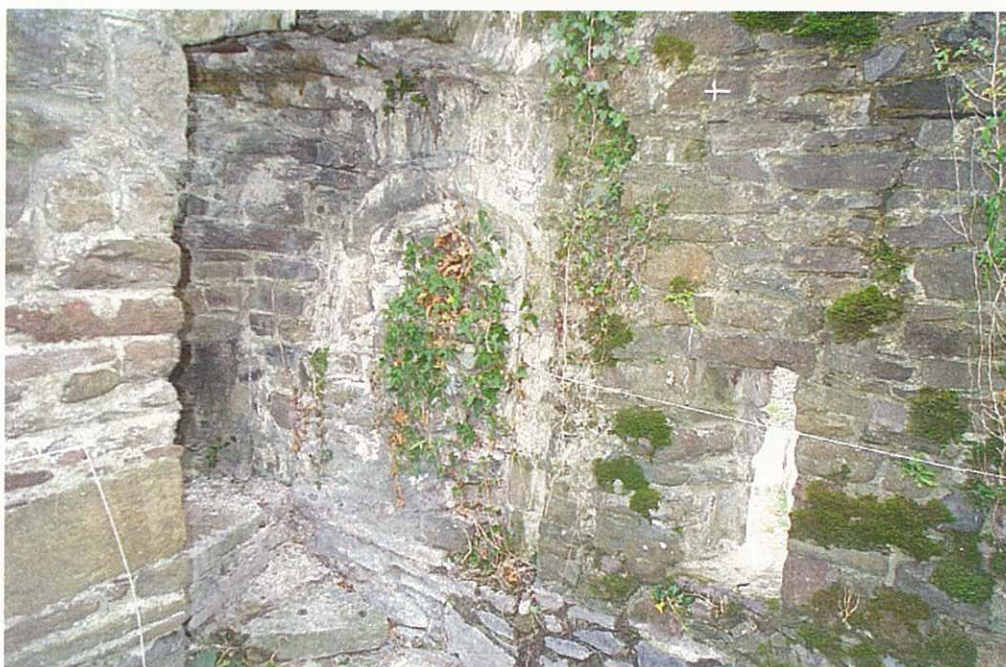
Photo 24 – The blocked entry into the former turret from the south side of the gatehouse first floor, facing southeast. The area to the left has been damaged and altered (see Fig. 24b)

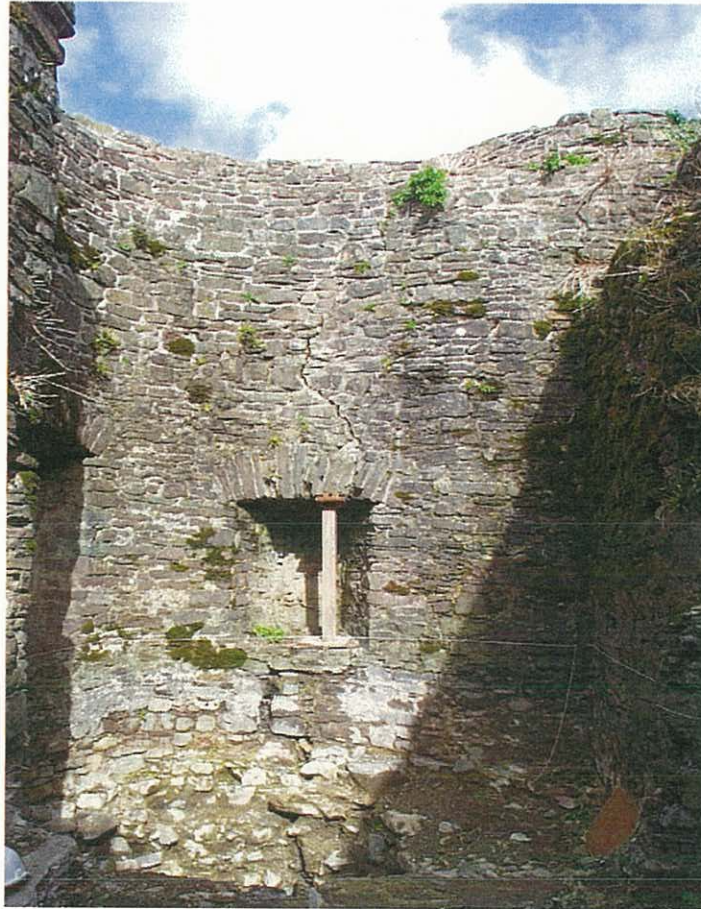
Photo 25 – The gatehouse first floor facing north, showing the blocked north tower window opening, and part-excavated ground floor infill below it (see Fig. 24c)

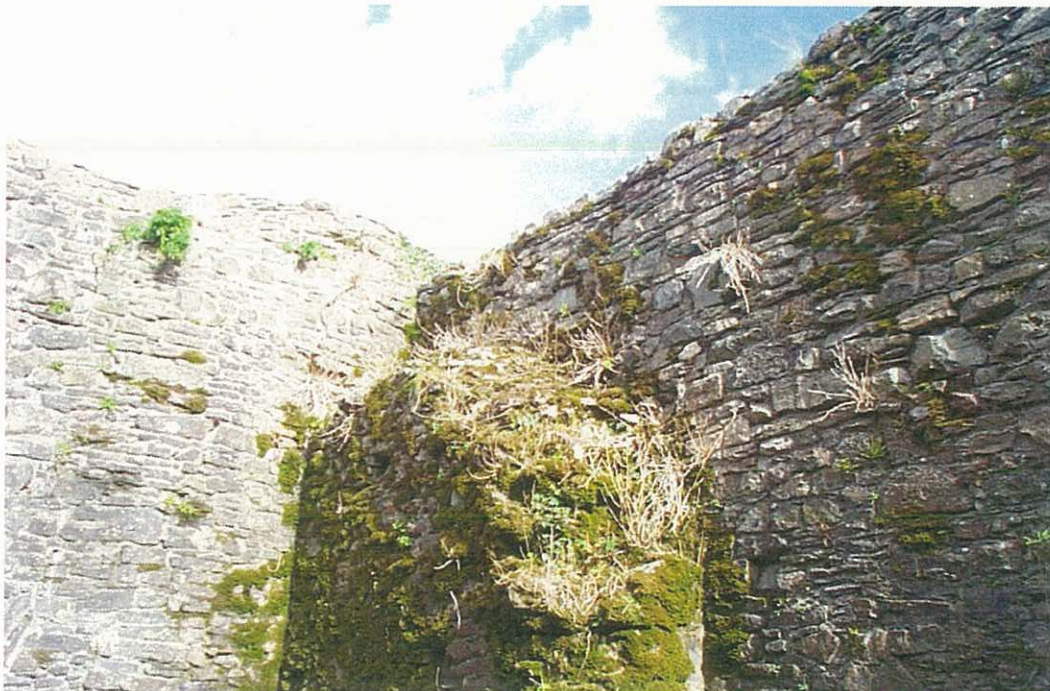
Photo 26 – The northeast corner of the gatehouse first floor, facing northeast, showing the coped vaulting over the mural passage to the west curtain wall-walk (see Fig. 24c and d)

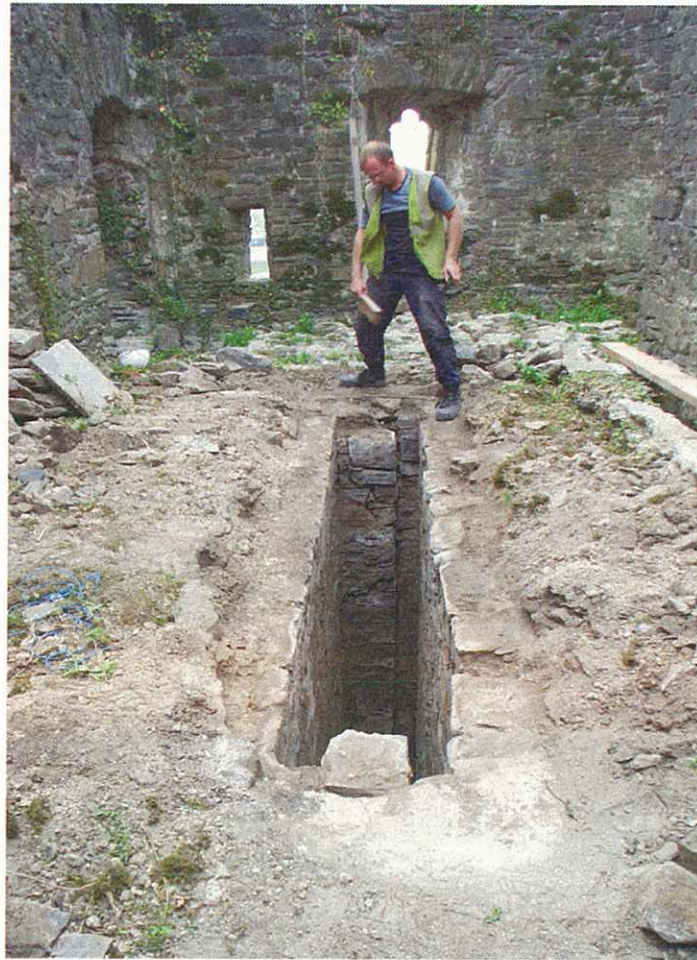
Photo 27 – The gatehouse first floor, facing south, during removal of later slabbing from over the portcullis slot (see Fig. 23)

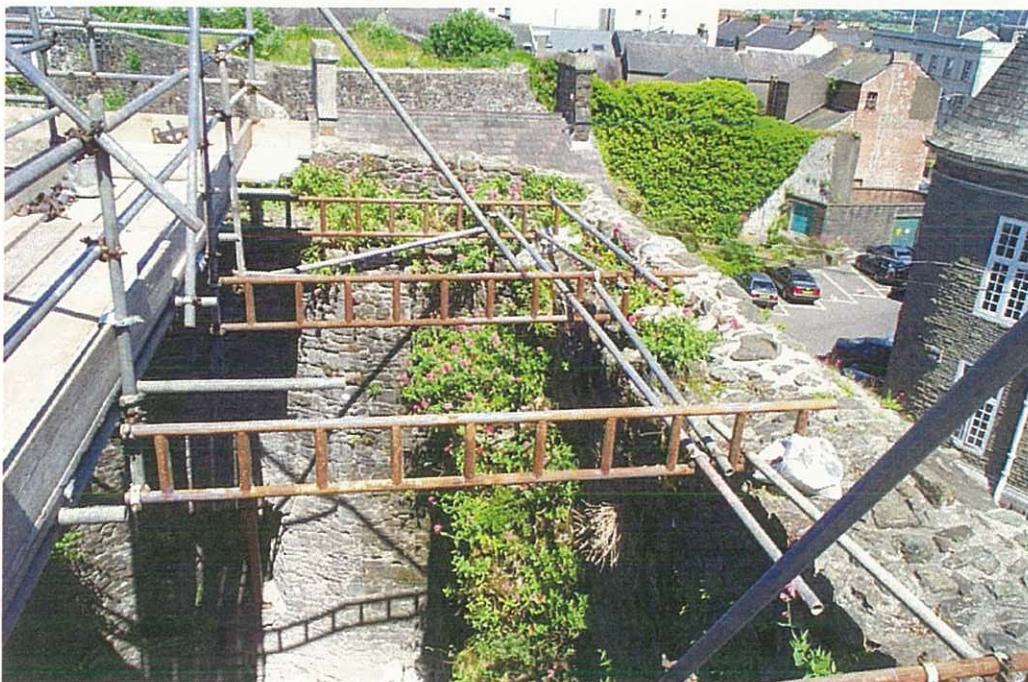
Photo 28 – General view of the gatehouse parapet, facing northeast (see Fig. 25)

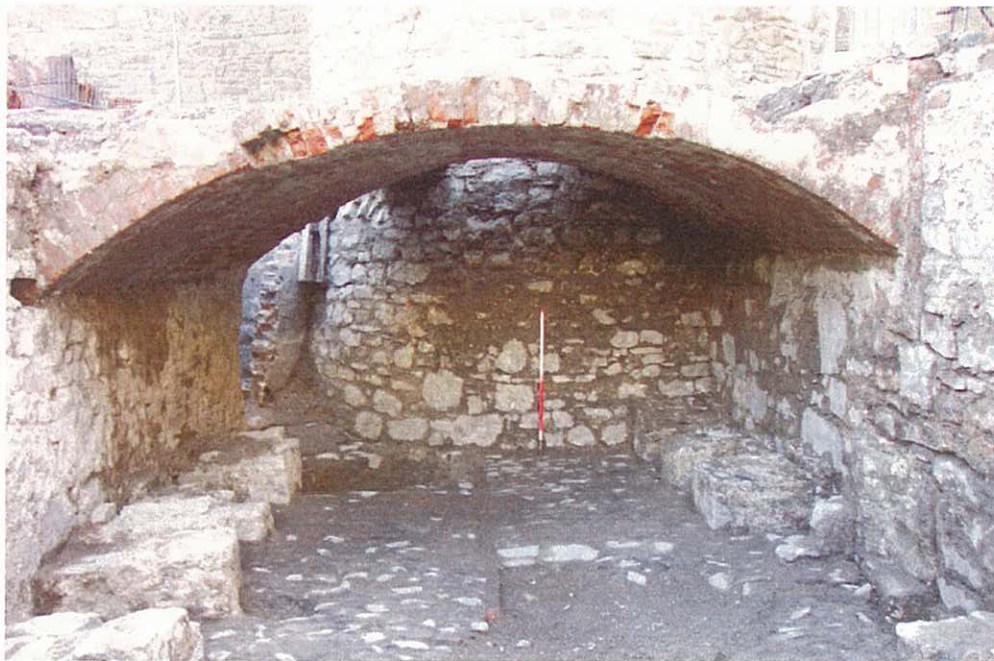
Photo 29 – The post-medieval cellar beneath No. 11 Nott Square, facing east. The gatehouse north tower can be seen beyond. The north wall (to the right) incorporates elements from the medieval bridge/causeway. The plinths lining both walls were barrel stillages

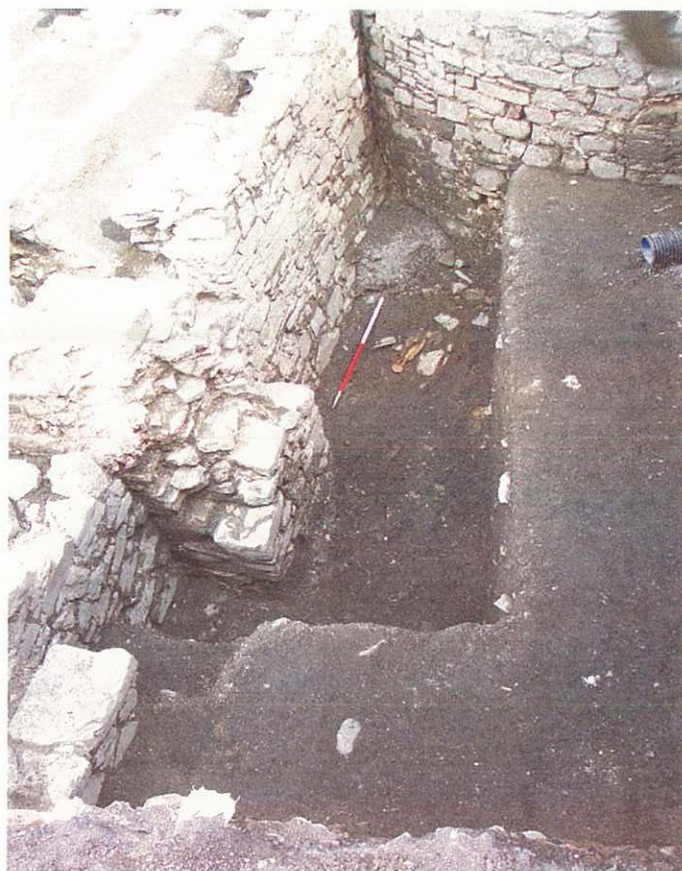
Photo 30 – The south side of the medieval bridge/causeway, during excavation, facing northeast. The photo shows the eastern bridge pier and later connecting walls, and the gatehouse south tower (right)

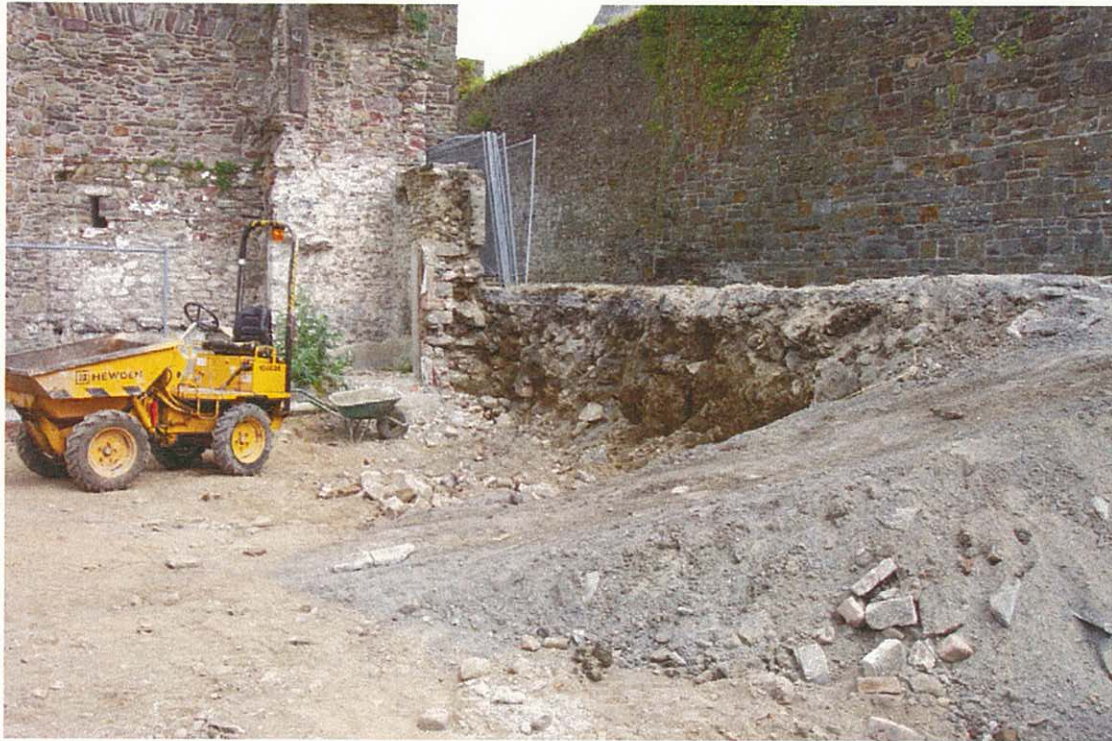
Photo 31 – The section left by the removal of the Rugby Club east wall, facing northeast. The gatehouse south tower is to the left. The remains of a post-medieval building are visible to the left of the section (see Fig. 31)

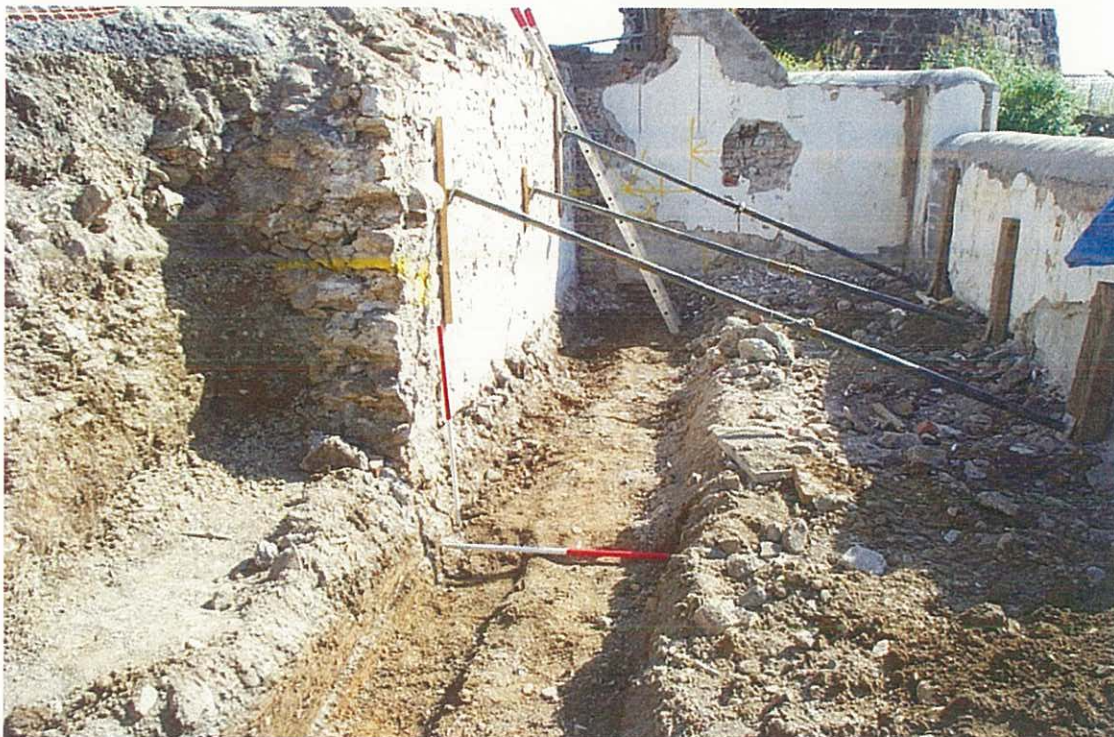
Photo 32 – The section left by the removal of the Rugby Club east wall, and the new wall trench, facing southeast. The bottom half of the section shows the redeposited subsoil (bank material?) and the buried soil can be seen in the new trench. See Fig. 31

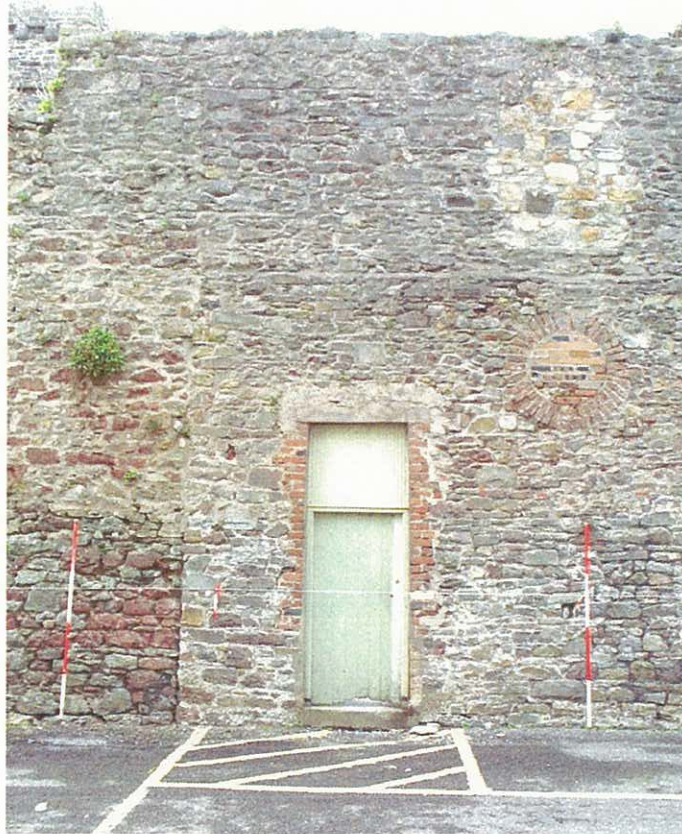
Photo 33 – The east face of the infirmary east wall, showing the blocked window and medallion (right), and the joint with the gaol wall (left). See Fig. 34

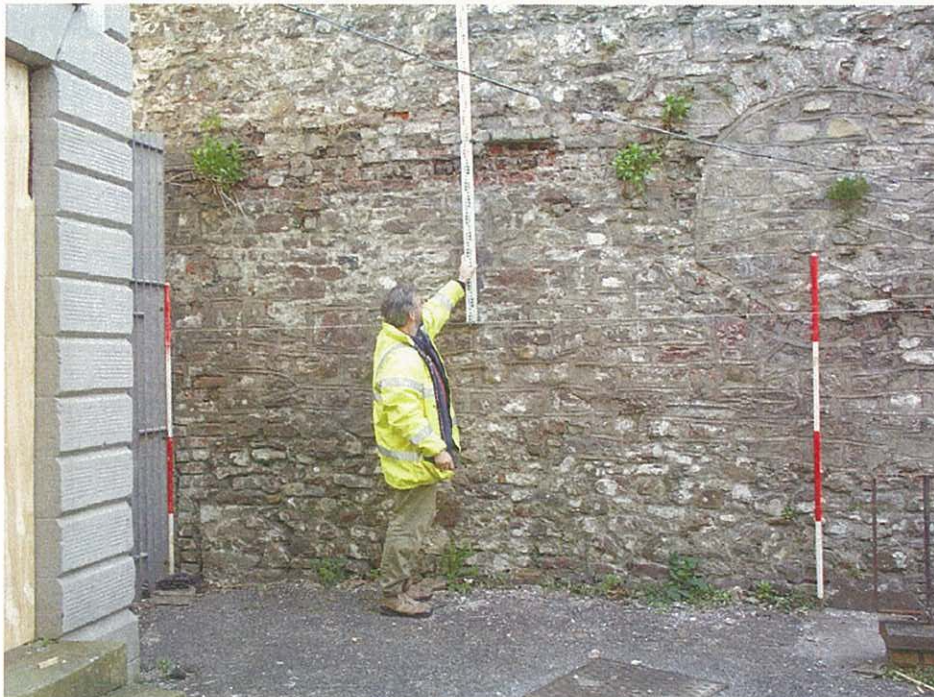
Photo 34 – The west face of the infirmary east wall, showing the medallion and the infill of the ?first floor chase (see Fig. 34)
