CARMARTHEN CASTLE

PHASE 3 ARCHAEOLOGICAL WORK

Report No. 2004/59

Prepared for TACP and Carmarthenshire County Council

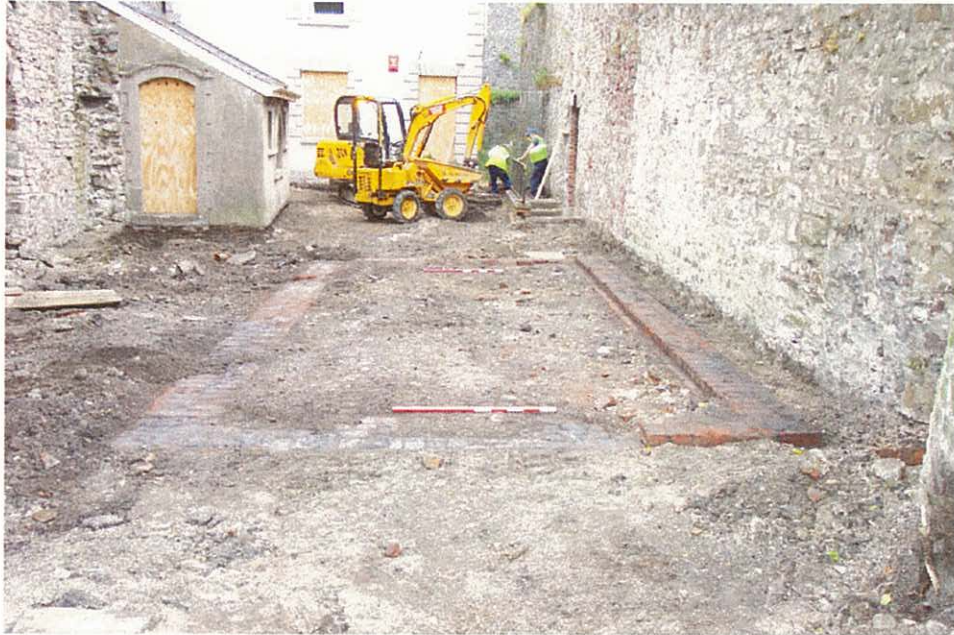
Photo 35 – The yard during removal of surfaces, facing north, showing the footings of an early 20th century gaol building. The gaol wall is to the right, and the Old Police Station can be seen beyond (see Fig. 35)

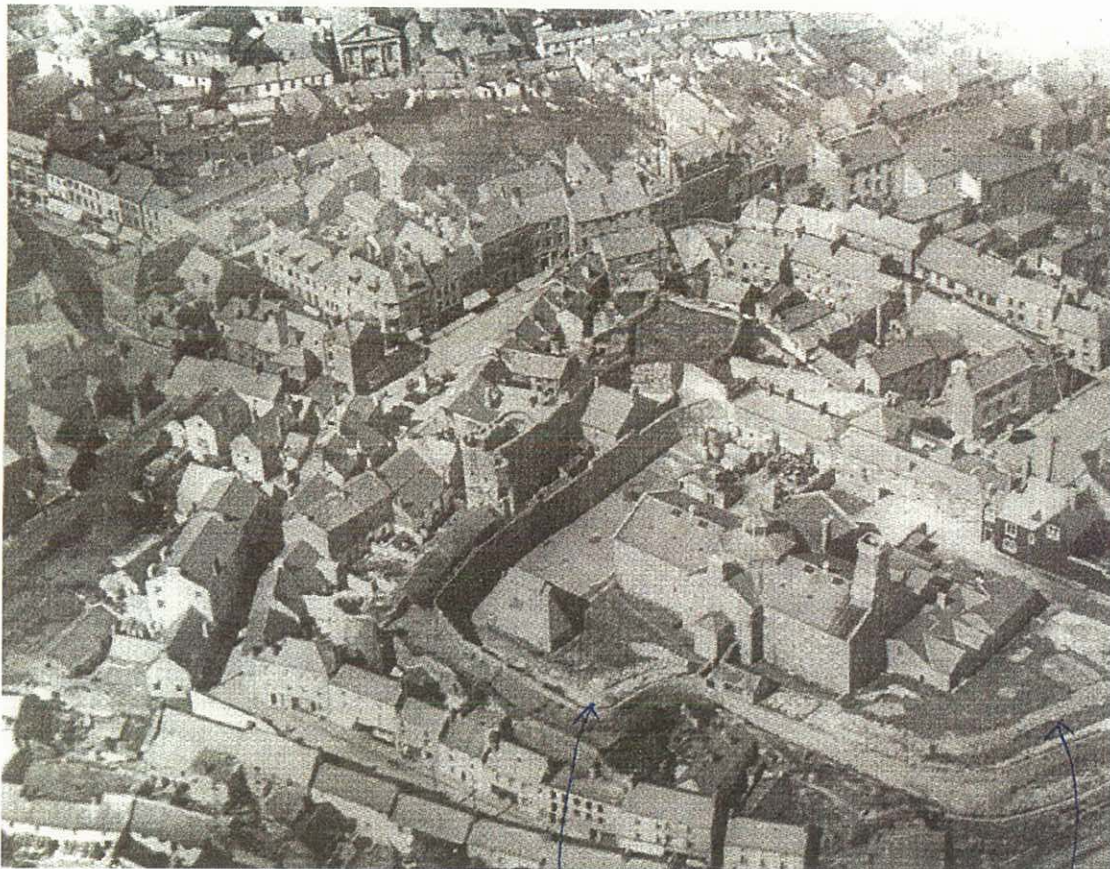
*Plate 4 - aerial photograph of Carmarthen Castle from the southeast, taken c. 1930
(Carmarthen Museum)*

The section drawings of 18 of the recorded trenches are reproduced here as Fig. 8. Most of the trenches were not deep enough to affect the medieval surfaces and deposits, but Trench 32 partly revealed the walling (019 & 020) that had been encountered during the 1997 evaluation. Remnant demolition/collapse debris from the medieval shell-keep, which was not removed for the Governor's garden, was also revealed in a number of trenches, overlain by the garden soil. Trenches 27-30 revealed (and were dictated by) a series of at least 4 masonry buttresses built against, and probably contemporary with, the internal face of the 1901 shell-wall (Figs. 5 and 8; Photo 10). These were at least 2m long, running N-S, and were truncated to present ground level, possibly at a later date. The trench for the 1901 shell-wall was also exposed in some trenches. In most of the trenches, the garden soil could be seen to post-date the 1901 shell-wall, while Trenches 1 and 39 showed evidence of two phases of garden soils, both probably post -1901. The earlier soils appeared to show bedding divisions, defined by vertical slates in Trench 1. The garden deposits contained a considerable amount of animal bone, some gaol-phase ceramics and metal prisoners' plates (see Section 9.0). The fruit tree may have been a later introduction still; an aerial photograph from c.1930 shows the current levels on the motte-top, apparently grassed, but no tree is visible (see Appendix 2, Plate 4), and so the tree may have in fact post-dated the gaol.

The south face of the wall is relatively featureless (Fig. 9; Photo 11), but is partly concealed behind the electricity substation. Much of the facework lies beneath the remnants of a limewash finish, but this is insufficient to obscure the facework, and no evidence of blocked openings etc. is present. There are two slight vertical cracks in the facework, and the slight impression, in the limewash fish, of a vertical line which may be derived from the former presence of an abutting structure. However, no structures are shown in this area on the 1786 plan, or on Suggett's reconstructed plan of Nash's gaol (see Appendix 3, Fig. 1), or on a plan of the enlarged gaol from 1881 (see Appendix 1, Map 5). The subsequent Ordnance Survey maps do not show the interior in any detail. Nor are any buildings shown against this face on the c.1930 aerial photograph (see Appendix 2, Plate 4).
