PONTYATES TO BANCYFELIN GAS PIPELINE

**ARCHAEOLOGICAL WATCHING BRIEF AND EXCAVATION
ON TWO BURNT MOUNDS AND A RING DITCH
APRIL- JUNE 2001**

Report No. 2002/7

Report Prepared for:
TRANSCO

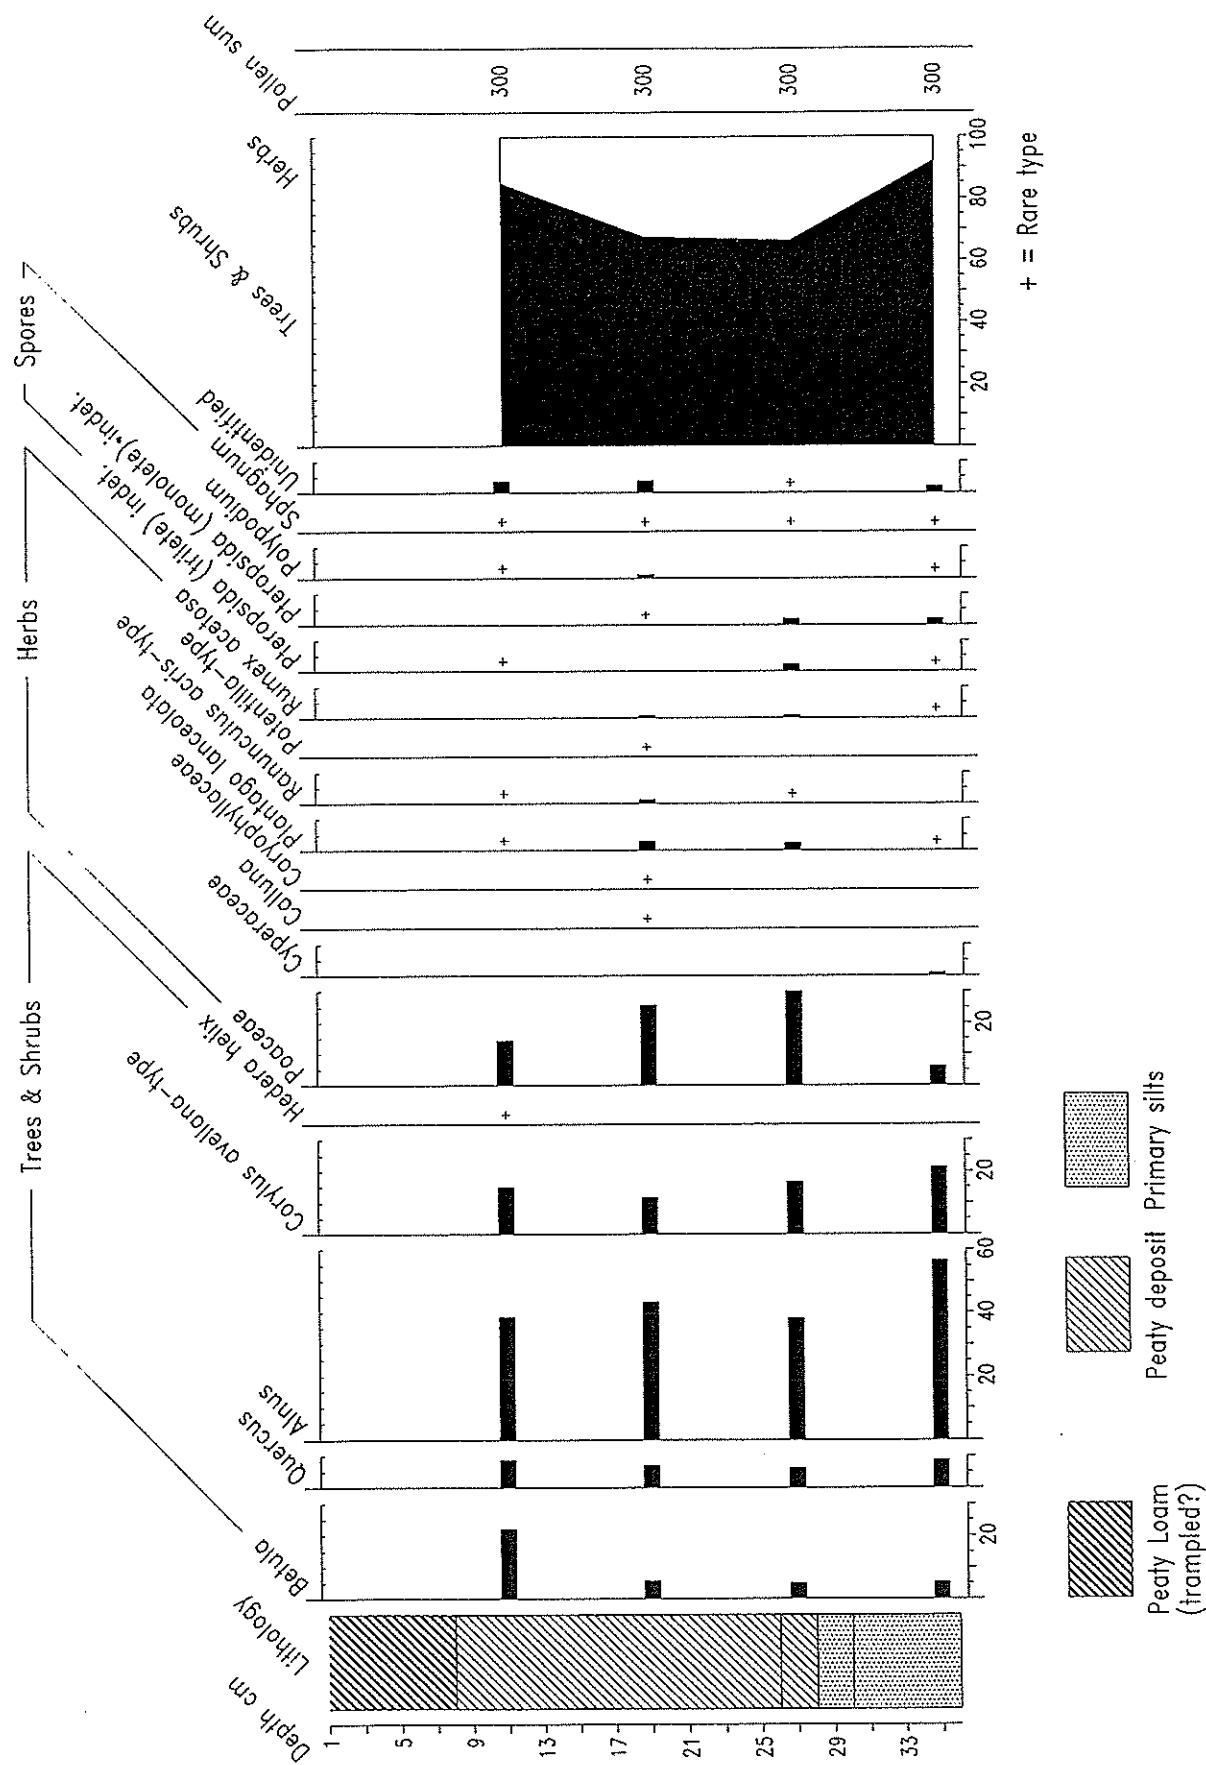
Table 3 Percentage pollen diagram from the ring ditch at Lodge Farm.

The pollen evidence initially suggests a wooded environment, probably reflecting alder carr woodland on the floodplain with some oak and hazel growing on the drier valley sides, around the time, or shortly after, the ring ditch was constructed. The decline in arboreal pollen, increase in grass pollen and presence of weed species such as ribwort plantain, buttercups and docks suggest possible clearance activity and an increase in grassland for pastoralism. However, the increase in grass and herbaceous taxa could represent taxa growing on the sides of the ditch and buttercup and grass seeds, though scarce, are recorded in the seed assemblage. An increase in birch pollen in the final sample and decline in herbaceous taxa is suggestive of abandonment and regeneration of birch woodland. The absence of elm indicates a post 'elm decline' date for the beginning of the pollen record while relatively high arboreal values throughout demonstrate the diagram pre-dates widespread permanent clearance in the area. The evidence is not inconsistent with a Bronze Age date but this could only be confirmed by radiocarbon dates.

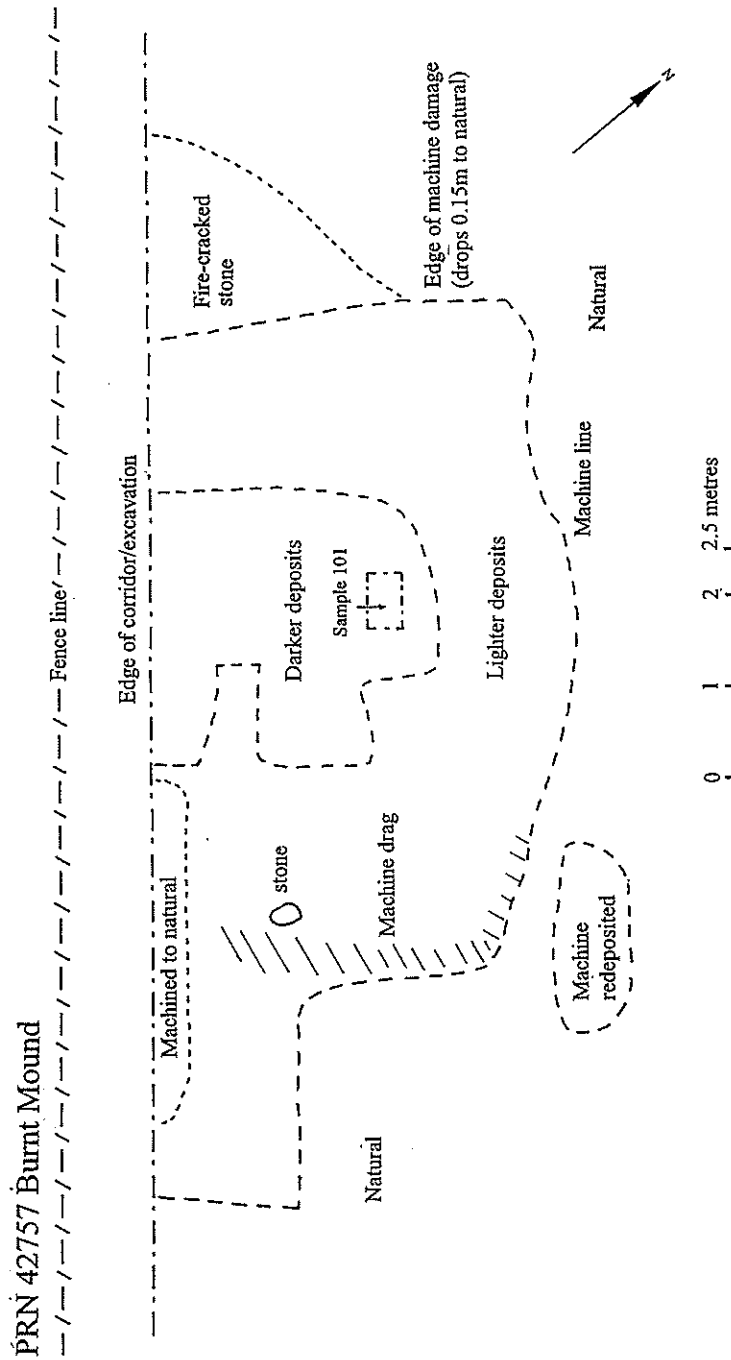
Figure 4: Burnt Mound 42757

During the topsoil stripping a small amount of damage had been done to the surface of the heat affected material of the mound (Figure 4 and Photo 4). The exposed material of the mound consisted of a dense layer of fire-cracked stone c. 150mm deep, with a darker (probably more charcoal rich) area towards the centre. No further excavation was undertaken except for taking a sample (101). Radiocarbon

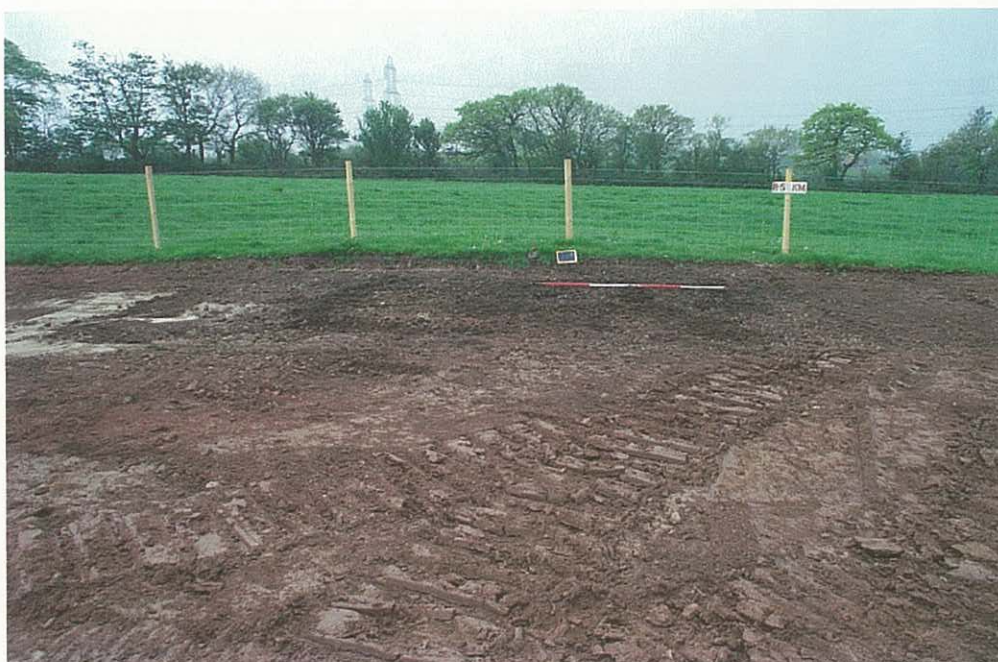
Photo 1: Burnt Mound 42757 as found

Scale 2m, View SW

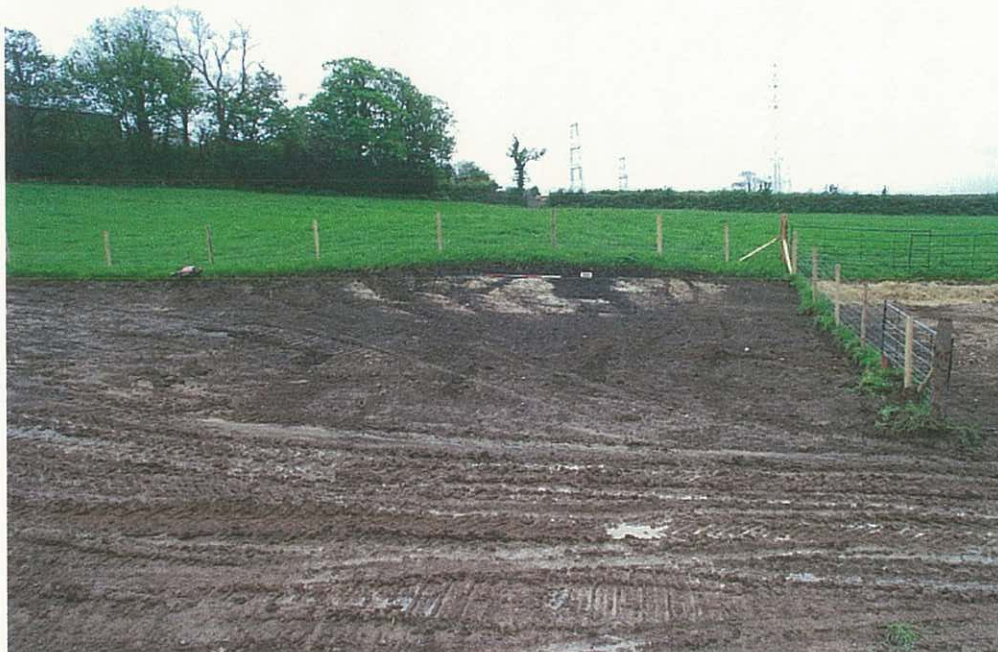
Photo 2 Burnt Mound 42758 as found

Topsoil and all the fire-cracked stone and dark soil had been removed from the higher part of the mound down to the natural by machine prior to its discovery (Photo 2). The remaining layer of fire-cracked stone only just extended into the eastern edge of the corridor. A pit (101 - Photo 2) 2m x 1.5m with a very dark fill could clearly be seen, as also could a narrow semi-linear feature. The pipe trench could not readily be moved away from the site due to other restrictions. Therefore it was agreed between the contractor and the Archaeological Development Control Officer that the area of the burnt mound within the area stripped of topsoil should be archaeologically investigated.

Scale 2m, View SW

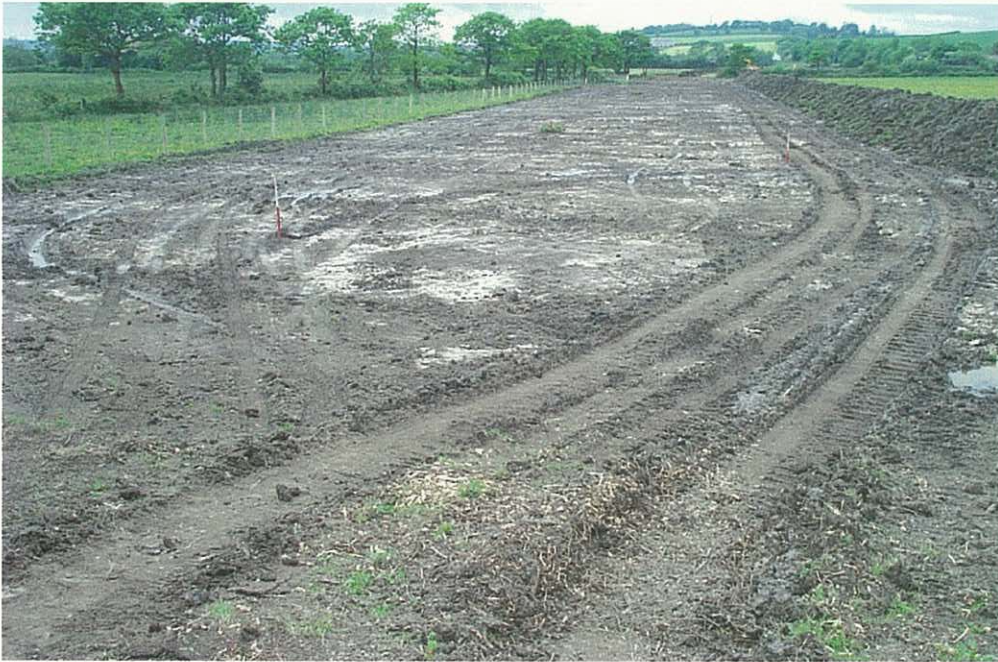
Photo 3: Ring Ditch 42764 as found

Scales 1m, View W

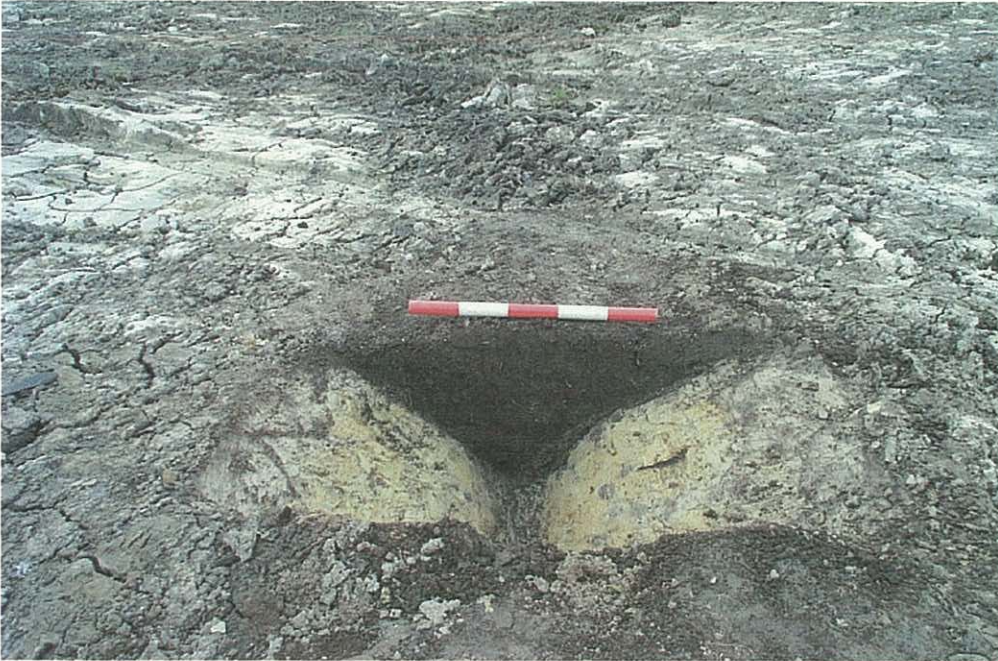
Photo 4: Ring Ditch 42764 section 201

Scale 0.5m, View SE

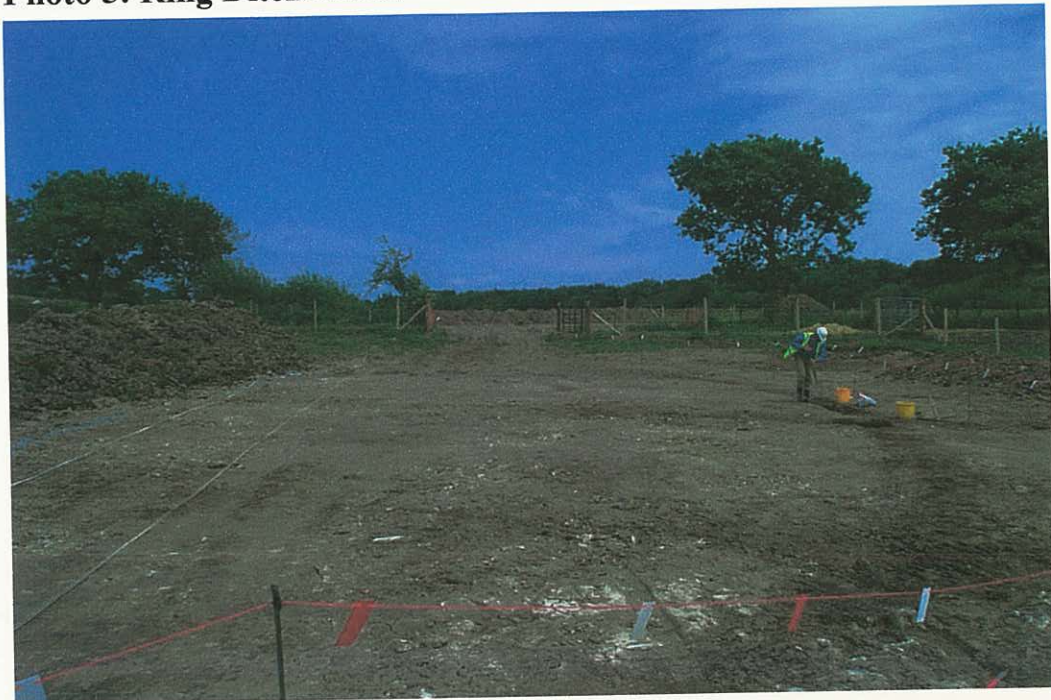
Photo 6: Ring Ditch 42764 Stone Tools

View E

Four sections (201-4 - Figure 9) were recorded across the ring ditch with a further sector excavated at the east end of the site, east of drain (019). The lower fills in the ditch were very silty with some thin lenses of differing silts. These silts probably derived, at least in part, from the ditch edges. Within the lower fills two stones were recovered (Photo 6), these neatly fitted the hand and showed smoothing, consistent with having been used for digging. One of these in particular fitted the lower profile of that part of the ditch.

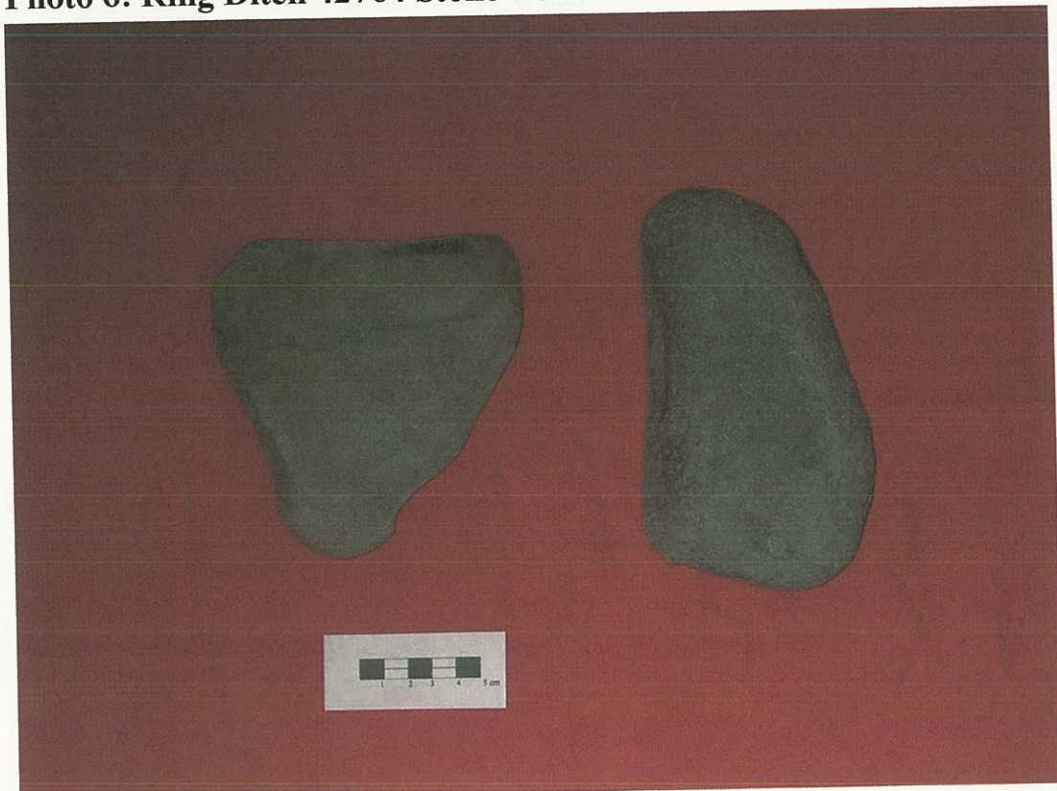
Scale 5cm
