DYFED ARCHAEOLOGICAL TRUST LTD

TY MAWR, PORTHGAIN SUMMARY REPORT ON EXCAVATIONS. DECEMBER, 1993

Client: Dyfed County Council

Report by: Q. Drew BA

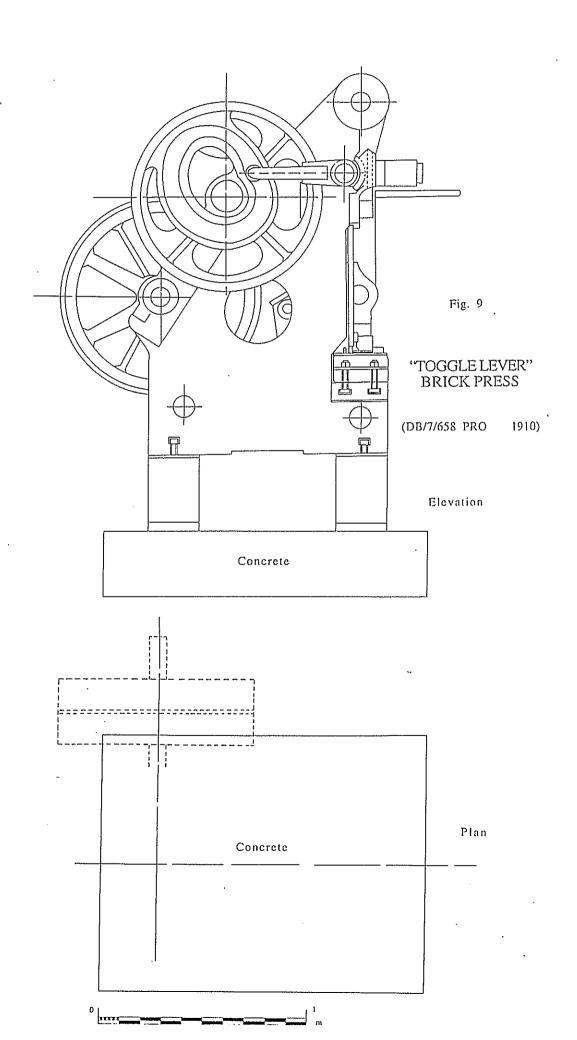
One further document proved to be valuable and has been included (see Fig. 9). DB/7/658 (dated 1910), was an engineering plan for a "toggle lever brick press". It is presumed that this relates to the toggle lever press listed in the above catalogue.
