A477 NASH - BANGESTON IMPROVEMENT WORKS HEDGEROW AND BOUNDARY SURVEY

REPORT NO. 2001/47
PROJECT RECORD NO. 43291

**ARCHAEOLOGICAL DESK-BASED ASSESSMENT
A477 NASH – BANGESTON IMPROVEMENT WORKS
HEDGEROW AND BOUNDARY SURVEY**

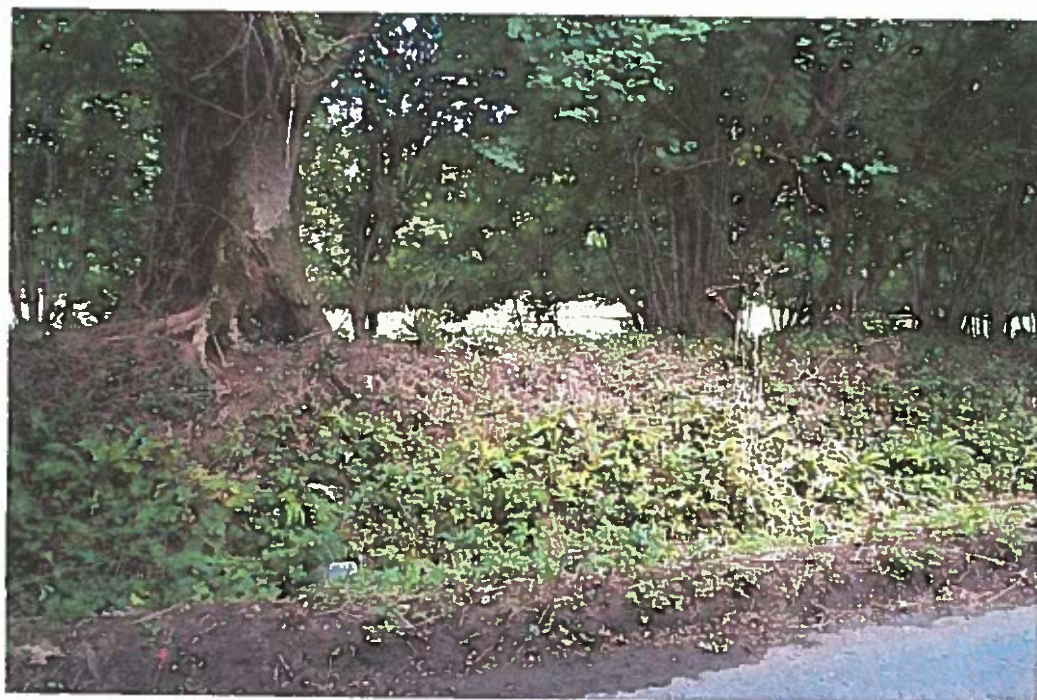
Most of the boundaries consist of a low earth bank (up to 1m high) topped with a mature hedge, which included some standard trees and coppiced hazel trees (plate 1). In some places the banks were higher, but for the most part they averaged about 1m high. There were also two areas where stone walls lined the roadside (boundaries 1 and 3) and one decorative entrance with stone gate pillars and an ornamental wrought iron gate (boundary 5 - plate 2) was also recorded. All of these walls appeared to be modern. The two historic parish boundaries were small streams that had well developed riverside flora, including mature hedgerow plants and trees.

Plate 1: Boundary 3 showing coppiced and standard trees.

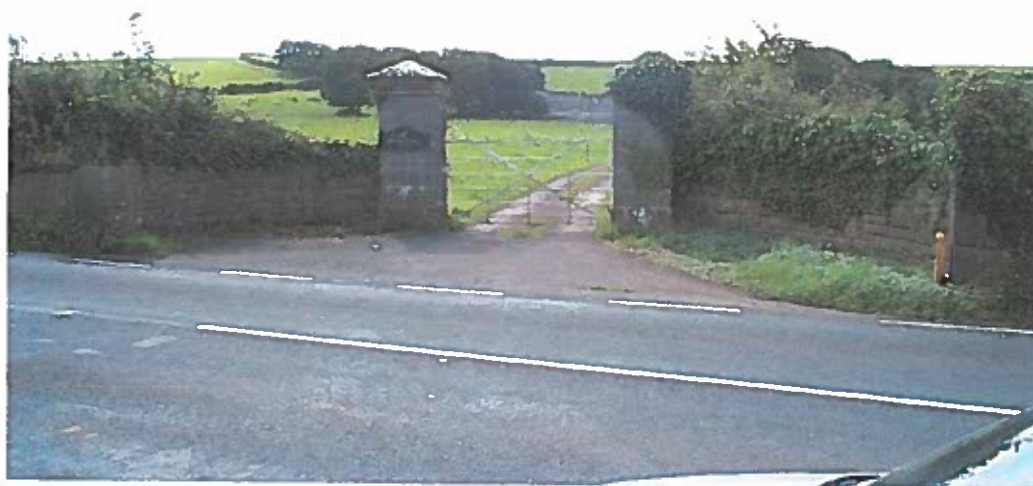
There are several post-medieval and modern boundaries of note along the length of the works. They include the stone walls (boundaries 1 and 3) and the decorative entrance to Brother-Hill Farm (boundary 5). The boundaries alongside the A477 are relatively modern and in some places consist of wooden post-and-rail fences with immature hedgerows alongside.

Plate 2: Boundary 5, the ornamental entrance to Brother-Hill Farm.

There are certain areas where the loss is potentially more significant: these are boundaries (6 and 7) that flank the road along the eastern edge of the Cosheston field system (PRN 6412) and along the west edge of the possible medieval strip fields (PRN 43413). Other areas of potential loss are the entrance to Brother-Hill Farm, with its decorative gate and stone gate pillars (boundary 5), part of the stone wall of boundary 1, a short length of boundary 3 and the new crossings of the parish boundaries (boundaries 2 and 8).

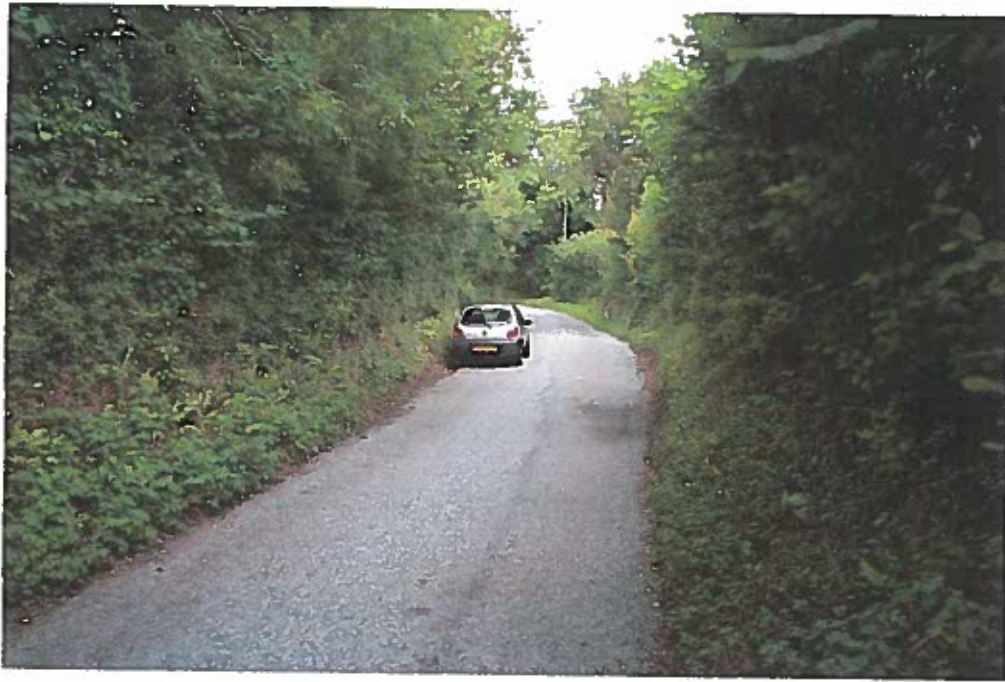
Boundaries 6 and 7 (plate 3) flank the road that leads south from Cosheston and marks the eastern extent of the Cosheston Field System (PRN 6412) and the west edge of the possible field system PRN 43413. This suggests either that the road is earlier than the field system(s) and that its existence helped to define the area available for cultivation, or that it was part of the original medieval layout. Boundary 4 follows the line of one of the strip field divisions within the Cosheston system (plate 4).

It is possible that the banks alongside the road (boundaries 6 and 7) were originally thrown up during the medieval period, although their present form is likely to be much later, with the hedges planted during the later post-medieval or modern periods. Boundary 4 is likely to date from the post-medieval period when the field system was being enclosed and the various strips presumably coming into single ownership.

Plate 3: Boundaries 6 and 7 flanking the medieval (or earlier) road to Cosheston.

7 (see figure 4)	The loss of short lengths of possible medieval boundary	Record profiles of the bank and any associated features during archaeological watching brief on road construction works.
8 (see figure 4)	New crossing of stream, part of the historic parish boundary.	Monitor construction works to record any streamside bank that may have been thrown up to demarcate the parish boundary.

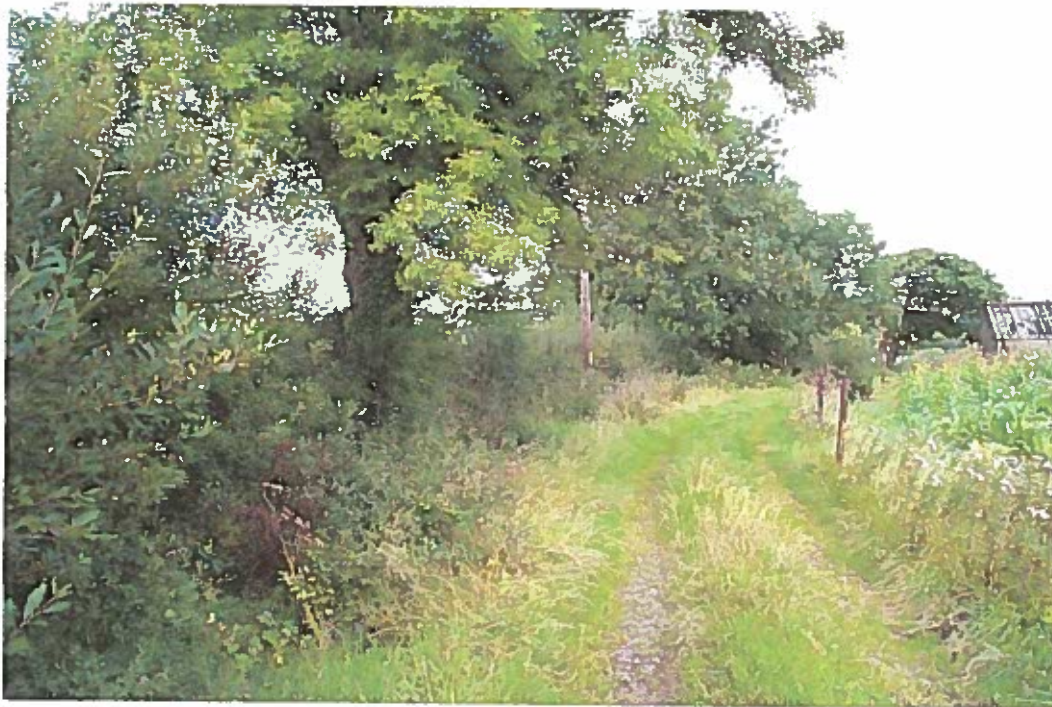
Plate 4: Boundary 4, bank and hedge following medieval strip field boundary line.
