6 AND 7 PICTON TERRACE CAREW PEMBROKESHIRE

ARCHAEOLOGICAL WATCHING BRIEF ON CAR PARKING AREA AND ACCESS

Report No. 2001/60

NOVEMBER 2001

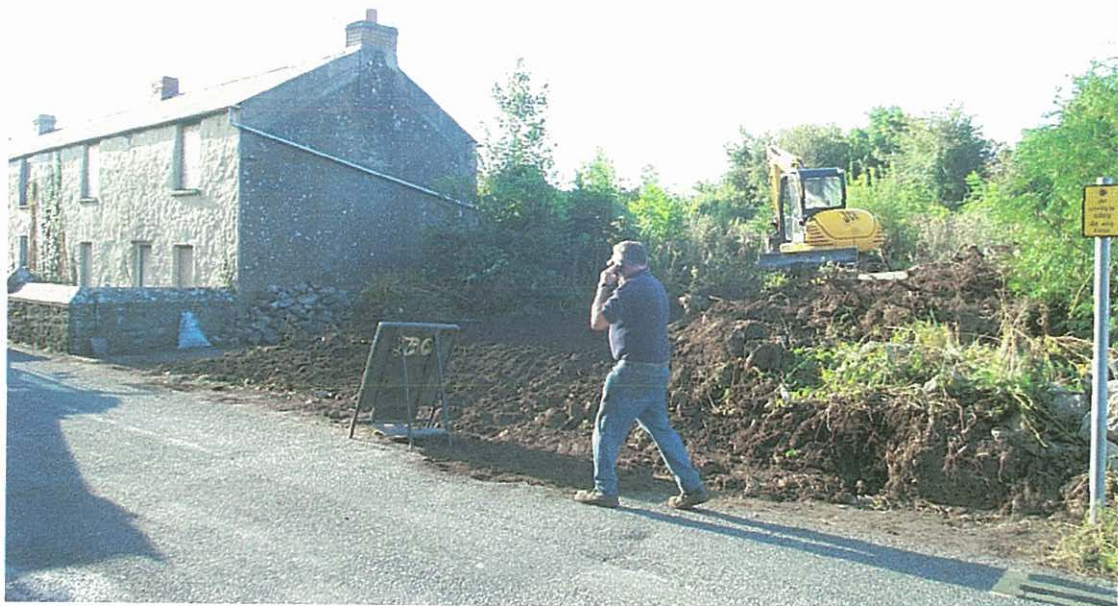
There is nothing to suggest that the structure of Picton Terrace is medieval, although they are most certainly on the site of earlier houses. Six and Seven Picton Terrace (front cover) are listed buildings, although the roofline has been heightened in the past. Both properties are now in need of refurbishment and uninhabited. They form a part of the Carew Castle Estate. Bird Lane was probably more of a sunken roadway in the past but with re-surfacing it is now at a level with, or above, the floors within the houses. A large pipeline was dug in the western edge of No 6 Picton Terrace garden in 1964 for a water main.

The following report details the results of an archaeological watching brief undertaken during ground clearance for a car parking area and access to the rear of Nos 6 and 7. The intended ground works involved cutting through and lowering the ground adjacent to the street frontage (front cover); removal of a driveway width topsoil along the west side of 6 and rear (south) of 6 and 7 garden areas, with small additional areas for parking (Figure 1), and the cutting of the dividing garden bank. Due to the finding of a mains water valve above the garden soil level it became necessary to make up ground rather than remove topsoil. Therefore the only disturbance below topsoil level was for an access ramp up from the lane.

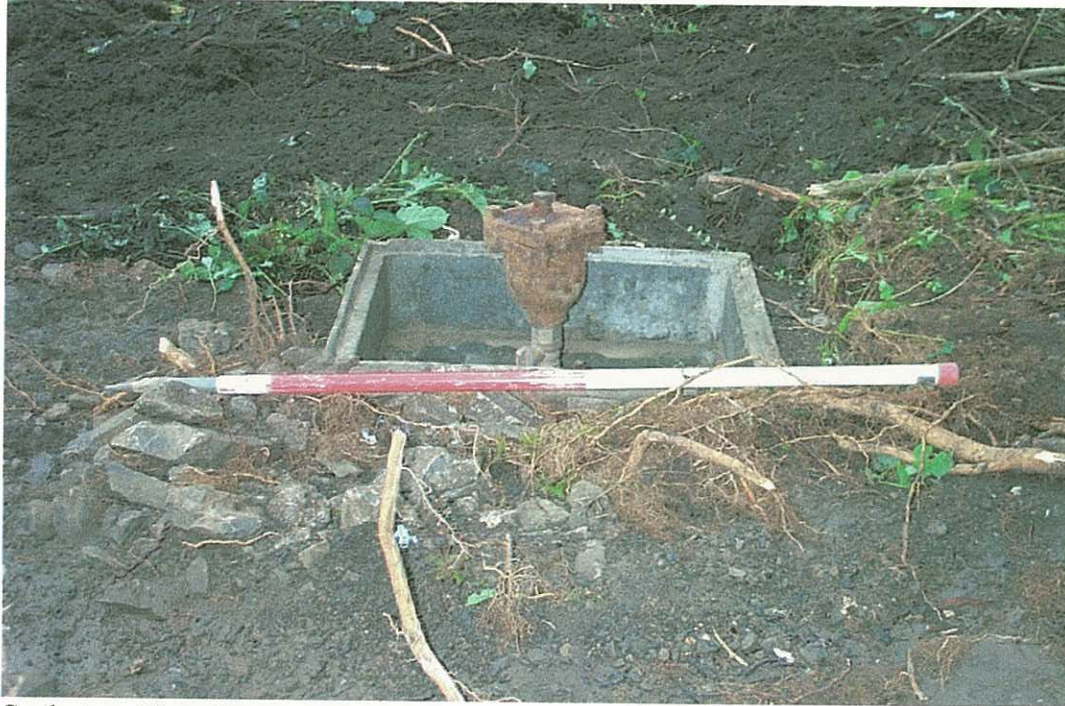
Figure 3: Mains Water Valve above ground level

During the clearance of the scrub the machine connected with a valve that was in a cover above the ground surface (Figure 3). The subsequent flooding ended excavation for the day.

Scale 1m. View S

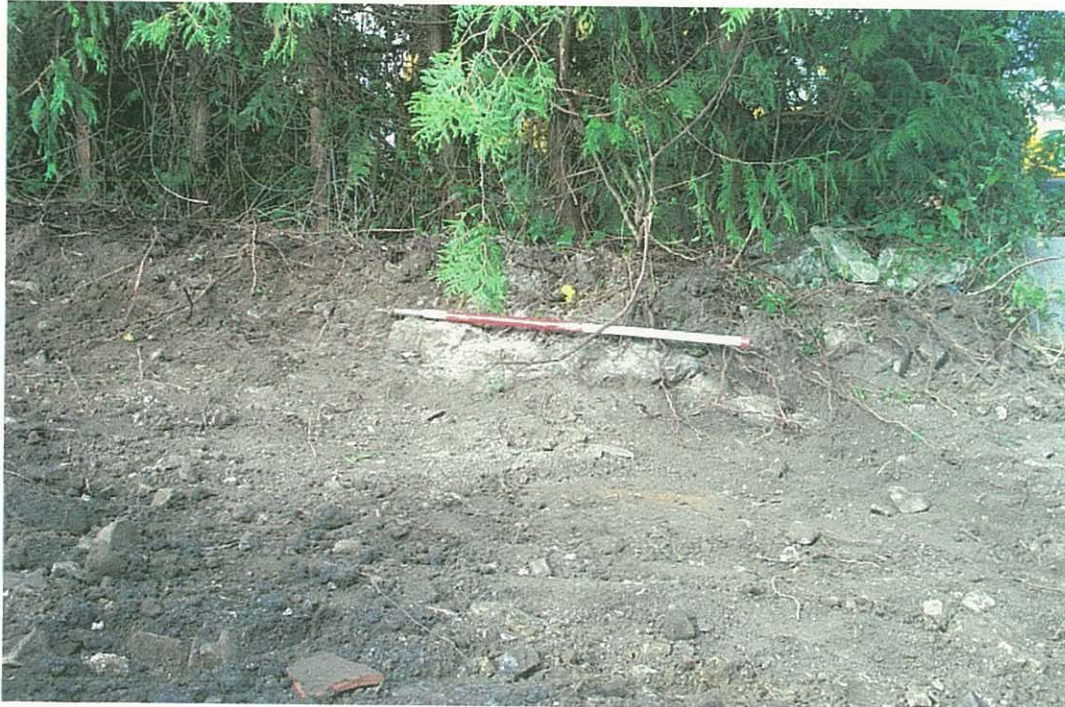
Figure 4: Wall Footing

The following day work proceeded on the access ramp from the lane. A 1.2m north-south length of wall or wall footing was found (Figure 4). This was composed of medium sized flat stones and bonded with lime mortar. It was fairly disturbed. There was a possible wall or footing turning to the east from the north-south footing 2m further to the south. There was a clay surface adjacent to these footings, which could be the remains of a floor. It extended 3.7m back from the lane frontage and up to 2.3m east of the boundary to the west. Immediately to the east of this structure a very deep sewer pipe trench disturbed the area and east of this ran the water main pipe.

Scale 1m. View SW

Most of the land frontage area was disturbed not only by the 1964 water main but also by sewer pipes that are very deeply buried. The structure located near the lane frontage is probably part of the remains of an outbuilding that can be seen on the 1881 OS first edition (Figure 2). This structure was still visible on an aerial photograph taken from a Naval Airship in 1919 (Brock 1989). It is likely that there are a number of features in the rear garden area, which is of high archaeological potential; these remain undisturbed by this project.
