# **HAFOD STABLE COURTYARD WATCHING BRIEF ON NEW SEWERAGE SERVICES**

**PRN 43590**

**REPORT NO. 2001/50**

**AUGUST 2001**

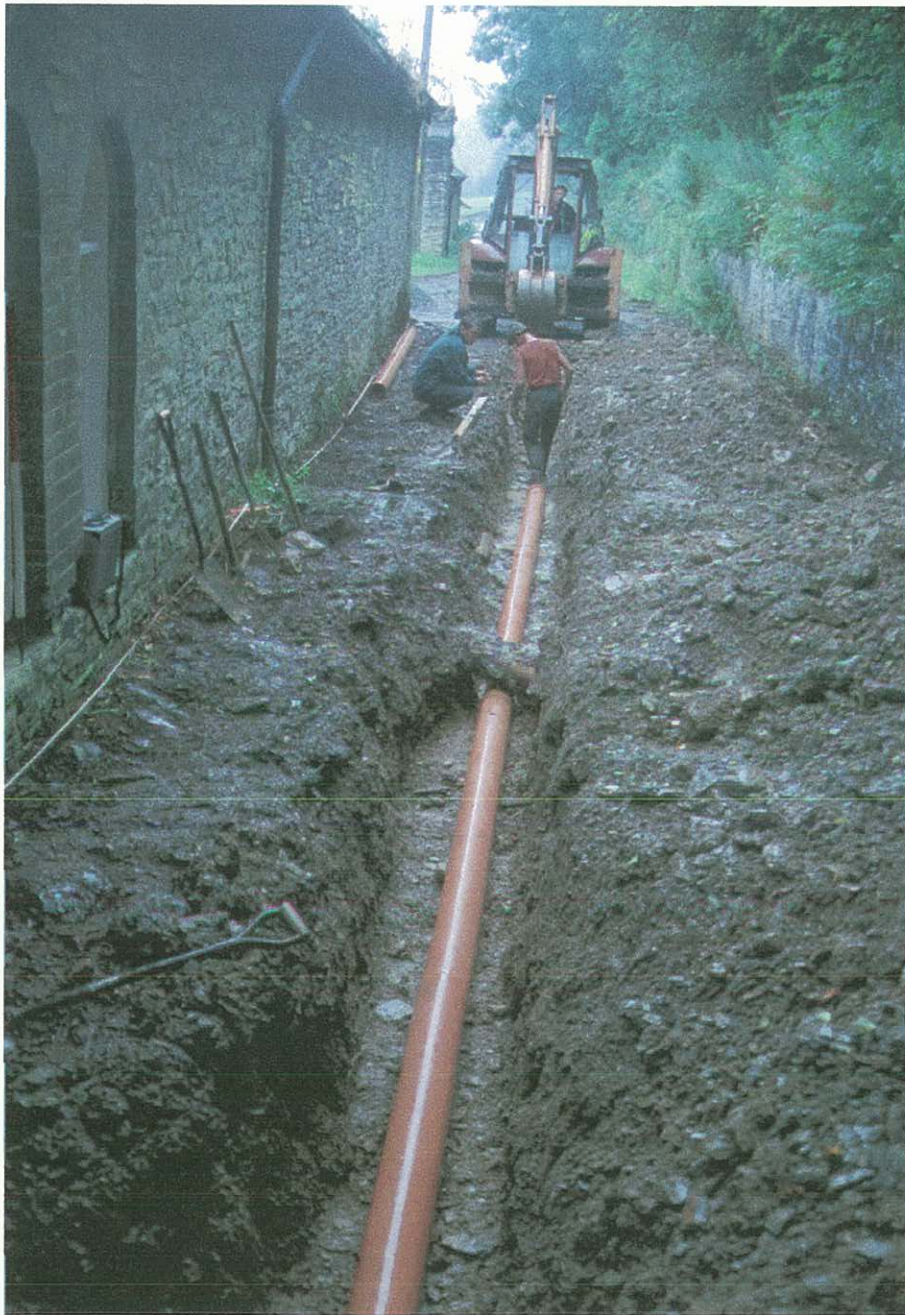
*Photograph 2. Working shot during excavation of sewerage pipe trench on north-west side of stable block.*

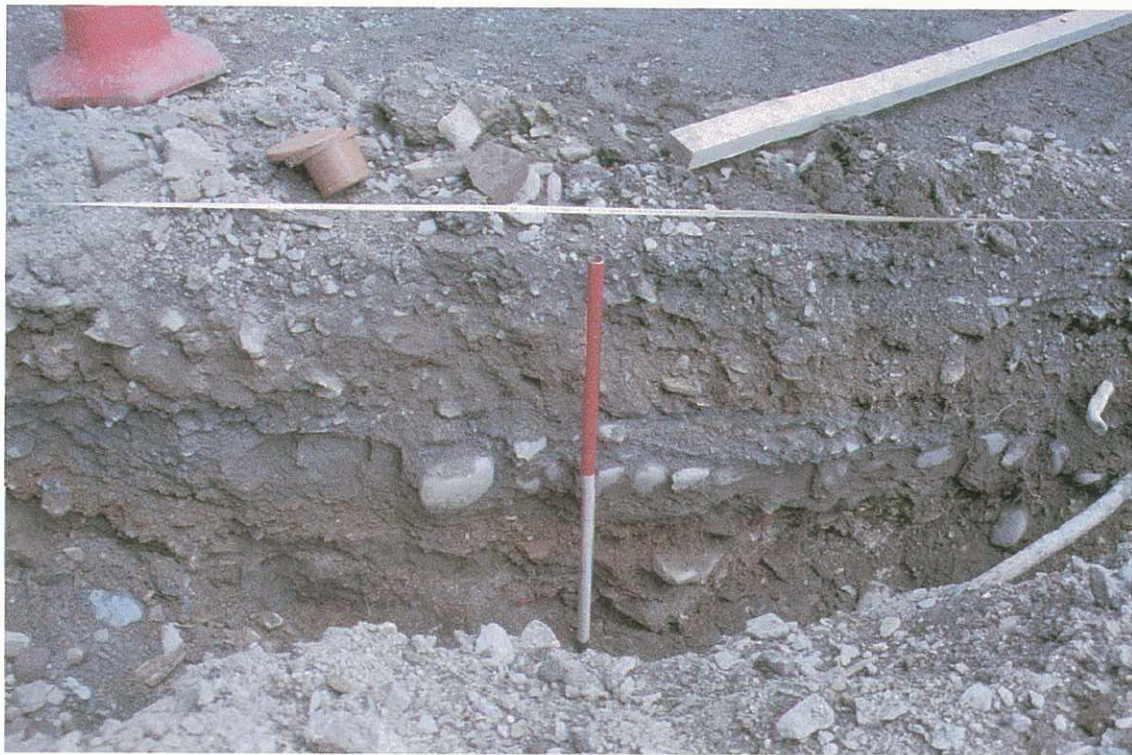
*Photograph 3. View of west facing section showing pitched cobbling (J).*

A discrete 2.2m length of pitched stone cobbling (**J**) was revealed in the west facing section of the pipe trench at a depth of 0.42m below the present ground surface. The rounded river washed pebbles averaged 0.10m x 0.10m in size and were set in a matrix of homogeneous greyish brown silty sand, the combined depth of the pebbles and sand averaged 0.22m. This pitched stone metalling exhibited a very gradual slope down from north to south and its upper surface was 0.45m below the present ground surface. The section also showed that the

previously mentioned buried ground surface lay 0.12m above the pitched stone cobbling. The cobbles were not represented in the opposite section of the pipe trench although the rest of the stratigraphic sequence appeared very similar, suggesting perhaps that the excavations destroyed a possible border edge of this feature.

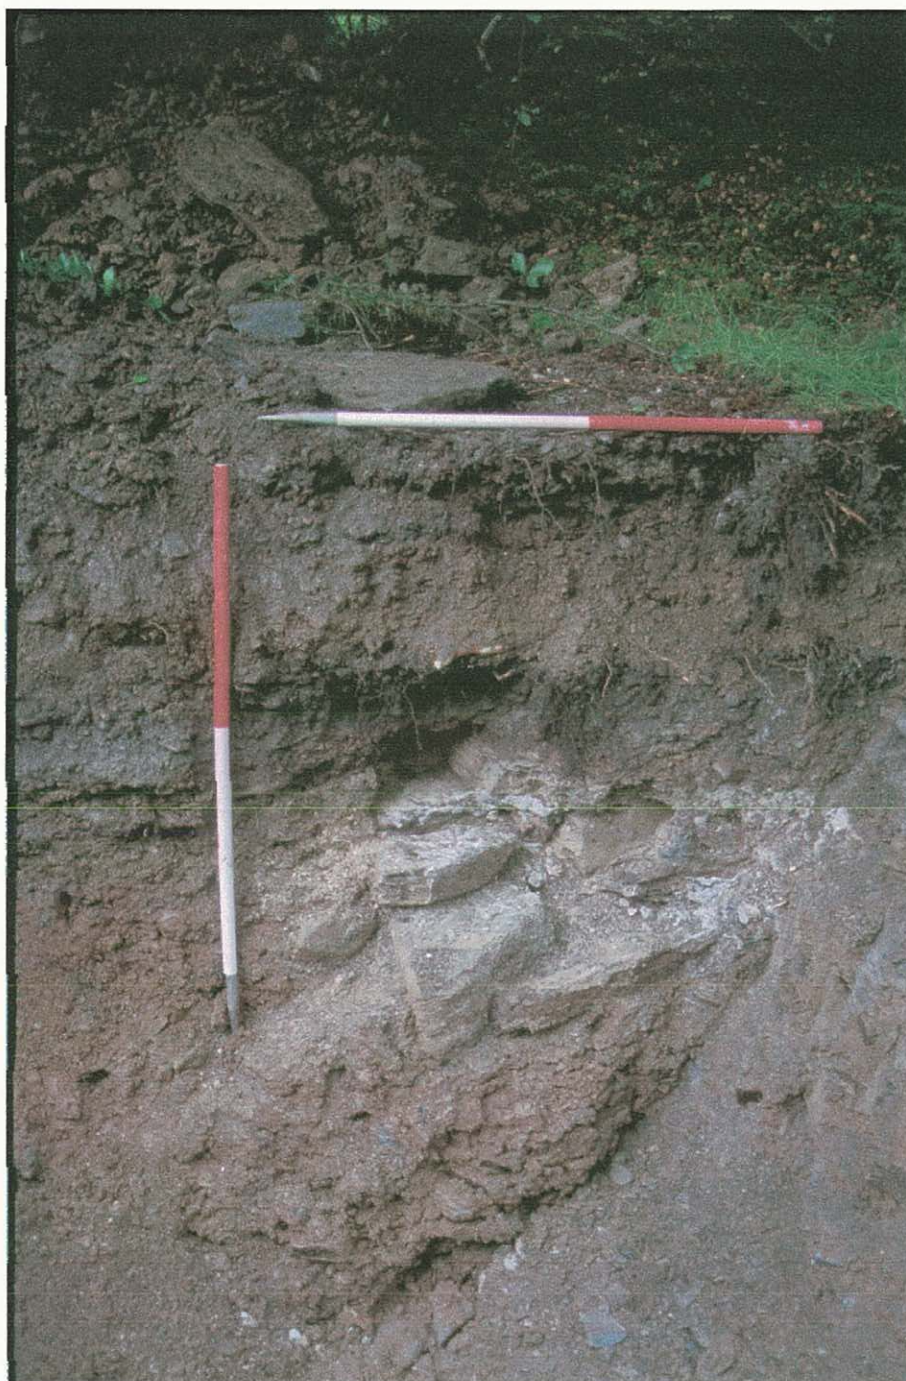
*Photograph 4. Probable foundation footing (N) of mansion.*

The corner of a possible building foundation for the mansion (**N**) was exposed in the south west corner of the cess pit trench, and showed clearly in the north facing section. This feature comprised three courses of lime mortared stone measuring 0.60m in height and 0.70m wide continuing into the east facing section of the cess pit trench. The coursed stonework, which was level, protruded at an angle of 90 degrees from the north facing section for some 0.40m and exhibited a right angle return as it continued to the west beyond the edge of the excavations. The top of the stonework lay 0.60m below the present ground surface, and was sealed by a 0.20m deep compact grey silty clay soil containing 70% small angular gravel fragments. This layer was topped by a thin layer of buried humic soil which again represented a soil horizon build-up on the buried ground surface make-up layers noted previously as lying

on the pitched cobble layers **J** and **M**. A near vertical foundation cut for **N** was seen to cut into the natural orange brown silty clay subsoil to a depth of 0.40m and the space between it and the footing was filled with a mortar rich silty clay soil. The stonework suffered a little damage during the groundworks but it was possible to leave the feature *in situ* and largely untouched.

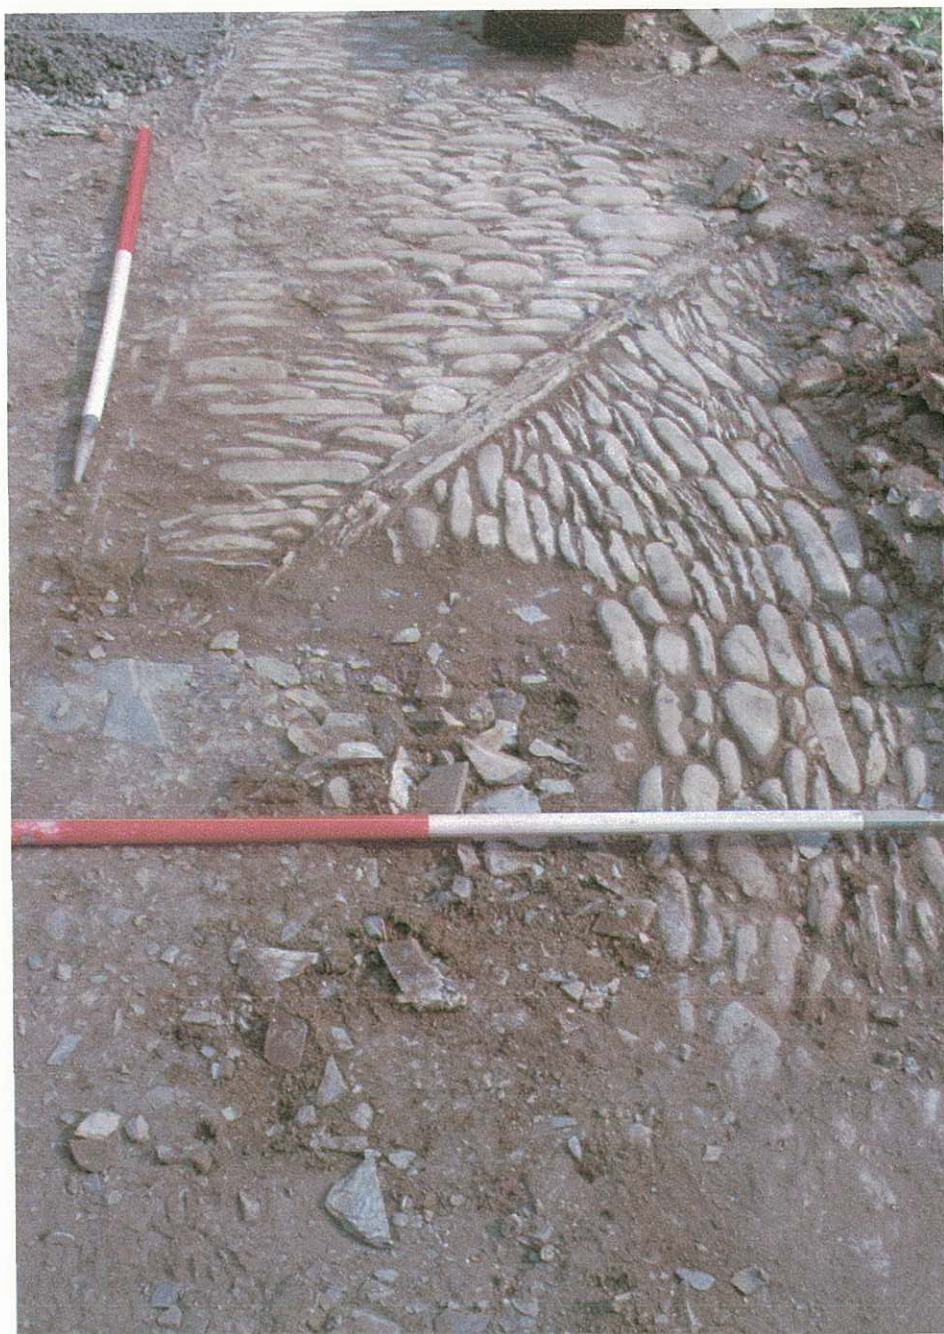
*Photograph 5. View of pitched cobbling (O) uncovered in stable courtyard.*

During topsoil clearance and preparation for the construction/laying of the stone apron in the stable courtyard a pitched cobble surface (**O**) was revealed. The cobbling was very well preserved and had been protected by a thin layer of concrete. As a result of this find the location of the stone apron was changed to a position which would leave the cobbling unaffected.

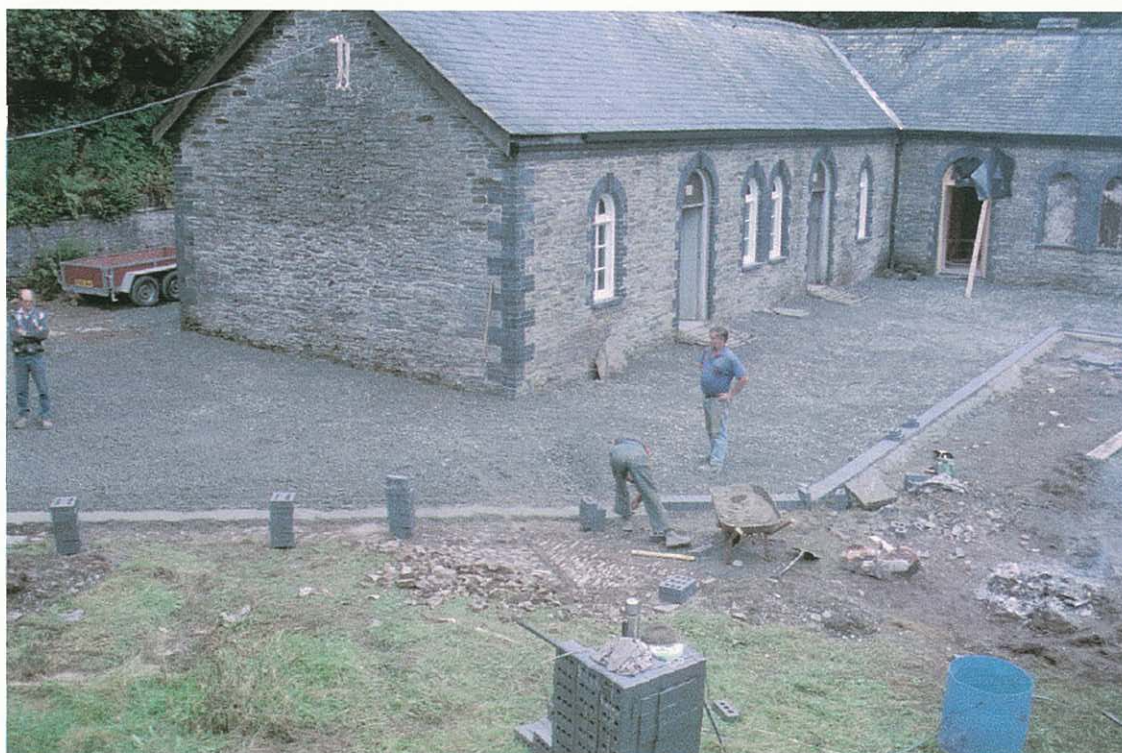
*Photograph 6. View of stable courtyard looking north during laying of stone apron. Pitched cobbling (O) in foreground.*
