# **CARMARTHEN CASTLE**

**ARCHAEOLOGICAL RECORDING AND  
WATCHING BRIEF,  
NOVEMBER 1995 - MARCH 1996**

**Dyfed PRN 57**

**REPORT BY N D LUDLOW FOR TCAP & CCC**

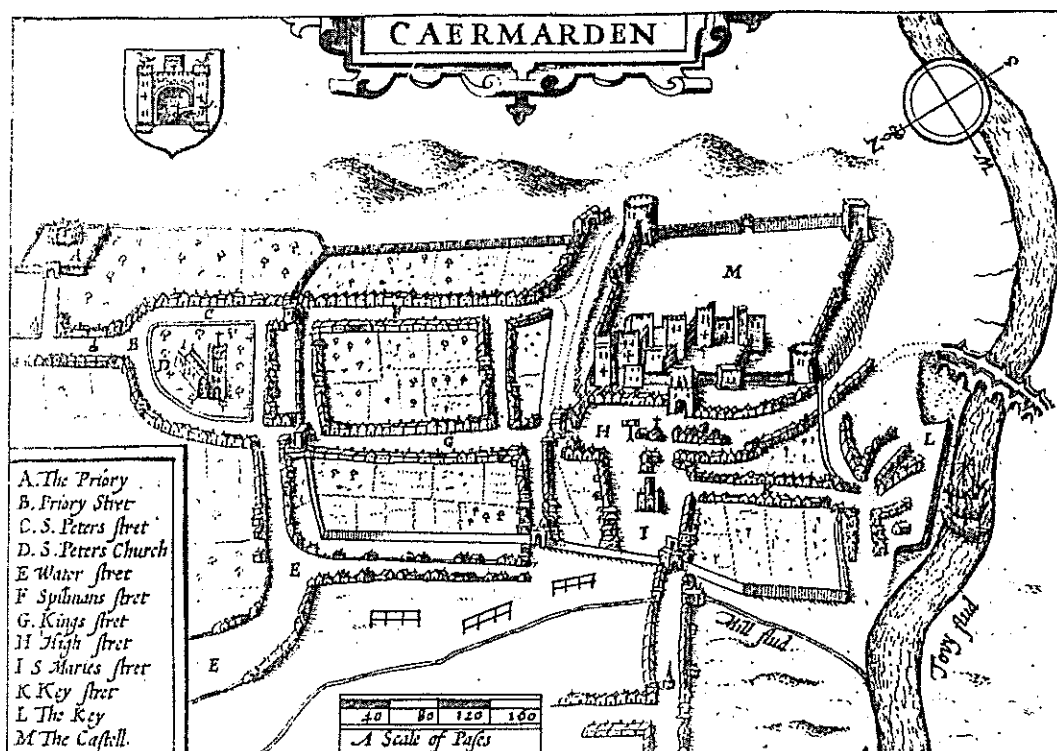
*Fig.3. Carmarthen: from a map by John Speed, 1610*

The antique print evidence is not particularly helpful; Speed's plan of 1610 (Fig. 3) is much conventionalised and shows an open-backed half-round tower at this location. The Buck print of 1740 (Fig. 4) is rather difficult to interpret; a structure of indeterminate form is depicted in a position which may correspond to that of the Square Tower, while a later Buck print of 1748 (Fig. 5) shows the tower much as it survives today, but (oddly) near the summit of a sheer cliff. The stepped pathway shown leading up to its base suggests that an entry was already present here (see below, 3.1), which may then be medieval in origin.

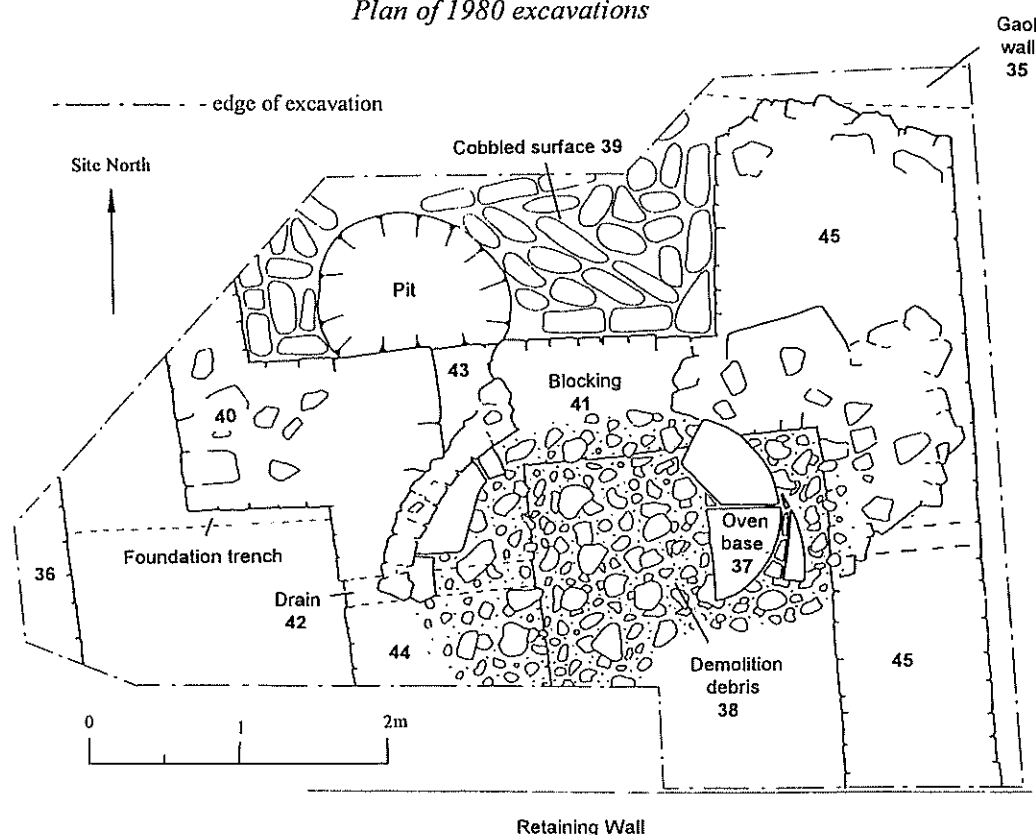
Fig. 14. Carmarthen Castle:  
Plan of 1980 excavations

Two N-S walls crossed the excavated area, both presumably connected to the former South Curtain (see Fig. 14). The western of the two [44] terminated at an E-W wall [43] which in turn ran to the eastern N-S wall [45]. All appear to have been of one build; there was possibly a gap, or entry, within wall 43 between the two N-S walls which was subsequently blocked by material [41]. Walls 43 and 44 were cut directly through the natural gravels in deep construction trenches (unlike either the South Curtain wall or the towers). In the angle of the two walls lay a small area of remnant mortar floor bedding, at approximately the same level as the SW Tower ground floor.

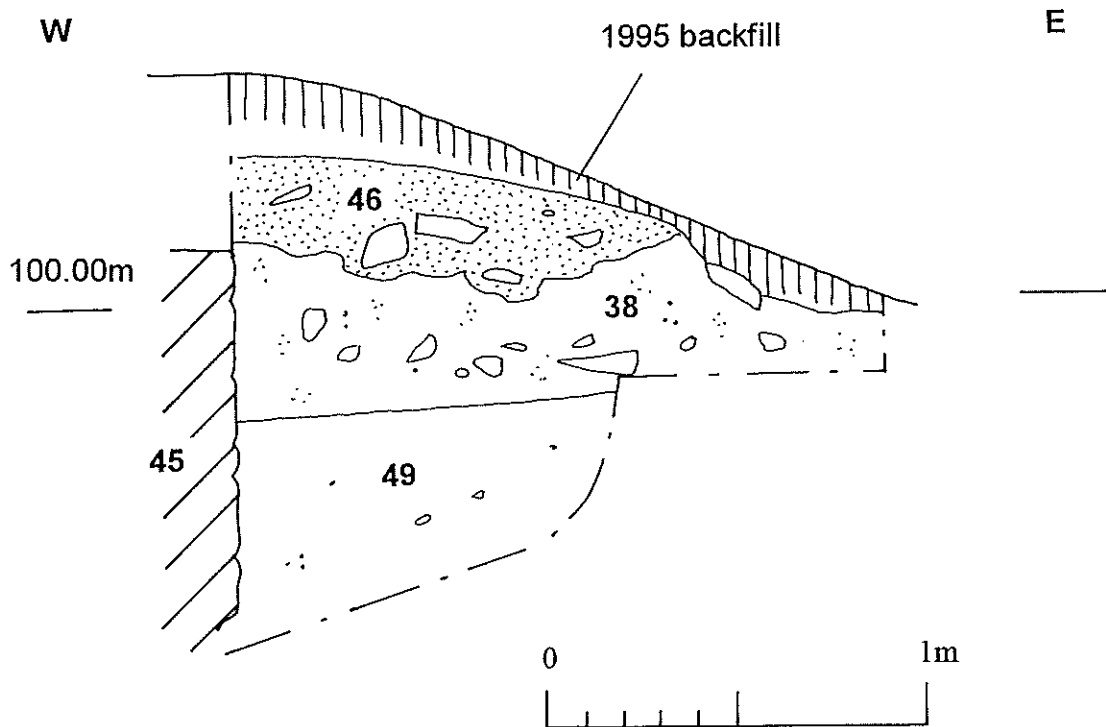
*Fig. 15.2. Section of Trench C looking north*

*Trench C (fig. 15.2)*

Against the east face of wall 45 the trench was extended to a depth of 1.45m in an attempt to reach footings level. Indeed, layer 49 did appear to run under the wall in this limited area, but as it also lay against 45 a localised void may be indicated here. Wall 45, then, appears to have been constructed from a still lower level.

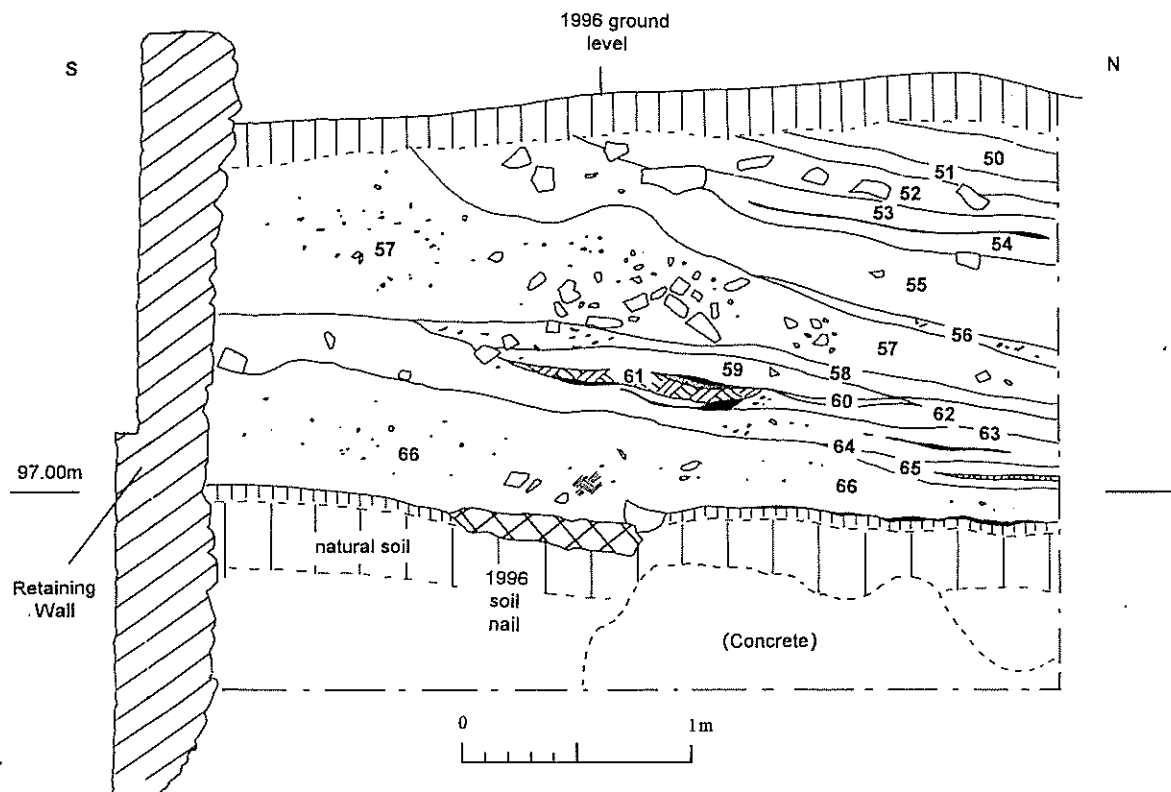
Fig. 16.1. West section of Trench D

Immediately overlying the buried soil was stiff yellow-brown loamy clay, [66], the crest of which rose to the south. This deposit was disturbed by the intrusion of a soil-nail from the 1996 consolidation work on the Retaining Wall. It contained some burnt clay lenses and may represent bank material that might pre-date the construction of the masonry defences.

Above this lay a plethora of layers, variously containing organic material, burnt material and charcoal spreads, and mortar. These are very mixed and appear to be debris layers deived from elsewhere on site and deposited against clay 66 rather than *in situ* burning. Within one of the lower of these layers, [64], was a sherd of Roman tegula (roofing tile) which was undoubtedly derived from a much earlier deposit.

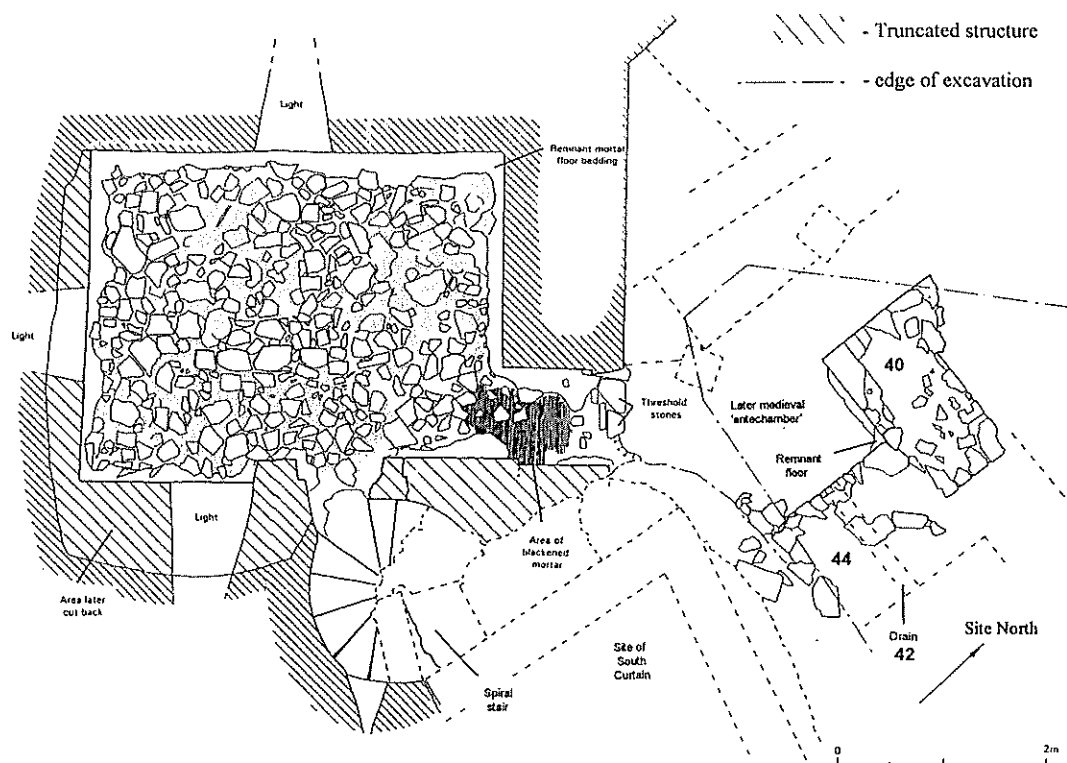
*Fig.21. Carmarthen Castle, SW Tower:  
Plan at ground floor level  
showing internal features (medieval)*

The chamber was floored at original bailey ground level, with angular, medium-large sized limestone flags over the basement vault below. A line of larger stones running down the long axis of the floor may represent the keystones at the apex of the vault; a hollow at the SW end of this line is probably a missing stone. No remains of the medieval floor surfacing survived, but a 0.3m wide strip of white mortar bedding (for a tile surface?) still survived along the foot of the walls (fig. 21). The mortar bedding ran out at the entry onto the spiral stair.

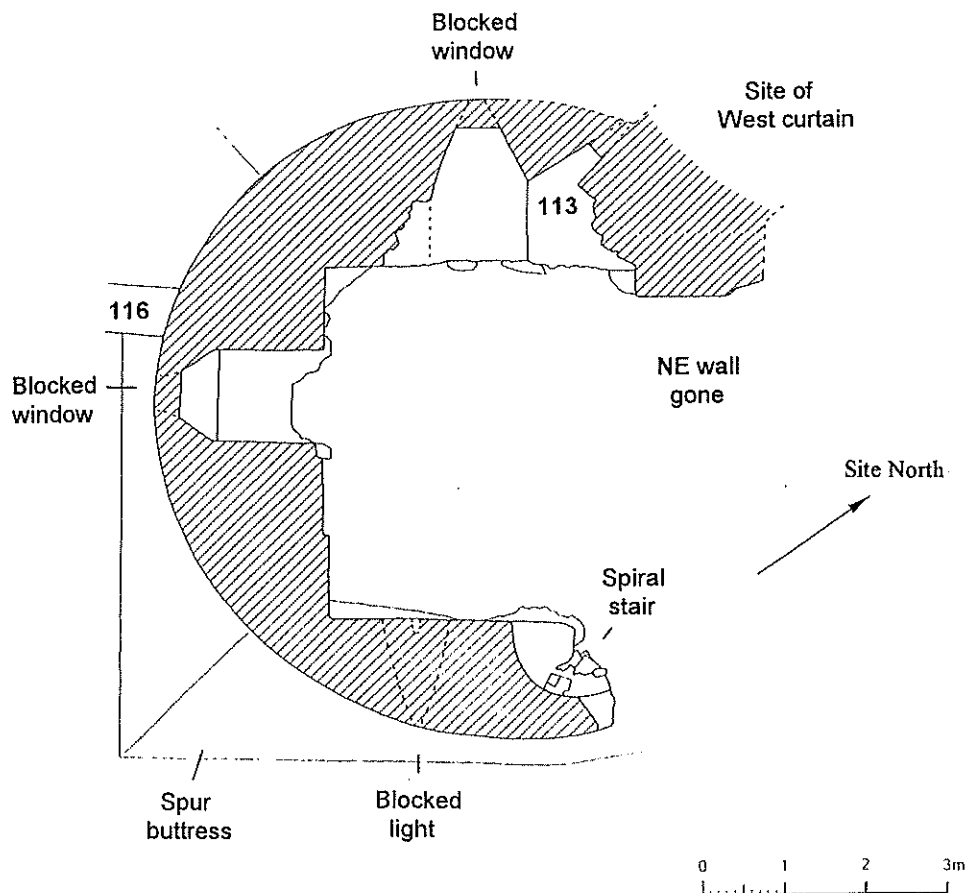
*Fig.24. Carmarthen Castle, SW Tower:  
Plan at first floor level*

The chamber was entered through the SE wall via a doorway from the spiral stair, which displays the remains of a shallow-splayed light (Fig 26). The possibility exists that a second doorway in the NE wall may have given onto an external timber stair down to bailey level. The light in the SE wall was later blocked with sandstone rubble and brick (see below); it was a narrow splayed loop, but the SW wall is pierced by the fine segmental rear-arched embrasure, which descends to floor level, of a large square-headed window (Fig. 28). The voussoirs have partially weathered, as has the sill, but it appears that window seats may have been present and later altered. The stop of the southern reveal is a proud ashlar surround, [113], which corresponds to offset 112 to the south and would have formed a smaller recess in this wall. The light was later blocked (see below).
