# LYDSTEP PALACE, PEMBROKESHIRE

ARCHAEOLOGICAL CLEARANCE AND RECORDING,  
NOVEMBER 2001-JANUARY 2002

Report No. 2002/60

REPORT NO. 2002/60  
PROJECT RECORD NO. 43925

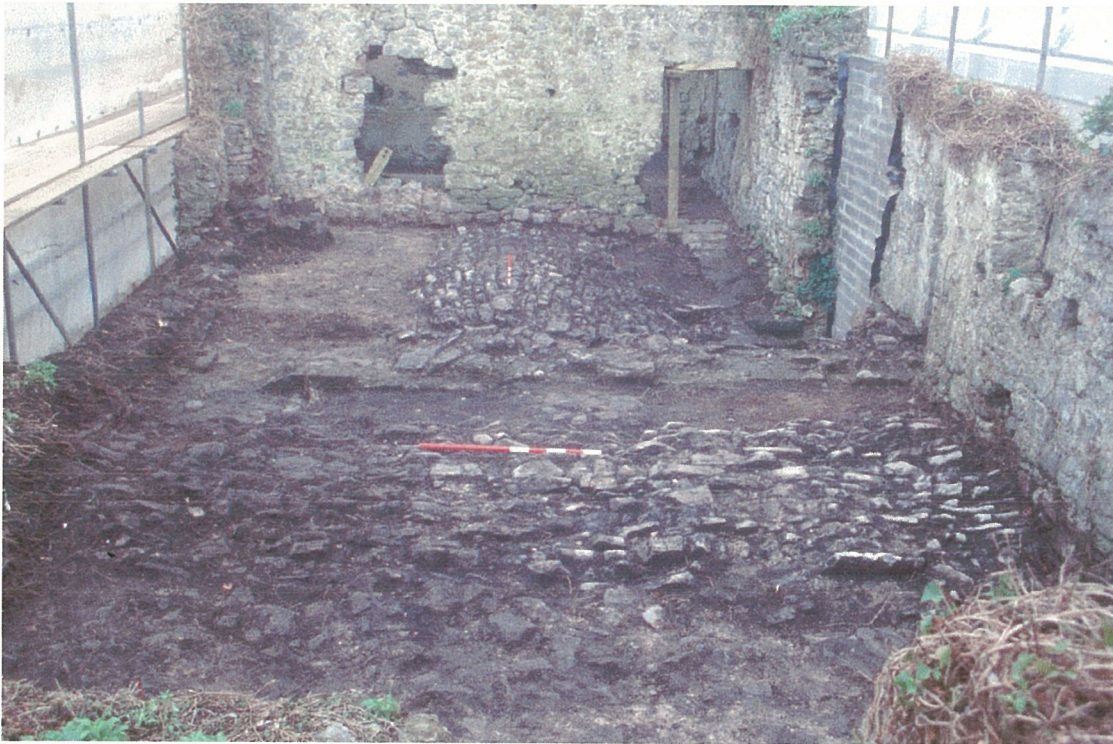
*Fig. 4: Lydstep Palace – Room 4 after removal of topsoil 101, looking south*

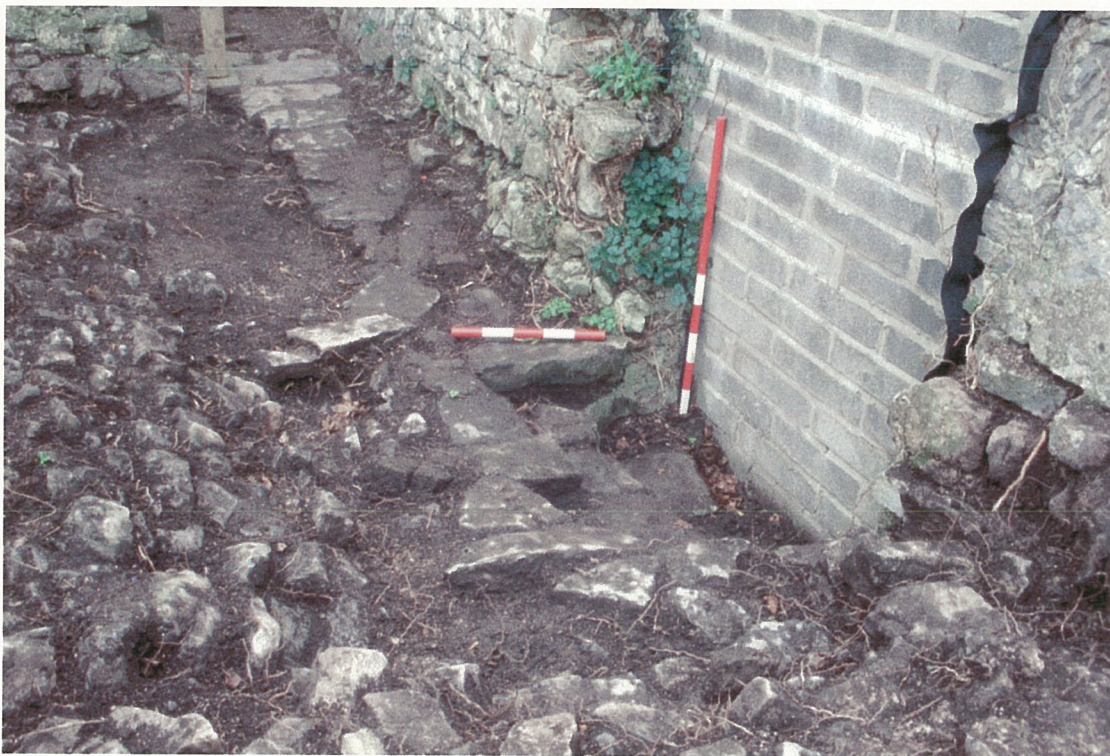
*Fig. 5: Lydstep Palace – Room 4, surface 104, looking southwest*

- Context 104** - In the SW quarter of **Room 4**, topsoil 101 overlay an area of large, flat limestone flags, deliberately laid and seeming to form a level surface, filling the western vault soffit of **Room 2**. The surface ran N-S, alongside the west wall, between the doorway in the *Phase V* dividing wall, 014, and ?fireplace 005. The flags lay in a matrix of mixed, dark, ashy soil of post-medieval nature. It also lay below the level of the top of the medieval vaults. No finds were recovered from 104.

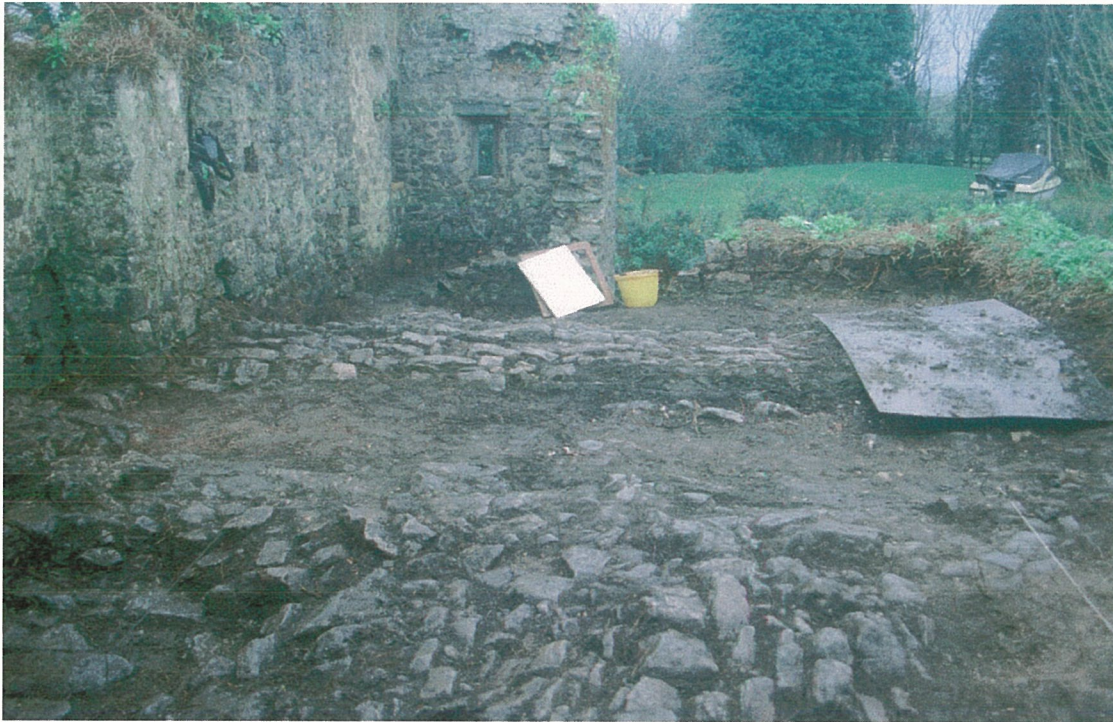
*Fig. 6: Lydstep Palace – Room 4 during removal of topsoil 101,  
looking north*

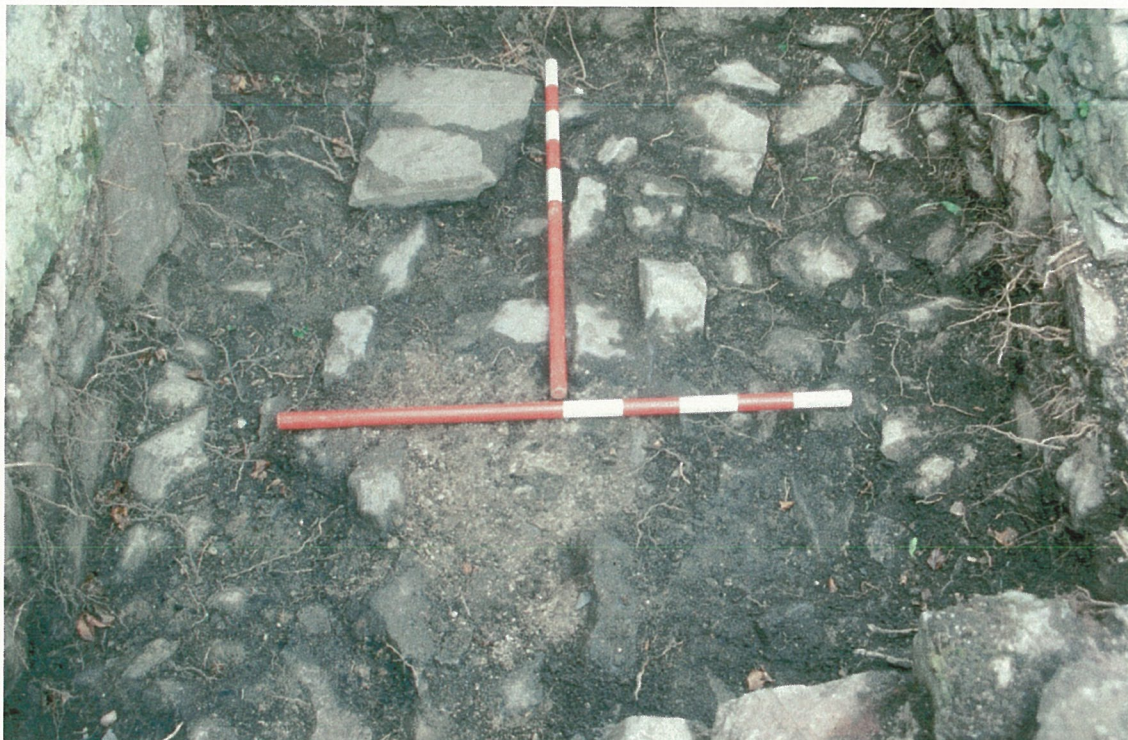
*Fig. 7: Lydstep Palace - surface 105 running into latrine,  
looking north*

- Context 105** - In the NW quarter of **Room 4** and the **Latrine**, topsoil 101 overlay a second area of large, flat limestone flags, again deliberately laid and seeming to form a level surface. The surface similarly ran N-S, alongside the west wall. The flags lay in a matrix of mixed, dark, ashy soil of post-medieval nature. It also lay below the level of the top of the medieval vaults. No finds were recovered from 105.

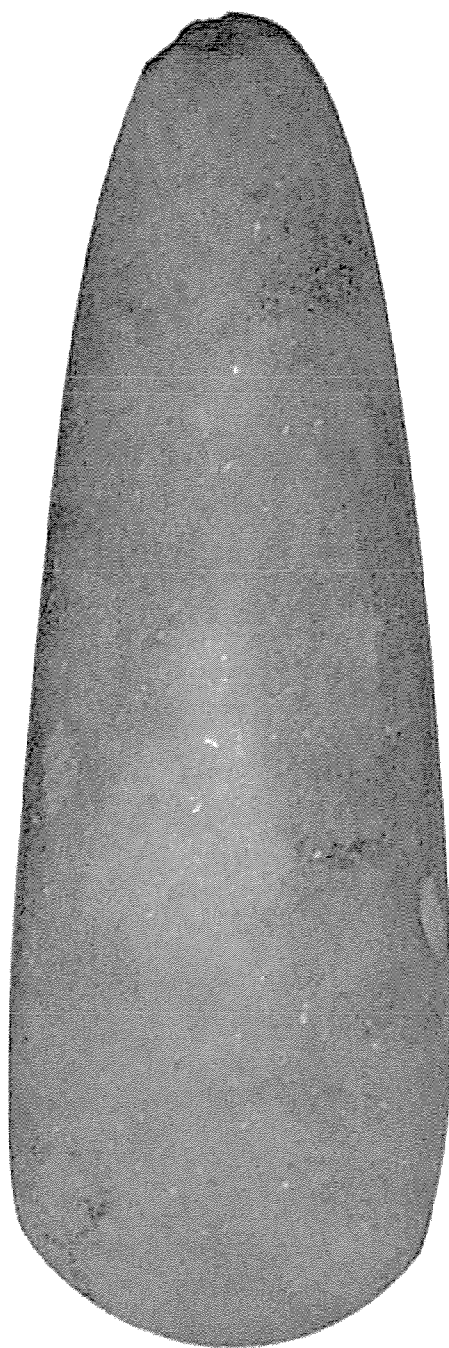
*Fig. 8: The Neolithic axehead from context 103*

The axehead was recovered during clearance work in the open first floor of Lydstep Palace from context 103, a layer of ?early post-medieval debris in the southeast corner of **Room 4**. It measures 243 mm (length) x 81 mm (width) x 40 mm (thickness). It weighs 1165.9g (after removal of a small slice for sectioning). It shows slight recent damage to the butt, but the blade is complete with the exception of one minor chip. The axehead shows evidence of having been ground and then subsequently polished (Figs. 8 and 9).
