Hafod E/10/2926

Tir Gofal Farm Visit Historic Environment Report

REPORT NO. 2002/84
PROJECT RECORD NO. 44102

Hafod
Tir Gofal Farm Visit Historic Environment Report

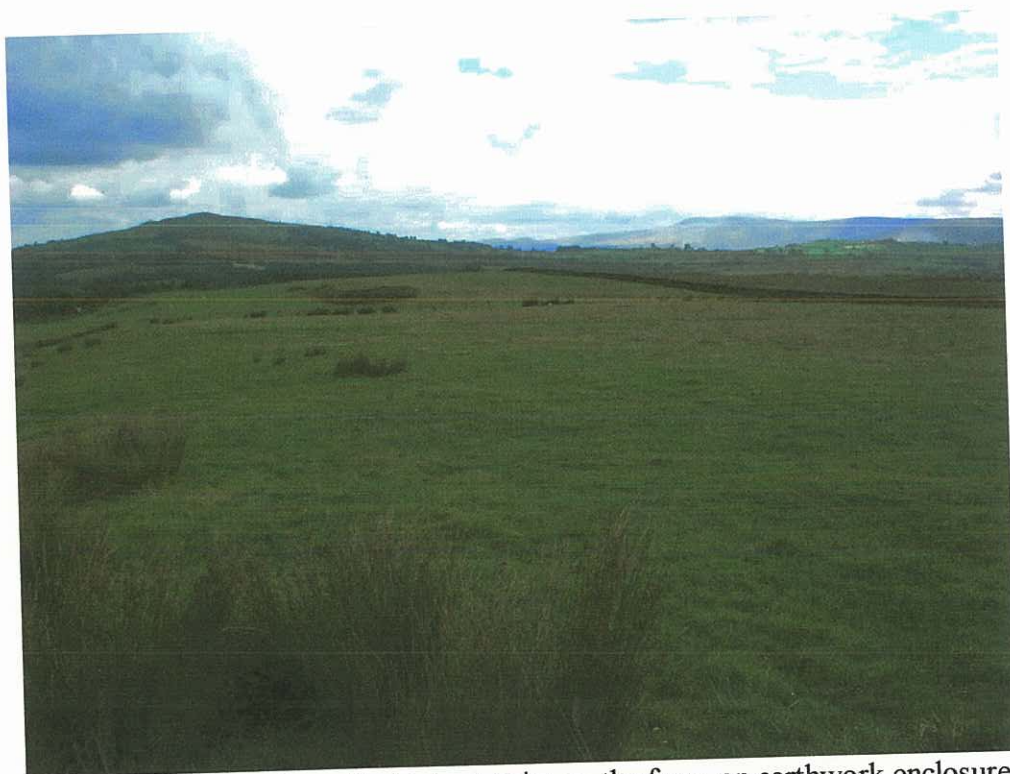
The view northeast from the highest point on the farm, an earthwork enclosure is visible in the middle distance (Prn 14384).

The site of this enclosure is currently under permanent pasture, this is an ideal landuse for this kind of site. There are undoubtedly very sensitive archaeological remains surviving below ground and the earthwork remains are also very vulnerable to ground disturbance. Therefore no ground disturbing activities should take place in this area and no livestock feeders should be located within 10 metres of this site. Care should also be taken to prevent poaching of the ground surface by livestock, which may occur in wet conditions.

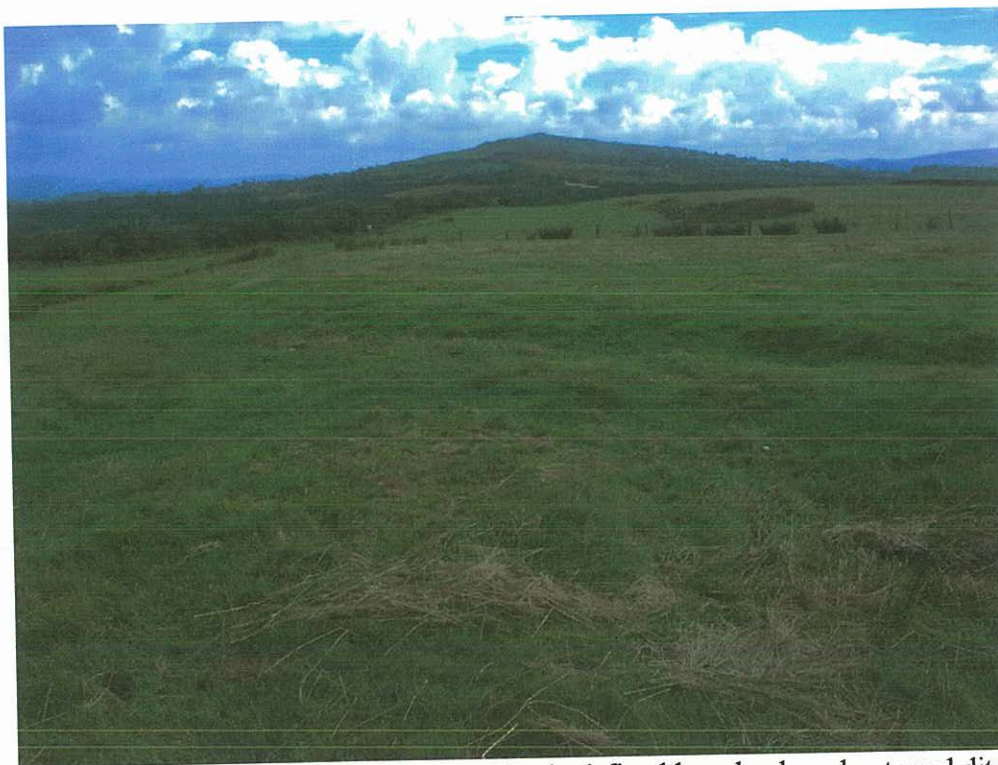
PRN 14384 Site Name Grid Reference SN66362085

An oval enclosure is visible as an earthwork defined by an internal bank and external ditch. It is approximately 1 hectare in area and 150 metres from southwest to northeast, and 90 metres at its widest from northwest to southeast. The bank is between 0.1 and 0.2 metre high and the ditch is c. 0.2 metre deep. Aerial photographs show two breaks in the bank and ditch to the northeast which may indicate possible entrances. During the farm visit no hut platforms could be identified on the ground, however aerial photographs indicate at least a couple of possible platforms.

The enclosure is of unknown date and purpose, and only further study and excavation would clarify its age and function. Little excavation has been carried out on similar sites in this region, but examples of enclosures elsewhere have been dated to the late prehistoric/Romano British period and are thought to be settlements or farmsteads.

Prn 14384 – a prehistoric enclosure is clearly defined by a bank and external ditch

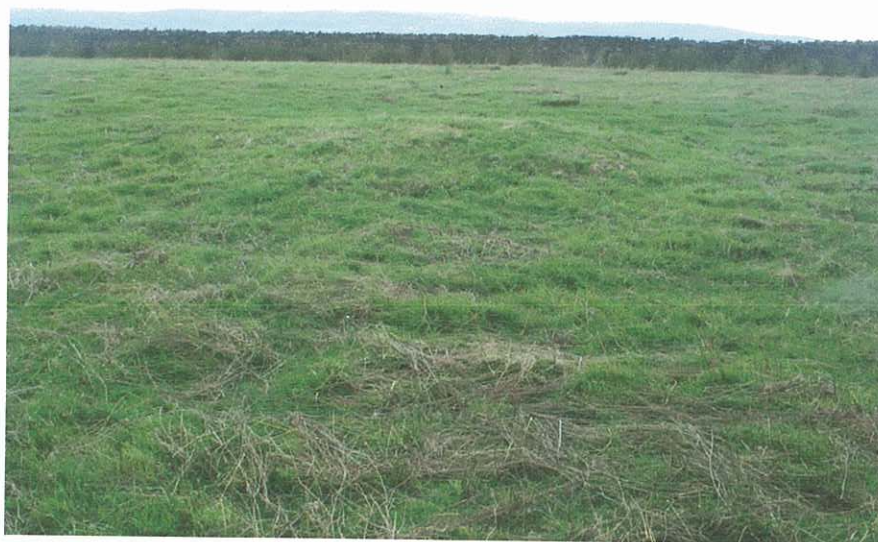
PRN 45759 **Site Name** **Grid Reference** SN66532088

A circular mound approximately 4 metres in diameter and 0.25 metre in height. The mound is entirely turf covered, and currently in a stable condition.

It is possible that this mound is a bronze age round barrow (an artificial mound of earth, turf and/or stone, normally constructed to contain or conceal burials). It appears that there is a grouping of these features (Prn 45760) on the high ground, a classic siting for monuments of this kind. Aerial photographs indicate that in addition to the possible round barrows identified within the farm holding there appears to be an alignment of barrows which lie to the southwest of the farm boundary.

Prn 45759 – a possible round barrow situated on the high ground

This possible round barrow is currently under pasture. This is the ideal landuse for this kind of feature which is extremely vulnerable to ground disturbing activities. Archaeological deposits of an extremely sensitive nature may survive below the ground surface and care should be taken that no activities take place in this area which may damage the ground profile, this includes feeding livestock.

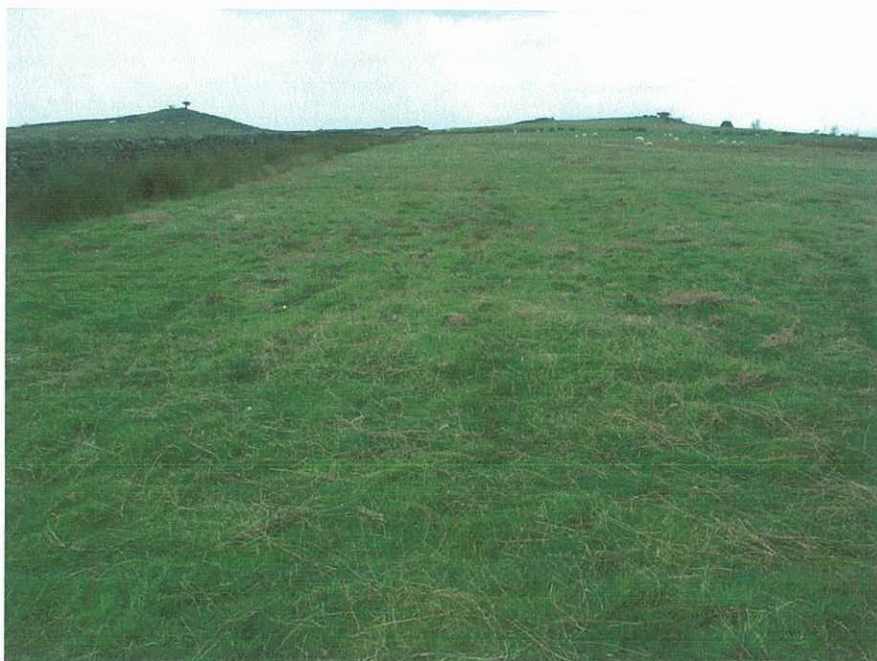
PRN 45760 **Site Name** **Grid Reference** SN66592089

A turf covered mound approximately 3.5 to 4 metres in diameter and 0.15 metre high is situated only a couple of metres to the northwest of the boundary wall.

It is possible that this mound is a bronze age round barrow (an artificial mound of earth, turf and/or stone, normally constructed to contain or conceal burials). It appears that there is a grouping of these features (Prn 45759) on the high ground, a classic siting for monuments of this kind. Aerial photographs indicate that in addition to the possible round barrows identified within the farm holding there appears to be an alignment of barrows which lie to the southwest of the farm boundary.

Prn 45760 – the remains of a possible round barrow?

This possible round barrow is currently under pasture. This is the ideal landuse for this kind of feature which is extremely vulnerable to ground disturbing activities. Archaeological deposits of an extremely sensitive nature will survive and care should be taken that no activities take place in this area which may damage the ground profile, this includes feeding livestock.

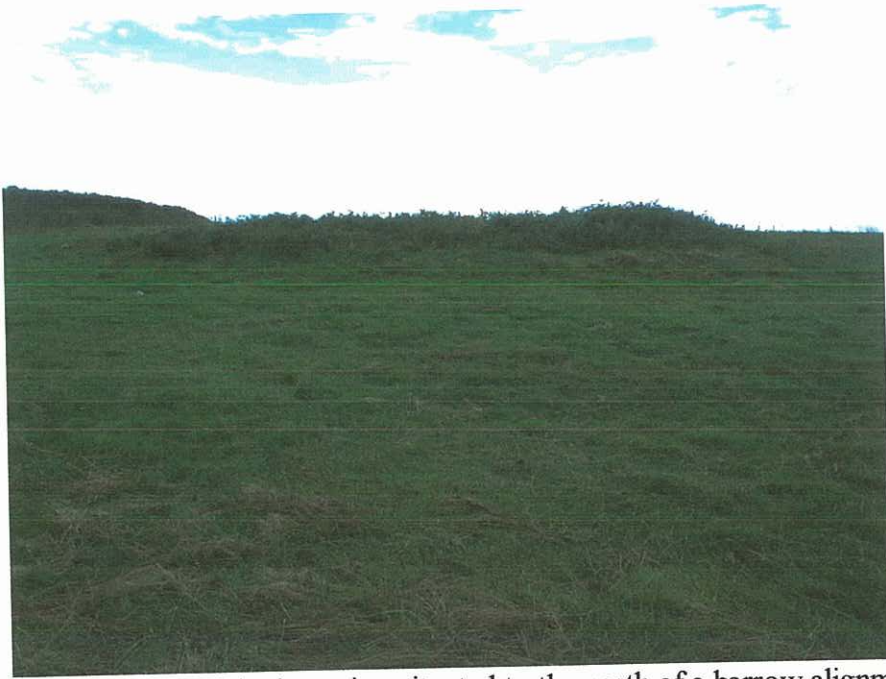
PRN 45761 **Site Name** **Grid Reference** SN66672093

Positioned on a northeast facing slope, where the height of the ridge begins to fall, is a circular structure approximately 14-15 metres in diameter defined by a bank of stone which, at its greatest to the east, reaches 0.30 metre high. It is possible that some of the stonework to the exterior of the bank is faced stone creating a kerb. The interior of the feature at the time of the site visit was rather overgrown, but appeared to be a level surface.

The form of this feature, its siting and context suggest that it could be a ring cairn. This type of feature which dates from the early to middle bronze age, is commonly found on hill-slopes, or on a high moorland plateau set in natural saddles or around the head of a stream. They are also often found within round barrow cemeteries. It is unknown what their function was but they are generally thought to be associated with burial rites since cremations have been discovered within excavated examples.

Prn 45761 – a possible ring cairn, situated to the north of a barrow alignment

This feature is likely to have very sensitive archaeological deposits surviving below ground level. In order to protect the underlying deposits no ground intrusive activities should take place with 10 metres of the site.

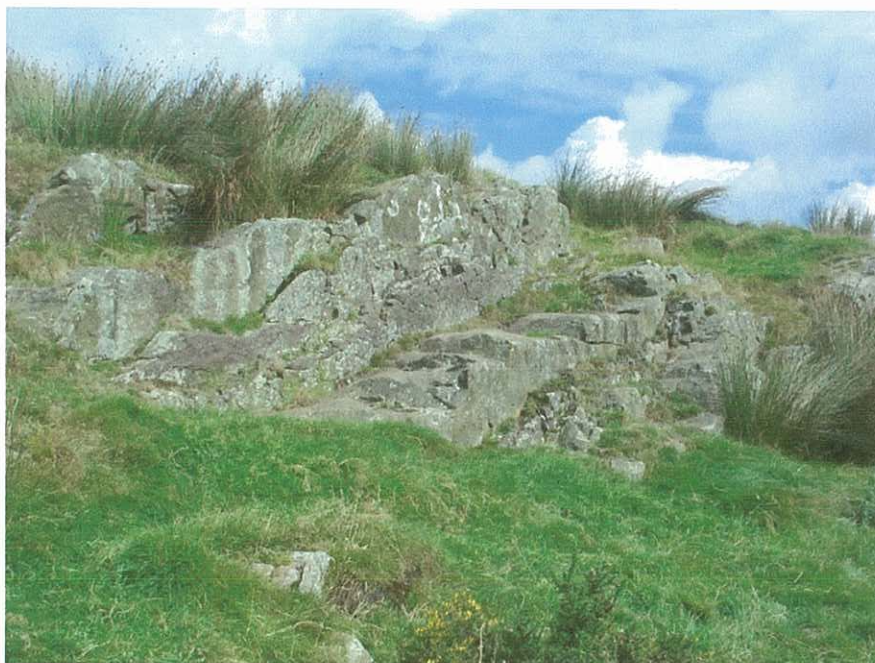
PRN 45762 **Site Name** **Grid Reference** SN66202072

To the southwest of the farm holding, situated along the south side of the natural ridgeline is a series of small scale quarry workings, and recent stone tips.

It is likely that these small scale quarries were opened in order to provide stone for the construction of the boundary wall to the south.

Prn 45762 – the remains of a quarry, one of a number along the ridge, some of which have been filled with loose stone.

These quarries should be retained as an open visible historic landscape features. They should not be used for dumping waste material. It has been proposed that if further stone is required for the proposed restoration of the farm boundary wall, then the loose stone from these quarries should be used in preference to using stone from the field surface which may be associated with archaeological features.

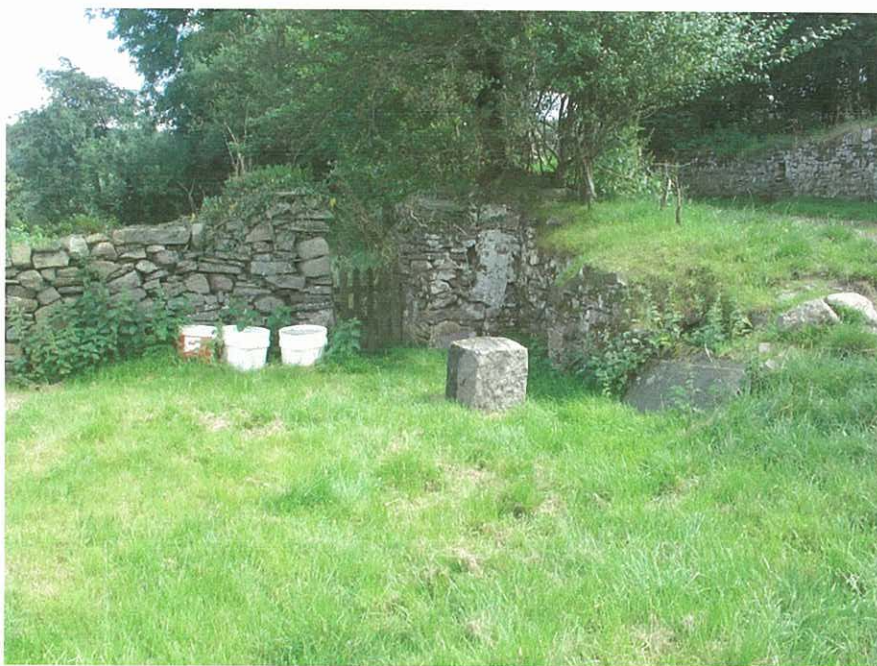
PRN 45765 **Site Name** HAFOD **Grid Reference** SN66532120

The ruined remains of a farmhouse. The current farmhouse appears to have been built between at the turn of the 19-20th centuries, it does not appear in its current position on the 1st edition Ordnance Survey map of 1890, but is located on the 2nd edition Ordnance Survey map of 1907. The remains of the former farmhouse are situated immediately to the northeast of the current farmhouse (PRN 48678). Part of the south and east wall survive and the interior plastering still adheres to the stone walls which stand to an approximate height of 1.3 metres. These sections of walls have now been incorporated into the walls of the kitchen garden, which is situated to the east of the old farmhouse.

Prn 45765 – the remains of the old farmhouse at Hafod have been incorporated into the garden wall

The walls of the old farmhouse should be retained. There are likely to be other features and buried archaeology relating to the former farmhouse, therefore areas which have not been previously disturbed should remain undisturbed.

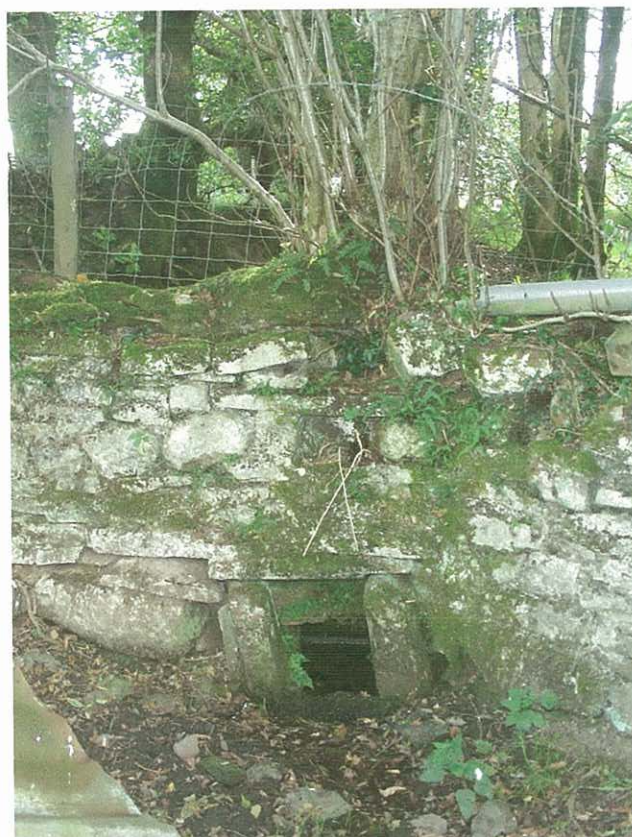
PRN 45766 **Site Name** HAFOD **Grid Reference** SN66562119

A well, marked on the 1st edition Ordnance Survey map of 1890, can be found situated to the east of the farmstead (PRN 48679). The well is located within a stone wall which lines the south side of a trackway which leads into the farmyard from the east. The well is constructed with two upright stones to either side supporting a single stone slab which caps the structure. The stone wall which stands to a height of approximately 1.2 metre has a hazel coppice growing from the wall top.

Prn 45766 – the well to the east of Hafod farmstead

The hazel coppice which is growing out of the masonry wall above the well, will potentially cause problems with the masonry and in the event of the tree falling will damage the structure. It is recommended that this coppice is cut back and the roots treated to prevent regrowth.

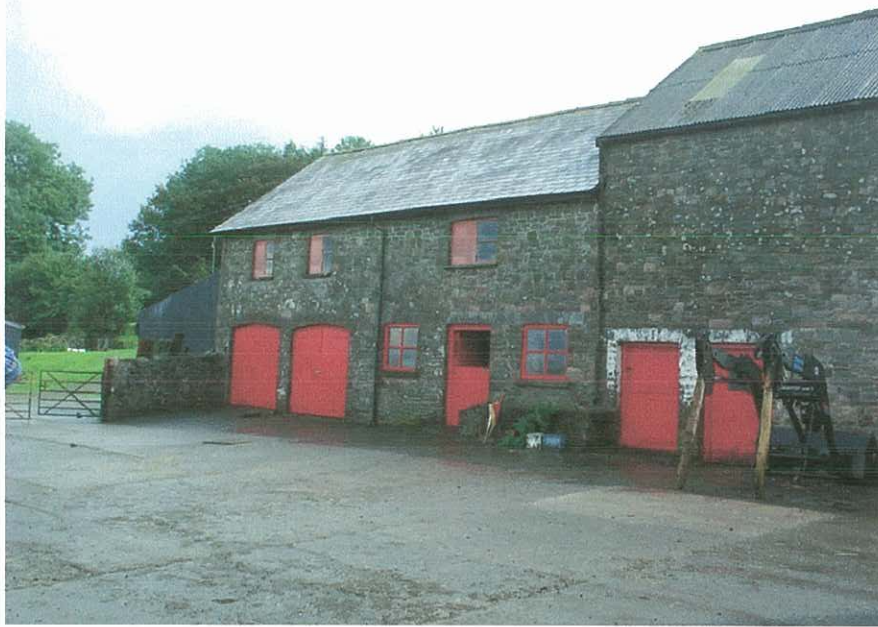
PRN 45768 **Site Name** HAFOD **Grid Reference** SN66482120

To the northwest of the farmstead is a two storey combination farm building range, situated on a northeast – southwest axis. The building is built into the natural slope so that the ground surface butts up to the first floor level on the south side of the building. On the ground floor the building appears to be divided into three separate elements, a cart house at the eastern end, a stable in the central section and a cow shed to the west.

The building is well constructed in uncoursed roughly squared stone, with substantial stone quoins and dressings around the openings. The cart shed and stable has a slate covered roof at a lower level than that over the cow shed which is covered in asbestos.

Prn 45768 – east end of the range of combination farm building, the cart shed at the far end and the stable to the right.

The combination farm building is in a good condition, and part of the roof has been re-slatted within the last 5 years. The farm building should continue to be maintained in a sound condition, with any repairs carried out using appropriate traditional building materials.

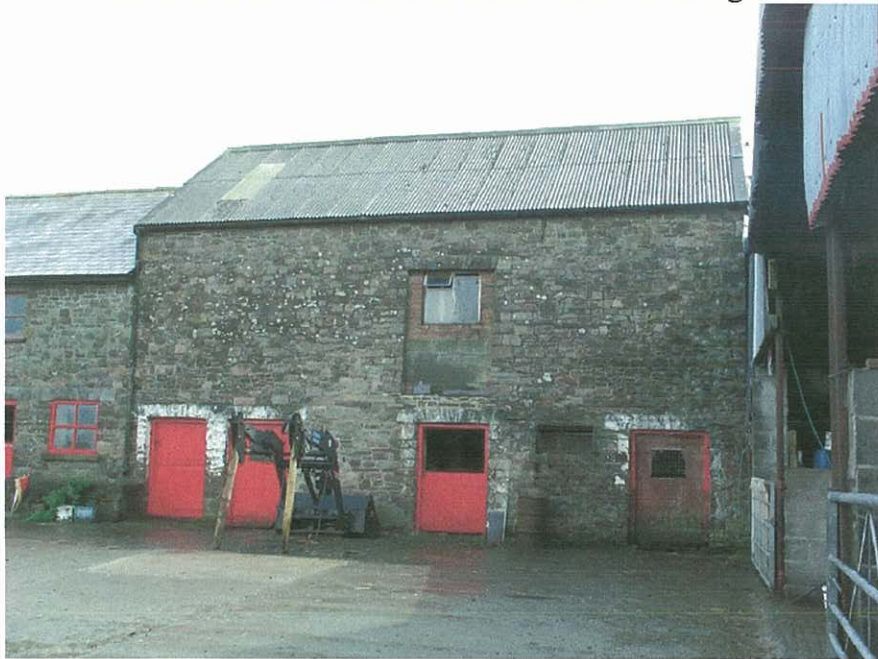
The upper floors are also divided into three sections, the western end appears to be primarily a hay and feed loft with a double width doorway to the south and a large loading door to the north. The eastern section has a row of harness hooks indicating its use as a tack room at an earlier stage.

Prn 45768 – the west end of the combination farm building includes the cow shed, with central feed passage with manure passages to either side.
