Bee Hall Farm

Tir Gofal Farm Visit Historic Environment Report

Report No. 2002/66

REPORT NO. 2002/66
PROJECT RECORD NO. 44111

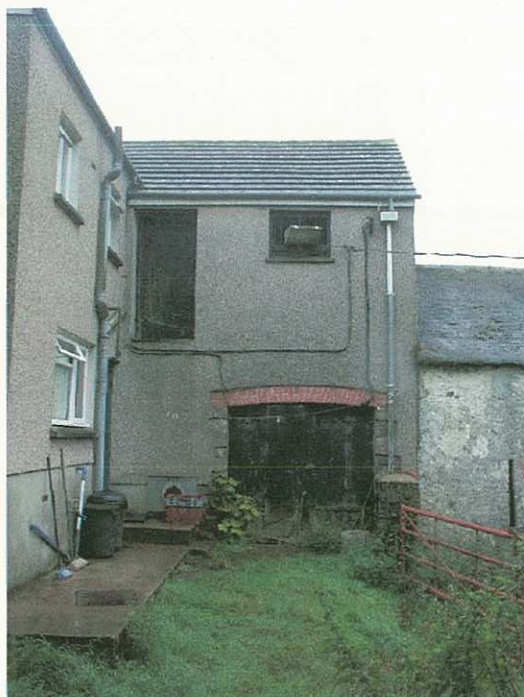
Plate 1 – Bee Hall Farmhouse and cart shed (PRN 45697)

East west orientated two storied gabled farmhouse with an attached cart shed wing to the north west forming an 'L'-shaped block. The house alone appears on the tithe map and apportionment for the parish of Cosheston (1841) but has been heavily modernised externally with pebble dashed walls, cement roof tiles, casement windows, and modern brick chimney stacks. The cart shed wing has been treated similarly but retains a brick arched cart opening in the east face, and externally accessed accommodation above which according to the owner Mr. Skeels was formerly the servants accommodation, (plate 1).

The farmhouse is not included in the Tir Gofal management agreement as it is occupied as a dwelling, but is in good condition.

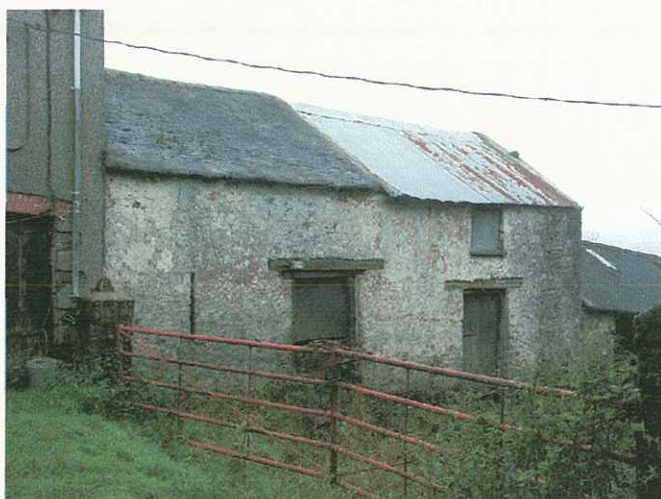
Plate 2 – barn and stables (PRN 45698)

A barn attached to the house and cart shed, appearing on the tithe map and apportionment for the parish of Cosheston (1841) and divided in two by a ridge height stone wall. The southern section (?threshing barn) is accessed by opposing doors in the east and west walls and internally by a doorway (now blocked) from the cart shed, and ventilated by two narrow slits beside each of the two opposed doorways. The roof to this section consists of two collared roof trusses supporting wooden pegged slates which have been covered in a sand and cement grout, (plate 2).

The northern section (?stables) is accessed through a central doorway in the east wall, the door is a half stable door with a hinged back, the room is lofted but no floor boards remain. There is also an opening above the doorway which is a probable pitching hole and a break in the floorboards presumably to provide ladder or hatch access between floors. This section is roofed with corrugated zinc sheet. There is also a doorway (now blocked) at first floor height in the north wall and two ventilation holes in the west wall, (plate 2).

The barn is in fair to good condition and should be maintained using appropriate materials. The grouted roof is an interesting and effective roofing method and should be maintained using appropriate methods and materials.

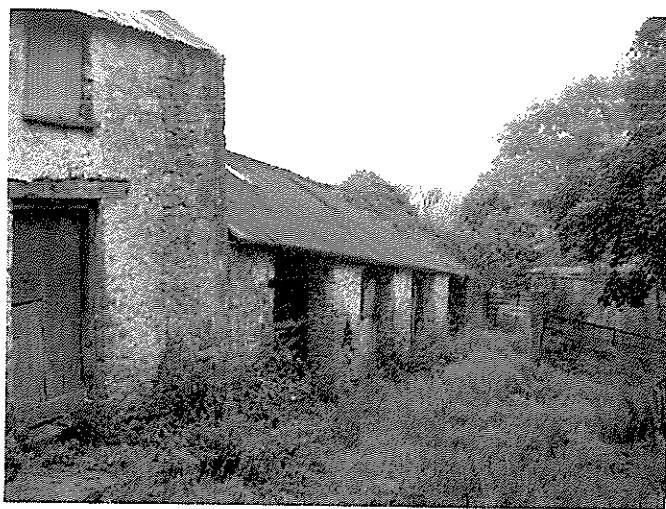
Plate 3 – cowshed (PRN 45699)

A low one storey cowshed range built against the north wall of the barn between 1841 and 1881, with four full height openings in the east wall, and covered by pegged roof trusses and corrugated asbestos sheet. The west external face and north end of this building have become heavily overgrown with ivy, (plate 3).

The cowshed is in fair to good condition and should be maintained using appropriate materials. The growth of ivy onto and over the roof is a potential cause for concern as the shed may easily become overgrown. The ivy and other vegetation should be removed and any damaged areas of masonry repaired using appropriate materials.

All three of these structures are in danger of becoming overgrown with vegetation with subsequent damage to the fabric of each structure. In particular the cart shed has largely become ruinous and obscured from view by vegetation growth.

In all cases the vegetation should be removed and where necessary the roots treated. Following this any parts of the fabric damaged by the vegetation should be repaired using appropriate materials

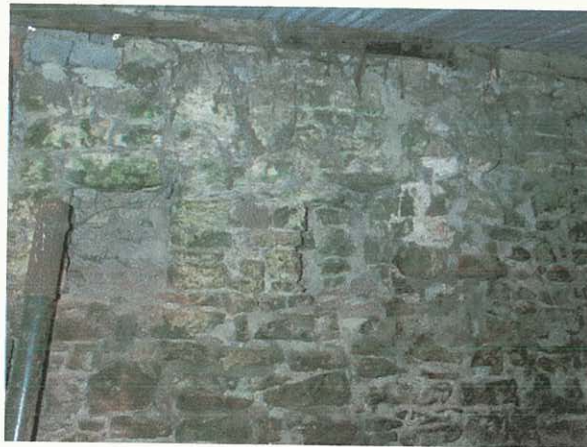
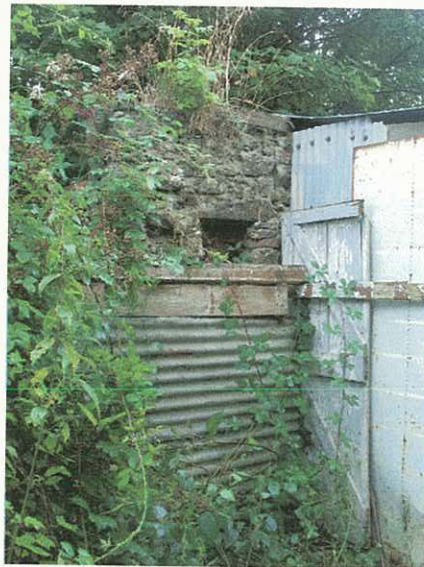
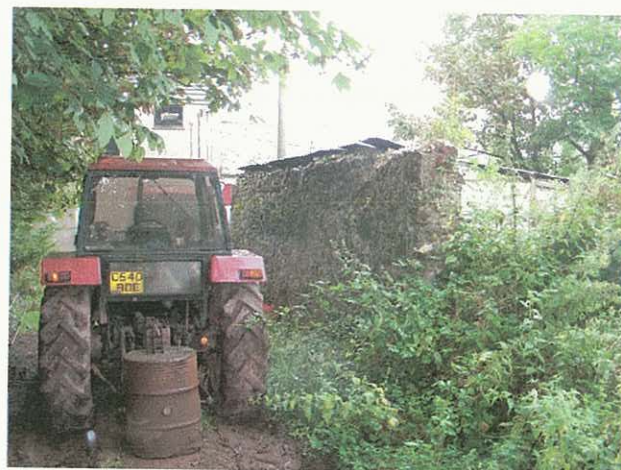
Plate 4 – bee boles (PRN 45702)

A series of three bee boles constructed within the north face of a short stretch of east west aligned stone wall to the south east of the farmstead. This wall has been used to support the lean to roof of a (now unused) modern cow shed to the north and also forms part of the enclosure around the farmyard.

Each bee bole is approximately 0.3m deep and 0.35m square, built at the same height (c. 1.4m above ground level) and at about 0.45m apart. A stub of masonry projects from the wall immediately to the right (west) of the bee boles, although it was impossible to discern the exact function of this stub, it does suggest some form of structure adjacent to and connected to the bee boles, (plates 4, 5 & 6).

The bee boles and surrounding wall are in fair condition but are in danger of becoming overgrown with vegetation and the fabric of the structure may subsequently be damaged. The roof of the cow shed should be repaired and moved in order to cover the wall head, which should also be repaired and any loose masonry secured. Materials appropriate with the construction of the wall and bee boles should be used throughout. Consideration should also be made prior to any consolidation work as to whether to remove modern attempts at repair around the bee boles.

The bee boles and surrounding wall are in danger of becoming overgrown and the fabric of the structure may subsequently be damaged. The roof of the cowshed that rests on the wall top should be repaired and moved in order to cover the wall head, which should also be repaired and any loose masonry secured. Materials appropriate with the construction of the wall and bee boles should be used throughout. Consideration should also be made prior to any consolidation work as to whether to remove any repairs made in inappropriate materials or repairs around the bee boles which obscure the stonework.

Considering the rare survival of these structures and the possibility of associated features it is recommended that an archaeological record is made of the bee boles and surrounding wall prior to any consolidation works.

Considering the rare survival of these structures and the possibility of associated features it is recommended that an archaeological record is made of the bee boles and surrounding wall prior to any consolidation works

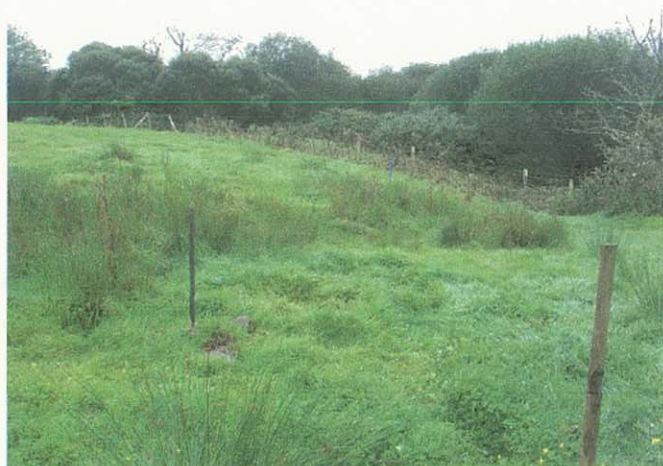
Plate 7 – well (PRN 45703)

According to the present farmer, Mr. Skeels, this was a square cut cistern with a corrugated zinc cover, located to the north west of the farmstead. The first recorded mention of a well in this area is on the 1st edition Ordnance Survey map of 1881. It is now a wet, muddy depression. Some large stones can be seen around this well feature although it is believed that these are related to later stages of well capping rather than a previous structure, (plate 7).

Mr. Skeels proposes to reinstate this well/spring feature, it is therefore suggested that an archaeological watching brief is carried out during these works in order to identify any possible historic structures related to the well. This could also inform any decisions about the form and type of reconstruction of the well structure and could be carried out concurrently with the recording of the bee boles (PRN 45702).

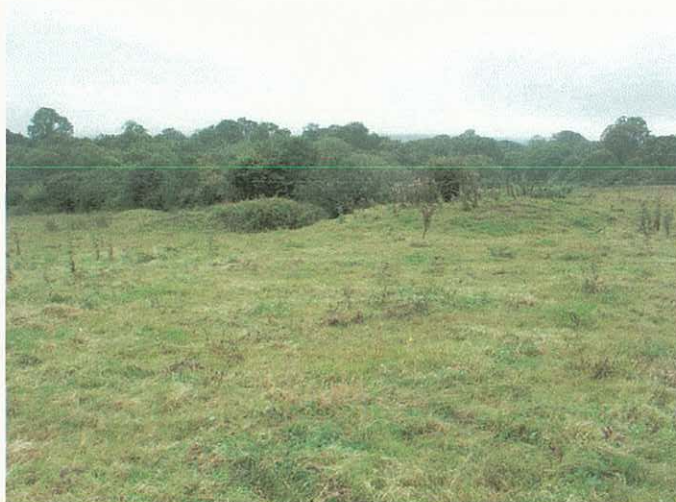
Plate 8 – earthwork (PRN 45704)

An irregular earthwork enclosure situated alongside the remains of a relic field boundary bank associated with the cottage site (PRN 45706). It measures around 10m across with its surrounding banks standing between 0.5m and 1m high. It's interior is heavily poached and some attempt has been made at draining it. It is unknown what this enclosure is. It may relate to the cottage site PRN 45706, (plate 8).

There is potential for surviving buried archaeological remains surrounding this earthwork and no intrusive groundworks should be undertaken in this area. It is also suffering from some livestock erosion. Stock levels should be reduced in this area and managed to avoid erosion especially when the ground surface is waterlogged.

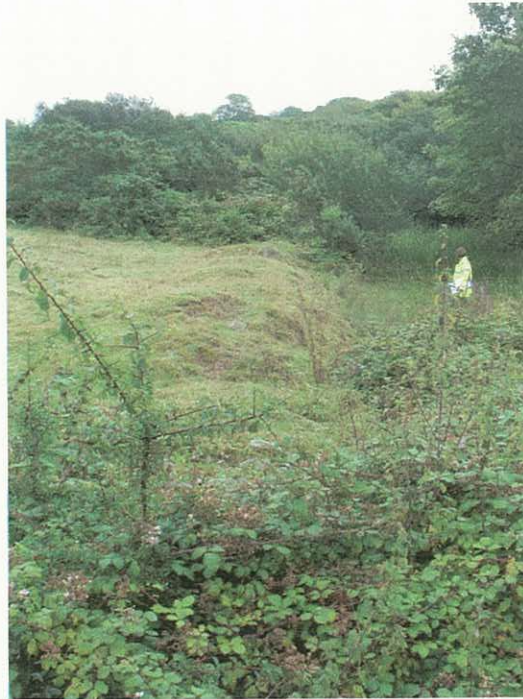
Plate 9 – bank at site of cottage (PRN 45706)

Cottage site as identified on first and second edition Ordnance Survey mapping (1881 and 1909) and identified as a "Cottage Garden" on the Tithe Map of Cosheston Parish (1841). Due to extensive vegetation growth no direct earthwork evidence could be identified apart from a bank following the north side of the water course from Bee Hall Farm to Penny Bridge, (plate 9).

There is potential for surviving buried archaeological remains in this area and no intrusive groundworks should be undertaken. Due to the proximity of the water course the ground in this area is prone to water logging and therefore in increased danger from livestock erosion. Reduced stock levels will prevent erosion and damage of any buried archaeological remains. The vegetation in this area could also be cut back to prevent concentration of any damage by livestock.
