# **Rhiwgraidd W/11/3803**

## **Tir Gofal Farm Visit Historic Environment Report**

Report No. 2002/57

Report Prepared for:  
Countryside Council for Wales

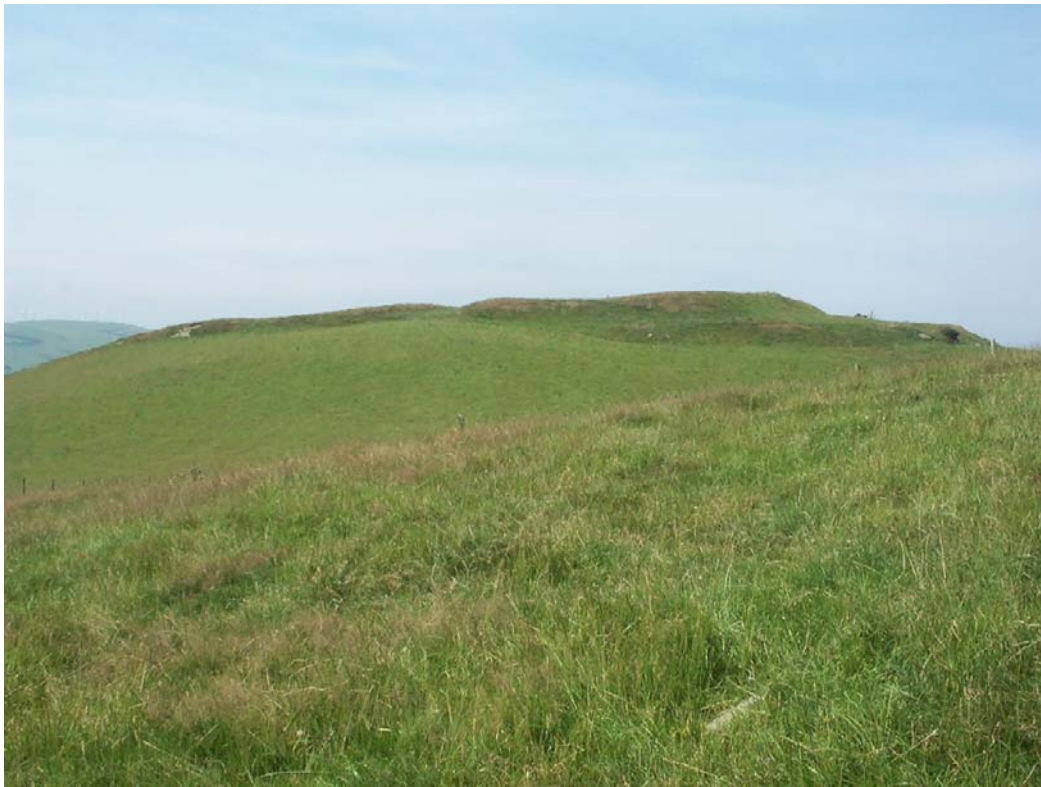
**Gaer Fawr Hill Fort (PRN 1997) viewed from the east**

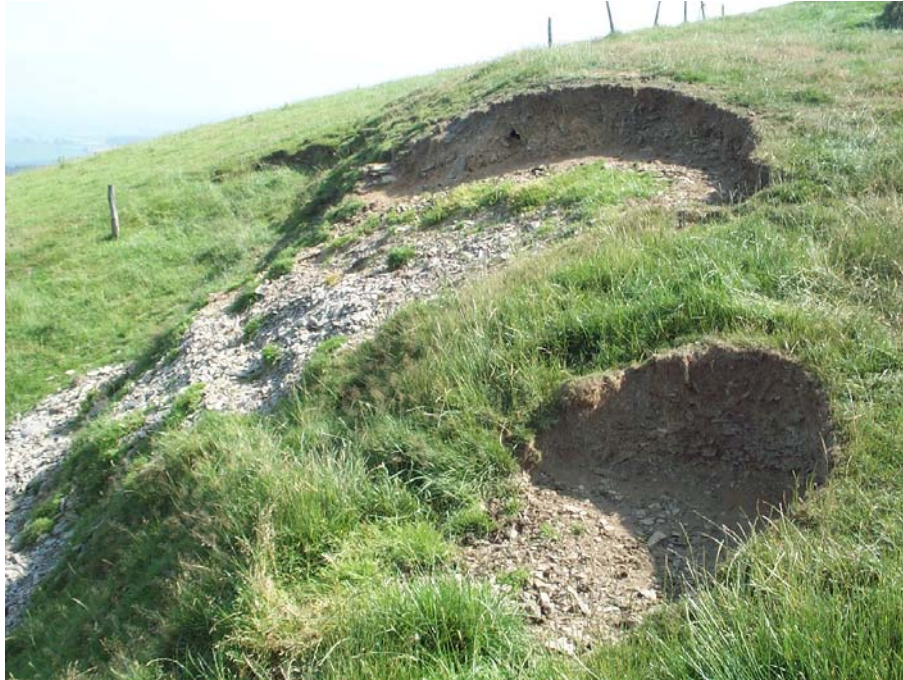
In places the hillfort ramparts suffer from pockets of erosion caused by sheep and rabbits (plate 1), this appears to be an ongoing problem. Whilst some of the scrapes caused by sheep are obviously actively being eroded in other areas there is evidence that these scars are healing.

Plate 1 – the north ramparts of Gaer Fawr (Prn 1997) showing pockets of active erosion.

In the long term the best solution to prevent the active erosion on the ramparts would be to reduce the levels of stock grazing and sheltering on the hillfort. However, it is suggested in the short term that either netting or brash is securely weighted down within the scrapes to prevent sheep using these pockets for shelter, thus causing further erosion. This would allow the grass cover to regenerate.

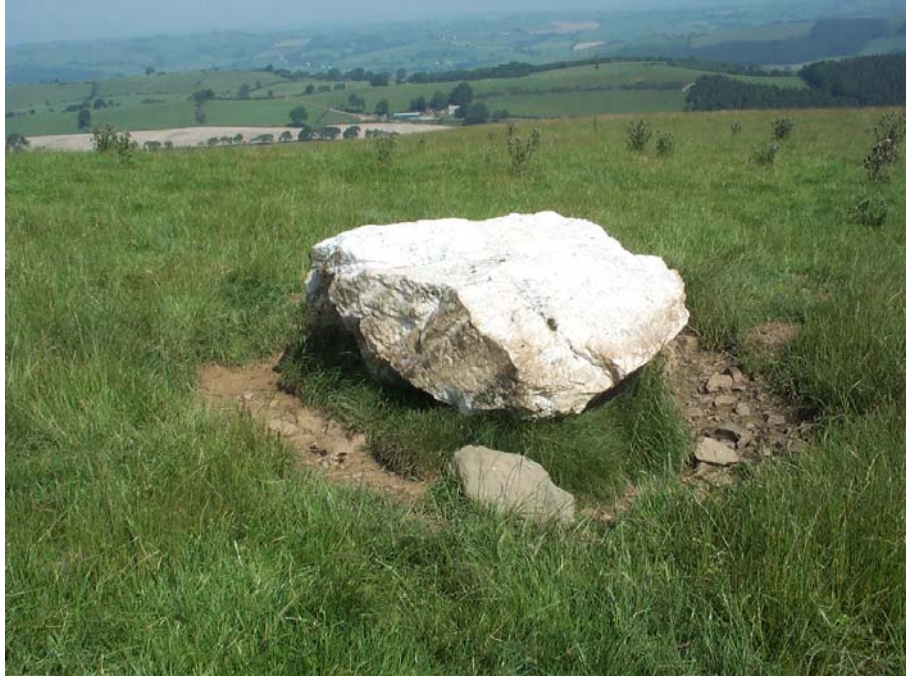
A large quartz stone lies on the summit of a saddle-like ridge which lies to the east of the hillfort Gaer Fawr. The quartz monolith is recumbent, lying 1.7 metres in a north – south direction, 1.4 metres east –west and 0.6 metres in depth. The stone appears to be lying on an earth pedestal, worn around the base by sheep using it for shelter.

Plate 2 – a recumbent stone (Prn 5178), suffering from erosion at its base.

The area immediately surrounding this stone is suffering some erosion from sheep sheltering against it. This could be reduced by brash or netting being weighted down around the stone, preventing livestock getting to close to the stone and thereby allowing the grass cover to regenerate.

The stone should not be moved nor should anything be deposited on or against it. In order to protect against damage to any buried archaeology associated with the stone, no ground intrusive activity should take place within a 15 metre radius of the site.

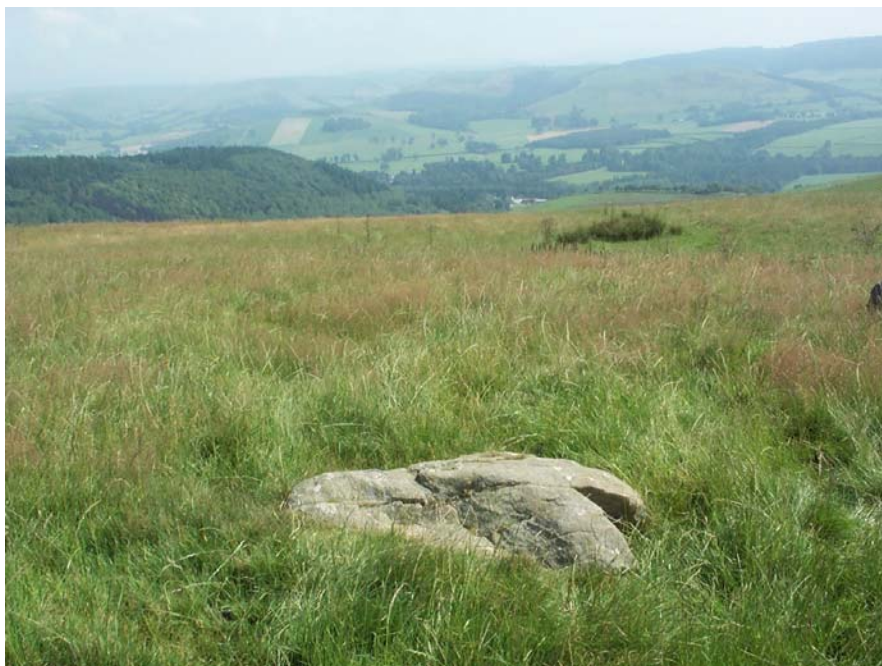
To the north east of the standing stone (PRN 5178) and the hillfort (PRN 1997) is a further recumbent large monolith. It is positioned on the hillslope facing north - east and appears partially buried. The dimensions are approximately 1 metre north – south and 0.75 metre east – west.

It is unknown whether this stone may be the result of prehistoric activity or whether it may be a natural feature.

Plate 3 – a recumbent stone of unknown origin (PRN 45008).

Until a further assessment can establish the origins of this stone it is advisable that it is retained in this position and in its' current state. For this reason it is also advised that no ground intrusive activities take place within 15 metres of this site, in order to protect any buried archaeology which may survive in this region.

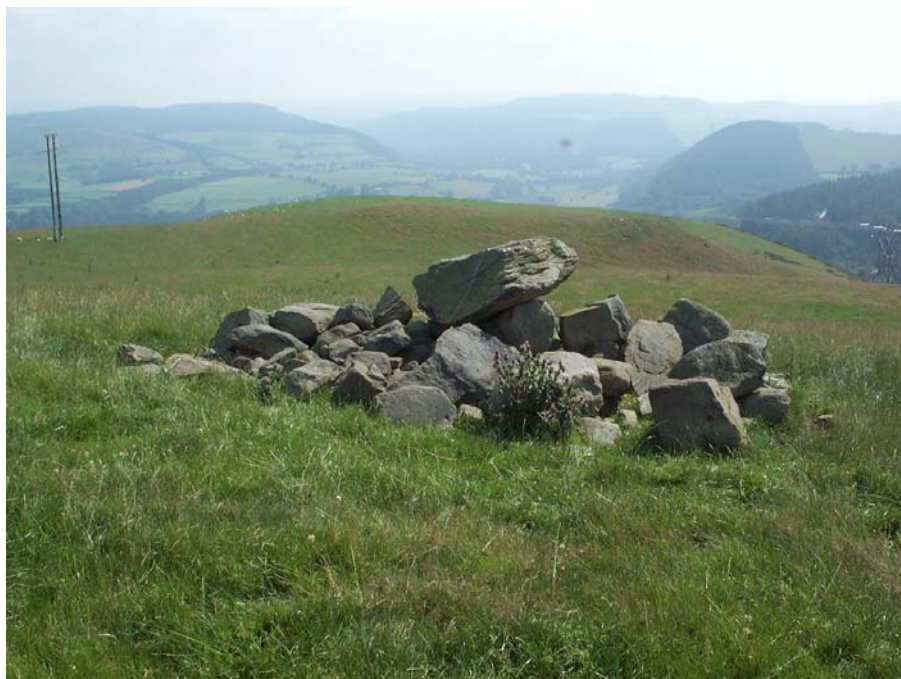
Approximately 10 metres to the south of the standing stone (PRN 5178) is a clearance cairn. The cairn is composed of an assortment of stones and also includes an iron rod. These elements of various sizes are randomly collected into a heap. The cairn extends 5 metres in a north-south direction, 3 metres across and approximately 1 metre high.

Plate 4 – clearance cairn (PRN 45009) situated to the south of standing stone (PRN 5178)

This clearance cairn is the end product of past agricultural practices and is a historic landscape feature in its own right. It should be retained as existing.

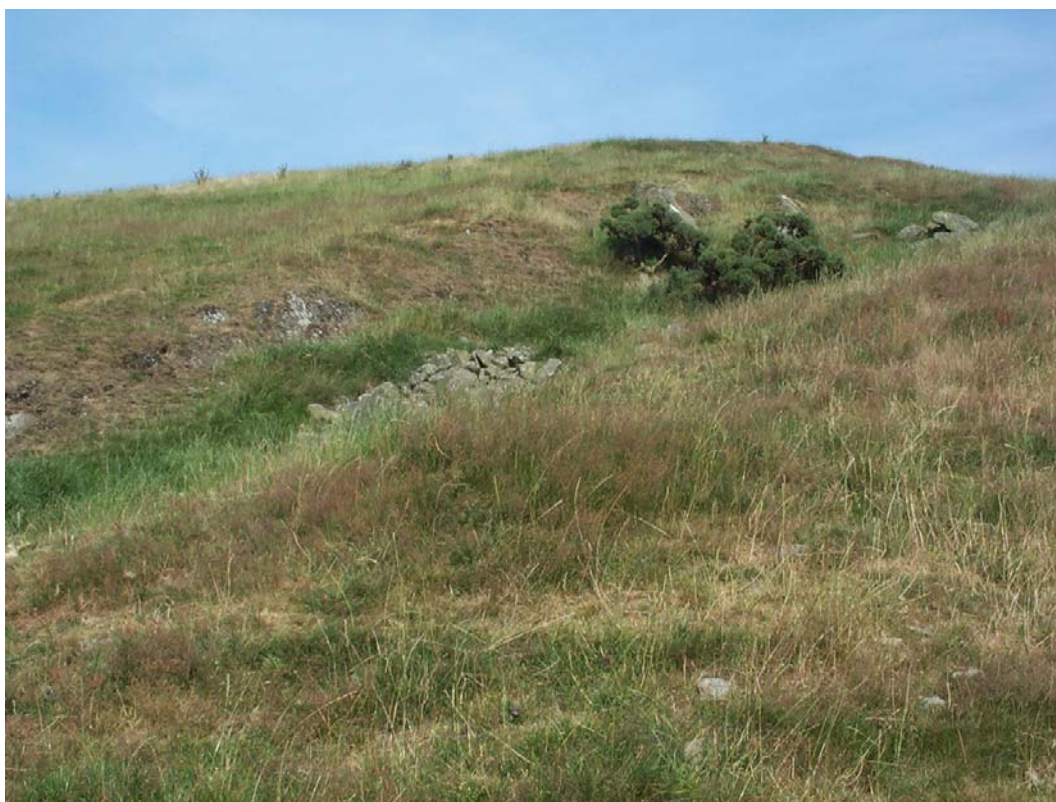
A long quarry cut is situated at the south east corner of the hillfort (PRN 1997) on the south facing slope. The quarry cut is 20 –25 metres long in a north south orientation, 6 metres wide and 2 metres deep. The natural strike of the rock is visible. The interior of the quarry has an assorted collection of small stones.

Plate 6 – a long narrow quarry cut in the south facing slopes below Gaer Fawr (PRN 1997)

This quarry should be retained as a visible historic landscape feature. No further infilling of the quarry should be carried out.

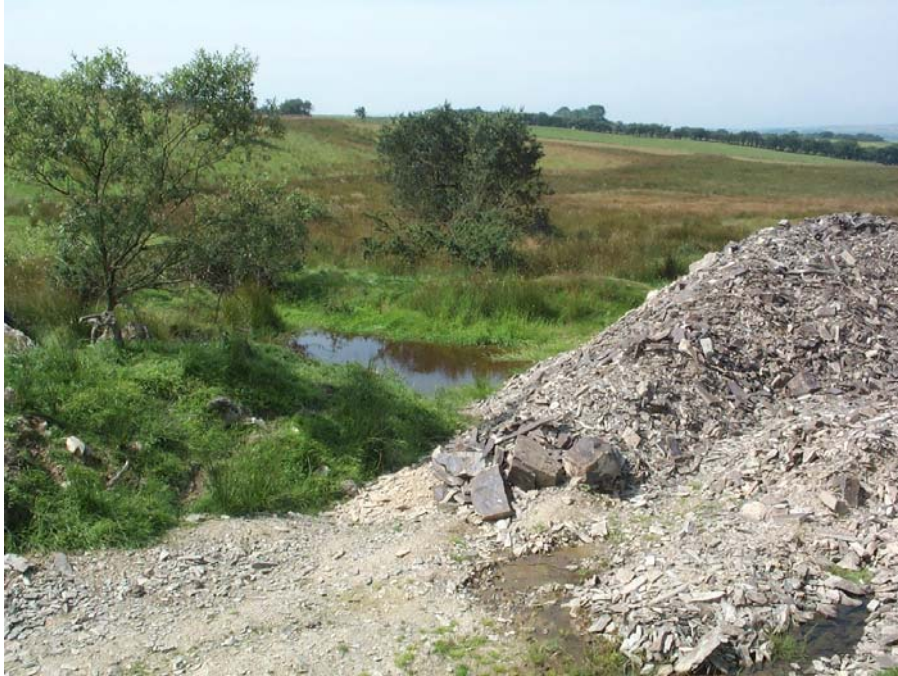
Today the north side of the site, where the cottage once stood, has been subject to recent quarrying and there are no further visible remains of any buildings. However, to the south in the valley are the low earthwork banks of the associated garden / enclosure, surviving to a height of approximately 0.5 metres.

A trackway is still visible which leads to the site, and is flanked by earth banks topped with overgrown hedgerow trees to either side. A large quantity of hardcore has been deposited over the track to a height of approximately 0.5 metre.

Plate 7 – the enclosure banks of the cottage site of Bryn Rhudd (PRN 45013)

No further quarrying should be carried out at this deserted cottage site. These features are a valuable element of the historic landscape and should be preserved. It would be desirable if the trackway could be restored to it's earlier form.

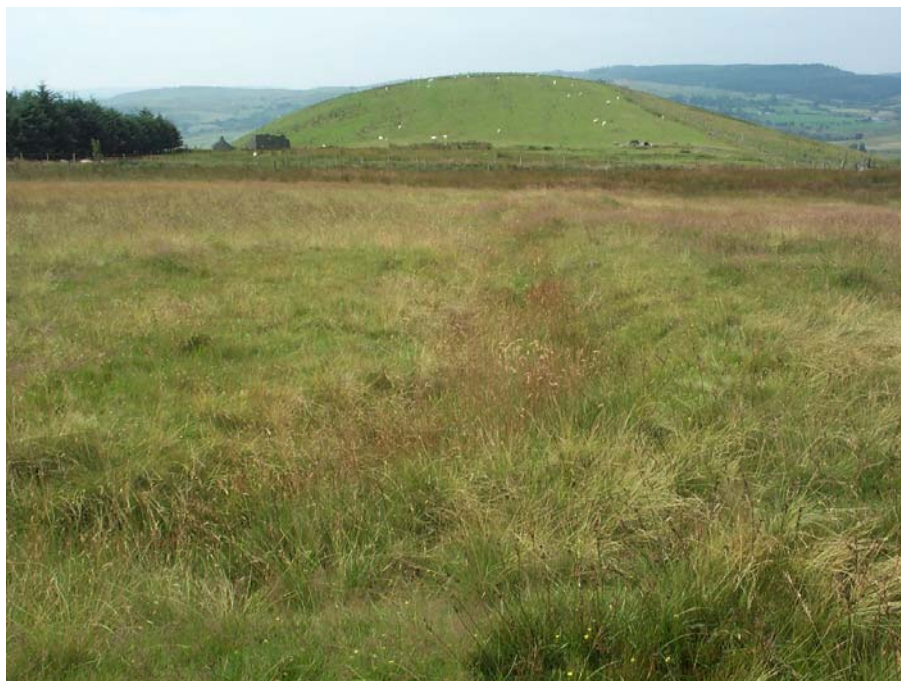
A series of linear features exist in this west facing, gently sloping field. A long trench runs from north – south, shallow to the south and gradually becoming deeper towards the north where it is approximately 0.5 metres deep. At its northern extent the gully turns to the north west where it continues for about a further 16 metres. Where the gully ends a linear bank continues on the same alignment to the west for a further 20 metres. A further bank run east - west in the mid point of the field.

It is unknown what these features are; they may be attempts to drain this predominantly boggy field or alternatively they may be features which relate to the lead mine which is situated to the north west, in the adjacent field.

Plate 8 – a linear bank in foreground (PRN 45015) with Llwyn-llwyd Mine beyond.

These banks and ditches should be retained as visible landscape features.
