Panttyrofyn W/11/2764

Tir Gofal Farm Visit Historic Environment Report

REPORT NO. 2002/97
PROJECT RECORD NO. 44125

Pantyröfyn
Tir Gofal Farm Visit Historic Environment Report

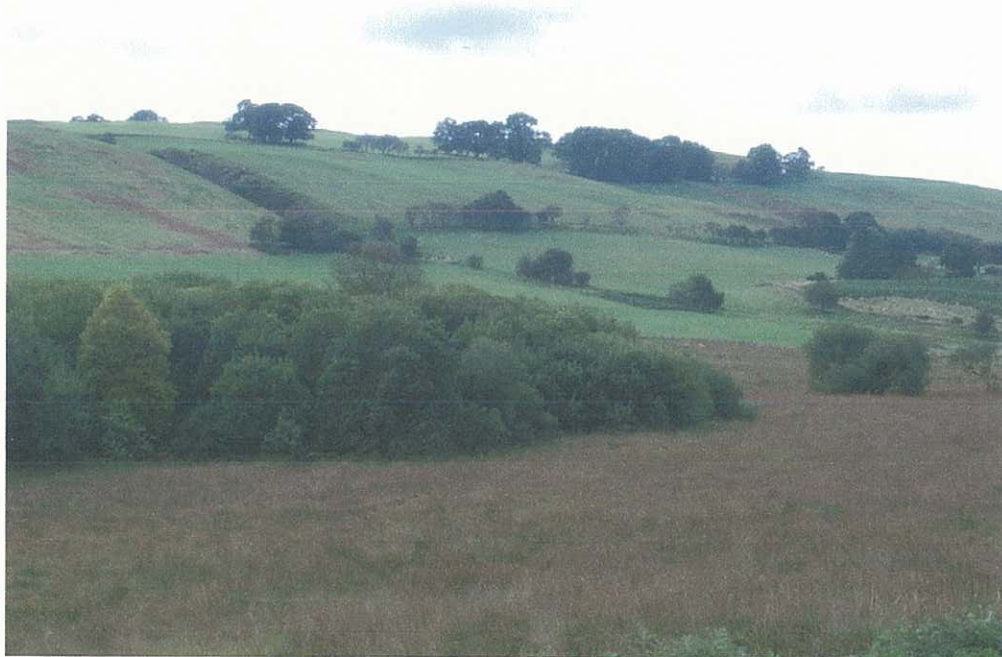
A view showing a group of cottage sites aligned along the brow ridge.

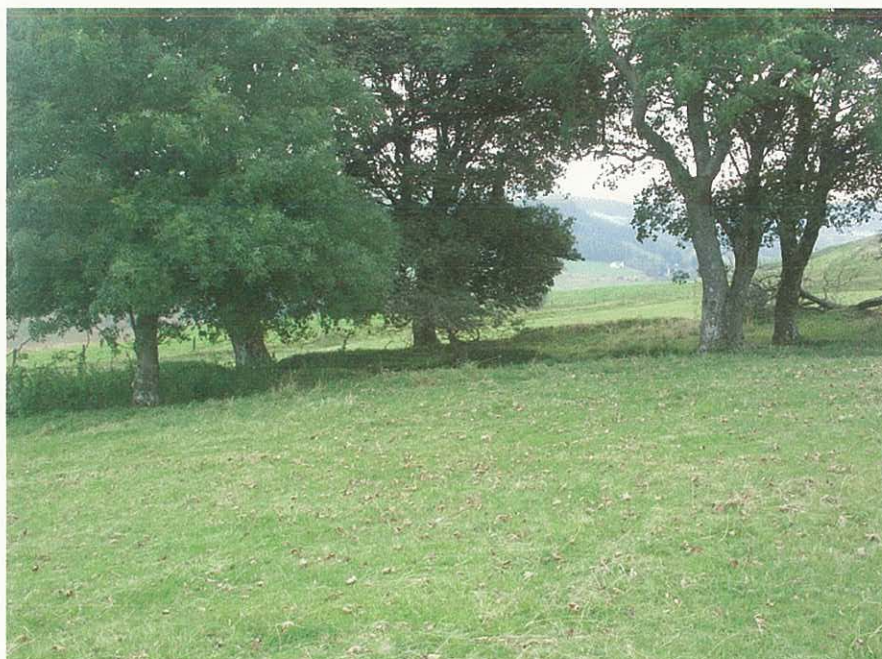
The site is currently unfenced and grazed. To the east a fallen tree is causing some erosion on the earthwork bank where stock have been congregating.

Prn 19721 – The site of Pantyffynon cottage

The fallen tree lying on the enclosure bank to the east should either be cleared or moved at least 15 metres away from the site to prevent stock from congregating and thus eroding the earthwork banks. This should be undertaken with care not to further damage the earthworks.

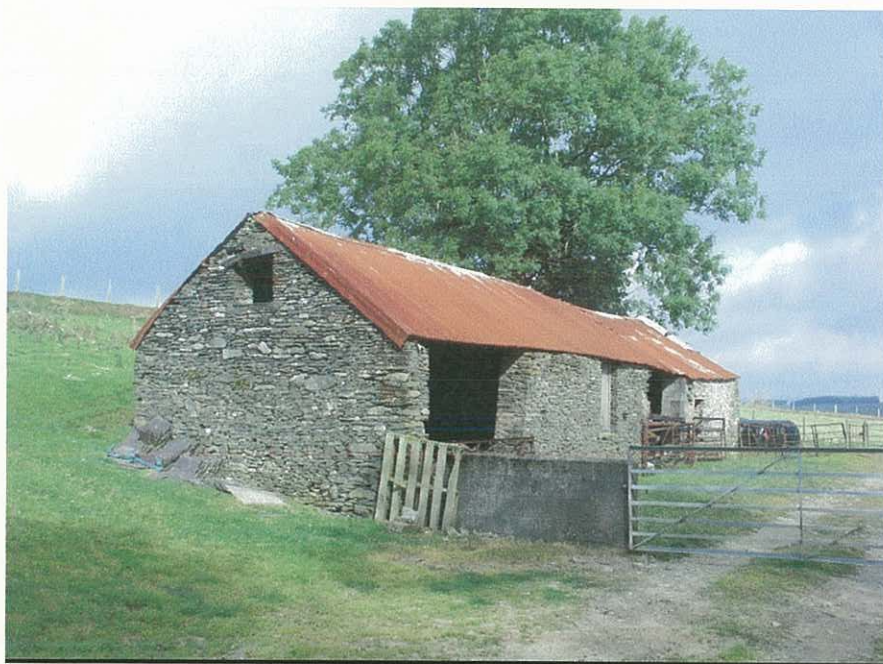
This building is in a vulnerable condition. The mortar bonding has almost entirely eroded away and consequently in places the masonry walls are becoming unstable and are beginning to bow out. This is particularly severe at the southern end of the west side of the building. The northern end is also in a poor condition where the roof does not quite cover the gable end and cracks have appeared in the masonry.

Prn 45767 – Pantygorlan cottage, now used as a store.

This building presents an excellent opportunity for restoration. Ideally the roof should be made fully watertight and the covering should extend over all masonry walls with a sufficient overhang to prevent water from running through the wall core. The walls require consolidation, and in some areas, where the masonry has become unstable the walls may require rebuilding. These works should be undertaken using appropriate materials, sympathetic to the original structure.

In the event of this building undergoing restoration it is recommended that a photographic record is undertaken prior to the work being carried out, please find attached guidelines appended to this report.

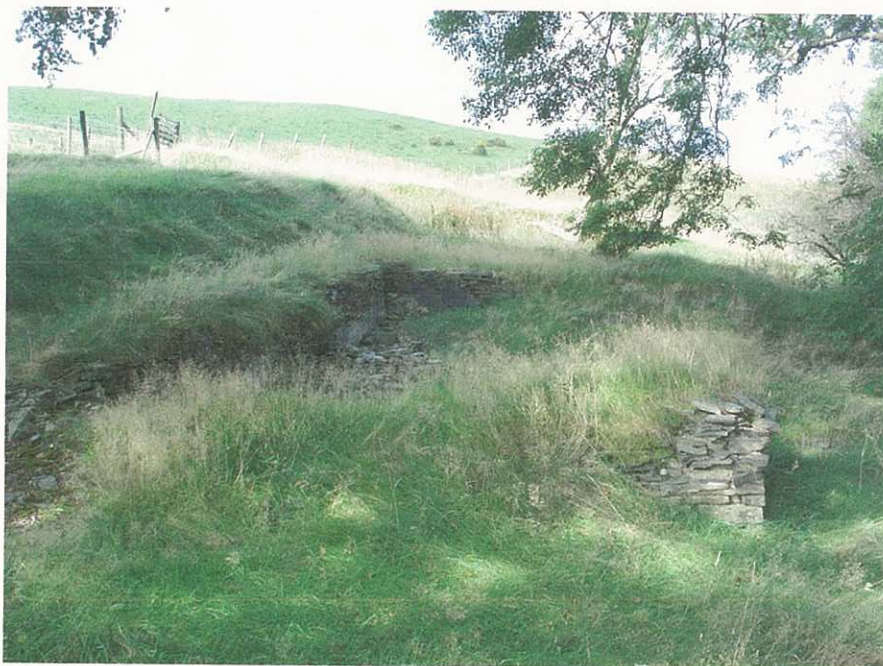
The site of a cottage shown on the 1st & 2nd edition Ordnance Survey maps of 1891 and 1907, survives only as low stone walls less than 1 metre high. The layout of the cottage is still discernible and traces of lime render are preserved on the interior of the walls. The cottage is approximately 8 metres long with a central doorway in the north wall, traces of an internal partition can be seen to the west of centre. To the west further low earth covered banks arranged in a rectangular form indicate a further element attached to the building.

Prn 45769 – The remains of Llechwedd cottage

The remains of this site appear to be under no apparent threat in the current management regime. The site should continue to be maintained with an even grass cover, with light grazing to prevent the site from becoming overgrown.

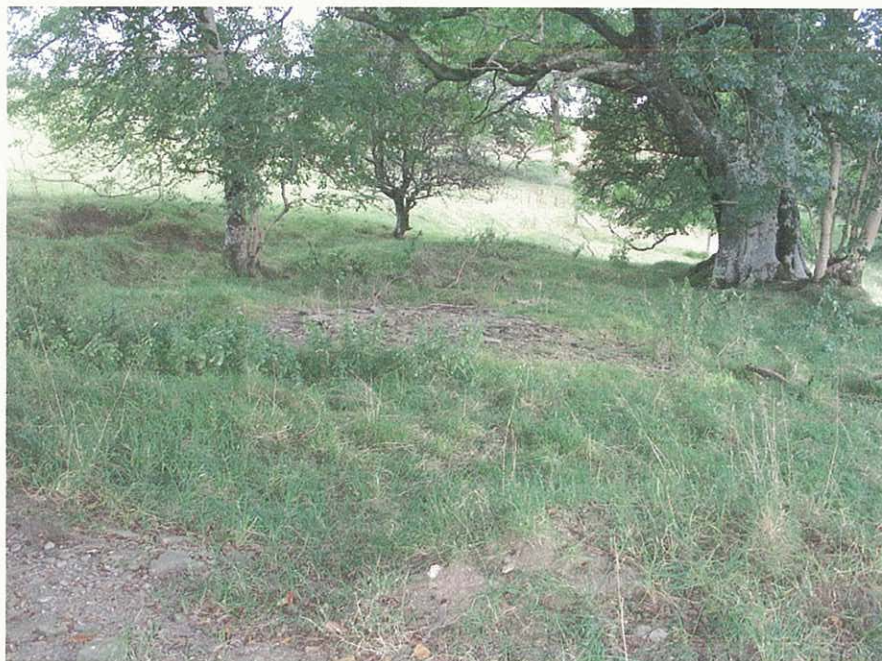
There are few upstanding remains of this cottage which is identified on the 1st and 2nd edition Ordnance Survey maps of 1891 and 1906. What can be seen are traces of walls, approximately 16 metres long, surviving no higher than 0.4 metre above the ground surface and a spread of loose stone. A trackway, with banks approximately 0.4 metre high, appears to serve the cottage rising up from the slope to the north and a possible further trackway also serves the cottage to the south. To the east of the cottage is a rectangular enclosure within which an animal feeder is situated.

Prn 45770 – The site of Ty Canol cottage

The animal feeder within the cottage enclosure should ideally be moved at least 15 metres away from the cottage site in order to discourage animals from congregating on the cottage site and eroding the sensitive archaeological remains.

The site should continue to be maintained with an even grass cover, with light grazing to prevent the site from becoming overgrown.

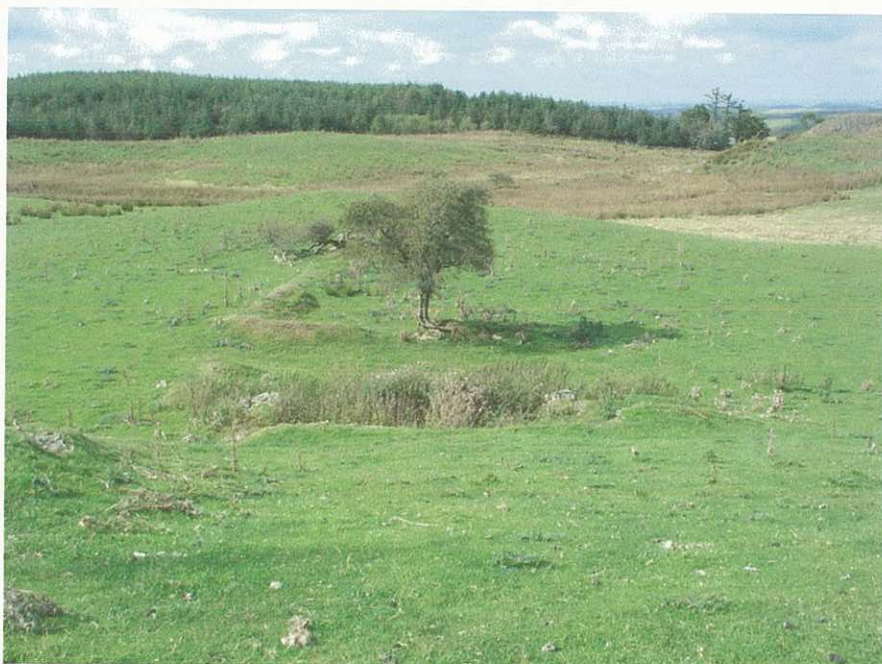
The remains of the cottage of Bryn-llwyd and part of its associated enclosure can still clearly be seen although the walls stand no higher than approximately 0.5 metre. The cottage is shown on the tithe map of Llanafon (1845), and appears to be still occupied when the 2nd edition Ordnance Survey map was published in 1906.

Prn 45775 – The site of the former cottage of Brynllwyd

The remains of this site appear to be under no apparent threat in the current management regime. The site should continue to be maintained with an even grass cover, with light grazing to prevent the site from becoming overgrown.

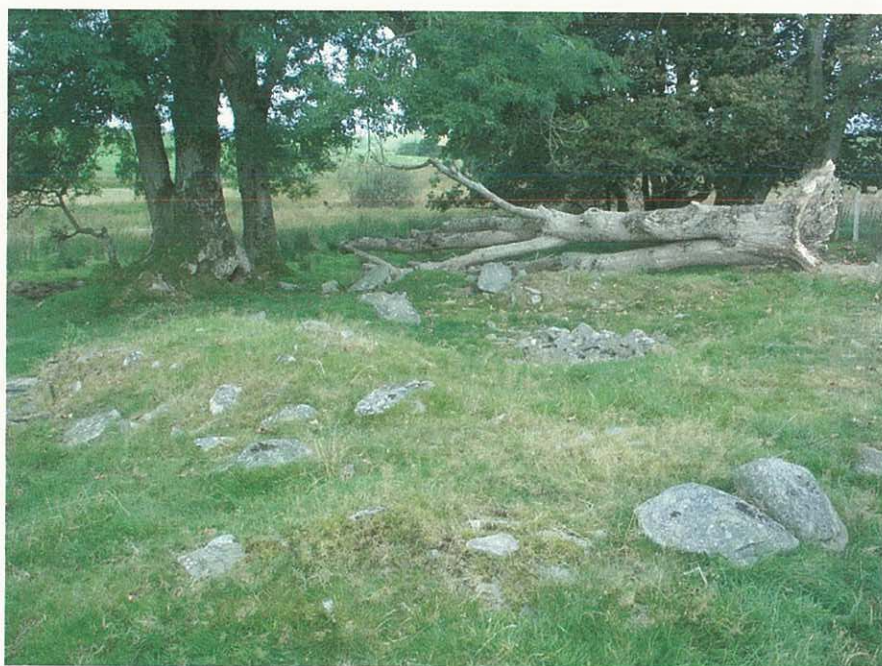
The site of a cottage named Glan gors is shown on the 1st and 2nd edition Ordnance Survey maps published in 1891 and 1906. Low earth banks from which stone protrudes are all that is visible of this building and its enclosure. The banks are no more than 0.5 metre high with a great deal of loose stone scattered about. A number of mature ash and sycamore trees line the outer edges of the site.

Prn 45777 – The site of the former cottage of Glangors.

This site should continue to be maintained in its current stable state. The remains of this site appear to be under no apparent threat in the current management regime. The site should continue to be maintained with an even grass cover, with light grazing to prevent the site from becoming overgrown.

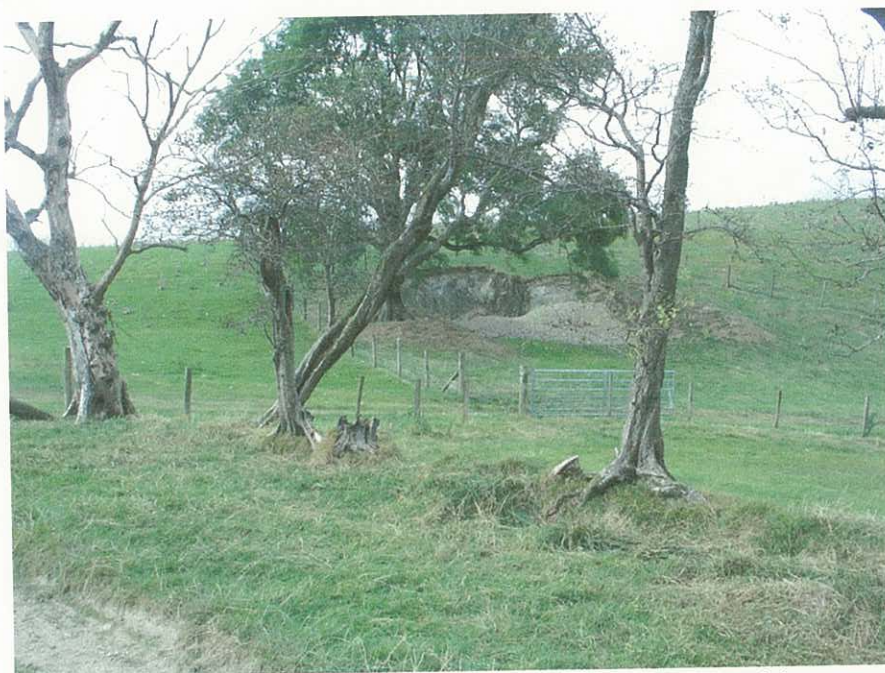
There is little evidence of the cottage today and it appears that the site of the cottage has been quarried. The only visible evidence of the cottage site is a single mature tree which may be a relic of the garden or enclosure.

Prn 45780 – The trackway and probable site of Lluest y Bwlch cottage

Although there appears to be little surviving of this cottage and its associated enclosure, there may still be archaeological remains which survive in this area. The quarried area appears to quite discreet allowing for the possibility of remains surviving in the vicinity. Ground intrusive activities should be avoided in this area and if further quarrying is carried out on this site, please inform Cambria Archaeology in advance.

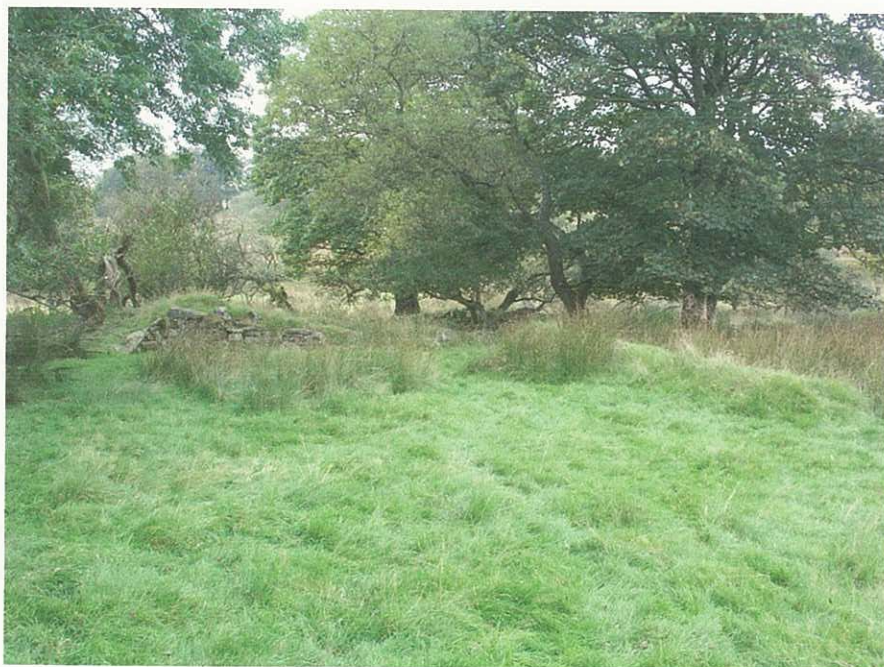
There are several mature trees which surround the site, many of them apparently outgrown hedgerow species. However, a large sycamore and some thorn trees are growing within the cottages themselves.

The site of the Glance cell cottages is now set within rough grazing. Attempts have been made to drain this field and it appears that the trackway indicated on the Ordnance Survey maps which served the cottages, has now been dug away to provide a deep drainage gully.

Prn 45781 – The site of the former cottage of Glancell

There is clearly the potential for tree fall to cause some damage to the remains of the cottages. Ideally the trees in this area should be managed in order to prevent this sort of damage occurring.

In other respects the site should continue to be maintained with an even grass cover, with light grazing to prevent the site from becoming overgrown.
