Glangors W/11/2762

Tir Gofal Farm Visit Historic Environment Report

REPORT NO. 2002/111
PROJECT RECORD NO. 44130

Glangors Tir Gofal Farm Visit Historic Environment Report

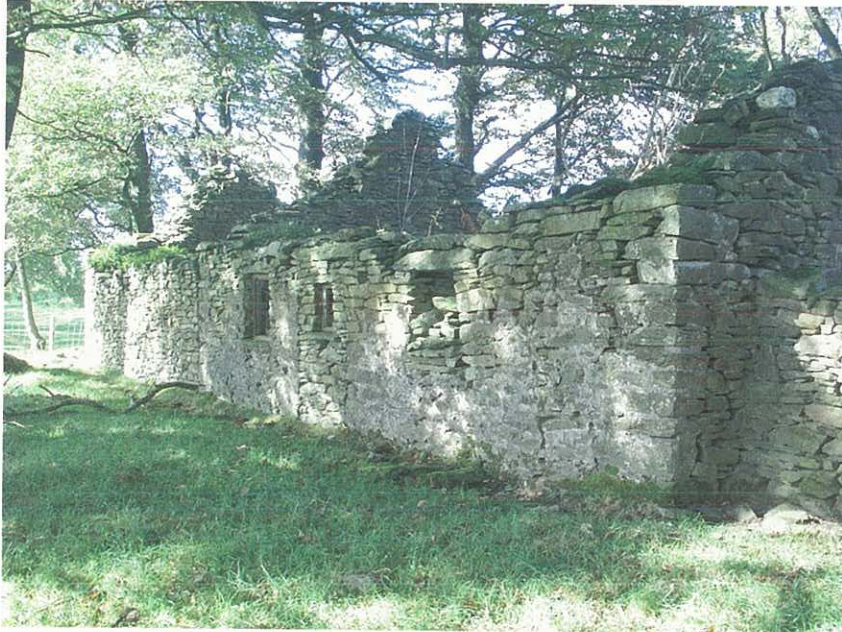
A cottage, named Gwar-drysgol on the 1st and 2nd edition Ordnance Survey maps (1891 and 1906) survives as a roofless shell. The stone walls remain standing to roof height and the plan and many details are still visible. The cottage is aligned northeast – southwest along an adjacent trackway. The cottage and the associated structures are constructed in rubble with roughly hewn stone lintels over the openings and stone sills. Although much of the bonding has eroded out of the walls, there is evidence of lime mortar bonding and a render finish on the cottage. The remains of corrugated iron roofing sheets lie in the northeast extension to the cottage.

The cottage itself is a single cell structure, with the remains of a brick lined bread oven still in place at the northeast gable end. The cottage has a central doorway in the southeast facing elevation which has been partially blocked to create a window. Windows to either side of the doorway have also been partially blocked. An extension to the southwest gable end appears to be a cow shed, accessed by two doorways in the northwest facing elevation, one of which has been blocked.

Since the wall tops have become exposed to the elements much of the mortar bonding has washed out of the walls and they have become unstable. Of most concern is the northwest gable of the cowshed, which is beginning bow outwards. Saplings are also becoming established within the buildings and soon the roots will also destabilise the structure and the branches will dislodge stones on the wall tops.

Prn 47700 – the remains of Gwar-drysgol cottage and cowshed

The owners are anxious to prevent this building from deteriorating further and hope to be able to reuse it in the long term. This would be a very worthwhile undertaking. In order to stabilise the structure the walls need to be consolidated and a roof covering reinstated. However, before a roof is replaced it is advisable to consult with the local planning authority to check if planning permission is required.

In the short term the saplings, which are growing either within or in close proximity to the building, should be cut back and the stumps treated to prevent regrowth. The wall tops should also be capped or covered by a waterproof membrane to prevent further erosion of the mortar bonding. Where the walls appear unstable it may be necessary to install a temporary buttress or prop.

It is hoped that the Royal Commission on the Ancient and Historical Monuments of Wales (RCAHMW) will be able to undertake a record of this building prior to any works being carried out. However, if this is not possible then alternative arrangements for a building record should be made. Please consult with Cambria Archaeology in advance of any works to this structure.

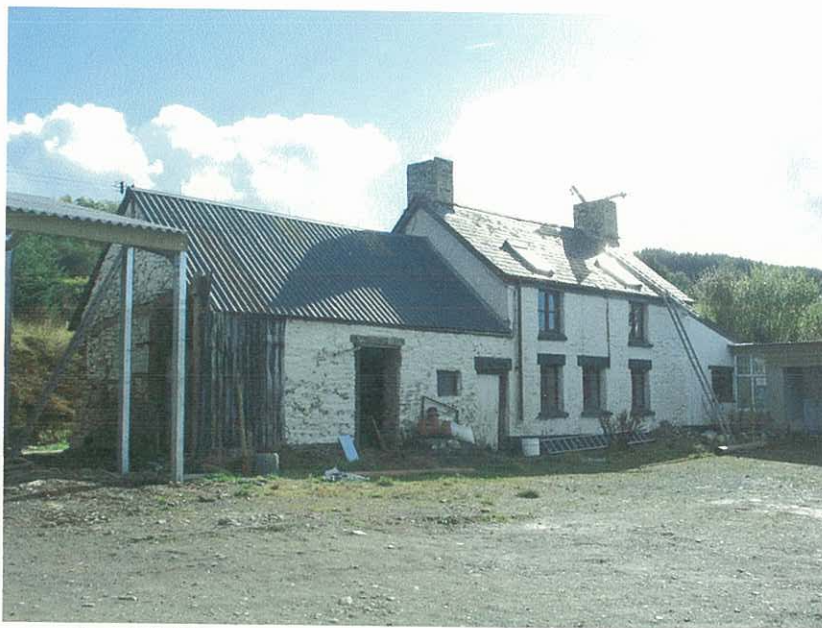
A cow shed situated at the northeast end of the range is constructed with stone rubble walls and a corrugated tin roof. A large modern open sided shed has been erected adjacent to the buildings. The cow shed at Gwndwn-melyn appears to be in a stable condition and weatherproof condition.

Prn 47702 – cottage and cow shed of Gwndwn-melyn

The cow shed at Gwndwn-melyn should continue to be maintained in a weatherproof condition, and any further repairs should be carried out using traditional building materials.

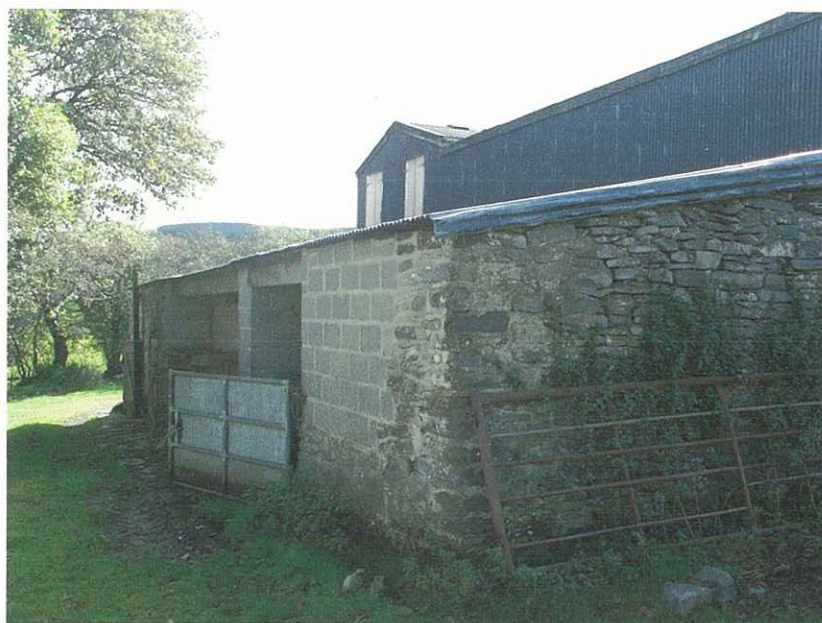
The remains of a cottage, recorded on the 1st and 2nd edition Ordnance Survey maps of 1891 and 1906, now forms a lean-to component to a large modern barn. The cottage, orientated on a northwest to southeast axis, survives in plan with stone walls reaching approximately 2 metres high. A large proportion of the northeast facing elevation has been rebuilt in breeze block. Retained within the early fabric are various features which indicate the form of the cottage and associated buildings. At the southwest end are two low doorways and an exterior paved causeway which suggest its earlier function as a cow shed. Within the centre section, a window opening with stone lintel and sill is preserved.

Gwar-ffynon is currently kept in a weatherproof and stable condition.

Prn 47703 – Gwar-ffynon now forms part of a larger farm building

The remains of Gwar-ffynon, although heavily modified, retains a great deal of its early fabric and much could still be learnt about its history and earlier form. Therefore, the remains of the earlier building should continue to be retained in a weatherproof condition.

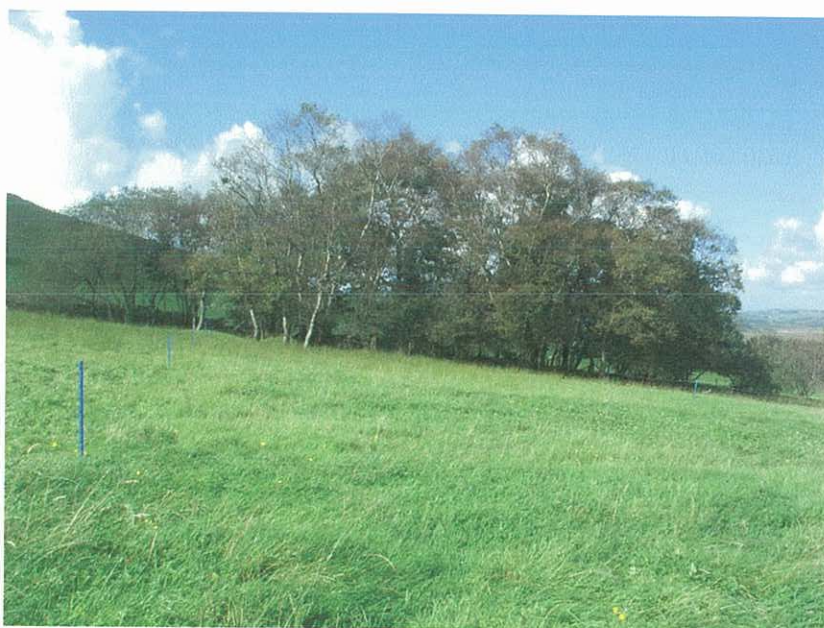
A square enclosure is indicated on the 1st and 2nd edition Ordnance Survey maps of 1891 and 1906. The outline of the enclosure is still visible and the southwestern bank survives in part with overgrown hedgerow trees lining the top of the bank. Within the interior of the enclosure various trees have grown up including birch, holly, oak and blackthorn.

Prn 4470 – the remains of an enclosure are still clearly visible

The remains of this enclosure should be maintained as a visible historic landscape feature.
