Tir Gofal Farm Visit Historic Environment Report

REPORT NO. 2002/58 PROJECT RECORD NO. 44131

Tynygraig
Tir Gofal Farm Visit Historic Environment Report

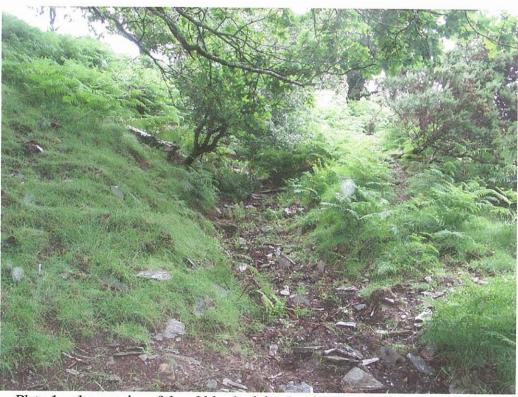
This site is recorded on the 1st edition Ordnance Survey map of 1886 as an "Old Level – Lead". The earthwork remains of a level can clearly be identified, with a characteristic cleft in the natural slope and on the downslope a mound of spoil all of which has become naturalised with vegetation (plate 1). There may be further earthworks associated with this mine which were not identified during the farm visit.

Plate 1 – the remains of the old lead mining level PRN 25831.

This site should be maintained as a visible feature and not in-filled or disturbed in any way. It is currently in a stable condition and should continue to be maintained in its' current condition.

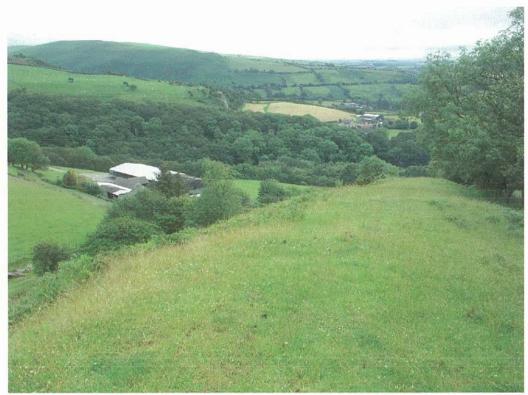
Above the farmstead of Tynygraig, following the line of the natural ridge is what is known locally as the Roman road and is thought to continue to the north east past a farm known as Pen-y-sarn. At ground level the ridge indeed does have the appearance of a trackway with a levelled surface approximately 4 metres across (plate 2). To the west is a hedge line and ditch 1 metre deep. While the route to the north east can be traced and is still defined by a public right of way, to the south, where the ridge drops away to the valley of the Afon Ceulan, the route is less easy to pinpoint.

Plate 2 – the course of a possible ancient trackway (PRN 44993)

Whatever the origins of this route it would appear to be of some antiquity and should be managed to retain it's character and form. Therefore no ground disturbing activities should be undertaken along its' course and the route should be retained as a visible landscape feature.

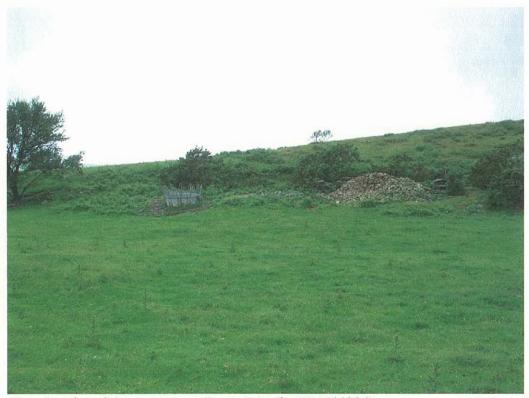
The remains of the settlement are still discernable and the outlines of two buildings are defined by stone rubble walls (plate 3). The buildings appear to be positioned in the lea of the ridge to the west, with the back walls standing to a height of 1.5 metres in places. The front, east walls are much degraded and are visible only as low earth banks. The buildings are currently being used as the location for a ring feeder and also as a stone dump. The outline of the settlement which can be seen today does not completely correspond with that recorded on the tithe map, which suggests that there may be other remains which lie below ground level and are currently invisible. The remains of these cottages are evidence of a settlement which appears to have been deserted for around 100 years.

Plate 3 – site of the cottages at Pant y Moelin (PRN44994)

These early structures should be retained as historic features. To help preserve these features the ring feeder should be relocated well away from the settlement to prevent erosion by animals gathering in this location. It is also advisable that the stone stored within the walls of the other structure is carefully removed.

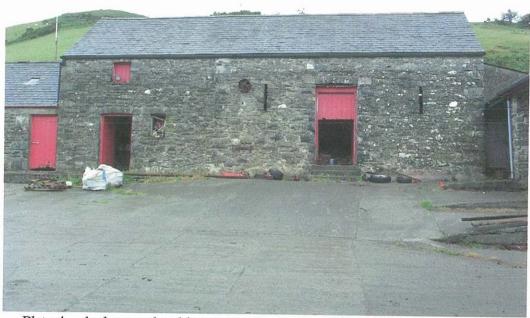
A barn is situated to the north east of the farm yard, constructed with squared stone quoins, with a central single width doorway and a ventilation slit to either side (plate 4). The doorway, entered by three steps is constructed with a flat stone arch. Characteristically an opposing doorway is situated in the north east wall, likewise centrally positioned between two ventilation slits. The roof, which is pitched slate, has been renewed approximately 10 years ago (Mr. Jenkins, pers. comm.). High in the south west elevation is a fly wheel connected to a drive shaft that still runs along the interior of the north gable wall. This was powered by a small engine which was located within a shed along the south west wall and has now been removed. Internally the barn is used as a workshop. This building appears to relate to that which is indicated on the tithe map of 1847.

At a later stage a two-storeyed stable has been added on to the north east gable end. The stable is constructed in a similar style to the adjoining barn although the stonework is more slatey. It has a doorway with a small square window to the south and a pitching door on the first floor. Internally there is a transverse wooden feeding rack and concrete manger, and one wooden stall partition surviving. Beside the doorway along the gable wall are harness hooks with various harnesses.

Plate 4 – the barn and stable range at Tynygraig (PRN 44996)

The barn and stable should continue to be maintained in good condition, using sympathetic materials. The existing internal fixtures and fittings should be retained if possible.

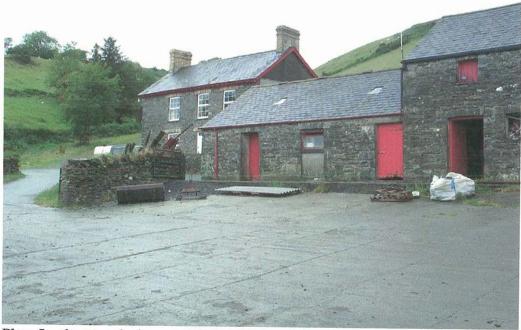
Adjoining the stable to the north west is a low range of cow sheds, apparently a later addition to the stable (Plate 5). Three doorways survive in the south west elevation; the central doorway has been partially blocked to create a window and the southern doorway has a later concrete lintel. The interior was not seen during the farm visit.

Plate 5 – the cow shed range (PRN 44997) with farm house beyond

This building, in common with the adjoining stable and barn, is in good condition and should continue to be maintained using appropriate materials.

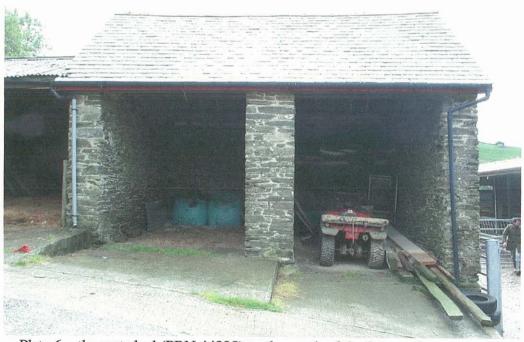
To the south east of the farmyard, at right angles to the barn range (PRN 44996 & 44997) is a rubble built stone cart shed, with a pitched slate roof (Plate 6). The north west facing elevation has two large cart entrances open to the eaves with a square stone pillar dividing them. The cart shed is in good condition and is in use as a store.

Plate 6 - the cart shed (PRN 44998) to the south of the farmyard

This building, in common with the other farm buildings, is in good condition and should continue to be maintained using appropriate materials.

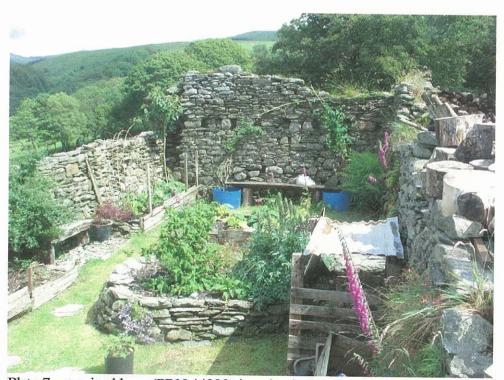
To the south of the farmstead of Gwar-cwm-uchaf are the remains of a building, situated to the east of the track on a north west-south east axis (Plate 7). The roof no longer survives and the walls have reduced from their full height. The south eastern gable stands to a height of approximately 2.5 metres and within the internal elevation are a series of sockets which indicate the position of joists for a first floor. Only evidence for one doorway remains, that is situated centrally in the south western lateral wall. This building has been turned into a sheltered walled garden, and although the wall-tops remain uncapped they appear well maintained and stable. The interior now holds a series of stone built raised beds and cold frames, with steps leading down from the doorway into the interior. It is unclear whether these steps are original or a more recent feature.

Plate 7 - a ruined barn (PRN 44999) imaginatively reused as a garden

This building has been reused imaginatively and although it is technically a ruin, it appears well maintained in its' new role as a walled garden. It should continue to be maintained in a stable condition.

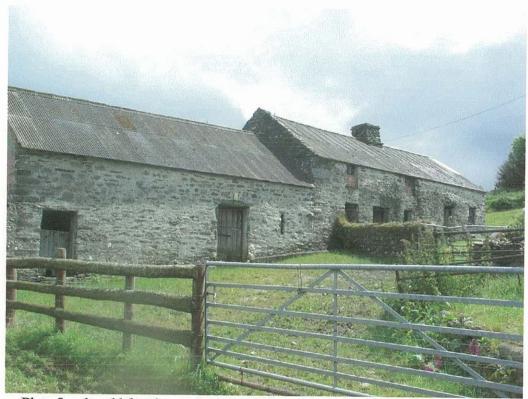
A small two storey farmhouse at Gwar-cwm-uchaf has been converted into a hay barn (Plate 8). It is situated across the slope, on a north south axis. The building consists of two major elements, at the top of slope (to the south) is the domestic range. At the lower end of the slope is a barn (PRN 45007). The domestic range is subdivided into two units, with a large central fireplace and square central chimney. Internally the south domestic end consists of an inglenook fireplace with a large timber lintel, with a stone winding stair at the side. The remains of a blocked doorway can be seen in the wall to the west of the fireplace and two existing doorways are located in the west and east elevations. There is only one window in the west elevation and a louvred vent in the gable end. The floorboards and joists have been removed to allow storage for hay but the beams survive.

To the north is a further two storey unit which has a fireplace in the north wall (external chimney has been removed). A central doorway is flanked by windows either side which are repeated in the second floor. A wooden feed rack and manger now occupy the east lateral wall divided into two by a wooden stall partition. The second floor has also latterly been used for hay storage.

The farmhouse is constructed out of rubble stone walling and pitched corrugated asbestos roofing. The building appears to be in a stable condition and have been well maintained.

Plate 8 - the old farmhouse (PRN 45000) and barn (PRN 45007) at Gwar-cwm-uchaf

The owners hope to restore the farmhouse back to a domestic use with the possibility of letting to holiday makers. This would be a very worthwhile undertaking. Such works are believed to require planning consent. The conversion back to domestic use should be carried out in a sensitive manner using traditional materials and retaining as much of the historic fabric and the integrity of the existing openings as possible. The Royal Commission on the Ancient and Historical Monuments of Wales (RCAHMW) has apparently already undertaken a survey of part of the building. However, it is essential that a record is made of all those areas which are to be affected by the restoration, including the fixtures and fittings which may relate to its' later agricultural uses.

Please contact Cambria Archaeology to discuss proposed works for this site in detail.

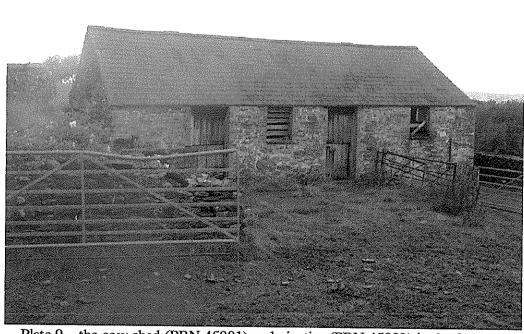
To the west and opposing the barn and farmhouse range (PRNs 45000 & 45007) is a small cow shed built in uncoursed rubble with brick dressings (Plate 9). There are two doorways in the east facing elevation with windows to the north of the doorways. The roof is pitched and slate covered. Internally is a lateral feed passage with concrete and brick stalls.

Plate 9 - the cow shed (PRN 45001) and pigsties (PRN 45002) in the foreground

To the south east of the cow shed (PRN 45001) and at right angles to it, are a pair of pigsties (Plate 9). The sties themselves seem to have collapsed and none of the roof structure survives. The yard walls remain and the openings survive although the interior is rather overgrown. The pigsties appear to be constructed out of rubble stone walling except where the dividing wall has been rebuilt in brick.

The cow shed should continue to maintained in its' current condition.

The pigsties are gradually becoming overgrown. Ideally the vegetation should be cut back, and if possible the roots should be removed unless this will cause damage to the masonry.
