# **Nantyrodyn E/10/3503**

## **Tir Gofal Farm Visit Historic Environment Report**

Report No. 2003/116

REPORT NO. 2003/116  
PROJECT RECORD NO. 44138

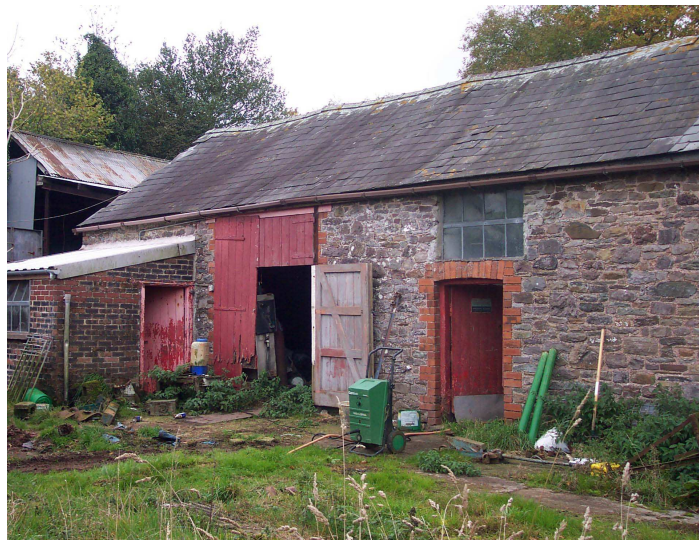
This building is now in a poor condition. The roof is the principal area of concern. Several slates are loose, and large holes have appeared above the cow shed. Water ingress is promoting rot in the roof timbers. The historic appearance of this building remains largely intact. It makes an important contribution to the group value of the farmstead and should be preserved.

Plate 1- front elevation of the combination farm building (PRN 49228) at Nantyrodyn farmstead.

A preliminary archaeological record was made during the call out visit. This comprised notes, an annotated sketch plan and some digital photos. It is recommended that further recording should be made before and after any restoration works in order to enhance the existing record of the structure. Some guidelines on the general photographic survey of buildings are attached.

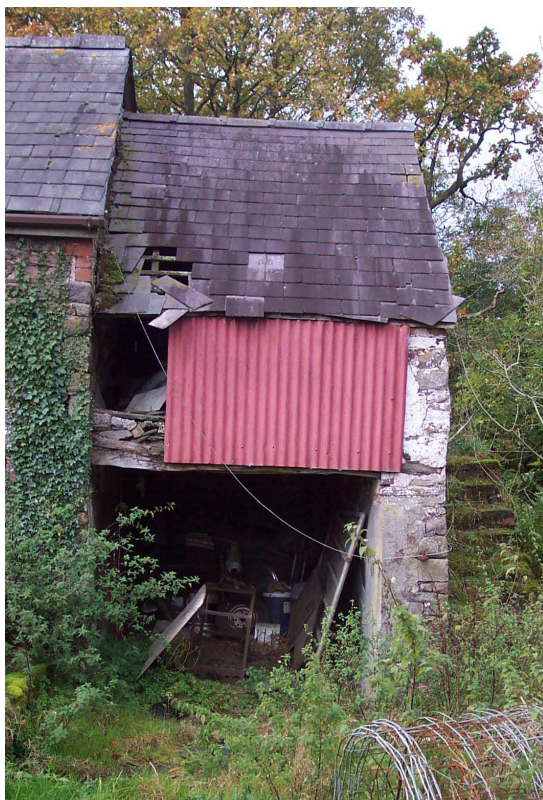
It is currently in a poor condition. Some roof slates have become displaced and are exposing the roof timbers, which are showing signs of rot.

The significance of the cart shed as a historic buildings in its own right is added to by its contribution to the group value of the farmstead as a whole. It would be a great loss if it were allowed to deteriorate further.

Plate 2- the cart shed (PRN 49229) at Nantyrodyn farmstead

A preliminary archaeological record was made during the call out visit. This comprised notes, an annotated sketch plan and some digital photos. It is recommended that further recording should be made before and after any restoration works in order to enhance the existing record of the structure. Some guidelines on the general photographic survey of buildings are attached.

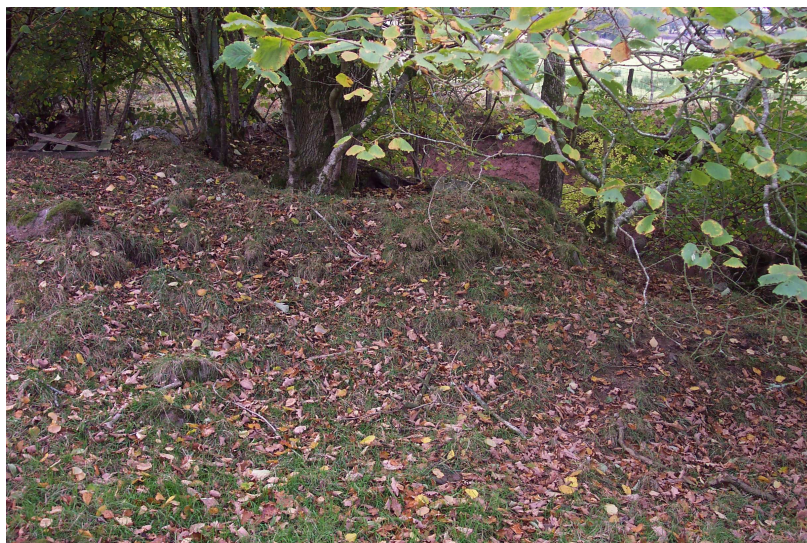
It is well preserved and mostly in a stable condition. The kiln pot remains open to a depth of about 0.5m, with the internal stone lining apparently stable. The drawing hole has slumped slightly although this also remains clearly visible. The site lies at the western end of a small fenced enclosure, which is used occasionally as a holding pen for sheep. It is periodically grazed and was under a stable grass sward at the time of the archaeological farm visit. No specific threats were observed from the current management regime, although some trees have become rooted around the site. A mature ash occupies the centre of the kiln pot, and appears to be stable, with no risk of falling in the foreseeable future. Some younger trees are also rooted in the body of the kiln. Most of these pose no significant threat. The largest threat is through scouring during flooding, which is gradually undermining the west side of the structure. A young tree, leaning outwards here, threatens to uproot this part of the kiln if it is not prevented from falling naturally.

Plate 3- the limekiln (PRN 49231) at Nantyrodyn farmstead.

The kiln would benefit from some active management of the tree growth around the site. The unstable young tree growing out of the western bank of the structure should be cut off above the roots and spot treated to prevent re-growth. This will prevent uprooting from damaging this part of the structure. Ideally the other young trees should also be removed and treated. This will enhance the visibility of the site and reduce the risk of future damage through root growth or falling trees. Mature trees should be monitored for signs of instability.

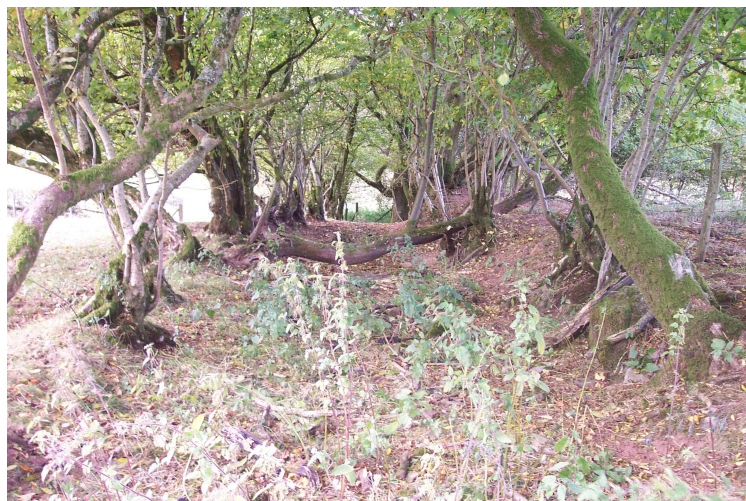
Plate 4- trackway PRN 49764 leading west from Llethr-Mawr farmstead.

The field boundaries, which line this trackway should be maintained in a sustainable manner.

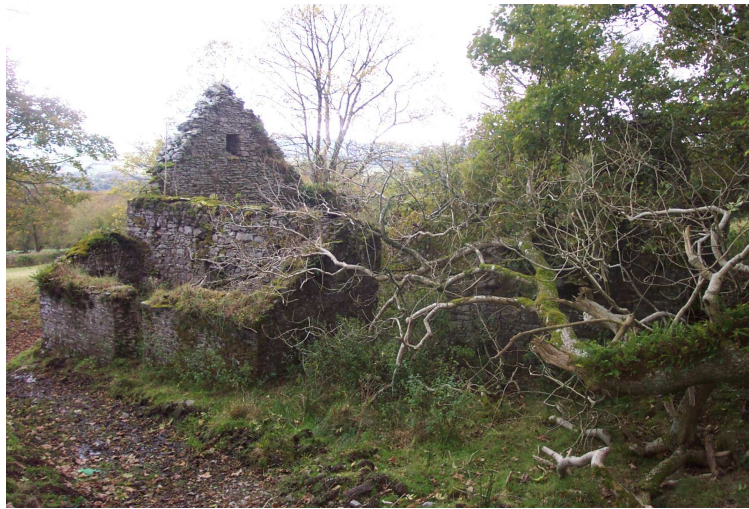
Plate 5- combination farm building (PRN 49767) and lean to (PRN 49768) at Coed-y-brain from the northeast.

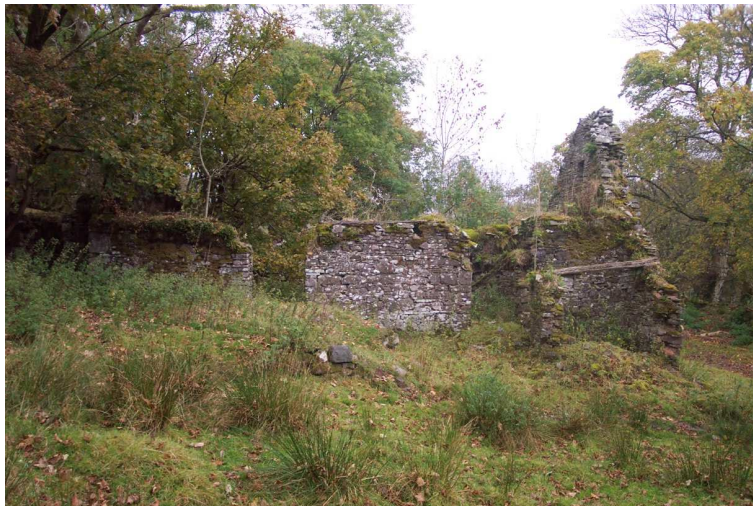
Plate 6- combination farm building (PRN 49767) and lean to (PRN 49769) at Coed-y-brain from the west.

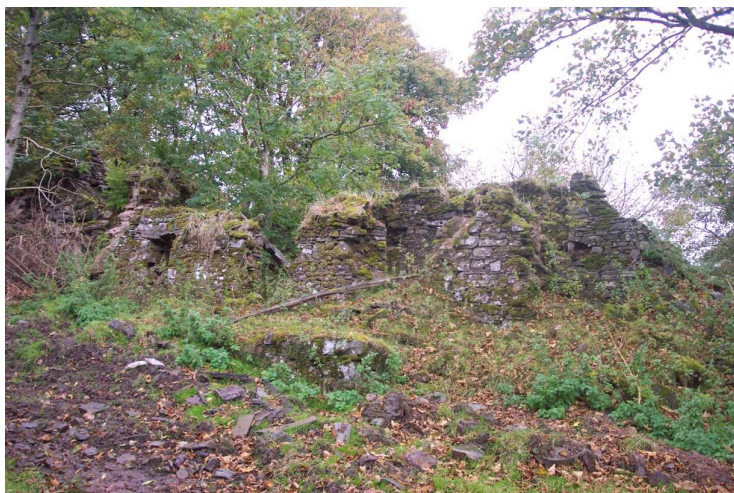
Plate 7- front (west) elevation of the farmhouse (PRN 49772) at Coed-y-brain farmstead (PRN 49766)

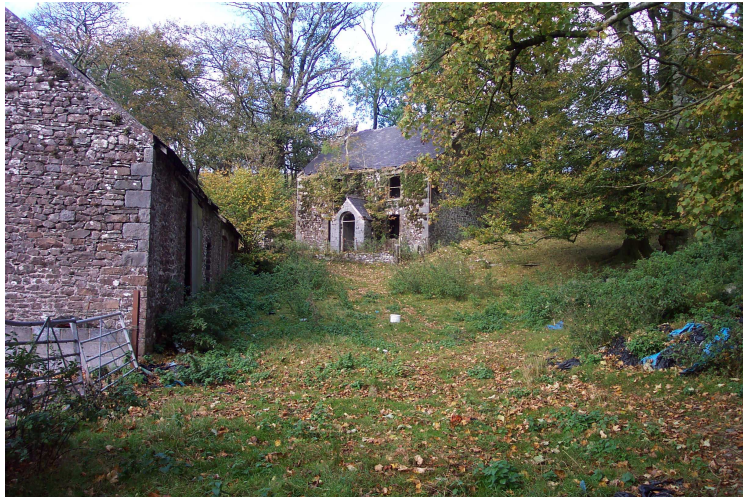
The farmhouse is now derelict and falling into disrepair. Several of the roof tiles are missing and water ingress is promoting rot in the roof timbers and floor joists, as well as washing out masonry bonds in the exposed wall tops. Vegetation growth is an increasing problem and ivy has become established around the façade. This threatens to erode lime mortar masonry bonds and de-stabilise masonry. Some young trees have become established in the wall tops. The combined threats of root growth and added weight are potentially damaging to structural integrity. A fallen tree to the rear of the house is leaning on the roof, adding weight to the structure.

The farmhouse makes a fundamental contribution to the group value of the farmstead. It would be a great loss if it were allowed to deteriorate further.

Plate 8- the farmhouse (PRN 49775) and agricultural buildings (49776, 49777) at Ty Ucha farmstead (PRN 49774).

Ideally, the farmhouse should be brought back into a stable condition necessary for its long-term survival. Materials used should be compatible with those of its original construction.

If restoration works are not to be undertaken, then future management should aim to slow down the process of building decay. Vegetation growth on the structure should be controlled. Ivy and other vegetation growth, which is potentially damaging to masonry bonds should be cut off at the roots and spot treated to prevent re-growth. The fallen tree at the rear of the building should be cut off at the roots in order to relieve the weight on the roof structure. The trees, which surround the site, should continue to be monitored for signs of instability in future.

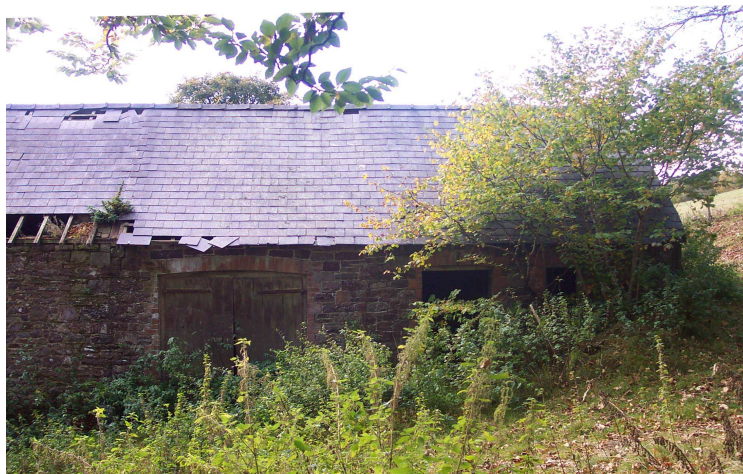
Plate 9- combination farm building PRN 49777 at Ty Ucha farmstead (PRN 49774)

The building, which does not appear to have been used recently remains in a reasonable condition. The roof is a concern, however and slates are missing from the eastern pitch. It is no longer weatherproof and water ingress is promoting rot in the battens. Young trees are growing out of the wall footings in the northeast corner of the building. These are potentially threatening to the structural integrity of the walls.

The building fell out use long ago and does not appear to have been modified from its original appearance. It makes an important contribution to the group value of the farmstead and should not be allowed to deteriorate further.

The landowner has expressed a desire to replace slates and roof battens on the eastern pitch of the roof. The building makes an important contribution to the group value of the farmstead, and this is to be welcomed. It is important that materials and techniques used are compatible with those of the original construction. The original roof timbers should be retained as far as practically possible.

A preliminary archaeological record was made during the call out visit. This comprised notes, an annotated sketch plan and some digital photos. It is recommended that further recording should be made before and after any restoration works in order to enhance the existing record of the structure.

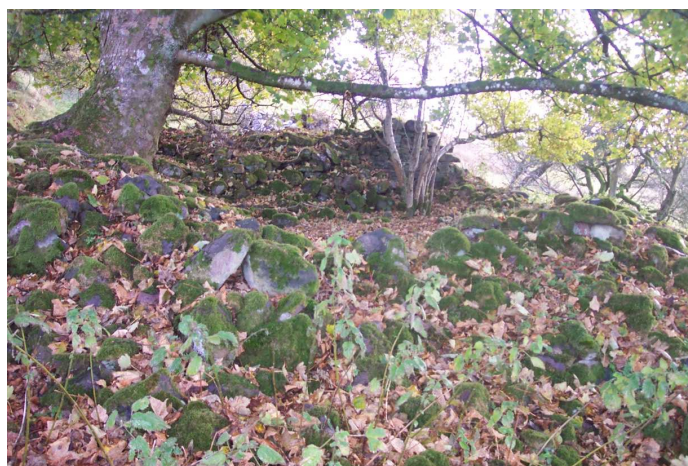
Plate 10- Pant-yr-arw cottage (PRN 49779), looking south.

The remnant walls of the cottage should be retained as a feature of the historic landscape. No ground intrusive activities should be undertaken within 5 metres of any built structural remains. Vegetation and tree growth should be controlled in order to prevent it from obscuring the site.
