Geufron W/11/2896

Tir Gofal Farm Visit Historic Environment Report

Report No. 2002/113

Geufron
Tir Gofal Farm Visit Historic Environment Report

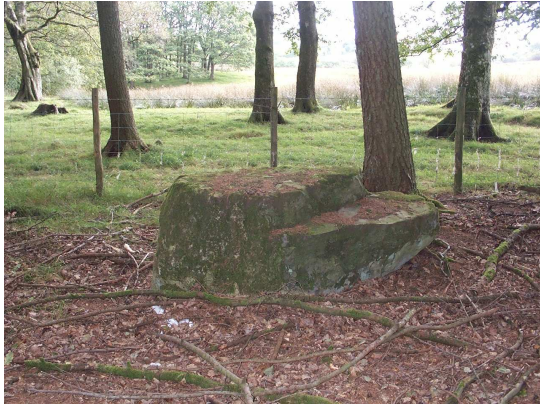
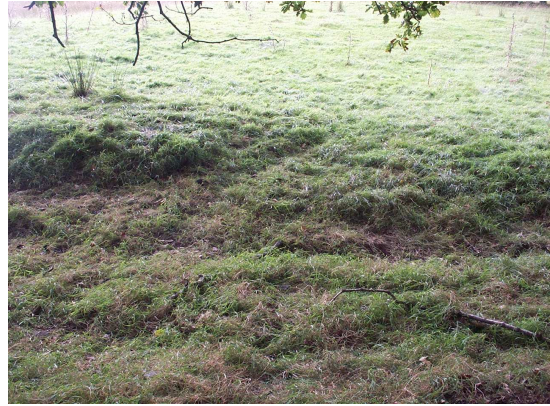
The standing stone was moved from its original position into the immediately adjacent trackway by the previous landowner. It was subsequently moved from this position by the current owner who moved it out of the way of the track and into its current position in the woodland to the northeast. The socket for the original location of the standing stone is still visible and is approximately 2 metres in diameter and about 0.2 metre deep.

Prn 5481 – Carreg Samson (left), lies recumbent in woodland adjacent to the its original location (right)

The current owner has expressed an interest in restoring the standing stone to its original position. This could be an interesting and potentially educational undertaking. It would, however, be necessary to take certain steps to ensure that archaeological deposits were fully recorded during such an undertaking.

A. The stone could be taken back to its original location and laid on the ground surface in a recumbent position. This course of action should not require any ground disturbing activities and could be carried out with minimal archaeological supervision.

B. Alternatively the stone could be fully restored into an upright position in its original location. In order to give the stone some stability and prevent it from keeling over the existing socket would need to be deepened to some extent to allow the stone to be dropped into an upright position. This would have to be undertaken by hand and with the supervision of an archaeologist. Excavations of the area surrounding standing stones have been found to be extremely archaeologically sensitive often with traces of pits, structures and even burials, therefore any ground intrusive activity in this area would have to be carried out with an archaeologist present in order to record archaeological deposits that may be uncovered. The standing stone appears to have a fairly blunt base which would allow it to stand in an upright position with a fairly shallow socket.

Any undertaking to move the stone must be extremely mindful to prevent any damage to the stone itself. If either of these courses of action are being considered please contact Cambria Archaeology at the outset to discuss these options further and to make adequate provision for the

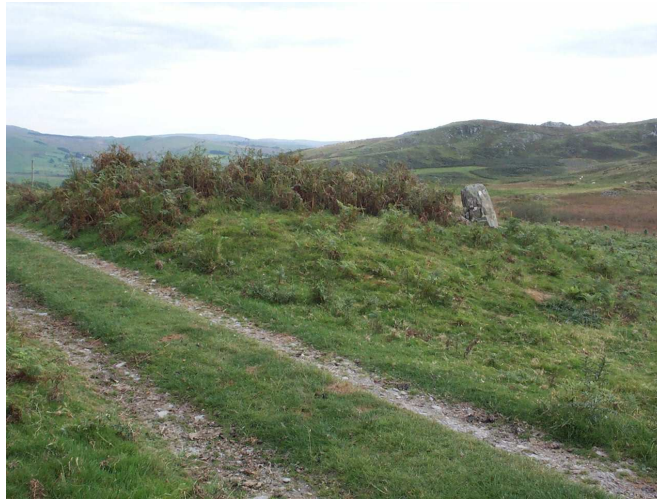
A burial cairn with the burial cist still surviving. The cairn mound is c.12m in diameter and up to 1.2m high. A stone kerb can be seen around the edge of the cairn.

When the cairn was visited in autumn there was a great deal of bracken growing within and on top of the monument. A trackway also runs immediately across the northern limit of the monument.

Prn 5486 – a bronze age cairn lies adjacent to a trackway

Recent studies on the effects of bracken cover on archaeological deposits reveal that this type of vegetation cover can be significantly damaging to sensitive below ground deposits. The roots system or rhizomes which are generated by bracken, have been shown to break up subsurface archaeological layers. In order to protect this site from further damage by the effects of bracken growth efforts should be made to discourage bracken and to return the site to grass cover. This may be achieved by spraying with a suitable herbicide, or by crushing the young vegetation growth in summer. In no circumstances should the bracken be pulled up or any mechanical means used to remove the vegetation.

Care should also be taken that no damage to the cairn is sustained by vehicle traffic using the trackway to the north.

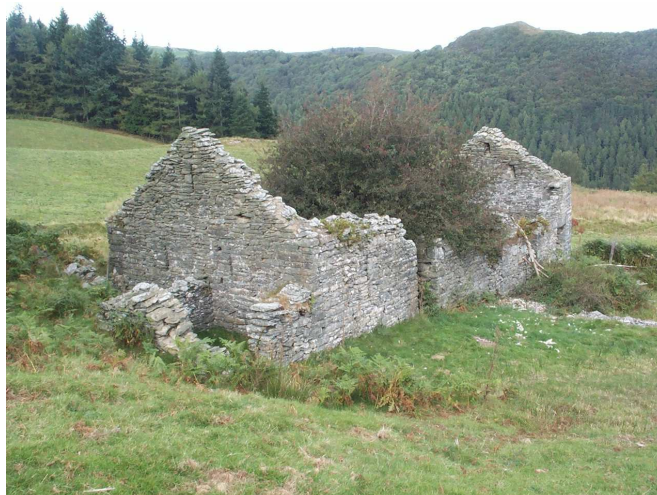
The range is an impressive two-storey building, positioned across the slope on a north-northeast to south-southwest orientation. The building is constructed in stone rubble walling, although no roof survives the walls stand almost to full height in most places. The openings are finished with flat stone arches.

Without its roof this farm building is in a vulnerable condition. The walls will not stand for long without protection or the infrastructure of the roof and floor to tie the building together. In addition a tree grows within the building.

*Prn 9380 – a substantial stone farm building lies to the north
of the farmstead of Cil-meddu*

Ideally this farm building should be either consolidated to retain as much historic fabric as possible or preferably brought back into use. However, it is acknowledged that this is probably not economically viable and therefore unrealistic at present. In order to slow the decay of this structure it is suggested that branches which overhang the wall tops and dislodge masonry are cut back.

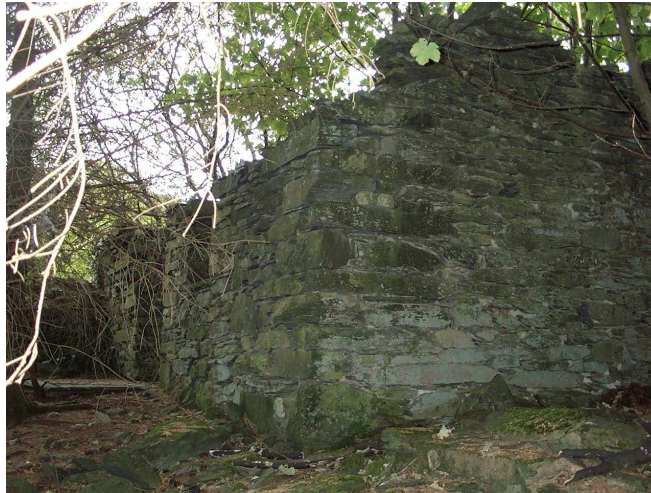
The cottage survives as a roofless ruin although the walls stand to a considerable height; the north gable stands approximately 2.5 metres. The cottage is built across the slope, on a north-northeast to south-southwest orientation. A doorway is provided with a substantial slate threshold on the east wall, with windows to either side. The fireplace was situated in the southern gable and a further doorway is situated in the west wall into a small outshoot thought by the owner, to be the dairy. Sockets for a loft are visible in the north gable end. Against the north end are traces of a further outshoot, accessible only from the exterior east side, the owner relates that a peat stove was housed here, used for boiling potatoes.

The cottage is situated within a fairly dense area of woodland and some self seeded trees have grown up within the cottage walls.

Prn 9381 – the remains of Cil-meddu cottage survive in a small pocket of woodland

This cottage is a reminder of the changing agricultural landscape and an important relic of past, made more poignant because of the sad tale of the last family to live there. In order for it to survive as a visible historic feature ideally some of the overhanging branches and the trees which grow within close proximity should be thinned out, taking care not to damage the wall tops and upstanding masonry.

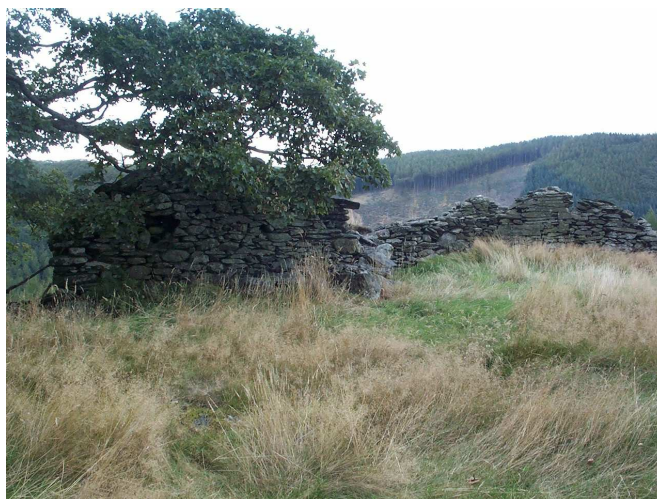
The rubble stone walls stand up to a height of approximately 2 metres at the their highest point on the gable walls.

Although ruined these buildings appear relatively stable and under no immediate threat, however the wall tops are exposed and much of the bonding material has been washed out

Prn 9382 – further remains of buildings associated with the farmstead of Cil-meddu survive as stone ruins

In their current state this small complex of buildings appears relatively stable, although exposed as they are, they will gradually deteriorate. So far as possible, the remains of these buildings should be maintained in their current condition and stone which falls from the wall tops should be replaced.

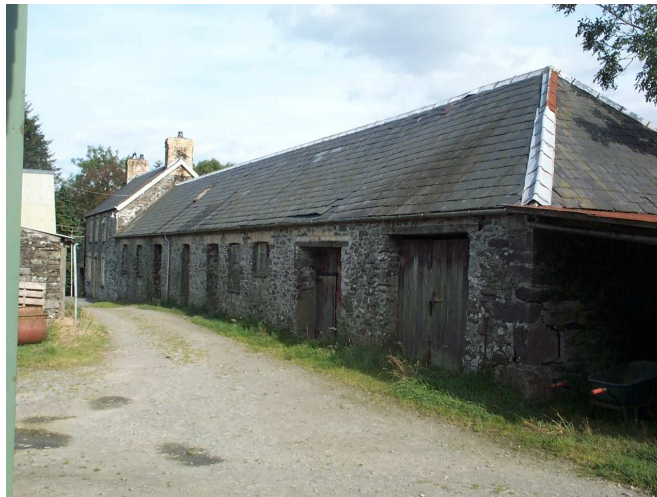
A low one-storey range of buildings approximately 27 metres long, is situated against the southwest gable of the farmhouse. The building is constructed with rubble stonewalling, and yellow brick dressings for the lintels. The pitched roof is hipped at the southwest end and covered with slate. Lead sheeting has been used to cover the roof ridges. The openings are situated in the northwest facing wall with two double sized doorways at the southern end; the second to last appears to have been a later modification. Adjacent to the cart shed is what may have been a stable, served by two doorways and a window. This interconnects with the room to the northeast, served by a single doorway. A cow shed with three doorways is visible at the end closest to the house. Within the cow shed part of a cobbled floor is still visible, however it has latterly been modified to have four bays of concrete stalls situated along the length of the building.

This building is of historic interest; it is largely unaltered and forms a vital part of the historic core of the farmstead. The building appears to be in a reasonable weatherproof condition. The

roofing slates are largely intact although some appear to have slipped.

Prn 48695 – Geufron farmstead incorporates a fine range of buildings including a cow shed and cart shed

This farm building should continue to be maintained in a stable condition using materials and techniques which respect those used in the original construction.

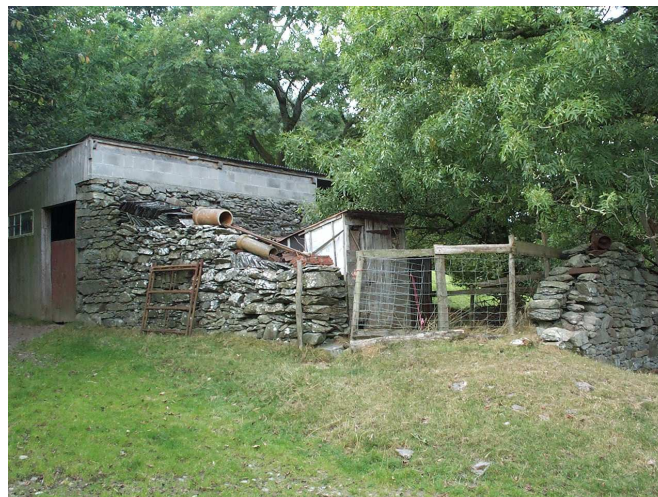
Situated to the west of the main farmstead, across a stream feeding into the Nant Cilmeddu, are the remains of a former farmhouse. This house was apparently still standing when the current owners grandfather came to Geufron in the 1890s. What survives of this building is now incorporated into a small enclosure with the highest back wall forming part of a modern timber lean-to barn. This wall survives to a height of approximately 3 metres and still incorporates the remains of the chimney; the wall top is now capped with breezeblock. The walls are rubble construction with roughly dressed local stone quoins.

Prn 48697 – the old farmhouse is now used as a small enclosure

This building is currently in a stable condition as it is still in use as an enclosure. The building should continue to be maintained in this state. If any ground intrusive work is considered within the building please inform Cambria Archaeology.

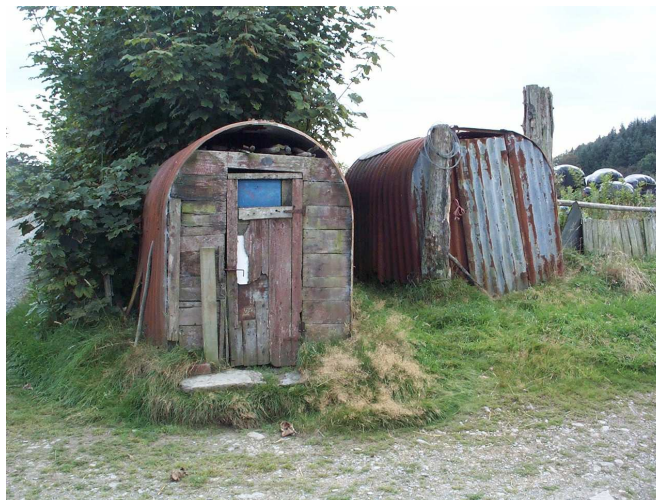
At the end of the farm track and to the southeast of the farmstead at Geufron, is a pair of air raid shelters. They are simple timber and corrugated iron structures. They are not *in situ*. One of the shelters has a plaque above the timber door which reads;

Prn 48698 – a pair of former air raid shelters have been reused as sheds at the farmstead of Geufron

These buildings are temporary in nature, however if possible they should be retained.

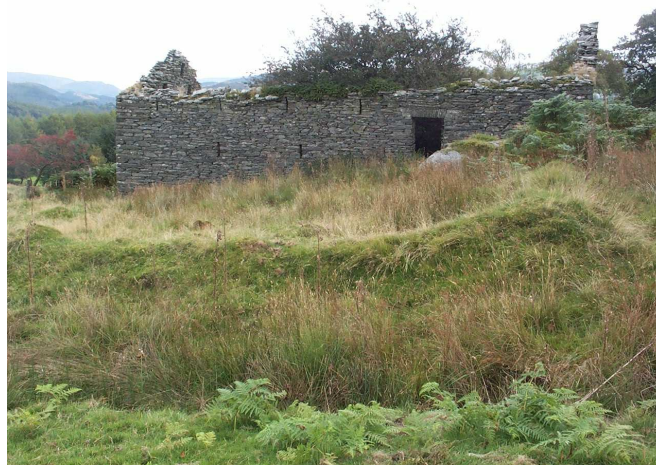
To the west of the farm building Prn 9380 is a rectangular yard, surviving now as low turf covered banks, no more than 0.5 metre high. The yard appears to be the same width as the farm building and extends approximately 20 metres to the west. Within the yard are a number of circular mounds, apparently stands on which to build the ricks or ‘helms’.

Prn 48699 – to the west of the farm building at Cilmeddu is the outline of the old rickyard, within it raised areas indicate the location of the individual ricks themselves.

The rickyard and the helms within it should be retained in their current condition as a visible historic landscape feature.

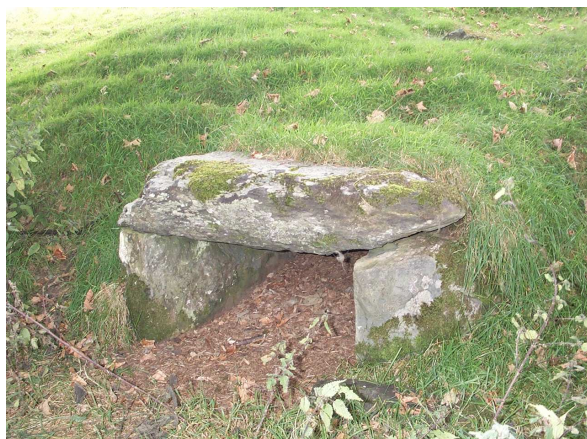
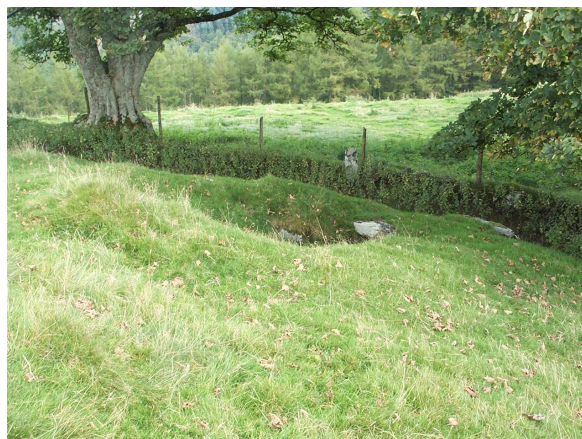
To the west of the farmstead of Cil-meddu is a rather remarkable and rare feature. A corn drying kiln or 'odyn' is situated on a northeast facing slope. The feature is a low circular stone built structure, the depression in the centre is approximately 4 metres in diameter, bounded by a turf covered bank, approximately 0.5 metre high, which slopes away gently to either side. A flue, capped and lined with stone is approximately 1.2 metres wide at its entrance at the exterior of the feature.

The kiln appears to be in a stable condition situated in a field of permanent pasture.

Prn 48700 – this corn drying kiln is a rare survival of a once commonplace feature. To the left, positioned at the lowest part is the entrance to the flue, lined with stone slabs. To the right is a view of the extent of the feature.

Any ground intrusive activities should be avoided in this area, or any activities which might cause erosion. The site should be monitored for animal erosion or burrowing. Happily there appear to be no threats to its continued survival at present.

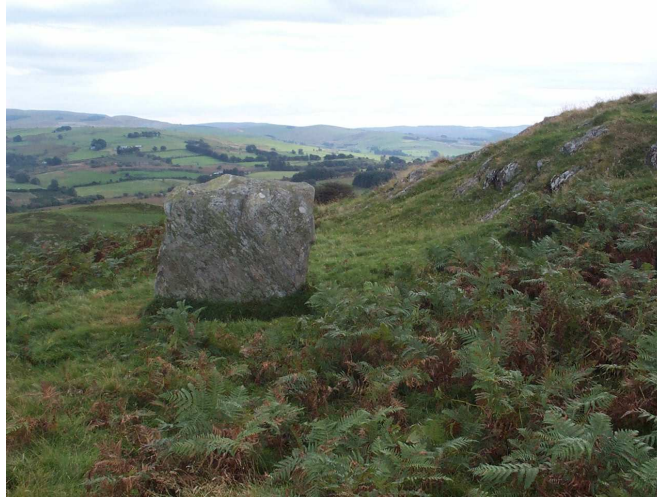
The stone appears to be in a stable condition, surrounded by a permanent pasture.

Prn 48701 – a large standing stone is located just below the brow of the hill

This standing stone, whatever its origins, should be retained as a visible landscape feature. The current land use for the area as grazing is ideal and should be continued. The stone and the surrounding area should not be disturbed in anyway.

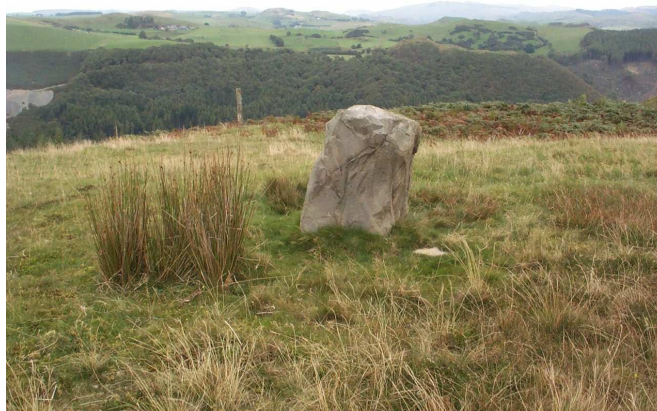
Prn 48702 – a small square standing stone is located on the summit of a spur below Mynydd Bach

The stone is in a stable condition; the surrounding land use of permanent pasture is ideal. The management regime should be maintained as existing. The stone and the surrounding area should not be disturbed in anyway.

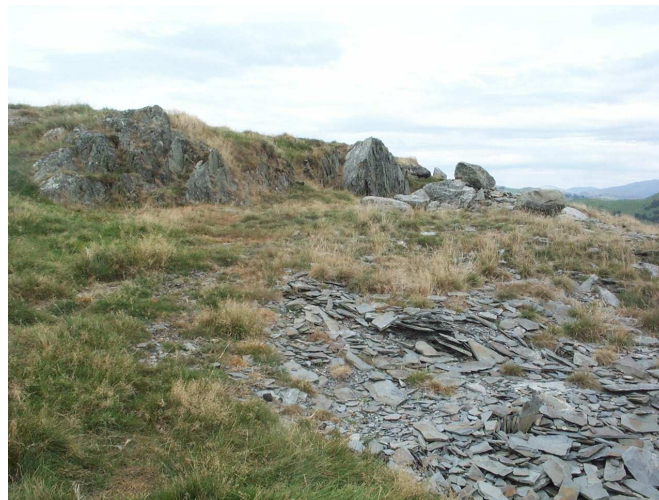
*Prn 48703 - this quarry, which was in use in the 19th century,
produces stone roofing slate*

The slate quarries should continue to be maintained in their current stable condition.

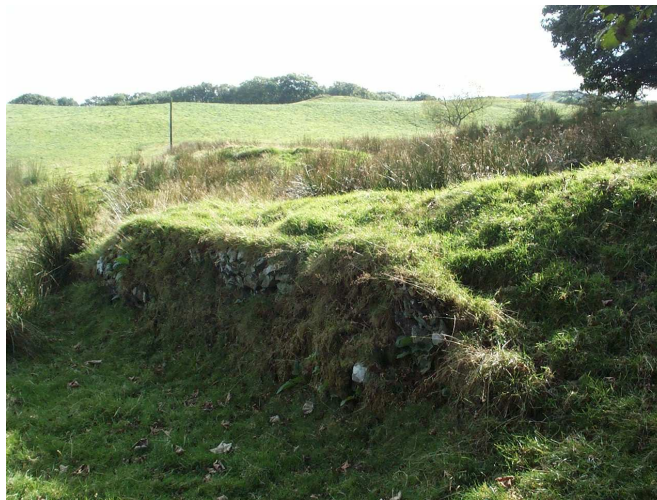
Prn 48704 – traces of stone buildings survive in a small triangular enclosure at Geufron Uchaf

The remains of the farmstead of Geufron Uchaf appear to be in a stable condition. The area within the enclosure which retains surviving low walls should be left undisturbed and lightly grazed in order to prevent dense vegetation encroachment.
