# **CILRATH FACH W/13/2784**

## **Tir Gofal Farm Visit Historic Environment Report**

Report No. 2002/64

CILRATH FACH  
Tir Gofal Farm Visit Historic Environment Report

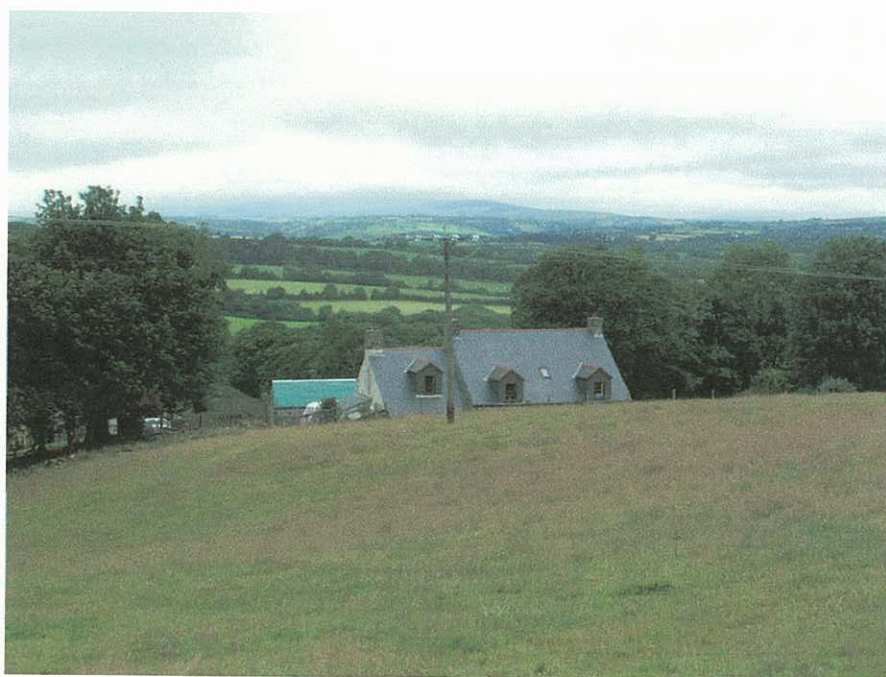
*Fig. 1: Cilrath Fach farmhouse from rear with the Preseli Hills to the north.*

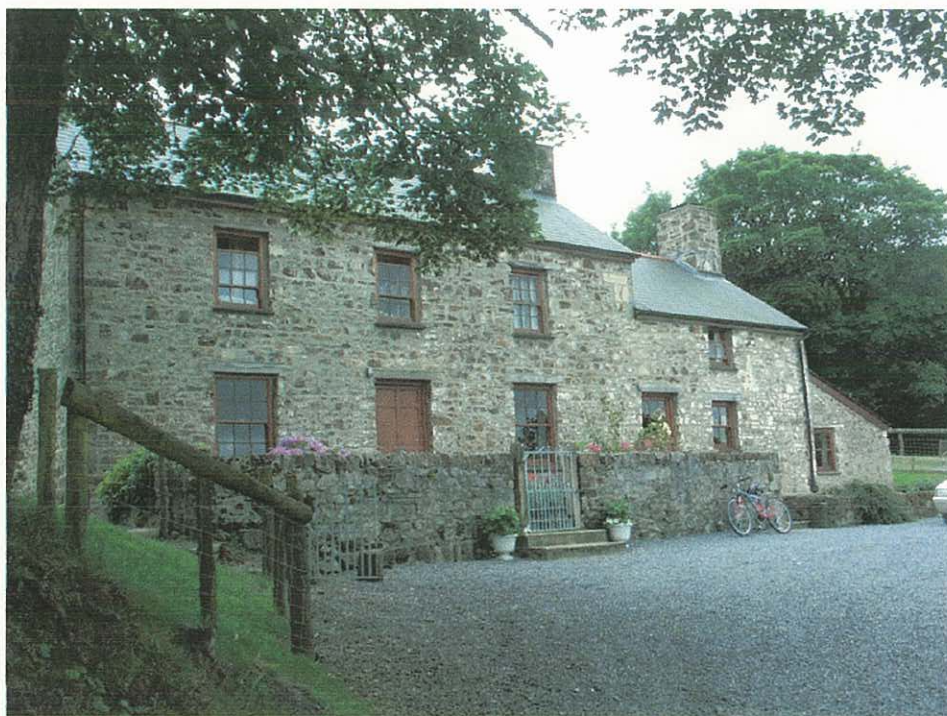
The farmhouse at Cilrath Fach was Grade 2 Listed in conjunction with its associated outbuildings. The listing schedule describes the house as being an excellent example of early or mid-19th century West Wales rural vernacular farmhouse. The house has however been substantially renovated in recent years, but its essential character has not been diminished greatly, particularly with regard to the front elevation.

*Fig.2: Cilrath Fach Farmhouse front elevation*

No specific recommendation

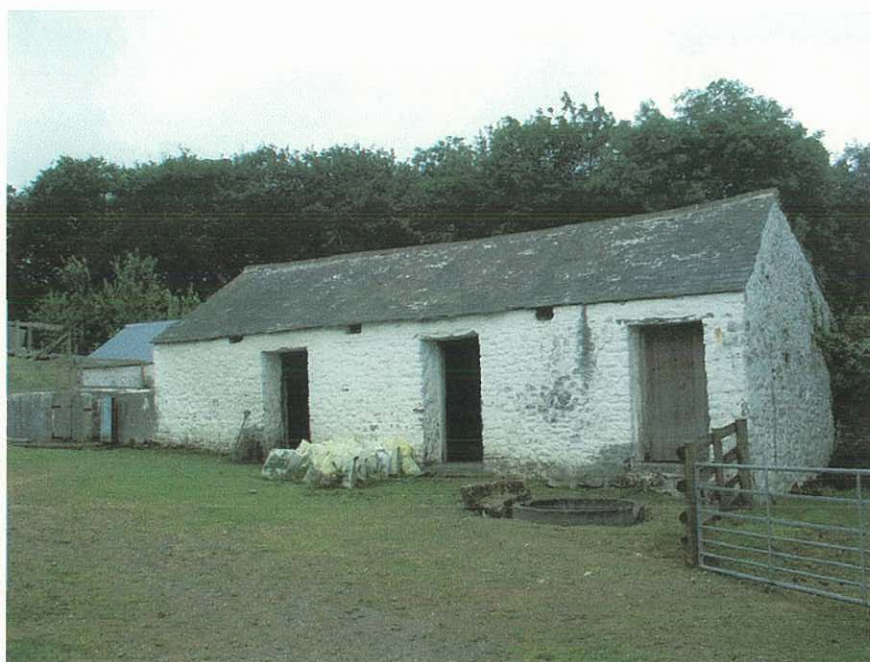
"Early- mid C19 cowhouse. Limewashed rubble masonry. Later moderately pitched slate roof. 3 doorways, offset to right. Timber lintels. Central transverse feed passage with door in rear elevation. Ventilation slits to right end elevation. Ruined cartshed attached to right end. Two box, pound and run pigsties to left end. Gabled corrugated iron roof. Entrances to centre, collapsed run walls."

*Fig.3: Front elevation of cowhouse viewed from the north-east.*

The 2002 Tir Gofal visit ascertained that some restoration and repair work has occurred to the pigsty (PRN45434) and that the cartshed remains in a ruined condition. With regard to the condition of the cowhouse itself, it is externally in very good condition and well maintained. It seems that the feed passage referred to as being within the building has apparently been lost, possibly due to the removal of stalls and feeding troughs - although as these are not mentioned in the listing schedule it is impossible to determine if this is the case (see also PRN45446).

This is a Grade 2 listed building and any future renovation or alteration must be undertaken with the consent of, and in consultation with the appropriate bodies

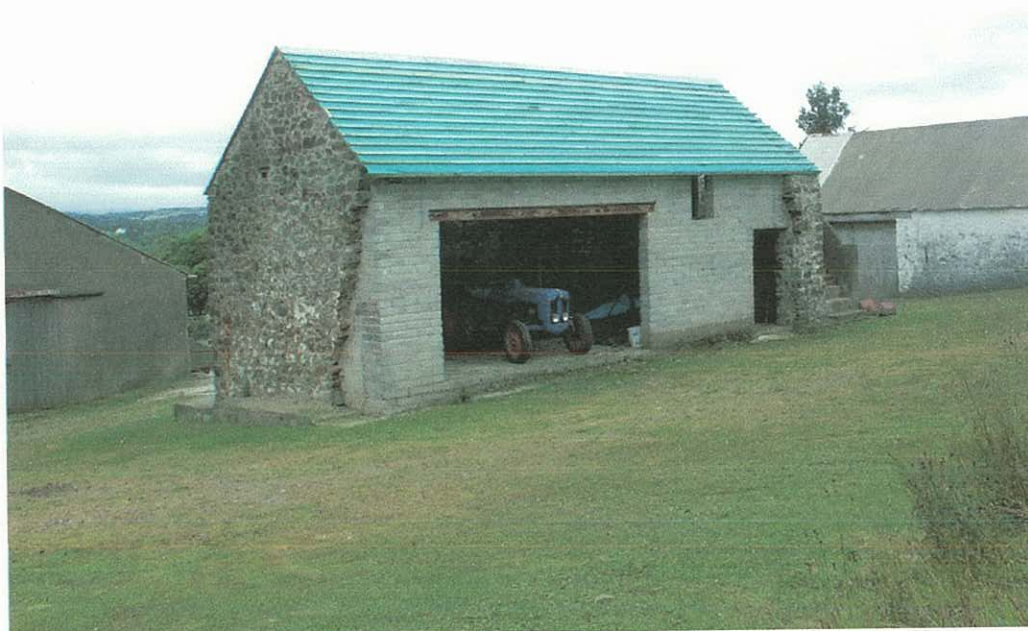
"Early-mid C19 lofted cowhouse. Limewashed rubble masonry. Steeply pitched corrugated iron roof. Symmetrical front. 2 rectangular loft openings set under eaves. 3 doorways, slightly cambered brick voissours. Stone staircase with later render and sidewall."

This building was found to be undergoing renovation when visited in July 2002, with most of the

front wall having been demolished and replaced with an inner skin of concrete blocks, which will be finished off with an outer skin of natural stone in keeping with the character of the rest of the building. A new slate roof is being added also.

*Fig.4: Front elevation of lofted cowhouse viewed from south-west*

Tir Gofal/CCW/DAT/2002.07.30/A/This building is undergoing renovation and no recommendations are thought necessary.

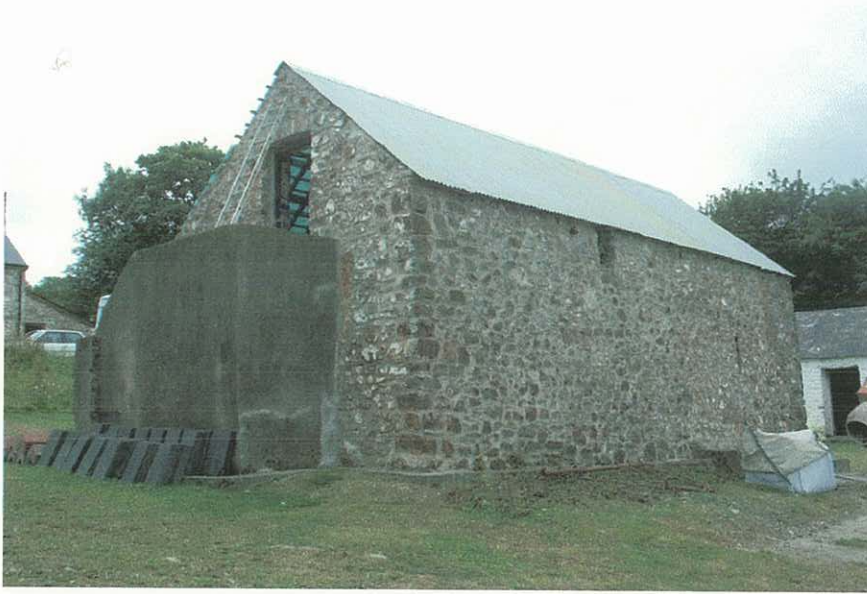
*Fig.5: Lofted cowhouse  
viewed from north-east  
showing rear elevation*

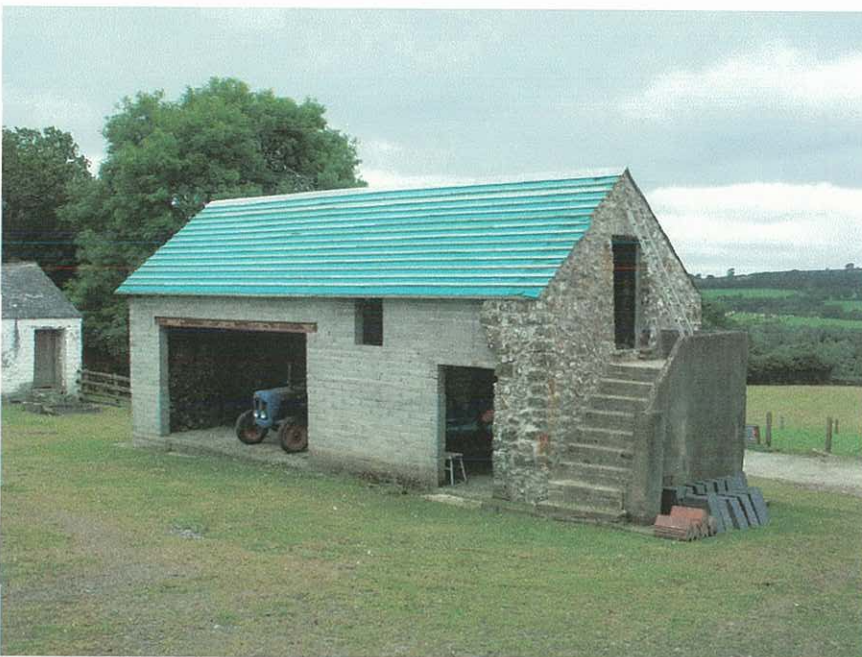
*Fig.6: Lofted cowhouse  
viewed from south-east  
showing external stairs*

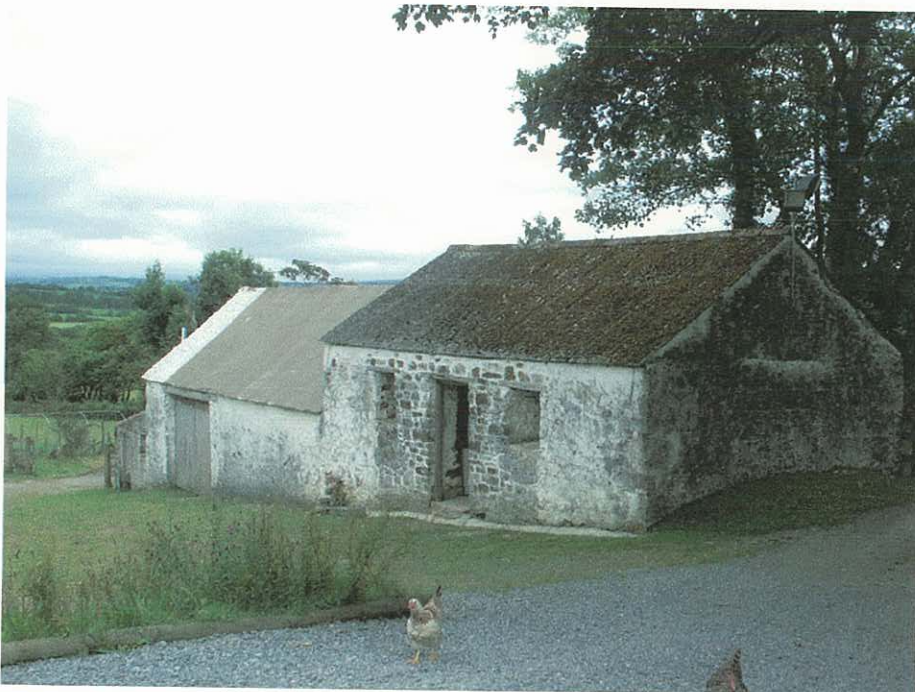
"Early-mid C19 stable. Limewashed rubble masonry. Moderately pitched corrugated asbestos roof. Central doorway with flanking windows. Timber lintels, plank door. Hopper windows; unglazed vent over wooden shutter."

There appears to have been little change to the appearance of this building which now houses chickens. However, part of the front wall had collapsed at some stage subsequent to listing and this damage has been repaired by the present owner.

*Fig.7: Stable and barn viewed from north-east showing front elevation. The stable is the upper portion of this building range.*

This is a Grade 2 listed building and any future renovation or alteration must be undertaken with the consent of, and in consultation with the appropriate bodies

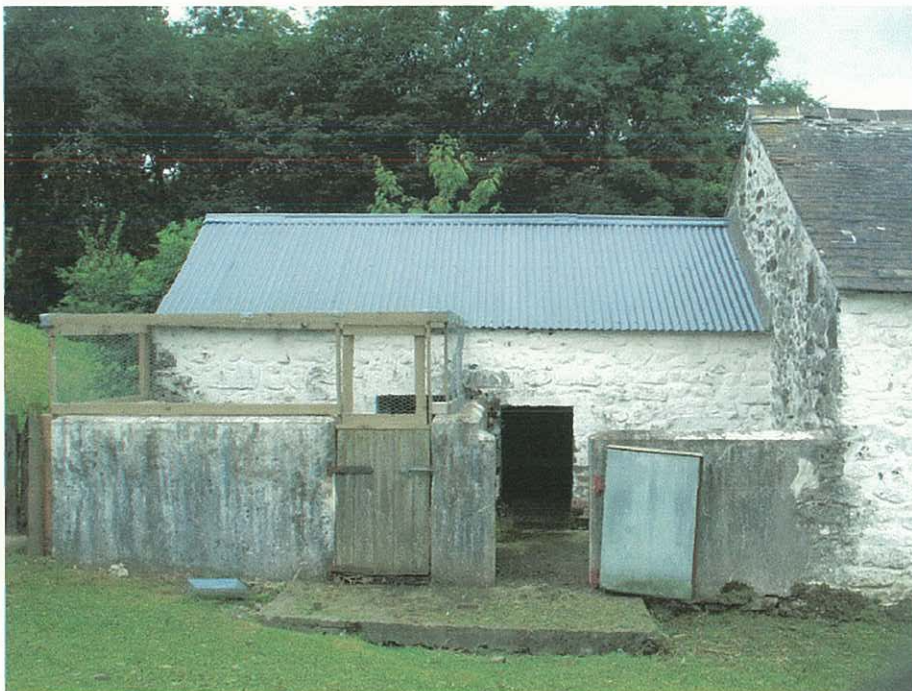
"Two box, pound and run pigsties... Gabled corrugated iron roof. Entrances to centre, collapsed run walls."

The pigsty has been restored since this description was made and is now used to house fowl.

*Fig.8: Pigsty viewed from east showing rear elevation*

This structure is in good condition and should be maintained as part of the historic building group at Cilrath Fach, the importance of which is recognised through its Grade 2 listed status.

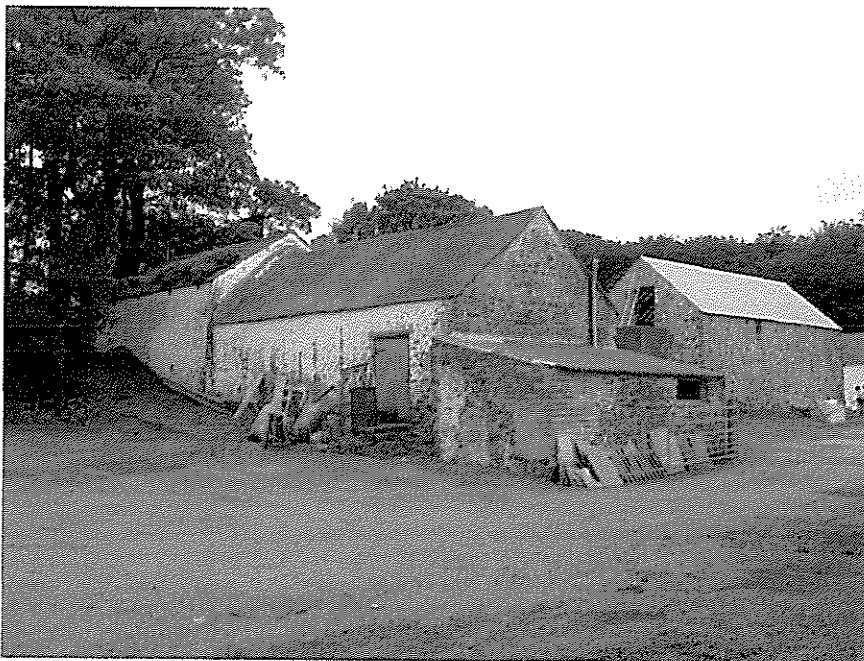
"Early-mid C19 barn, stepped down from and adjoining stable. Limewashed rubble masonry. Moderately pitched roof of small quarry slates laid to diminishing courses. Single storage bay with threshing floor set to left end. Front doorway enlarged, split door to rear; timber lintels. Single ventilation slits to side walls of storage bay."

This description of the external characteristics of the barn appears to describe its appearance in 2002, other than that a small aluminium chimney ventilation pipe now comes through the top of the northern gable wall. The interior of this building was not examined in 2002.

*Fig.14: View of the rear elevation the barn and stable at Cilrath Fach. Note the calf house attached to gable end wall of the barn.*

This is a Grade 2 listed building and any future renovation or alteration must be undertaken with the consent of, and in consultation with the appropriate bodies
