Allt Nant y Gro W/12/2631

Tir Gofal Farm Visit Historic Environment Report

Odyn Jac Lime Kiln - Prn 27571

Report No. 2002/115

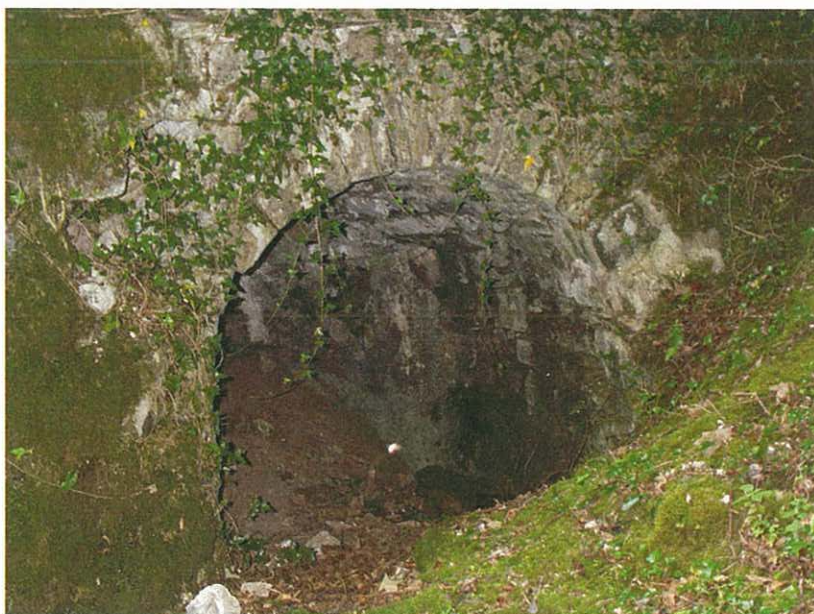
A free standing lime kiln standing approximately 6 metres high with two draw holes facing north-east and north-west each with a single kiln eye. The kiln pot is approximately 2.5 metres deep and 6 metres in diameter.

The lime kiln is in fair condition, Mr. Jones, the owner has been carrying out vegetation management regularly; cutting back woody growth and spot treating the roots to prevent regrowth. Mr Jones has also carried out some masonry repairs to the arch of the north west draw hole, part of a one off payment from Cadw.

Prn 27571 - the draw hole to Odyn Jac lime kiln

The present management regime for this monument seems appropriate. The main concern is keeping the vegetation under control; which is currently being carried out on a regular basis. To the east side of the kiln near the wall top is a bulge in the masonry which is potentially a structural problem. Although it appears reasonably stable at present it will probably require intervention at some time in the future. Any work of this kind will require Scheduled Monument Consent from Cadw: Welsh Historic Monuments and there should be a record of the affected area together with a record of the extent of the work undertaken. These repairs should be carried out using traditional materials appropriate to those used in the construction of the lime kiln.

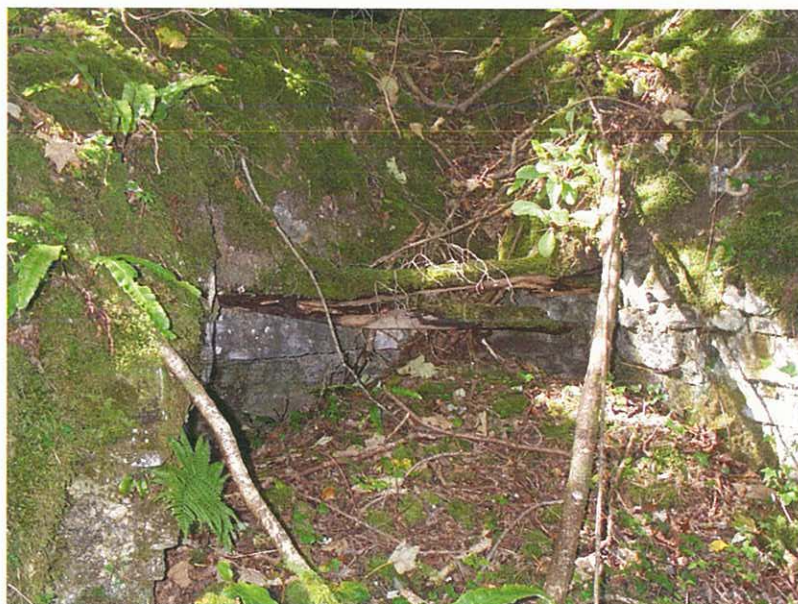
A free standing kiln. Central part of kiln has collapsed revealing detail of kiln eye which was capped by a large stone lintel in front of which is a large wooden beam. The west side appears to show evidence of a rebuild of the masonry structure. The single drawhole faced north-east. Pot diameter 5.2 metres x 2.5 metres deep. Kiln c.5.0 metres high x 10.5 metres long.

Kiln has some large saplings growing in the masonry of the charging hole. The east edge of the charging hole has also collapsed.

Prn 27572 – the collapsed remains of the draw hole and kiln eye

This kiln would benefit from regular vegetation control; cutting back woody vegetation and spot treating the roots to prevent regrowth.

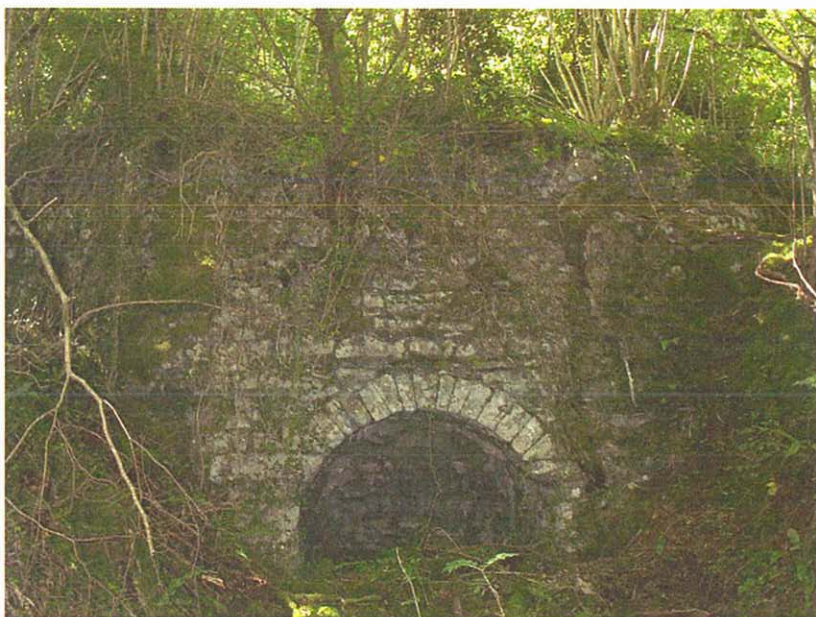
Stone built partly freestanding kiln. One drawhole with two kiln eyes. Kiln pot virtually empty 3.0m deep x 5.5m in diameter. Kiln 9.5 metres long x 6.0 metres high. Faces north-east.

This kiln is very well preserved and the masonry appears intact. Like other structures in this area it suffers from woody vegetation that has become established within the masonry.

Prn 27573 – a very well preserved lime kiln

Mr. Jones has undertaken some vegetation control on this kiln to prevent damage to the structure. However, some large saplings are becoming established on the rim of the charging hole. The maintenance of this kiln should be a priority to ensure its continued survival in good condition.

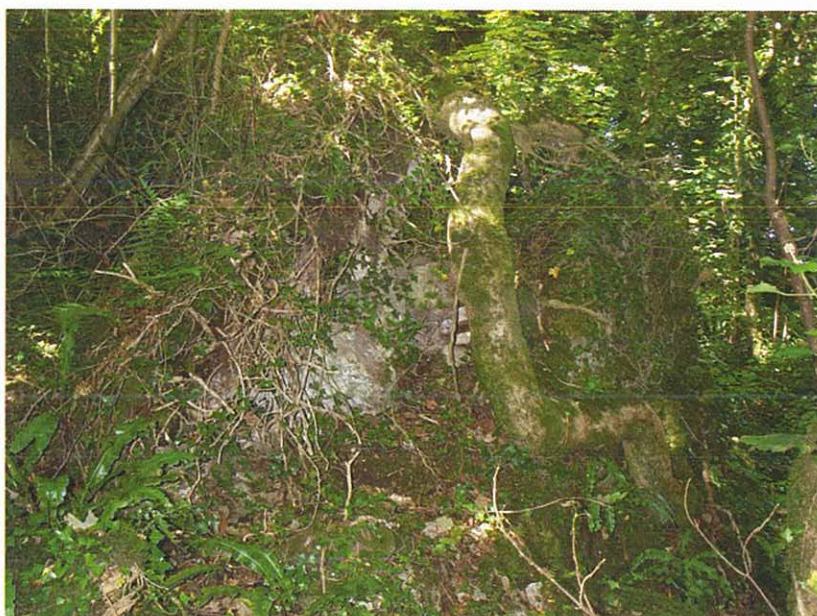
Badly ruined remains of small stone-built building. Similar stonework construction to that of adjacent lime kilns prns 27571, 27572, 27573. The building is approximately 7 metres in length and unknown width. The remains stand to a height of between 2 and 5 metres. It is of unknown function but may be a lime burner's hut?

The building is very overgrown with woody growth and has suffered from tree fall.

Prn 27824 – the remains of a small building, a lime burners hut?

The large woody growth, which is penetrating the masonry structure, should be cut back and the roots treated to prevent regrowth.

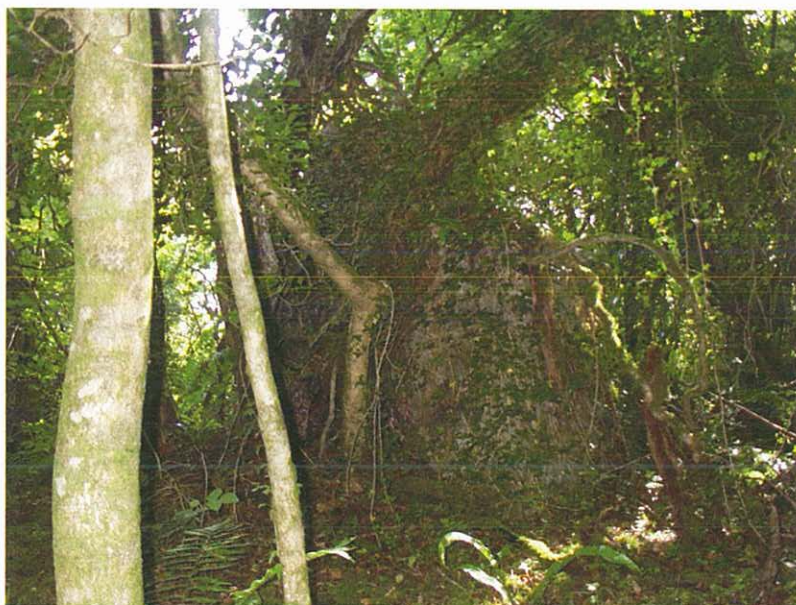
A low one-storey hut, one gable end survives to a height of approximately 1.8 metres, indicating a pitched roof. Constructed in rubble stone, the approximate dimensions of the building are 4 by 2.5 metres. The other walls are almost completely collapsed. Some large trees are growing from the ruin.

Prn 45047 – the remains of a small building

In order to prevent damage by tree fall, this structure would benefit from regular vegetation control; cutting back woody vegetation and spot treating the roots to prevent regrowth
