Gelliddewi Uchaf W/12/2745

Tir Gofal Farm Visit Historic Environment Report

Report No. 2002/86

REPORT NO. 2002/86
PROJECT RECORD NO. 44222

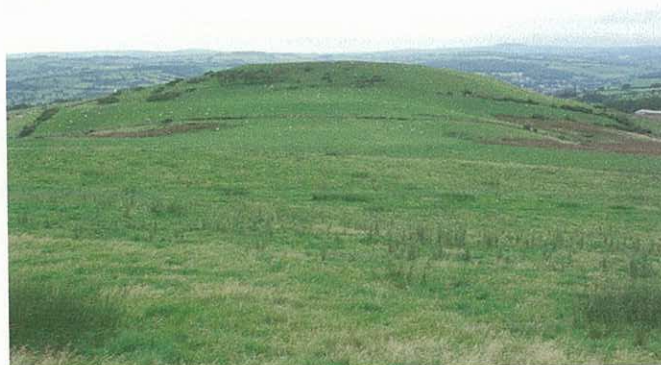
Plate 1 – Pen Carreg hillfort from the south (PRN 787)

Caer Pen Carreg is a fine site in good condition covering about 3 acres in area and measuring around 100 metres in diameter. It is defined by a single bank and ditch. The bank has an external height of 1.8 to 2 metres and an internal height of 0.7 to 1 metres. There is an entrance to the south east of simple type.

The hillfort benefits from a Cadw management agreement which has lead to the repair and reseeded of some areas of the defensive bank. This has targeted areas where sheep had created scrapes in the bank profile. Reduced stocking levels should help to prevent this damage occurring in the future. If areas of erosion are identified then brash or netting should be pinned over the affected area to allow the turf cover to regenerate naturally.

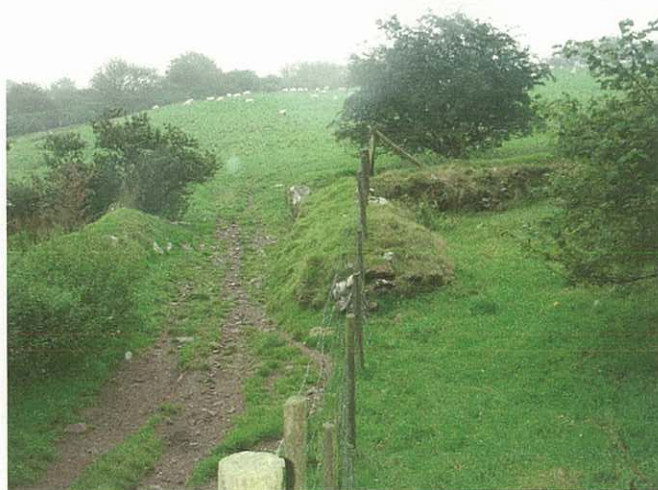
Plate 2 – Front of cottage (PRN 8354)

In 1984 it was recorded of this site that "only the foundations now remain. The wall stands about a metre high, and about 0.75m in width. Constructed of rough oblong square blocks." Now this site is visible as well defined banks. The adjacent enclosure to the south west is currently planted with pine trees.

This site should be maintained as a visible landscape feature. In order to protect buried archaeology the area within 15 metres of this site should not be ploughed, or subjected to any other intrusive activity and should not be used for feeding or watering livestock.

Extreme care should be taken not to damage the enclosure banks if the pine trees are felled and harvested and the use of heavy machinery in this area should be avoided.

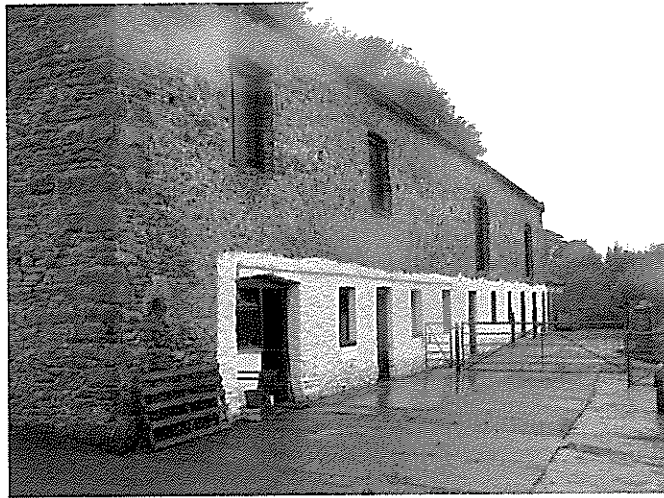
Plate 3 – North (front) face of farm building (PRN 45745)

The front (north) elevation comprises: at the eastern end a separate subdivided office space with remains of an engine driveshaft, and a pitching window above at first floor level. This room could have previously served as a cart shed. Next there is a small former stables?, accessed by a door with windows to either side and a pitching window above. Finally there is a long former cow shed ? range with seven doorways and two first floor full height pitching doors.

Although it is currently in fair condition, the owners expressed an interest in restoring some of the wooden fixtures ie: doorways and window openings (some of the ground floor openings have been replaced with steel doors). Any discussions to restore wooden fixtures and repairing those existing wooden ones should be encouraged. There is also potential for repointing the stonework and repairing the occasional loose roof slate; this would help to maintain this fine building in good condition.

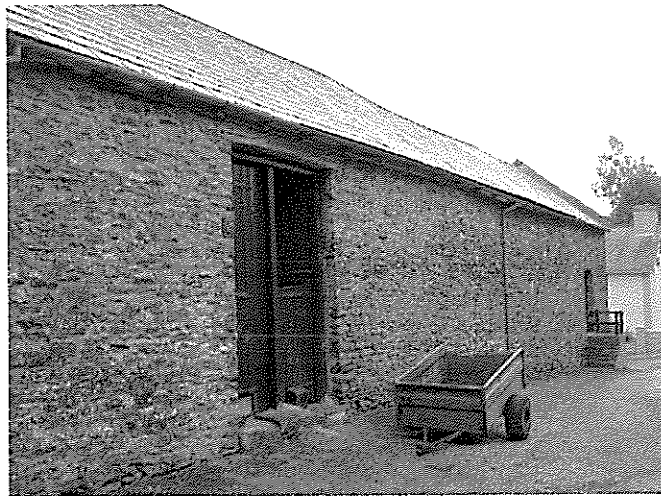
Plate 4 – South (rear) face of farm building (PRN 45745)

The rear (south) elevation contains a set of steps at the east end leading to a door into a room over the office, this room is divided from the rest of the range by a full height stone wall. Two further double doors are provided to give access to the rest of the first floor, and internally the space is divided as below, with a further full height stone wall and integral door for access.

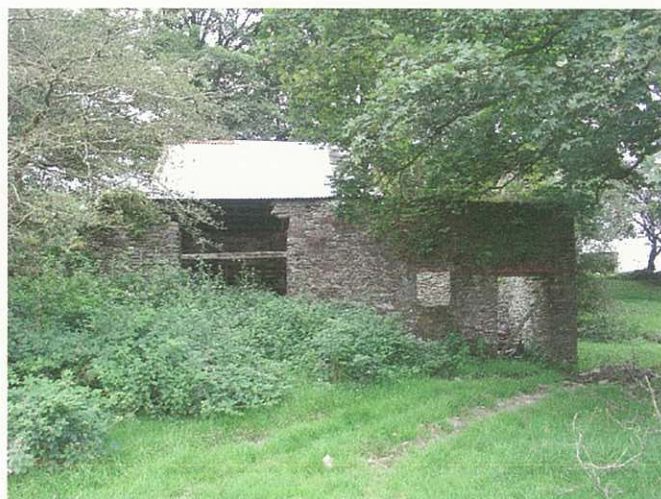
Plate 5 – Exterior of barn section (PRN 45746)

It survives as a two celled building in various stages of decay. The southern (domestic) half is now roofless and the walls have largely been reduced to rubble or low banks. Where it adjoins the northern half the walls stand to height of around 2.5m and structural features such as a doorway, blocked recess and flue are evident. The northern half (barn), which appears to butt against the southern half, is only partially roofed. Around half of the roof trusses and slates have been lost,

whilst corrugated sheet covers the surviving collared truss and iron stapled roof timbers.

Ideally, at least half of this building should (and could) be reroofed and made good. This would prevent any further decay to the upstanding fabric of this farmstead and maintain the building as a usable structure.

Trees are growing within the ruins of the buildings and also immediately adjacent to the masonry. Ideally these trees should be cut down and treated to prevent regrowth, in order to help preserve the remains of this cottage.

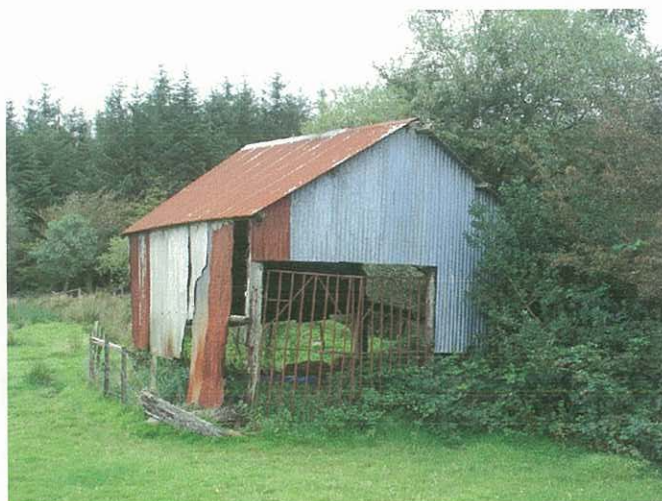
Plate 6 – Field barn (PRN 45747)

This is a field barn constructed from whole logs and with a corrugated iron roof and corrugated iron cladding to the upper parts of the sides.

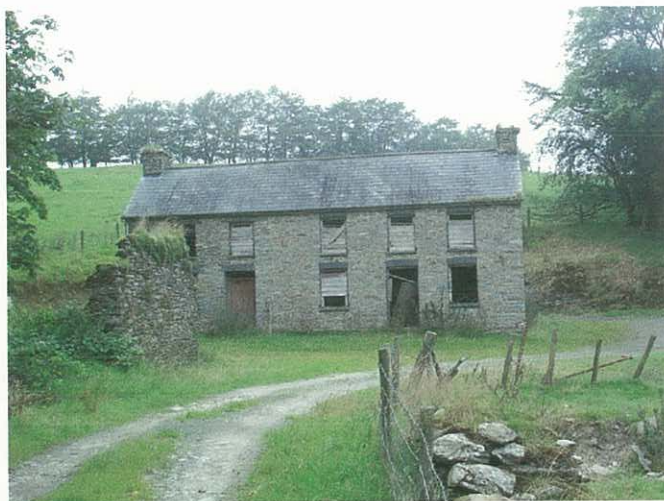
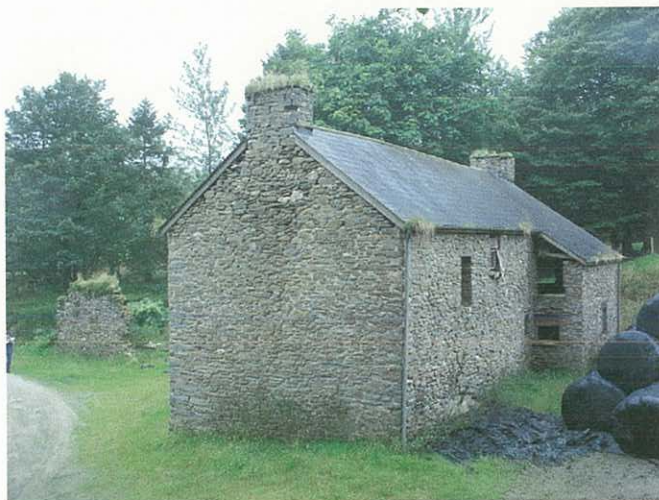
The farmhouse survives reasonably intact although empty and without doors and windows, and with some decay to the fabric (most notably the brick dressings to the chimney stacks). The modern roof is in good order, but the guttering is in some places becoming overgrown.

Plate 7 – Front elevation of farmhouse and mill building to the side (PRN's 45748 and 45749)

Plate 8 – Rear elevation of farmhouse and mill building to the side (PRN's 45748 and 45749)

Ideally this building should be brought back into use before it becomes completely derelict. This would be a large restoration project, but would undoubtedly be worthwhile. It is not known if the owners, Mr and Mrs Jones have any intentions for this farmstead.

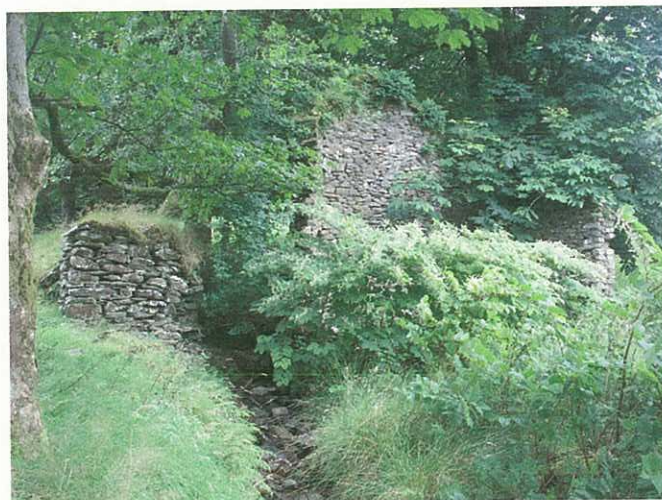
Plate 9 – Interior of mill building and mill race (PRN 45749)

This is a semi derelict roofless mill building situated around 10m to the south of farmhouse (PRN45748). Some of its walls still stand to full height, and some evidence of the angled mill race survives. A date stone survives in the east wall bearing the date '1919'.

This building is in a ruinous condition and perhaps the most that can realistically be hoped for is that the process of decay is slowed, by keeping vegetation in check, particularly where overhanging boughs threaten the wall tops.

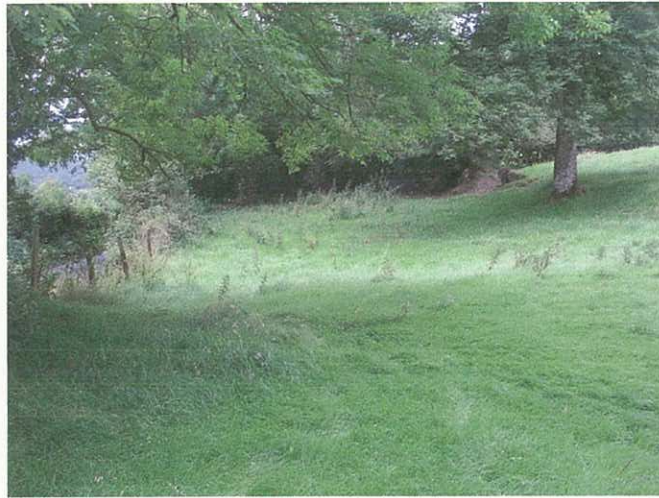
Plate 10 – Cottage site (PRN 45756)

Cottage site near Bwlch-newydd. Shown as abandoned on the 2nd edition Ordnance Survey map of 1906 and now survives as a roadside platform measuring 30m by 15m with traces of a low earth and stone bank on the upslope side.

Maintain as a visible landscape feature.

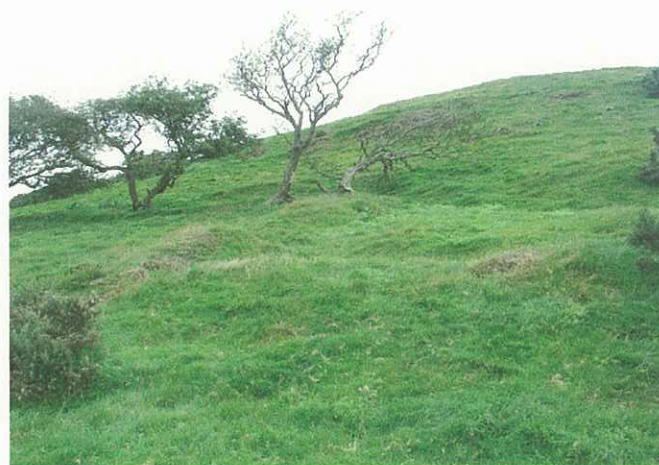
Plate 11 – Enclosure (PRN 45757)

A kink in the field boundary may suggest the site of an enclosure or building. The hillslope has been excavated in this area, possibly for a platform or because of quarrying.

Maintain as a visible landscape feature.
