TYNANT FARM

W/11/2978

Tir Gofal Farm Visit Historic Environment Report

REPORT NO. 2003/29
PROJECT RECORD NO. 44229

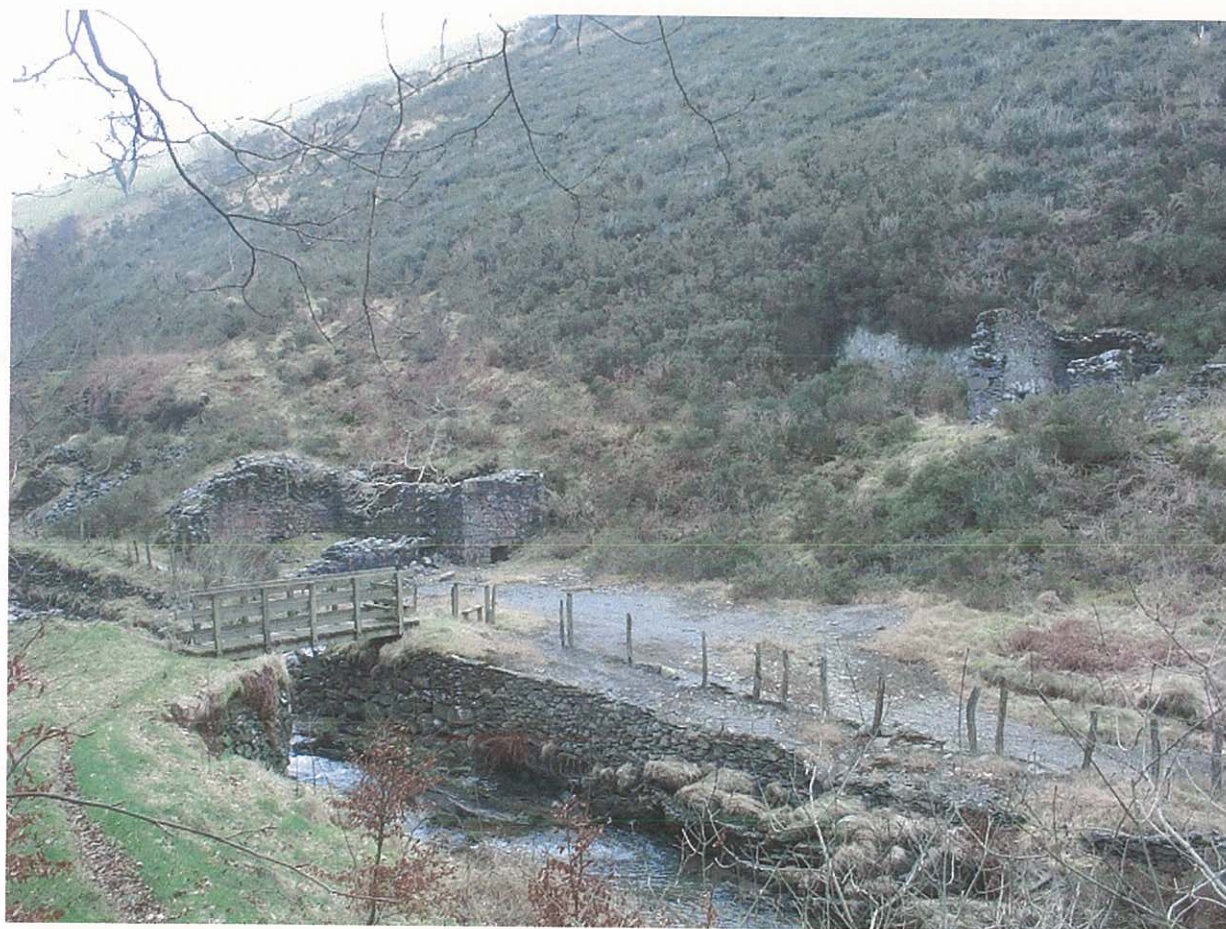
Plate 1: PRN 9132 Cefn Gwyn Metal Mine

The Cefn Gwyn mine is represented on both first and second edition Ordnance Survey maps. The site was visited in 1993 as part of the Ceredigion Metal Mines Project (Protheroe-Jones) when the nature of the various visible features was identified. PRN 9132 represents all the features associated with this mine. The majority of features associated with the mine are located along the west bank of the Afon Leri, within Ty Nant Farm land parcel 'D'. The remains of the mine workings are concentrated in a fairly small area, constrained by the topography of the location. The remains of the various mine buildings are in a ruinous state and are mostly overgrown with gorse. Other features are obscured by collapsed masonry and spoil tips. Because of the difficulty of identifying specific features on the ground, no additional PRNs have been allocated to individual features within the mine complex as part of this farm visit. The site is fenced off from stock but is easily accessible from the nearby footpath.

It is recommended that all remains be maintained as visible historic landscape features. The remains of masonry buildings are generally prone to gradual deterioration. Ideally these remains should be recorded archaeologically in their present condition and where appropriate, consolidated to prevent further deterioration. Clearance of vegetation from the remains would help to delay further deterioration. Since the site is located near to a public footpath, with a bridge crossing the

river at the northern end of the mine complex, the remains of the mine could be considered as a candidate for improved public access and interpretive facilities. Alternatively, measures to more effectively prevent public access could be considered. No stone or material from spoil tips should be removed from the site.

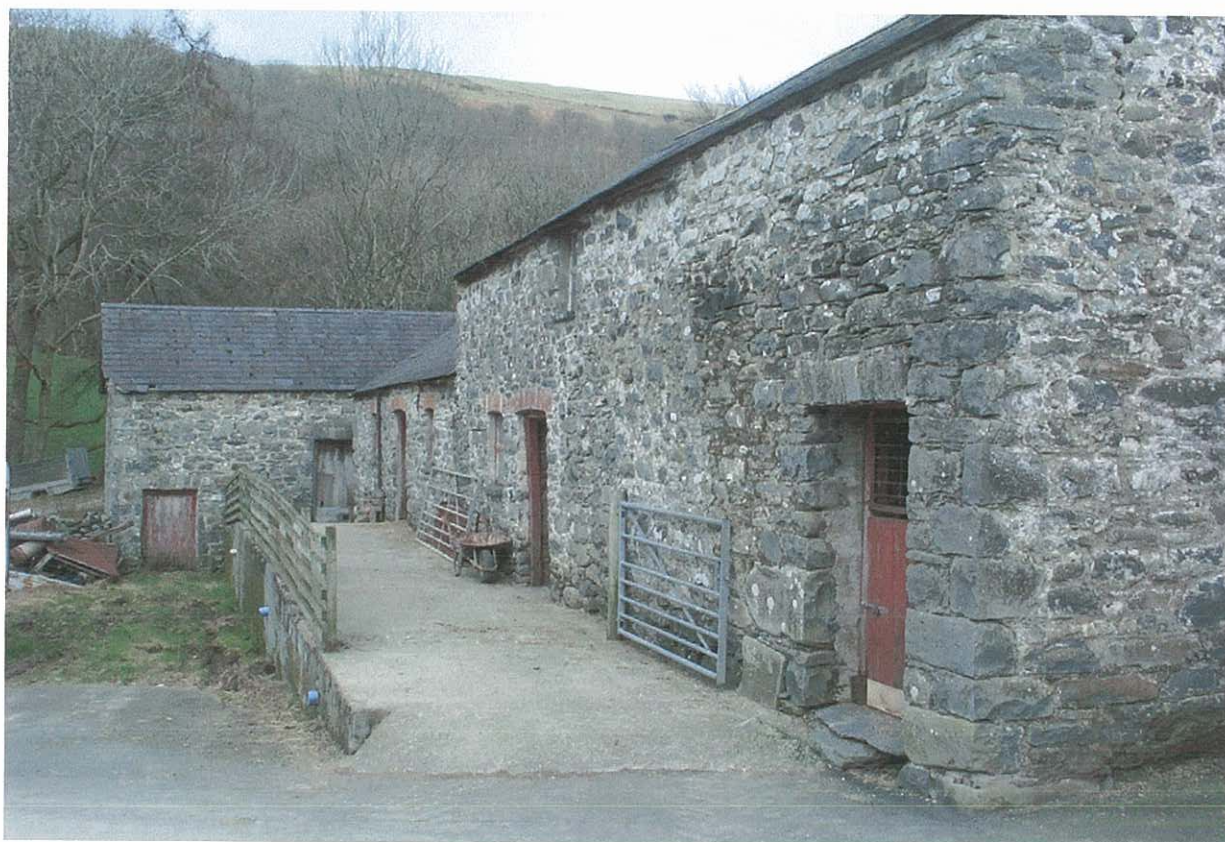
Plate 2: PRN 47563 Tynant Farm Buildings

This range of farm buildings (indicated on both 1891 and 1906 Ordnance Survey maps) is still in use at present. The interior of the buildings was not investigated. There is a detached barn at the north end, set at right angles to the rest of the range. The northern section is single storey and its west face consists of a central doorway with a window on either side, all with red brick flat arches. The southern section is of two storeys and may pre-date the northern section. It is terraced into the slope and access to the loft is through a single doorway, from the east side. The west facing elevation of the southern section consists of a doorway and a window at the north end, each with red brick flat arches. To the south is a stone built flat arched doorway. There is a single window on the first floor. The stone arched doorway may be an original opening, while the brick arched openings are probably later modifications. There is some evidence of blocked up openings associated with earlier phases, visible in the stonework. There is a corrugated iron roofed shed at the southern end of the range. Externally it is apparent that repairs to the roof and guttering are necessary at this stage, to prevent further deterioration. There are several significant cracks in the masonry at the south end of the range on the west facing elevation.

It is recommended that repairs are made to the roof and guttering to prevent further deterioration to the fabric of the buildings from rainwater. The cause of the severe cracking in the masonry at the southern end of the building is uncertain but will require remediation. All repairs and rebuilding of masonry should be undertaken using traditional materials and techniques appropriate to the area. Surviving fixtures and fittings on the interior should be retained if appropriate. The shed at the southern end of the range appears to have been recently repaired and repointed using cement. To avoid problems that cement pointing can cause to the fabric of lime-mortared masonry, it would be preferable to re-point the building using traditional lime mortar.

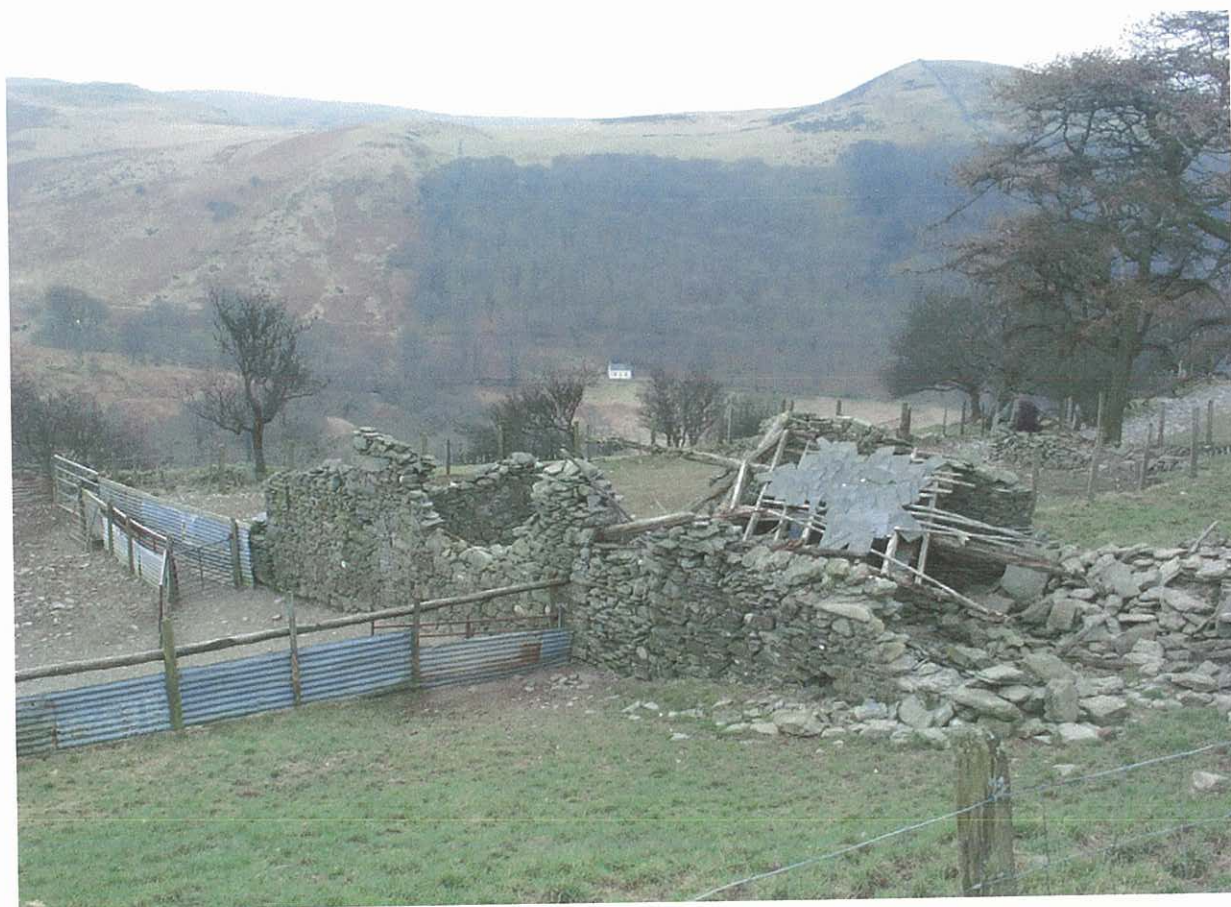
Plate 3: Brynfedwen Fawr Farmstead site PRN 47565

The remains of this farmstead site are in a ruinous state but are not overgrown. The exact layout is uncertain but appears to consist of a cottage and various outbuildings partly terraced into the hill slope. Parts of the site are at present periodically used as sheep pens, but this does not appear to be adversely affecting the condition of the site since the more ruinous parts are fenced off.

The upstanding masonry of this complex of buildings is at general risk of further deterioration. Consolidation of the upstanding masonry should be considered. No stone should be removed from the site and it should not be used as a location for feeding livestock. Current usage of the site does not appear to be adversely affecting the remains.

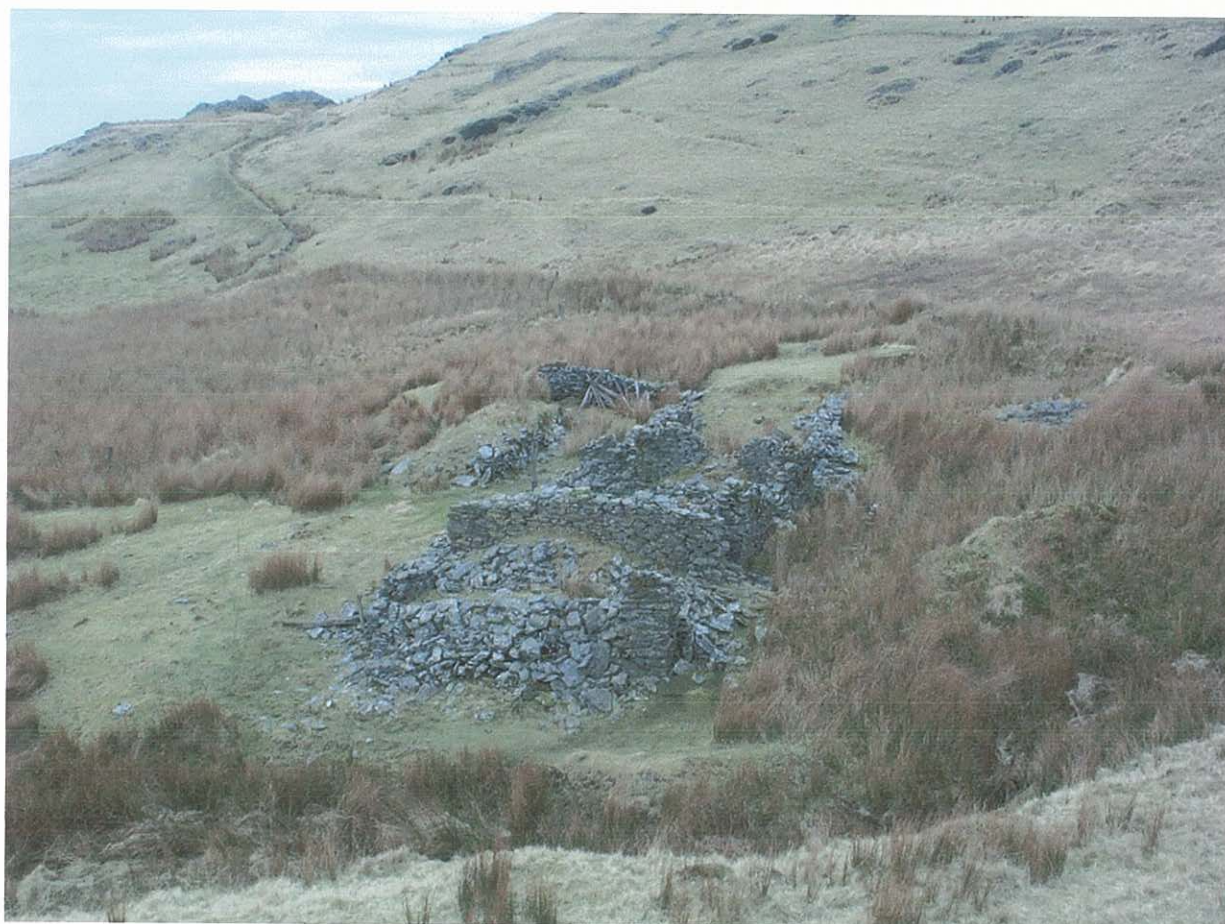
Plate 4: Bwlch y Gareg Farmstead site PRN 47567

The site of a ruined cottage and associated farm buildings in an east-west alignment indicated on both 1891 and 1906 Ordnance Survey maps. The site is located in rough pasture, is not overgrown, and appears to be in a reasonably stable condition.

It is recommended that the site be maintained in its present condition. No stone should be removed from the site, and it should not be used as a location for feeding animals.

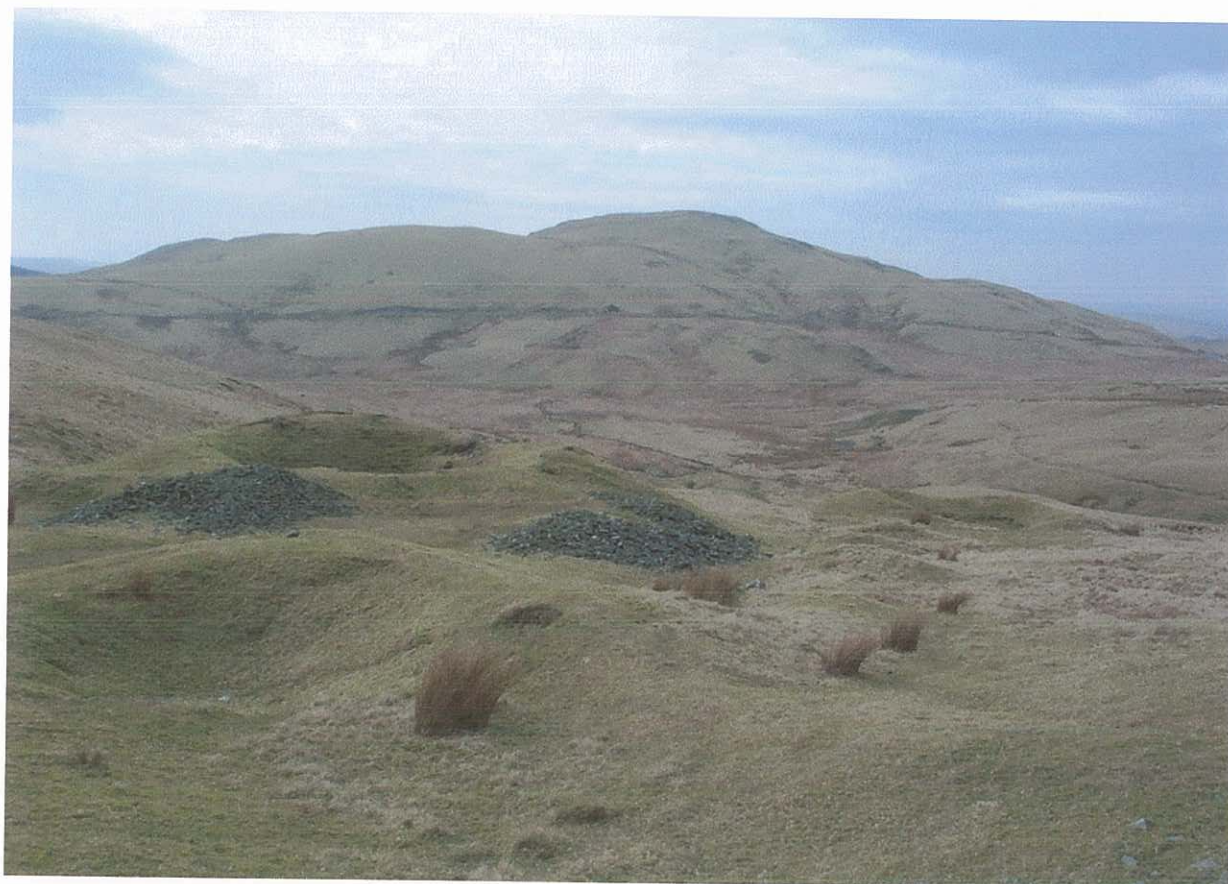
PLATE 5: Esgair-hir Mine Shafts PRN 47572

This PRN represents a group of mining features, represented on first and second edition Ordnance Survey maps, form part of the Esgair-hir Mine. The features include levels, shafts, craters, and a prospecting trench, with their associated spoil heaps. These features run in a north-easterly direction and are distributed along the line of a seam of ores between the mine buildings PRN 47574, 47576, and mine shaft PRN 47573. The features are all in a stable condition, with most of the spoil heaps being grassed over.

The shafts and other features should be retained as visible historic landscape features associated with the other remains of the mine. No material should be removed from spoil tips. Current management should be continued.

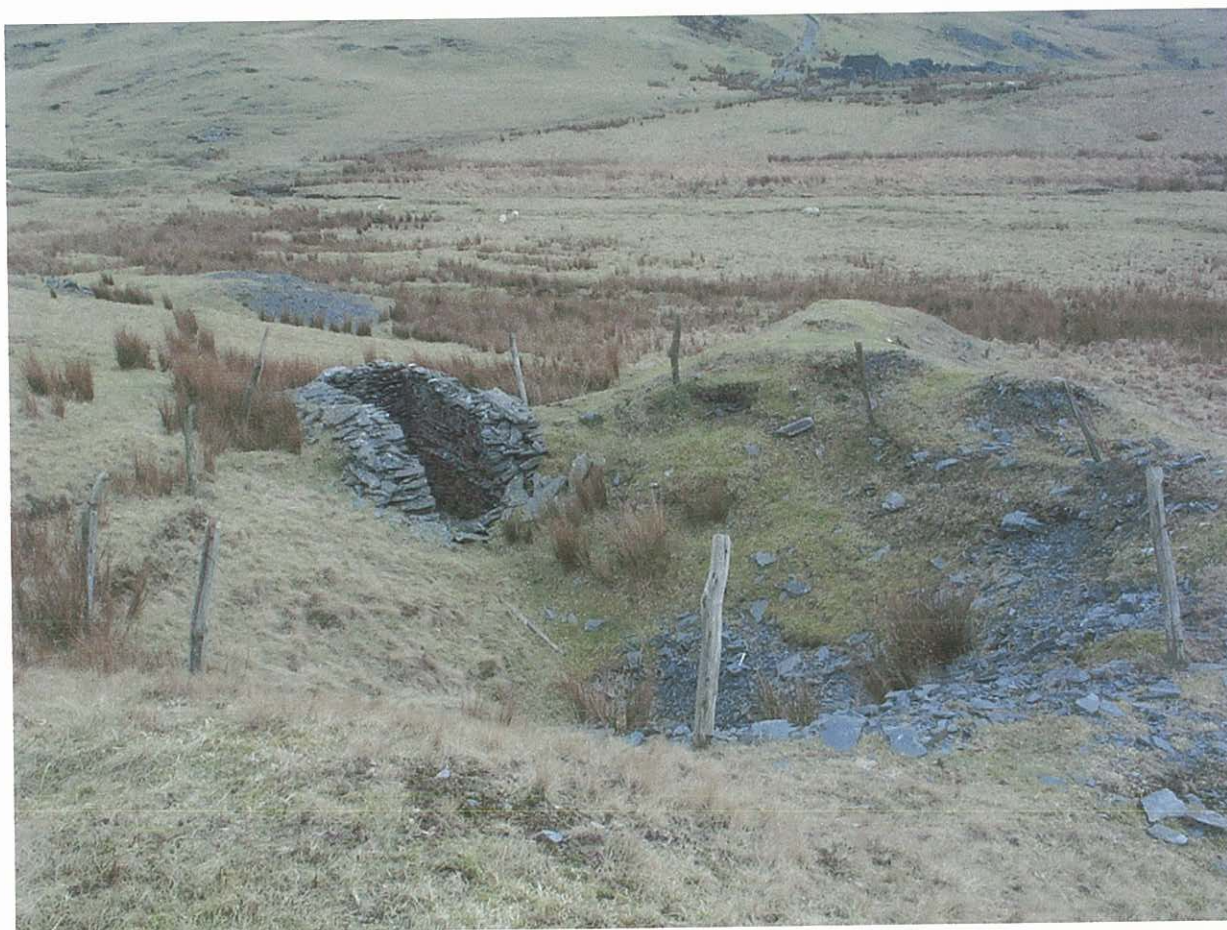
PLATE 6: Esgair-hir Mine Shaft PRN 47573

A discrete group of features associated with an old mine shaft that form part of the Esgair-hir metal mine (PRN 5626). Features identified by Protheroe-Jones during the Metal Mines Survey in 1993 include a well preserved whim circle; a probable adit; spoil tips; a run-in shaft with a stone built bob pit; a masonry bob base and a well preserved wheel pit. The group lies at the end of a line of shafts (PRN 47572) that run in a north easterly direction towards the Esgair-hir mine buildings. The features are in a reasonably stable condition. Parts of the group have been fenced off in the past, but this fencing has not been maintained.

The shaft and associated features in the vicinity that form this group, should be retained as visible historic landscape features associated with the other remains of the Esgair-hir mine. The majority of the earthwork features are grassed over and are relatively stable. There appears to be little or no active damage occurring to these features from plant growth, livestock or other activities. No material should be removed from the spoil tips and current management should be continued. The remains of masonry structures are generally prone to gradual deterioration. Ideally these remains should be recorded archaeologically in their present condition and consolidated to prevent further deterioration. The extensive remains of the Esgair-hir mine that are evident in the landscape (of which this group forms part) should be considered as a candidate for improved public access and interpretive facilities.

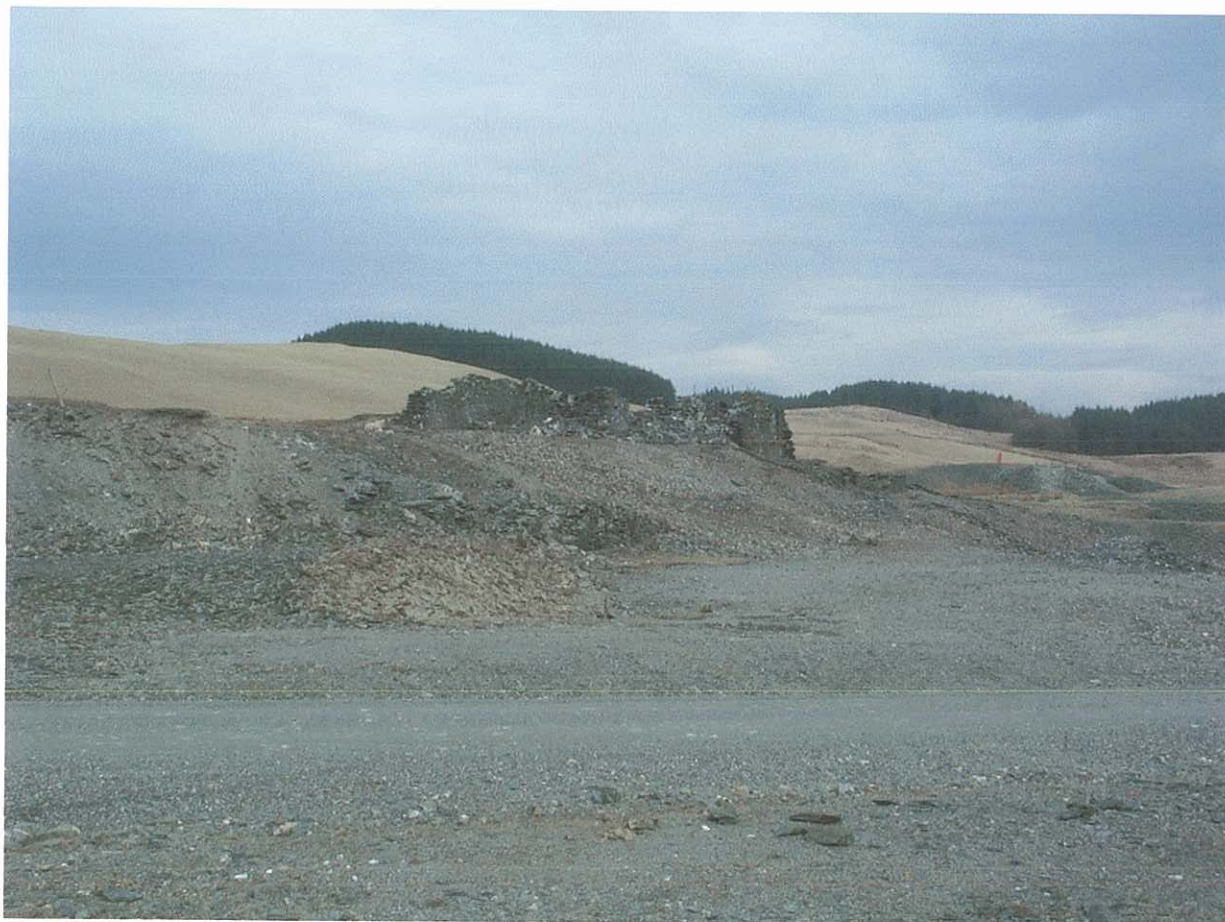
PLATE 7: Esgair-hir Mine Engine House PRN 47574

The engine House is the most intact feature in this group of mine features situated immediately to the north of the Esgair-hir mine offices (PRN 47576). The group includes the engine house, spoil tips, ore bins, boiler house and bob pits.

The features in this group are in a less stable condition than others in the Esgair-hir mining complex. Ideally these remains should be recorded archaeologically in their present condition and consolidated to prevent further deterioration. The extensive remains of the Esgair-hir mine that are evident in the landscape (of which this group is part) should be considered as a candidate for improved public access and interpretive facilities. No material should be removed from the spoil tips and current management should be continued.

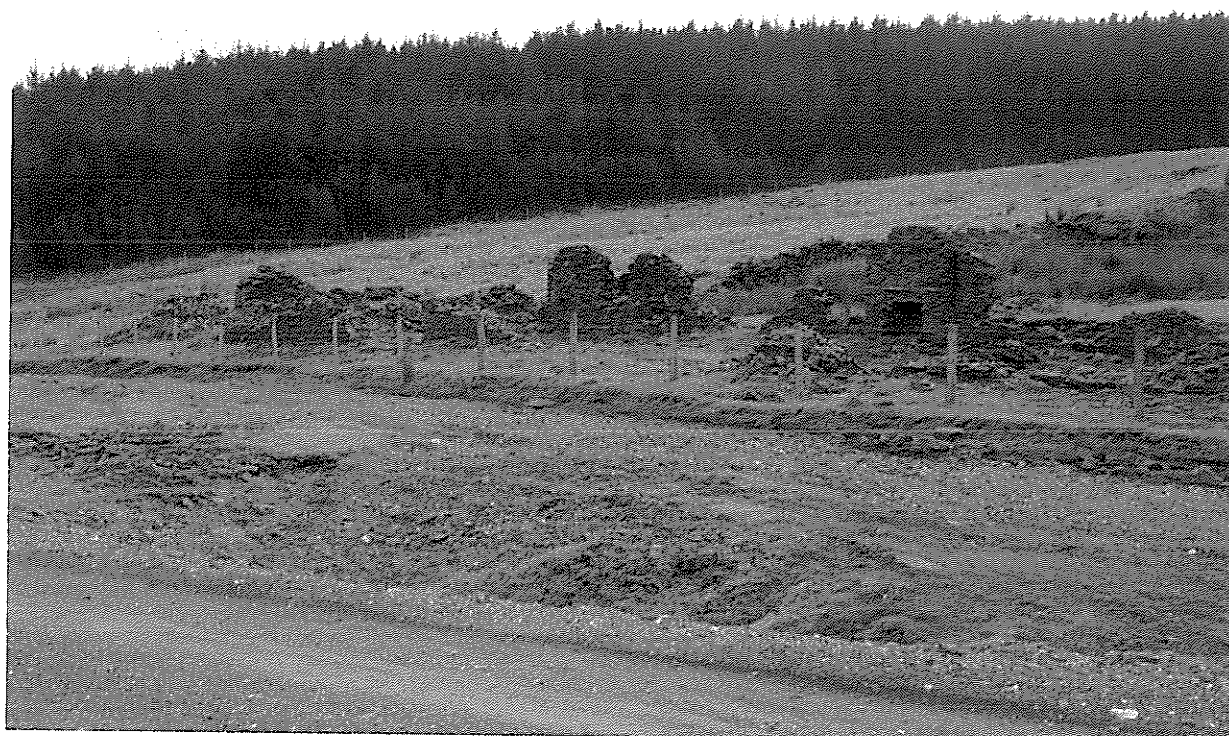
PLATE 8: Esgair-hir Mine Offices PRN 47576

The ruins of the Esgair-hir Mine Offices are the most clearly visible surviving remains of this group of mine buildings. Although in a ruinous state, the remains are in a reasonably stable condition compared with the group of features immediately to the north (PRN 47574).

The site is at present fenced and there appears to be little or no active damage occurring from plant growth, livestock or other activities. Current management should therefore be continued. The surviving remains of the mine buildings and associated workings should be retained as visible

historic landscape features. This site, along with the other mining remains in the mine complex as a whole should be considered as a candidate for improved public access and interpretive facilities.
