Tir Gofal Farm Visit Historic Environment Report

Report No. 2002/117

REPORT NO. 2002/117
PROJECT RECORD NO. 44230

Wallog
Tir Gofal Farm Visit Historic Environment Report

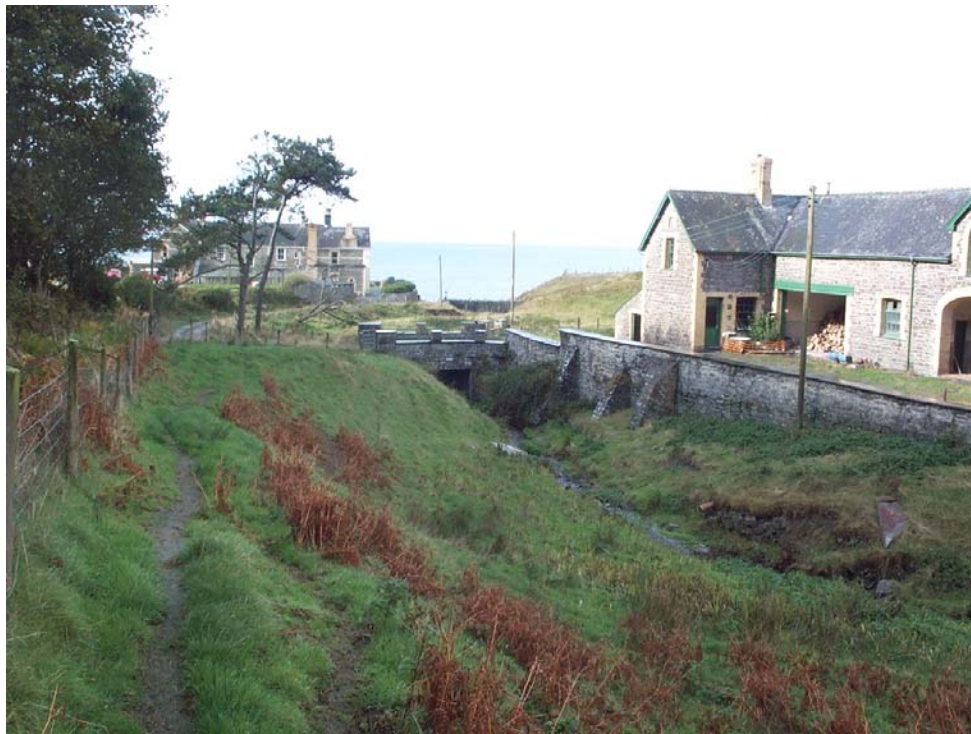
Wallog Stables in the foreground, and Wallog House beyond

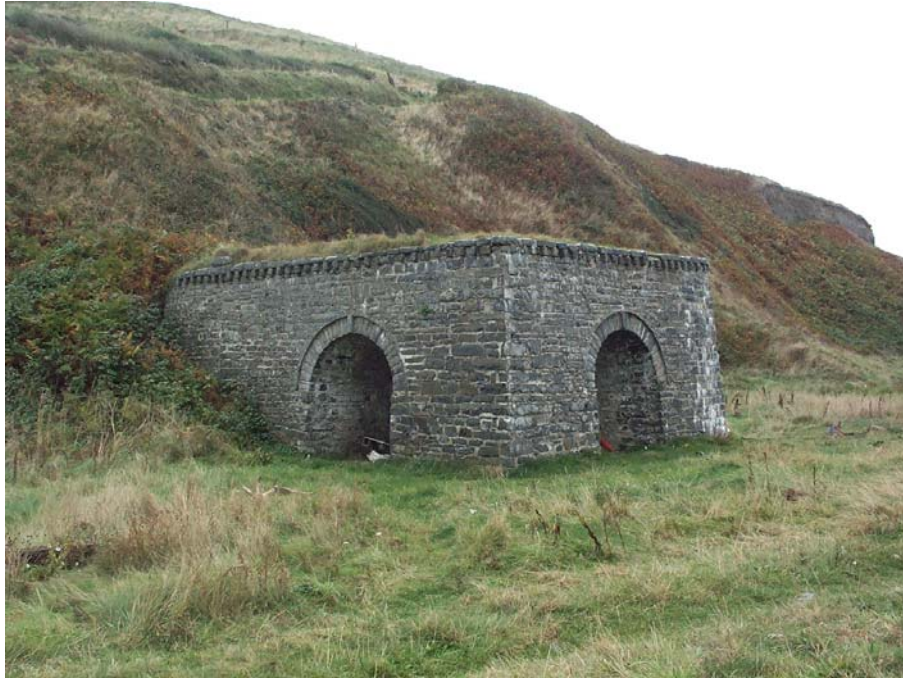
PRN	8487	Site Name	WALLOG	Grid Reference	SN58978570
Site Type	LIMEKILN	Period	Post Medieval	Site Status	LB Grade II Rec no. 19073

A limekiln is situated at the bottom of the coastal slopes just to the south of Wallog house. The limekiln is shown on a map of 1769 (owner pers. comm.). It has been identified as architecturally significant and consequently it has been listed as a Grade II listed building. It has recently been subject to some repair and is therefore in good condition, although there are one or two coping stones which have become loose.

Large squat rectangular lime-kiln, with 3 open sides, built into sloping ground with loading access at the rear. Coursed Wallog rubble-stone, with some coarsely dressed stone, each side similar with battered wall, corbelled coping and centre arched openings to kiln-eyes. Cut stone voussoirs to arches with keystones and raised outer arch rings. Kiln-eyes are barrel-vaulted within, splayed down to furnace openings. Inner furnace area is fire-brick. Top is now grass-covered, and the centre crucible is infilled with loose stone and debris. Large non-dressed coping-stones around the rim.

Prn 8487 – the limekiln is an impressive feature on the coastline at Wallog

This limekiln is in good condition following a recent restoration project. Any follow up maintenance works should be carried out using traditional and sympathetic materials.

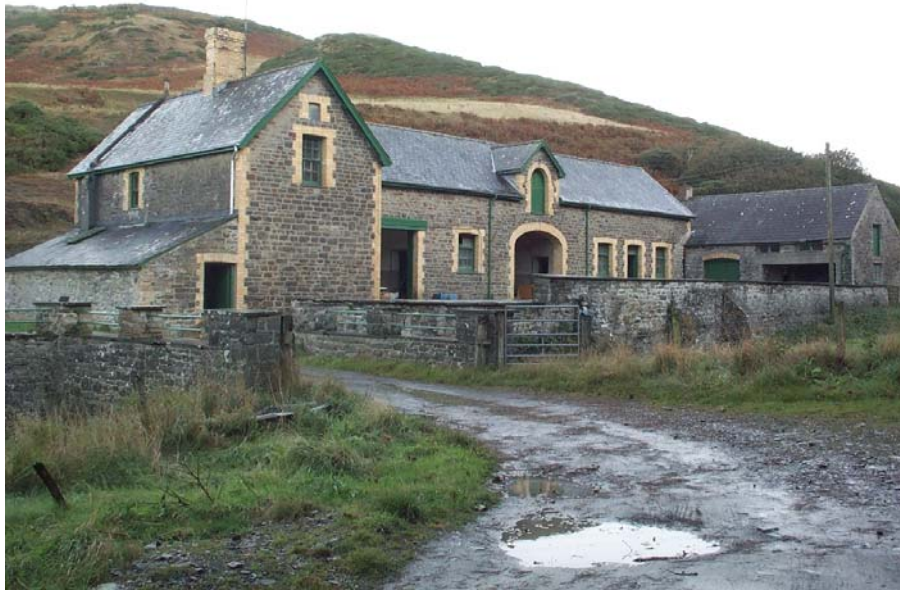
PRN	48728	Site Name	WALLOG	Grid Reference	SN59168572
Site Type	STABLEBLOCK	Period	Post Medieval / Modern

A large and impressive stableblock is situated about 80 metres to the east of Wallog house, on the north side of the valley. It is a U- shaped structure with side wings projecting forward. The western wing was a groom's cottage, and is still in use as a residential let.

The building is distinctive and built with great attention to its appearance, which is understandable when considered that it is a prominent feature on the approach to Wallog house. The later building is characterised by yellow brickwork dressings around the doorways and windows set in local stone roughly dressed and built to courses, a style which corresponds to some sections of the main house.

This building is in reasonable condition at present and appears secure. There are some areas of concern at the rear of the structure where roofing slates have slipped and the masonry is poor. These areas should be repaired in materials sympathetic to the original construction. The internal fixtures and fittings which survive should be retained if possible.

Prn 48728 – the impressive stableblock at Wallog, the grooms cottage to the left of the building is in residential use

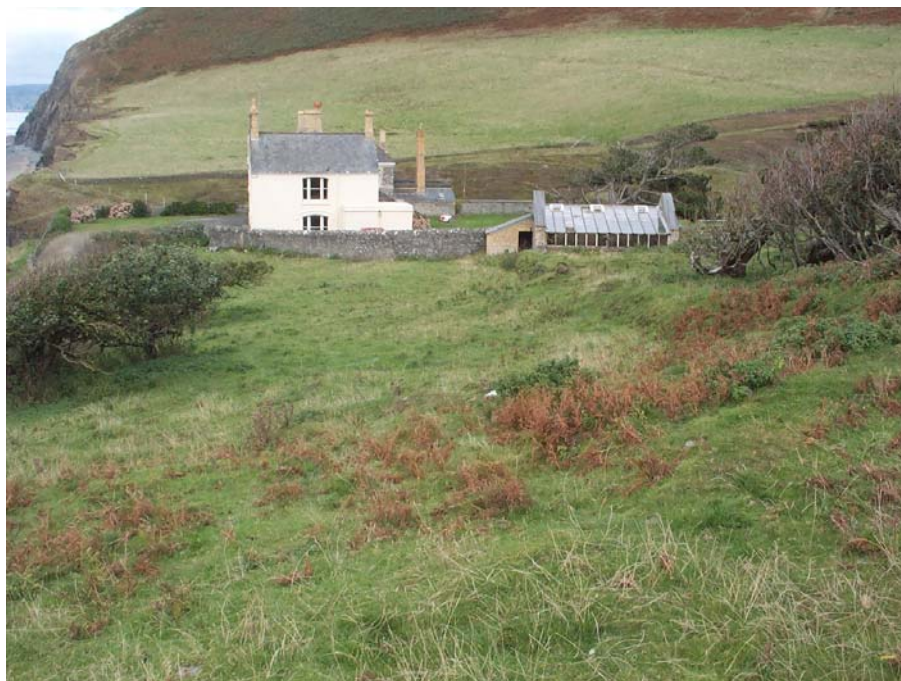
PRN	48729	Site Name	WALLOG	Grid Reference	SN59028569
Site Type	GARDEN	Period	Post Medieval

To the south of Wallog house is an area of land partially enclosed by a low wall which is thought to have been a garden. A glasshouse is positioned to the north of this enclosure against the boundary wall. This land is now used for pasture and whilst there are no obvious relic garden features there are undulations in the ground surface which indicate possible structures, and relic boundary walls suggest subdivisions within the enclosure.

Prn 48729 - the garden at Wallog is now under pasture, however the glasshouse is a lasting reminder of its previous use as a garden.

This relic garden is currently used for grazing and is in an ideal management regime. If any works involving ground surface disturbance are planned please consult with Cambria Archaeology in advance.

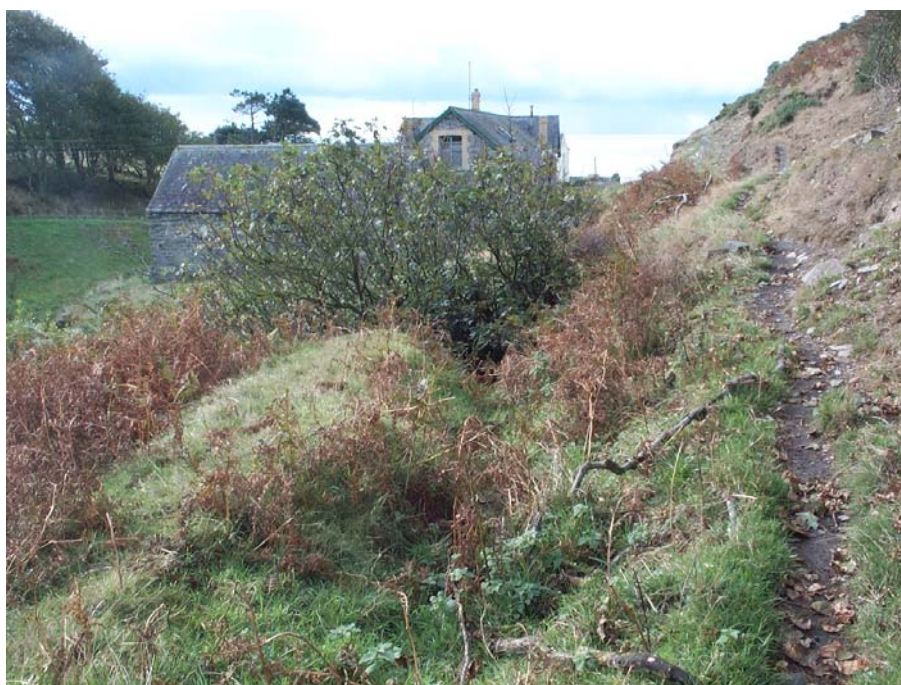
PRN	48730	Site Name	WALLOG	Grid Reference	SN59308572
Site Type	LEAT	Period	Post Medieval / Modern

The remains of a leat constructed to divert water from the stream to the stables at Wallog, can be seen on the north side of the valley. The channel is now dry but is still traceable, following the contour of the hillside. It is an earthwork construction approximately 2 metres wide and about 0.3 metre deep. Also surviving is a slate (holding or settling?) tank constructed with slate slabs and bolted together with iron bolts.

Prn 48730 – the remains of a leat diverting water from the stream to the stableblock

The leat should be retained as a visible historic landscape feature.

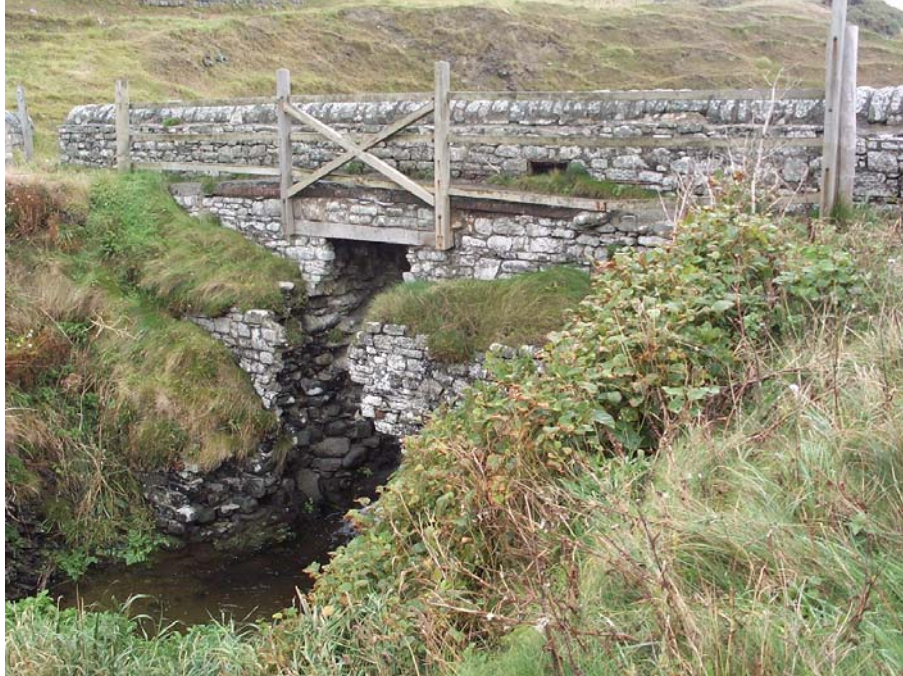
PRN	48732	Site Name	WALLOG	Grid Reference	SN59058577
Site Type	DAM	Period	Post Medieval / Modern

To the north of Wallog house is a stone built dam positioned across the stream before it washes out onto the foreshore. The dam appears to have been constructed at the turn of the 19th and 20th centuries, as it is not apparent on the 1st edition Ordnance Survey map of 1889 but is clearly recorded on the revised edition in 1906.

The dam is an impressive structure, approximately 3 metres at its widest at the base and around 6 metres high. The seaward side of the dam is stepped in from the base with the upper section providing access for the coastal path across the stream. Due to a large breach in the centre of the dam, water is no longer held back by it.

Prn 48732 – the upper level of this dam supports the public footpath, below the stone revetment has been breached in the centre.

Although breached in the centre, the dam appears to be relatively stable at present, however the extent of the breach should be monitored to ensure that the dam (and consequently the footpath) remain safe. If necessary consolidation works may have to be carried out to stabilize the breach. Any works to the structure should be carried out in materials which are sympathetic to the historic fabric.

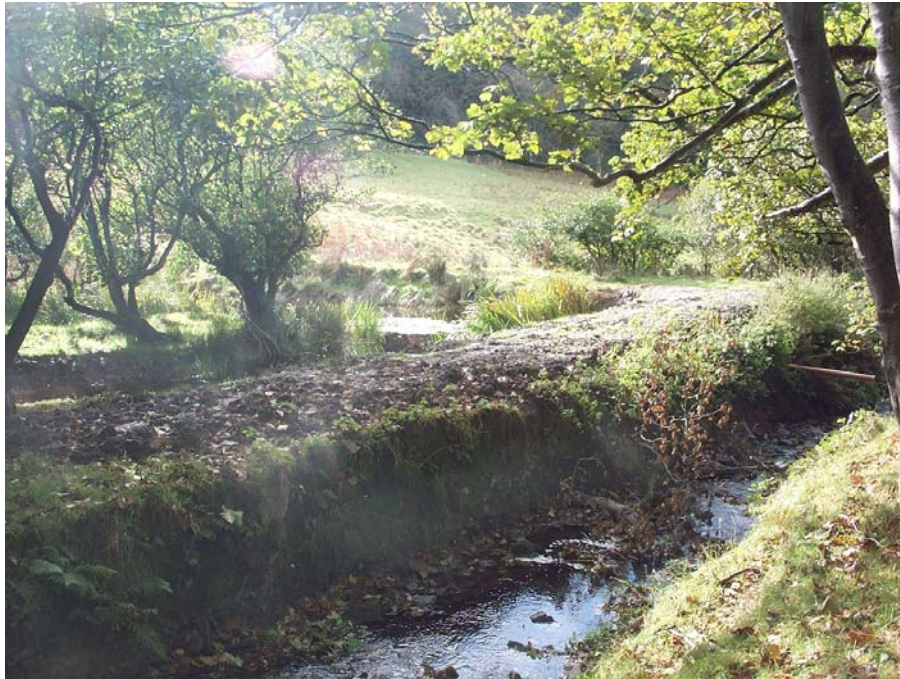
PRN	48734	Site Name	WALLOG	Grid Reference	SN59288570
Site Type	POND	Period	Post Medieval / Modern?

A pond formed by an L-shaped earth revetment bank 2-3 metres high and 6 metres wide is situated to the side of the existing stream. The revetment banks have been recently repaired and improved. It is unclear from the historic maps when this pond and revetment came into existence, the early Ordnance Survey maps (1889, 1906) do not indicate a pond but there is a suggestion of some alteration in the natural watercourse, which appears to dog-leg at this point.

Prn 48734 – beyond the stream is a large revetment bank holding a pond.

The revetment bank and pond have recently been repaired and are therefore in good order, they should continue to be kept in a secure condition.

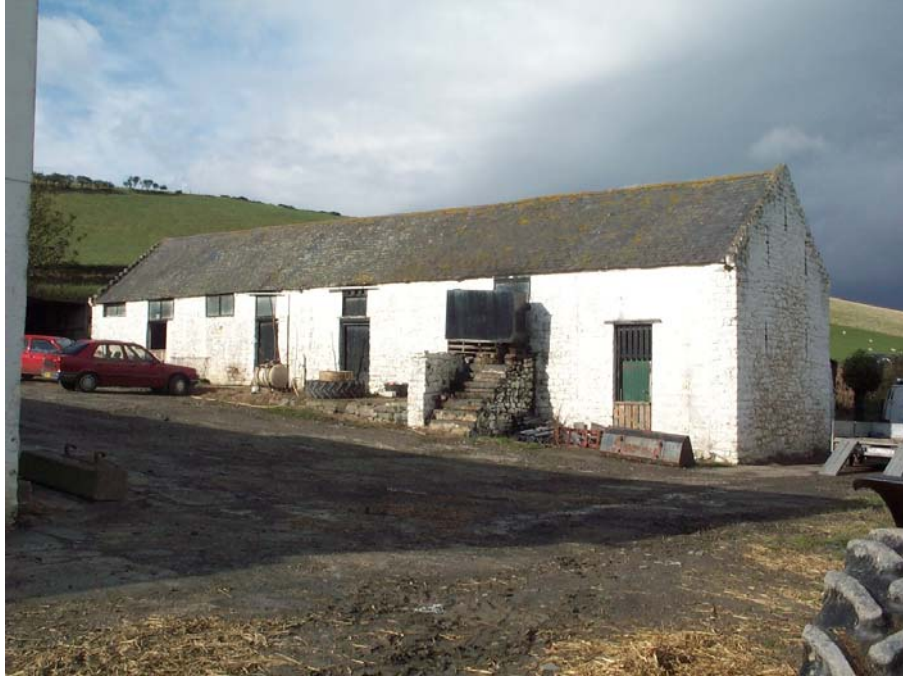
PRN	48735	Site Name	RHOSGELLAN FACH	Grid Reference	SN59598524
Site Type	FARMSTEAD	Period	Post Medieval

The farmstead of Rhosgellan fach is situated on a northeast facing slope. The farmstead is arranged on a U-shaped plan with the farmhouse situated at the top of the slope and the two parallel ranges of buildings running down the slope to either side. Adjoining the southeastern range is a series of further breeze block and asbestos buildings enclosing a foldyard.

The traditional farm buildings (excluding the farmhouse) which survive in the farmstead include the cow shed and the shelter shed. These historic buildings are distinctive in their construction, sharing a characteristic feature of raised crow-step gables, which lends the farm buildings a distinguished signature.

Prn 48735 – a cow shed on the northwest side of the farmyard at Rhosgellan fach, the distinctive ‘crow-step’ gables can be seen at either end.

The farmstead retains much of its historic integrity and although some of the buildings have been modified to a greater or lesser extent the farm preserves its historic character. This is greatly enhanced by such features as the crow-stepped gables which are very distinctive.

If any works are to be carried out on the buildings of this farmstead please inform Cambria Archaeology.
