Drefach Farm W/13/2954

Tir Gofal Farm Visit Historic Environment Report

Report No. 2002/118

Drefach
Tir Gofal Farm Visit Historic Environment Report

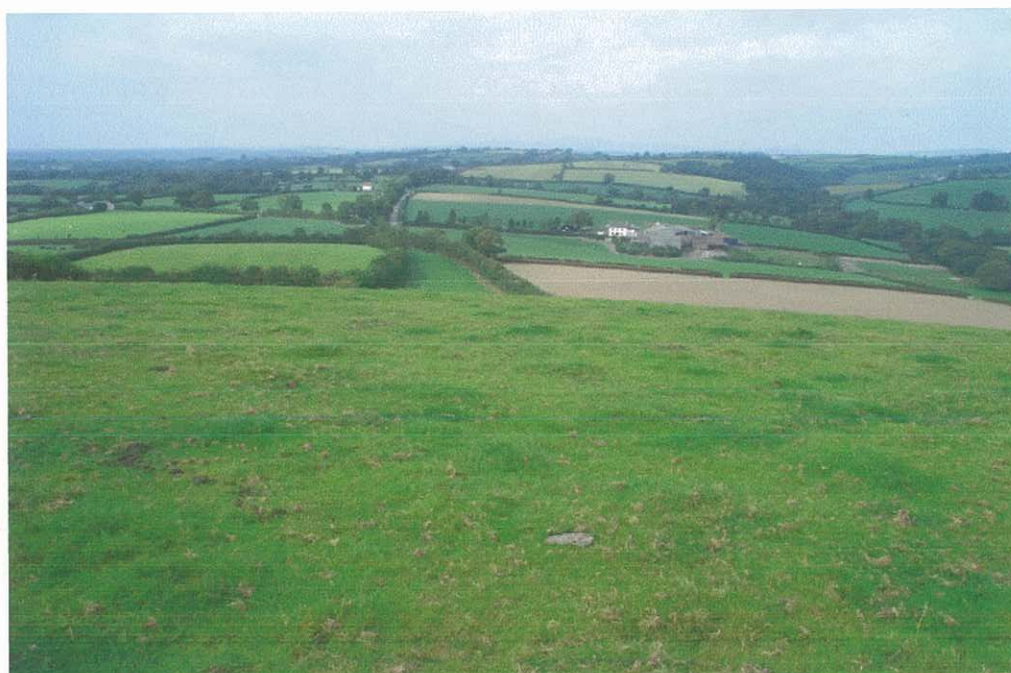
View from the hillfort, Prn 3739, across to Drefach Farm

The hillfort should be retained in an undisturbed state. Ground disturbing activities such as ploughing or tree-planting could potentially damage the very sensitive archaeological deposits which survive and therefore should be avoided in this area.

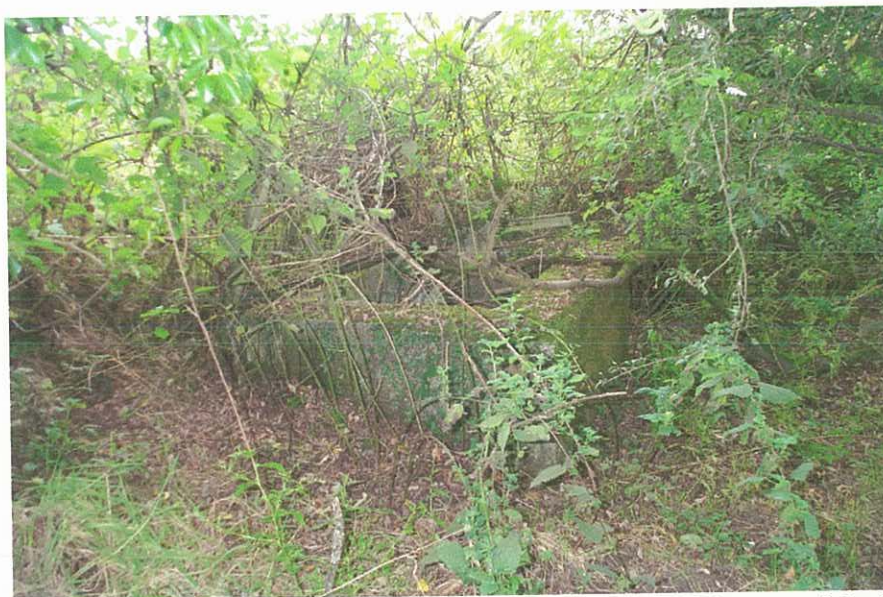
A holy well, named Canna's Well which was reputed to cure intestinal complaints, was situated to the east of Llangan church. The site is marked as a spring on the 1st and 2nd edition Ordnance Survey maps of 1891 & 1908. It is thought that works to the well in the mid 19th century caused it to dry up (Jones 1954, p204). A modern breeze block cistern now appears to mark the site of the spring, situated in an area of rough ground which is rather overgrown.

Prn 3735 – a concrete cistern appears to be the only marker of the site of the Holy Well

If any works are to be carried out on this well please inform Cambria Archaeology in advance.

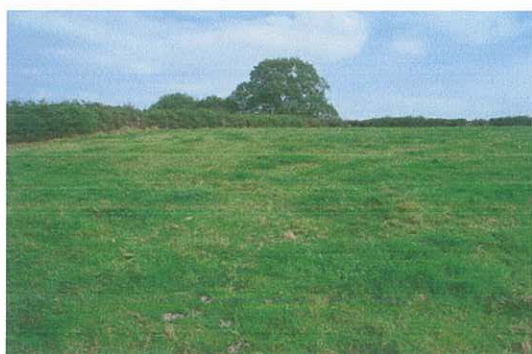
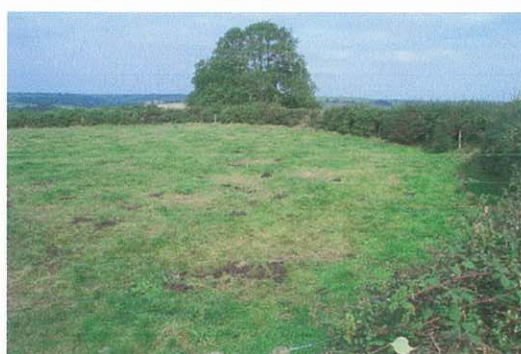
On the summit of the hill, with commanding views for miles over the surrounding area, are the remains of an iron age hillfort. This site is largely indicated by the existing field boundary which exhibits a distinctive kink and curve echoing the line of earthwork defences. There is also a slight depression, no more than 0.5 metre deep, curving around to the west of the field boundary, suggesting the line of a ditch. The field boundary is composed of a large earth bank on which a hedge sits.

It is likely that since the fields to either side of the hedgebank have been cultivated in the past, that archaeological deposits will have been disturbed to some extent. However, below cultivation levels and where the hedgebank is situated, it is possible that there is survival of archaeological features.

The hedgebank is no longer completely stockproof and it appears that, in places, stock are beginning to break down the hedge and the supplementary fencing.

Prn 3739 – the remnants of the defensive ditch can be seen on the west side of the hillfort (left) while the hedgebank appears to indicate the line of the defences to the east.

The hedgebank should be restored to a stockproof condition, if works to the hedgebank involve ground disturbance please inform Cambria Archaeology.

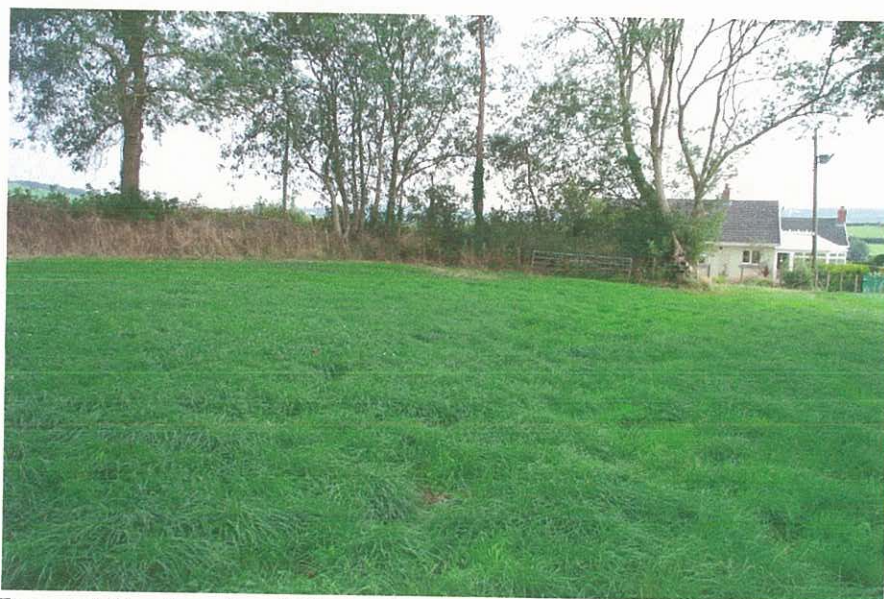
There is now no visible trace of this cottage. The only indication of the cottage is a group of three mature trees situated at the end of a field boundary which may survive from the enclosure.

This field appears to have been periodically cultivated and at the time of the farm visit had recently been reseeded.

Prn 13149 – the site of Llwyn-du cottage lies in the corner of this field.

Although this area has been cultivated in the past, there may still be archaeological deposits surviving below cultivation levels. In order to protect the site further ground disturbing activities should be avoided.

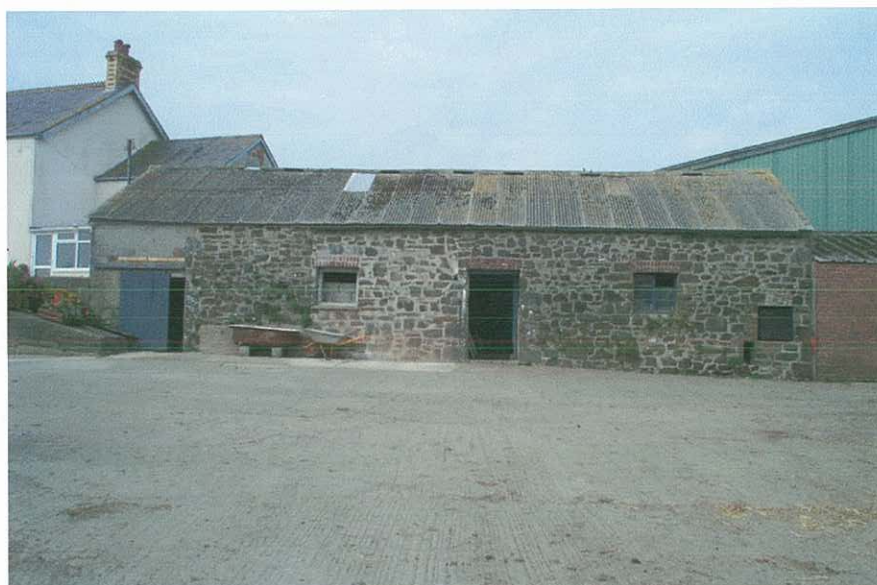
The cow shed is constructed in rubble stone walling with low brick arches over the openings. It has a central doorway with windows flanking to either side. A low level drainage opening issues from the corner of the main elevation. A doorway at first floor level is positioned in the southwest gable, suggesting that originally the cow shed was, at least in part, lofted. The roof is a simple collar truss construction with metal fixings and corrugated asbestos sheeting.

At the time of the farm visit the cow shed was in use as a feed store and in a fair and weatherproof condition.

Prn 48689 – the cow shed to the northeast of the farmhouse at Drefach

It is intended to restore this building to a slate roof and use the building as storage for a new bulk tank for the dairy unit. This would be a very worthwhile undertaking and would help to restore the historic character of the farmstead.

Hygiene regulations will undoubtedly be imposed on such a proposal, and may present problems for the restoration of an unlined slate roof. In this case it may be sufficient to satisfy health and hygiene regulations to line the roof with a breathable membrane.

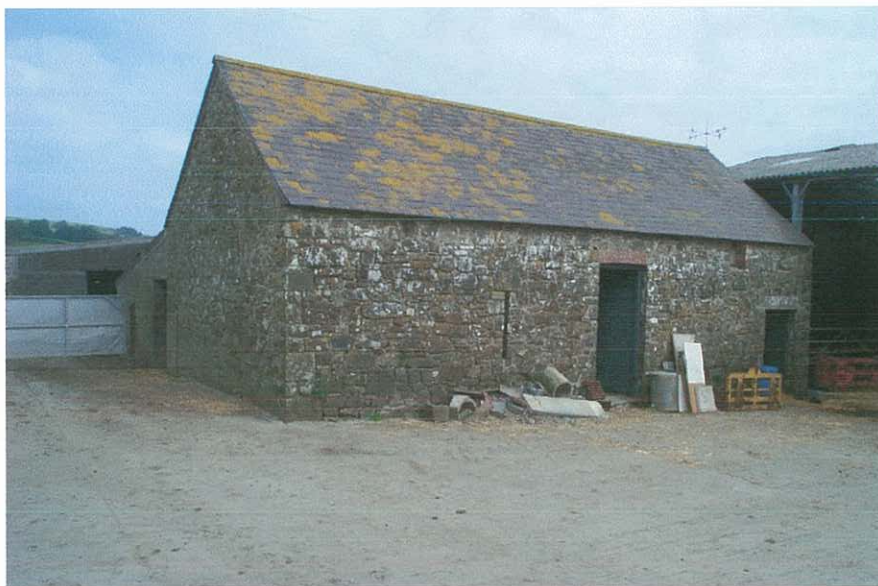
A barn is situated to the east of the farmstead and appears on the 1st edition Ordnance Survey map of 1891. Subdivided into two sections and positioned across the slope, the upper (west) end is open to the roof while the lower section is two storey. The upper end has the traditional opposing doorways to enable a through draught for threshing with a ventilation slit to the side.

The roof is a collar truss construction and was reslated approximately 10-15 years ago. The barn is in good condition and in use as a workshop. However, some slates have slipped and the masonry would benefit from repointing.

Prn 48690 – the barn at Drefach farmstead is in use as a workshop

It is hoped to carry out essential repairs to this barn through the scheme, in order to maintain the barn in good condition. Any repairs should be carried out using traditional materials, similar to those used in the original construction.
