Dol Rhanog Isaf W/13/2959

Tir Gofal Farm Visit Historic Environment Report

Report No. 2003/34

REPORT NO. 2003/34
PROJECT RECORD NO. 44238

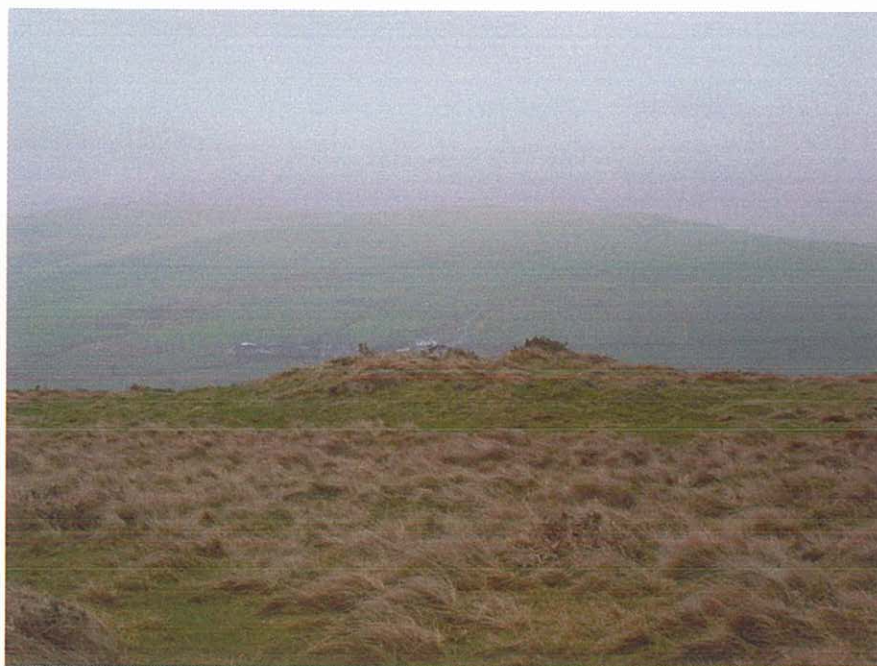
A denuded roundbarrow standing upto around 0.7 metres high, and measuring around 8 metres diameter. An even spread of angular granite blocks between 0.2 and 0.4 metres diameter visible over the surface suggests that it may be a round barrow cairn rather than simply an earthen mound. A large flat slab, possibly the capstone of an internal cist, is exposed to the south of the mound. Possible satellite cairns, (PRNs 47553, 47554) were identified c. 30 metres to the west and 40 metres to the northwest of the monument.

The site is currently under rough pasture and heather and is regularly grazed.

Plate 1- roundbarrow (PRN 1521) looking southeast

There are no immediate threats apparent from the current management regime. The monument is currently under an even cover of rough grass, which is considered to be a favourable management regime for its long term survival. Although there is currently little scrub growth on the monument itself, there are several large patches of heather nearby. Pasture is currently maintained through controlled heather burning, and if targeted to the area around the monument, this would be an ideal means of preventing heather growth over the site.

No ground disturbing activities should take place within fifteen metres of the edge of the site and it should not be used as a location for feeding livestock.

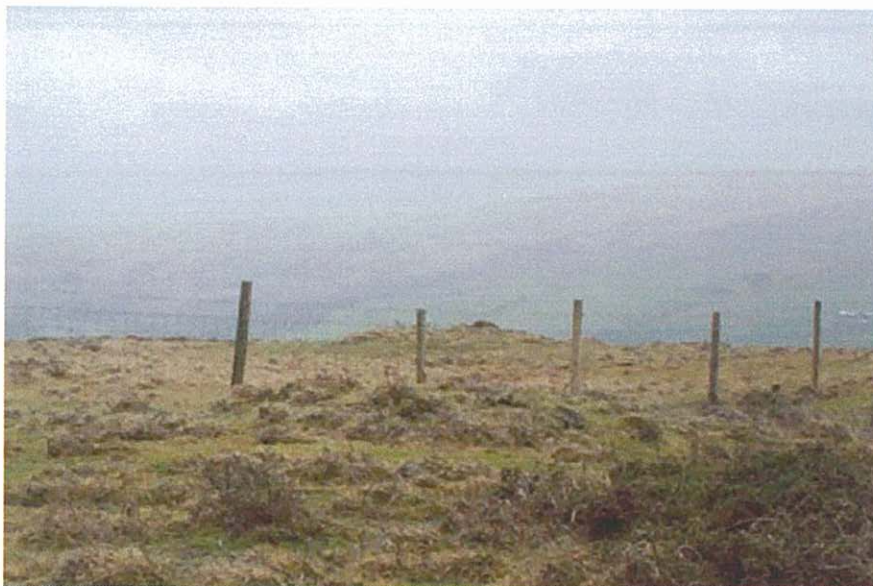
A possible round barrow located 40 metres to the northwest of round barrow (PRN 1521). This sub-circular feature measures around 6 metres along its long axis and is 4 metres at its widest point. It is much denuded and is around 0.5 metres at its highest point. An even spread of angular granite blocks visible over the surface suggests that it may be a round barrow cairn rather than simply an earthen mound. The site is currently under rough pasture and heather and is lightly grazed.

Plate 2- round barrow (PRN 47553) with round barrow (PRN 1521) in the background.

No immediate threats can be identified from the current management regime. The monument should continue to be kept clear of intrusive heather growth by targeted heather burning, followed up by sensitive grazing.

No ground disturbing activities should take place within fifteen metres of the edge of the site and it should not be used as a location for feeding livestock.

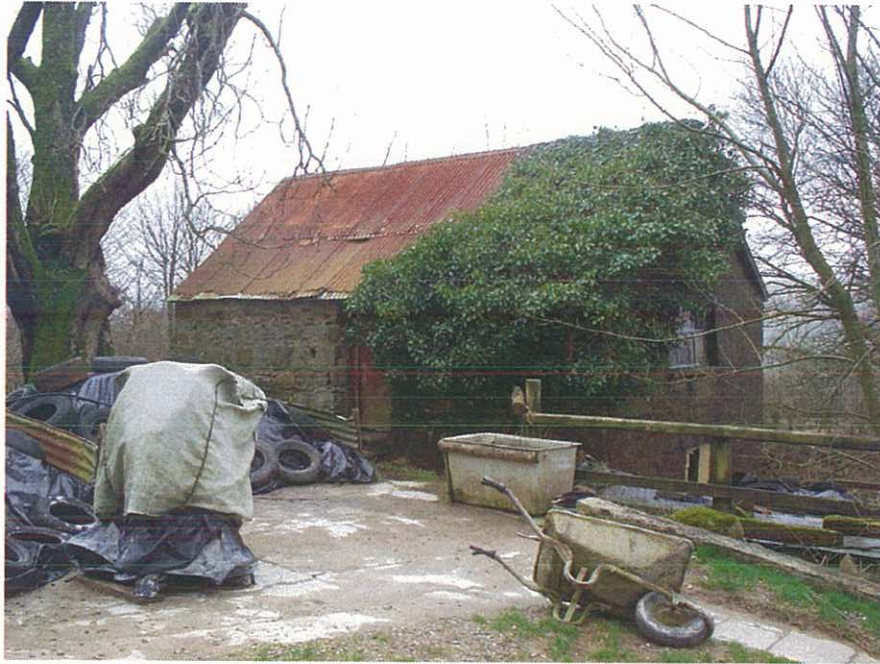
This two storey mill building is aligned north northeast to south southwest along its long axis and measures around seven metres by four metres. It is constructed of stone built to rough courses with a pitched corrugated iron roof, although the south gable end and part of the east gable wall has been rebuilt with breeze blocks. The building is situated across a steep slope and access is gained to the upper storey at ground level to the west, whilst the lower storey is entered at ground level to the east. The mill race is situated to the north of the building and the northern gable wall would formerly have supported the mill wheel, although the mill axle fitting is no longer visible. No machinery or mill working apparatus survives and the nature of the mill wheel and gearing is not known. The mill, which is shown on the 1891 Ordnance Survey map is likely to be of a nineteenth century date.

The building is currently in reasonable condition, although there is considerable ivy growth over the southern pitch of the roof, which is potentially damaging to masonry bonds. The mill is now used for storage.

Plate 3- the mill (PRN 47542) from the southwest

In order to prevent further damage to masonry bonds and the roof structure by intrusive ivy growth, the ivy should be cut back, allowed to die then removed. This should be followed up by a programme of masonry consolidation and roof repairs using traditional building techniques and materials. Any additional areas of building instability should be repointed using a traditional lime mortar mix.

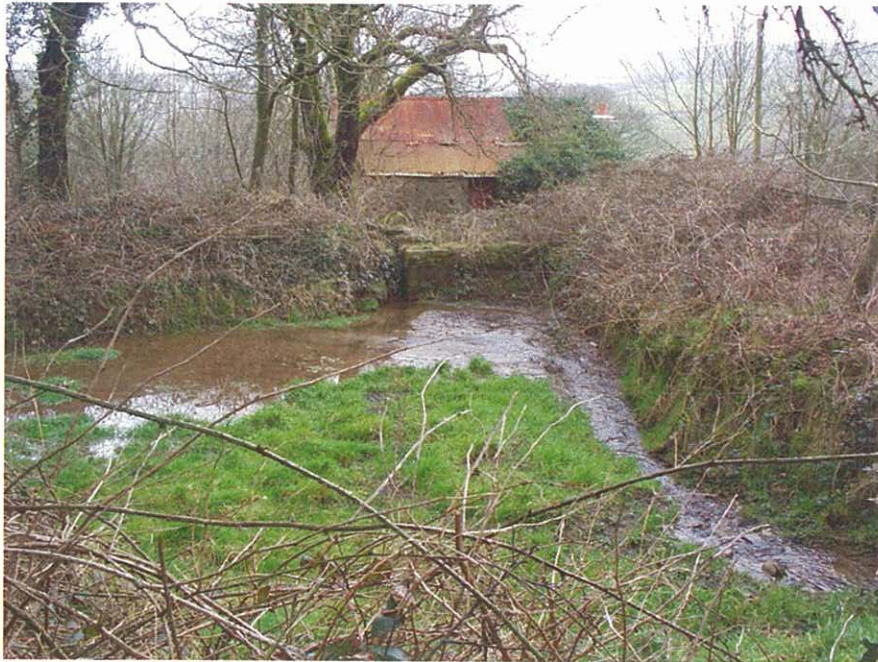
Plate 4- the mill pond (PRN 47543) taken from the south.

The triangular mill pond is first shown on the 1891 Ordnance Survey map and is located around ten metres above the mill to the west. Water is supplied from the southwest through a culvert under the trackway. The stone dam wall and sluice are currently exposed and the sluice appears to have been repointed with cement recently. The sluice gate, which would have regulated water levels originally, has been lost and the pond no longer holds water.

The mill pond is an important historic element of the farmstead. It should not be infilled. Ideally the pond should be restored to its original form as a water retaining feature. The revetment banks and dam wall remain structurally sound and the pond could be made watertight again by the reinstallation of a sluice gate.

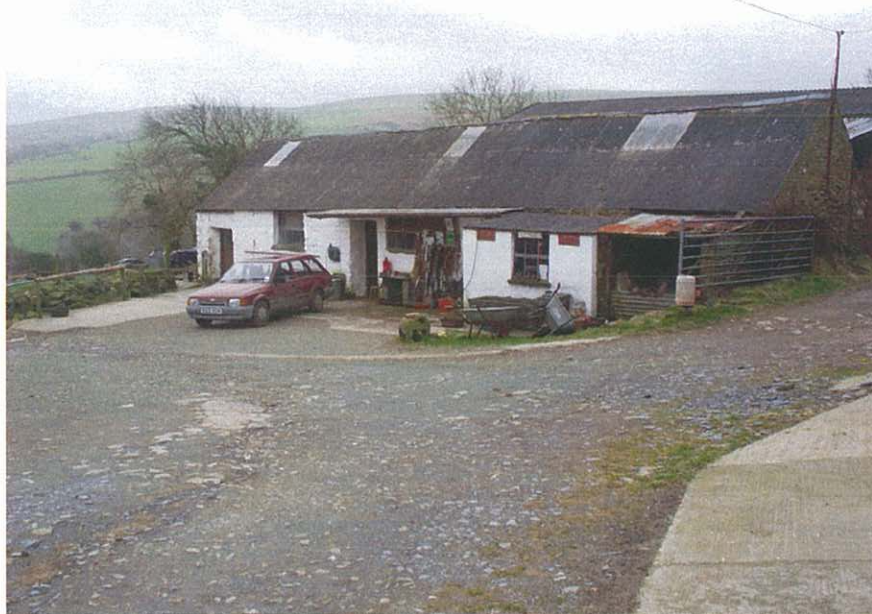
Plate 5- the northern elevation of outbuilding (PRN 47546) to the south of the farmyard

This low range follows an east-west orientation and defines the southernmost extent of the farmyard at Dol Rhanog Isaf. It is principally of rubble construction with roughly squared stone quoins, although the south lateral wall is of brick. It has a pitched corrugated asbestos roof. The building is divided into two units, separated by a brick partition wall. The western unit is accessed by two wooden heck doors in the north lateral wall and a wooden heck door in the west end of the south lateral wall. The western unit is built entirely of stone and is accessed by a doorway in the west end of the east lateral wall. The interior of the building is currently divided into stalls for horses. None of the original internal arrangements remain, and the original function of the building is not known. The building, which is first shown on the 1891 Ordnance Survey map is likely to be of a nineteenth century date.

The building is currently in a reasonable condition. Lime mortar bonds have been washed out of the west gable end, which requires some repointing with a traditional lime mortar mix. Any repair works should conform to the original building materials and techniques.

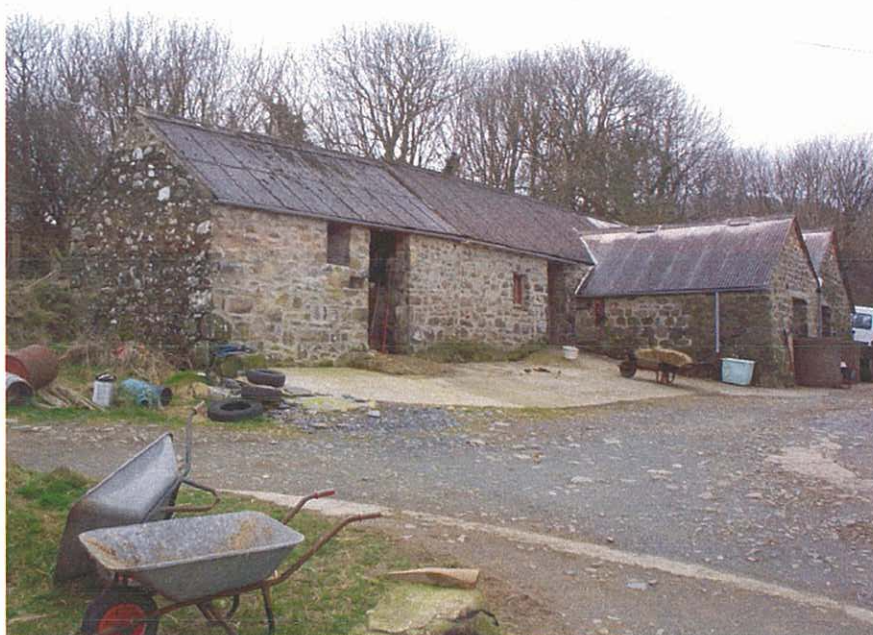
Plate 6- outbuildings (PRNs 47547, 47548) to the west of the farmyard.

This outbuilding follows a north-south alignment and forms the southern unit of the building range which defines the western extent of the farmyard at Dol Rhannog Isaf. It is of stone construction built to rough courses with a pitched corrugated asbestos roof. It is accessed by a narrow doorway in the west lateral wall. None of the original interior fittings appear to survive, although the building appears to have been used as a stable recently. The building is shown on the 1891 Ordnance Survey map and is likely to be of a nineteenth century date.

This stable follows a north-south alignment and forms the northern unit of the building range which defines the western extent of the farmyard. It is of stone construction built to rough courses with a pitched corrugated asbestos roof. It is accessed by a narrow doorway in the west lateral wall. The building is currently divided into two bays and is used as a stable. The building is shown on the 1891 Ordnance Survey map and is likely to be of a nineteenth century date.

The building is currently in reasonable condition, and the eastern lateral wall appears to have been repointed recently. Lime mortar bonds have been washed out of the rear lateral wall, which needs repointing if it is to be maintained in a stable condition necessary for its long term survival. Any repair works should conform to the original building materials and techniques.

The building is currently in reasonable condition, and the eastern lateral wall appears to have repointed recently. Lime mortar bonds have been washed out of the rear (western) lateral wall, which needs repointing if it is to be maintained in a stable condition necessary for its long-term survival. Any repair works should conform to the original building materials and techniques.

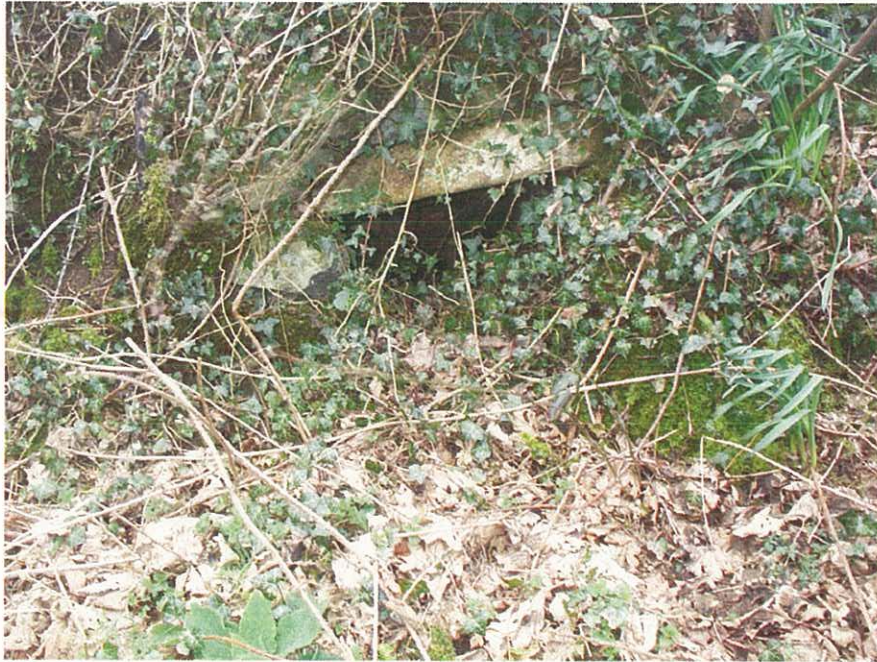
This structure is located opposite the farmhouse and is built into the structure of the garden wall. A low entrance, around 0.8 metres wide with a stone lintel gives way into a wide chamber approximately two metres wide. Such features were often intended as poultry shelters, and geese were particularly common on Welsh farms during the nineteenth century and earlier where they served a variety of purposes. Aside from providing a source of meat and eggs, they would have served as useful watchdogs. In upland areas, they were also considered to be the most effective means of controlling liver fluke. Left to graze with the sheep, the geese would eat the fluke worms (Wiliam, E. 1986). Although a function as a goose pen seems most likely, these structures could have formed a variety of purposes, and use as a dog kennel for example cannot be discounted.

Plate 7- the goose pen (PRN 47549) in the garden wall to the north of the farmhouse.

Maintain as a visible historic landscape feature.

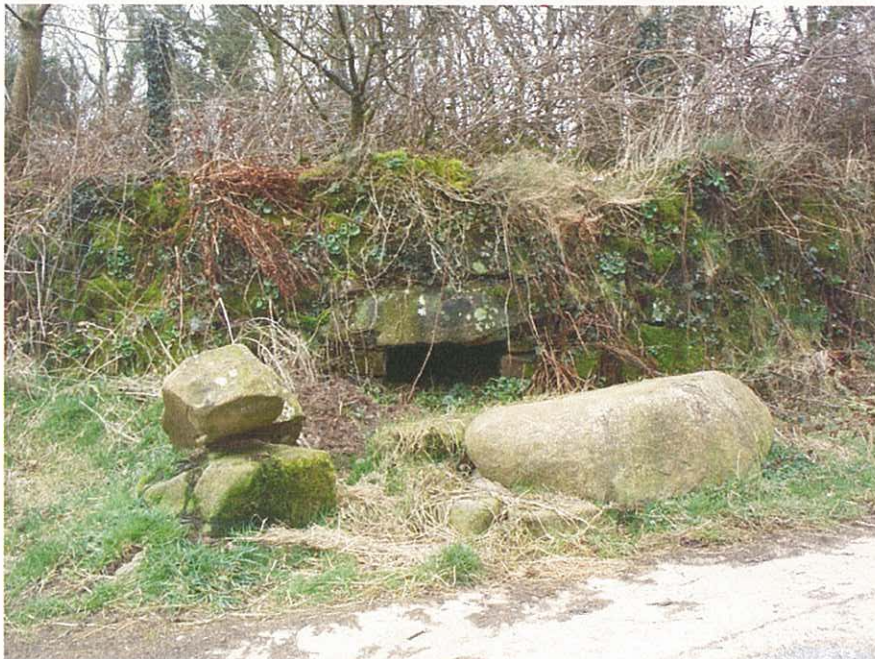
Plate 8- the passageway opening of the possible pound (PRN 47551)

This stone structure is located near the entrance to the farmyard at Dol Rhanog Isaf. A low entrance with a stone lintel, around a metres wide and 0.4 metres high leads into a long, stone passageway of equal width as the entrance, which is believed by the landowner to be several metres long. The opening lies beneath a D-shaped enclosure, aligned northsouth of around 20 by 20 metres, defined by substantial stone walls with a flat interior ground surface. The level of the interior ground surface is around one metre above the passageway entrance. Both the passageway and above enclosure are contemporary and considerable investment in time and labour would have been necessary for their construction. Such a large investment is likely to have been associated with the sheep industry, which has for a long time formed an important part of the regional economy. It is possible that the structure would have been intended as a livestock handling system where animals were sorted by being sent down a passageway into the farmyard below. No link between the interior of the enclosure and the stone capped passageway was identified during the site visit however. An alternative interpretation of this feature as a poultry shelter seems less feasible due to the effort involved in its construction.

This feature survives largely intact, and the passageway entrance and stone lintel are in a stable condition. The south wall of the enclosure is in a poor condition and has partly collapsed at the end near to the road. The other enclosure walls survive intact and are in a stable condition.

Maintain as a visible historic landscape feature. The thick stone enclosure walls should be repaired and maintained using traditional building materials and techniques.
