## **Droslyn Farm W/13/3235**

### **Tir Gofal Farm Visit Historic Environment Report**

Report No. 2002/89

CAMBRIA ARCHAEOLOGY

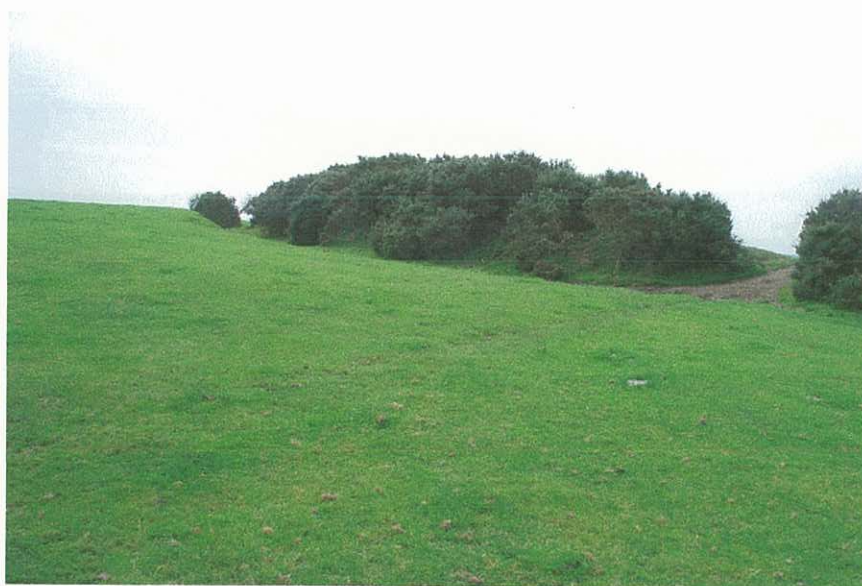
PRN 4905 - CAERAU GAER HILLFORT

"Circular enclosure consisting of a fairly flat interior surrounded by a single bank and ditch except on the east side where there are two additional outer banks and on the south west where there is also an additional bank." Cadw description 1981.

The site is currently under pasture with high gorse and scrub growth on the slopes of the earthwork defences. The site is currently suffering erosion in various places around the ramparts and poaching of the ground surface around the outer edges of the defences. This largely seems to be due to the movement of animals through narrow gaps in scrub and gorse over ramparts. This is probably exacerbated by the movement of animals to the feeders located within the scheduled area.

The following management recommendations have been formulated in consultation with Cadw:

Ideally the management of the site should aim to create a permanent grass cover over the site, which will protect the ground surface and the archaeological features.

Preferably, the gorse and scrub cover should be cut and removed from the ramparts. Stems should be cut at ground level and the roots left undisturbed. The brash should not be burnt within the scheduled area. The ramparts would then have to be routinely topped to prevent regrowth.

Alternatively, if the owners are not happy to see total gorse and scrub removal, the gaps through the gorse and scrub cover should be widened so that stock movements are not concentrated in the LB

narrow tracks. The gorse and scrub on the remainder of the ramparts should be trimmed to 1 metre in height. The cutting of gorse and scrub to this height will improve the light penetration to the ground surface and the turf layer. However, this approach would require subsequent yearly 'hedge-cutting' of the gorse to maintain this low height. Any works on the monument should be undertaken when conditions are dry.

Areas of erosion should be protected to encourage natural recovery of grass cover. This may be achieved by pinning chicken wire over the affected areas. If the eroded areas do not recover, they should be reseeded and protected.

Stock levels should be controlled to limit erosion and it may be necessary to avoid grazing the site during periods of prolonged wet weather.

Feeders, drinkers or feed supplements should not be located within the scheduled area to prevent poaching of the ground surface. If there is little alternative for the location of feeders or feed supplements they should be frequently moved to avoid erosion, although vehicular use should be limited when conditions are wet.

The site should be managed to protect the underlying archaeology and to enhance the visibility of the earthworks. Therefore, no ground intrusive activities should take place within the scheduled area and the area should be kept clear of any dumping.

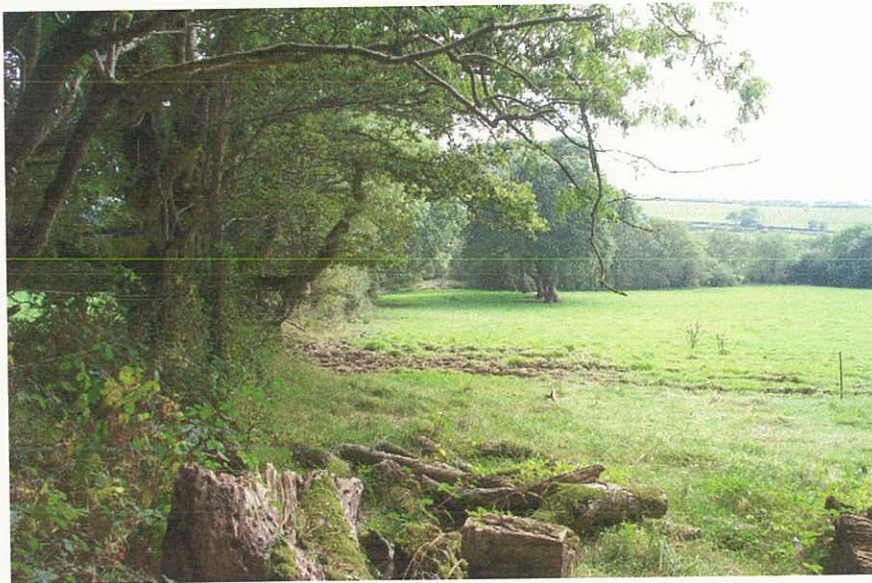
PRN 45775 – RELIC FIELD BOUNDARIES

Both the tithe map (1841) and the 1<sup>st</sup> edition Ordnance Survey map of 1891 show a field pattern which is indicative of medieval strip fields. These long narrow fields have been fossilized into field boundaries which have largely been lost. However, traces of the field boundaries survive either as a low earth bank and a line of mature hedgerow trees.

These relic field boundaries, although no longer stock proof, are the vestiges of an earlier system of farming and should be preserved as visible historic landscape features.

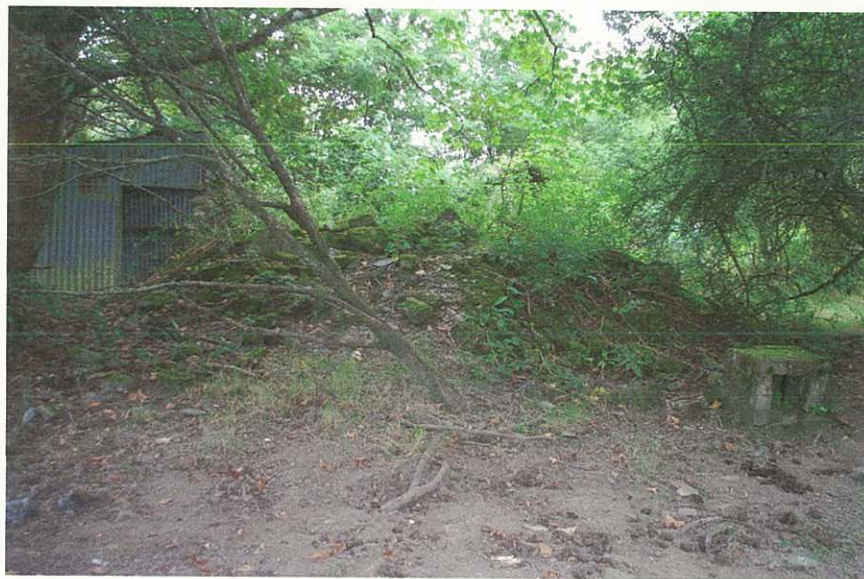
PRN 45776 – LLANDYBIE COTTAGE

The remains of a cottage are still upstanding in places to a height of approximately 2 metres high. This small rectangular building is recorded on the tithe map (1841) and identified on the 1<sup>st</sup> edition Ordnance Survey map of 1891 as "Llandybie". It appears latterly to have been used as a barn or shelter, indicated by the large double doorway of brick construction inserted into the south elevation. The remains of the other walls appear to have been of clom or mud construction built upon stone plinths approximately 1 metre high - only the plinths now survive. At the west end is the collapsed remains of a chimney stack. To the north survives an asbestos and corrugated iron lean-to. The remains are becoming somewhat engulfed by encroaching vegetation.

The remains of this cottage should be retained. Ideally vegetation should be controlled to prevent further destruction of this site.

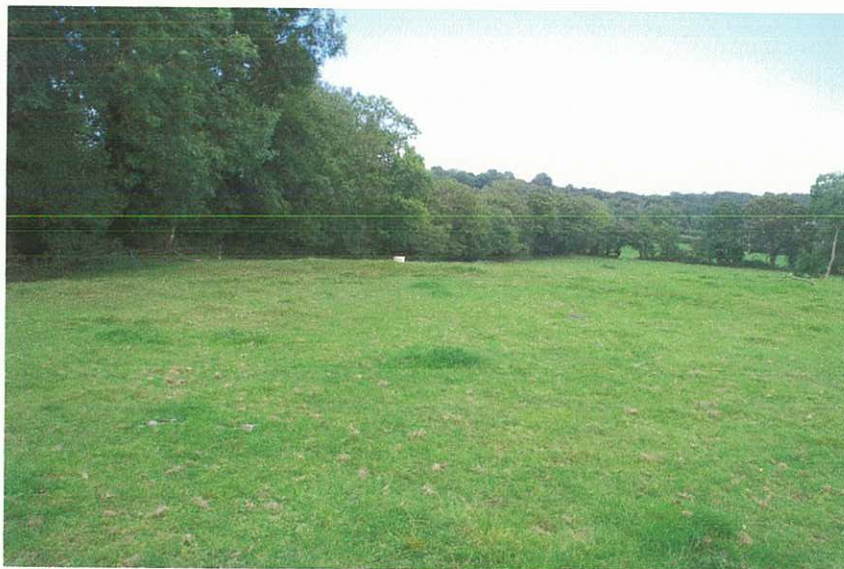
PRN 45778 – EARTHWORK REMAINS OF COTTAGES

The tithe map of 1841 records three cottages in this area. They had evidently been lost when the 1<sup>st</sup> edition Ordnance Survey map is recorded in 1891. Currently this field is under pasture and the only suggestion of the existence of these buildings are low amorphous earthworks (no higher than 0.30 metre high) to either side of a depression which leads off the trackway to the north west.

There are undoubtedly sensitive archaeological remains surviving in this area. Under the present management regime this site appears to be under no threat. This site should continue to be maintained as existing, and no ground intrusive activities should take place in this area.

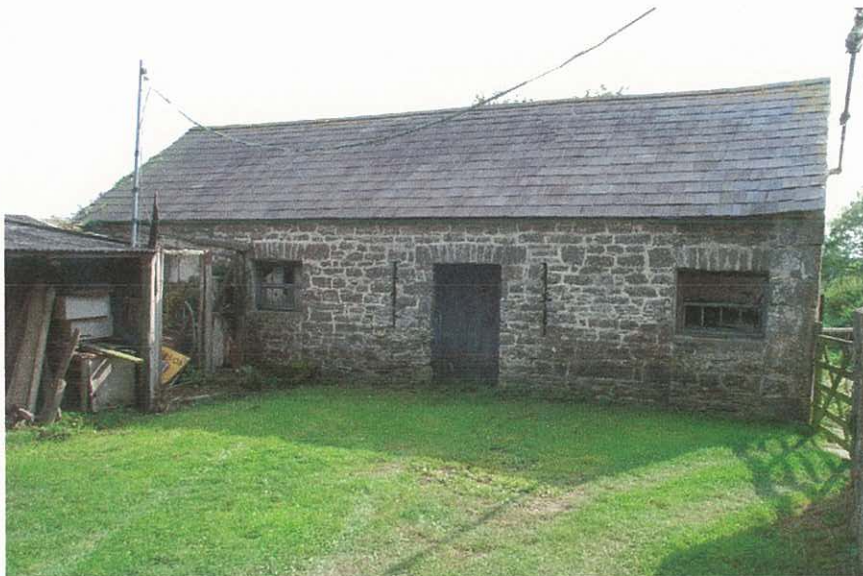
PRN 45780 – STONE BARN

A large stone barn is situated to the south of the farmyard. The barn is constructed with roughly hewn stone built to courses and large stone quoins. The original openings have flat stone arches. The north elevation originally had four doorways two of which have been half stone blocked to create windows. Two ventilation slits flank the existing doorway. The arrangement of the openings in the north elevation suggest that this building was formerly a cow shed. The west, gable elevation has a large double doorway inserted and much of this wall has been rebuilt in breeze block. The roof is pitched slate.

This barn is in reasonably good condition, although some ivy is beginning to encroach at the east gable end where the pointing is also eroded.

This barn should be retained in a stable and watertight condition. Any repairs should be carried out using traditional materials.

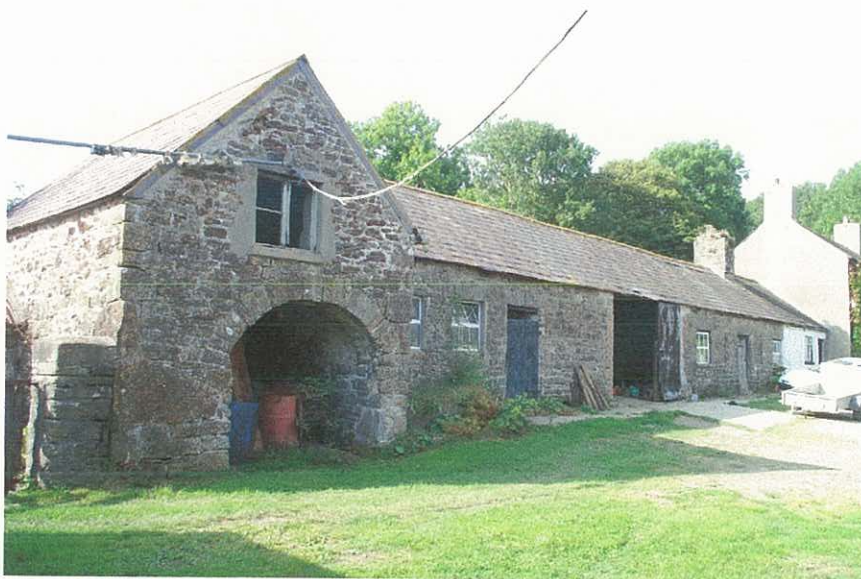
PRN 45782 and 45783 – range of farm buildings incorporating a cart shed

At the southern end of the range Prn 45783 is a cart shed built as a cross wing to the main range. To the east, in the gable wall, is a fine stone arched cart entry above which is an inserted window to the loft over the cart shed.

Extending from the farmhouse to the cart shed (Prn 45782) is a low one storey range of farm buildings. A large double doorway has been inserted into the central section to form a large open barn area.

The cart shed is currently in reasonable condition and Mr. Freeman is keen to maintain the building in a good state of preservation. Any repairs should be carried out using traditional materials.

This building is in fair condition and should continue to be maintained in a stable state of preservation. Any repairs should be carried out using traditional materials.
