Dyffryn Isaf W/13/2991

Tir Gofal Farm Visit Historic Environment Report

REPORT NO. 2002/81
PROJECT RECORD NO. 44254

Dyffryn Isaf
Tir Gofal Farm Visit Historic Environment Report

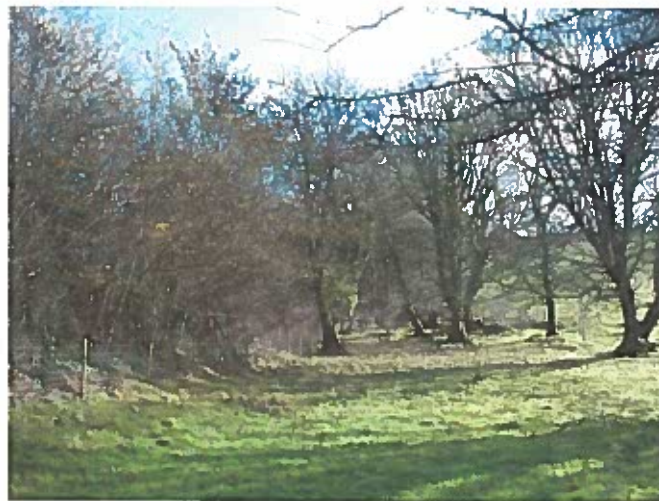
Plate 1 – Cottage site from the north (PRN23207)

This site is shown on the Tithe map and Apportionment for Llandissilio Parish (1839) as a cottage and garden owned and occupied by a George James of Marble Hall and called Ffynnon Bach. It is shown unchanged on the first and second edition Ordnance Survey maps of 1891 & 1908 respectively. It survives today as a low irregular platform fronting the roadside and with mature trees on the line of the surrounding cottage and garden enclosure.

This site should be maintained as a visible landscape feature. No ground disturbance should take place within the main focus of the cottage site. The farmer expressed a wish to plant a limited number of trees (six) within the larger area of the cottage enclosure, as defined by the mature trees of the outgrown hedgerow enclosure. Any planting of trees should take place at least 10m to the north of the cottage site in order to protect any buried archaeology which may survive in this area, and within the former cottage enclosure in order to respect the boundary line of the enclosure.

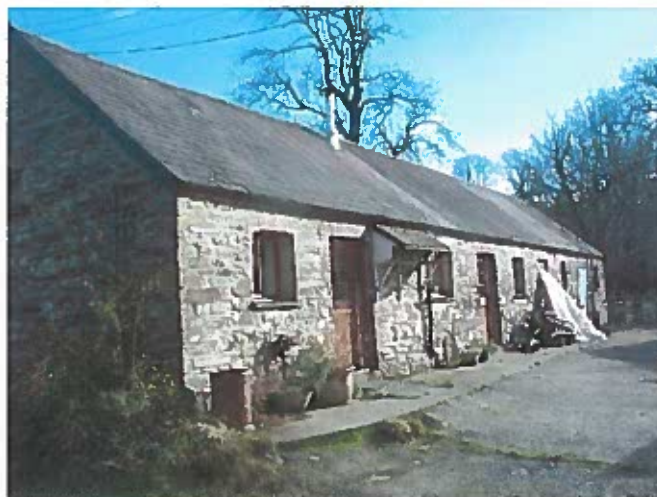
Plate 2 – Farm building (PRN 46504)

A one storey north south stone built range that has largely been converted to holiday

accommodation.

Although part of this building is in residential use, the south part is yet to be converted. It is believed that it is the farmers intention to convert the rest of this building. If any further building work is to be undertaken, attention should be paid to the use of traditional materials and methods.

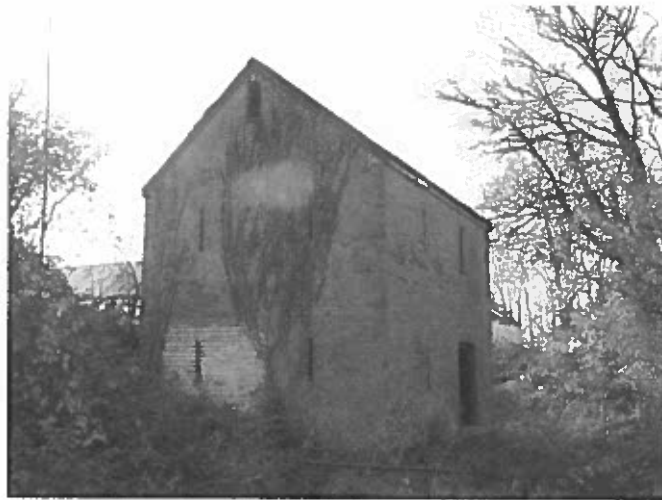
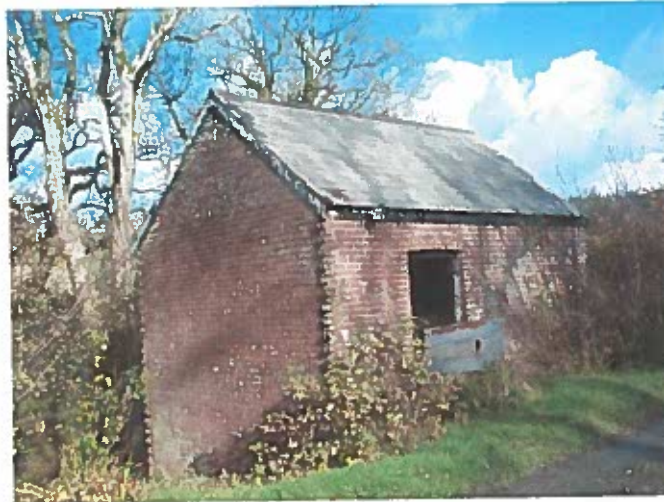
Plate 3 – Mill Building (PRN 46505)

A two storey brick built gabled building to the north east of Dyffryn Isaf farmhouse (PRN 46524). A mill building and leat at Dyffryn Isaf first appear on the 1891 Ordnance Survey map, however the present mill building is more likely to be the building that is shown on the second edition Ordnance Survey map of 1908.

The waterwheel (overshot?) would originally have been housed in an extension to the west. Modern Ordnance Survey LandLine mapping data shows a more rectangular building than exists now and keying bricks which project out of the west face of the mill building suggest that part of the original structure has been lost. The Leat (PRN 46506) would have reached the north east corner of the mill building and then been diverted around the east, south and west faces, before reaching the wheel whose axle pivoted centrally through the west wall.

There are narrow ventilation slits in the north and east faces and a narrow light high up in the east gable and above the door in the north face. A door in the north face allows access to the ground floor, and the upper floor is accessed from a footbridge over the mill race into a door in the south

face. A further (wide) door on the ground floor in the south face directly under the would appear to allow access to the mill race

Internally the wheel axle and pit wheel still survive, as well as the wheel framework, drive wheels and drive belts. On the first floor the threshing machine also still survives.

The mill building survives in a very good condition although there are a few problems concerning the fabric of the building, notably the first floor joists and floorboards as well as the roof cover and missing doors. Ideally this building should be brought back into use to preserve its long term future. It is believed that it is the farmers intention to do this and this should be welcomed. During any works on this building special attention should be paid to the preservation of surviving internal features.

Any work carried out on this building should use traditional methods and materials and may have implications for the surviving archaeology of the other mill elements, such as the wheel pit and millrace. Please contact Cambria Archaeology in advance of any works.

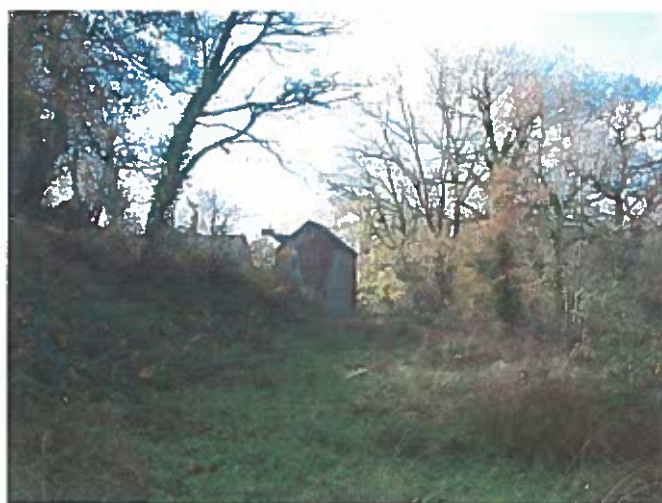
Plate 5 – View along line of Leat (PRN 46506)

The leat would have been diverted from the Afon Rhyd-y-bil near where the road from Llandissilio fords the river (SN11652320), indeed some maps mark this spot with 'Sluice' and 'Weir', and run directly as an offshoot from the stream to the mill building (PRN 46505). The line of the leat is now a levelled platform between 1 and 2 metres higher than the stream bordered by a sharply rising bank to the south. It is possible that this represents a backfilled leat trench or other form of structure.

Although it is difficult to identify any positive upstanding mill leat features, it is probable that surviving archaeological features remain within this area. Any planting of trees should take place at least 10m to the east of the mill building (PRN 46505) and at least 5m from the break of slope at the bottom of the bank which defines the line of the leat. Any planting should also be of a managed corridor of a species such as willow, this will prevent extensive woody vegetation growing in an area that is archaeologically very sensitive.

Hopefully such an approach will enable active use of this area of land whilst protecting any buried archaeological deposits.

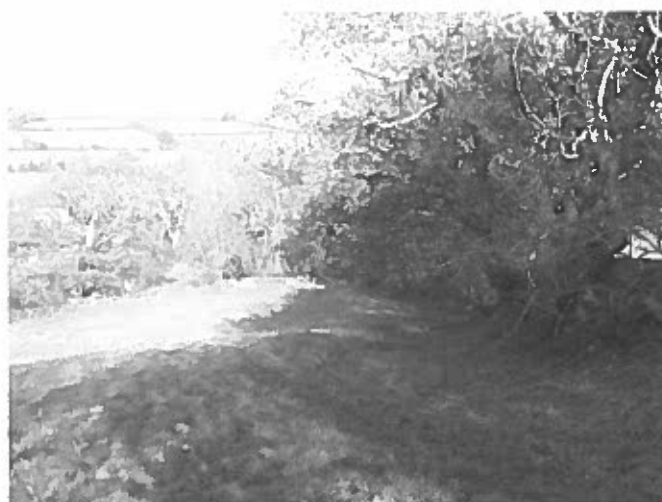
Plate 6 – Trackway (PRN 46507)

This trackway survives in two parts; a well defined straight section with hedgerow topped banks to either side to the north, and to the south a curving section, of which only a hedgerow topped bank on the east side survives and a very slight earthwork bank to the west side.

As the curve of the field boundary is shown on the 1839 Tithe Map, it is possible that this trackway pre-dates the existing field layout and the present boundary respects an earlier routeway.

The north section of this trackway is currently an integral part of the farm, it should be preserved as a landscape feature and ideally the hedgerows on either bank should be laid to maintain a viable and stock proof field boundary. If this is not done the banks should be kept in sound and stable condition and any excessive vegetation growth controlled. Any damage to the banks caused by fallen trees should be repaired.

The southern section of trackway should also be preserved as a visible landscape feature. To achieve this no ploughing or other ground disturbance should take place within 15m of the west side of the field boundary, this will protect the relic trackway. Ideally the hedgerow forming the field boundary should be laid or replanted where necessary and consideration could be given to the removal of particularly large or unstable trees to prevent further collapse of the bank. Fencing along the length of the field boundary could be considered as a short term measure and as part of a long term restoration programme. This would protect the bank and boundary from animal erosion, although would not prevent the long term decay of the boundary.
