Tir Gofal Farm Visit Historic Environment Report

Report No. 2002/103

REPORT NO. 2002/103
PROJECT RECORD NO. 44259

Dolgarreg Tir Gofal Farm Visit Historic Environment Report

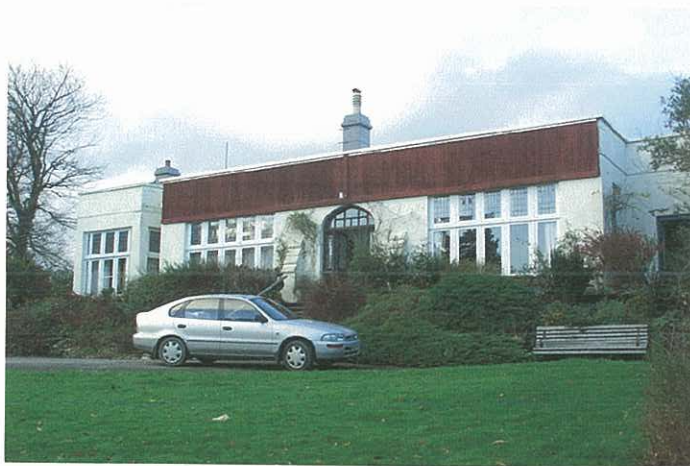
Dolgarreg is known from documents dating to 1760. The mansion was reportedly rebuilt in 1842 for Charles Bishop and a tower was later added to the house, also for him. The house is said to have contained much carved wood. However, it burnt down in 1930 in suspicious circumstances. A whitewashed large scale bungalow was then constructed on the rubble of the old house, incorporating much material taken from a South American Cruise Liner then being broken on the South Wales coast. The bungalow was topped by red stone crenellations and a greenhouse. The greenhouse was accessed by a ramp and bridge at the west end of the house. However it was regarded as a landmark for enemy aircraft during the Second World War and subsequently dismantled. The connecting bridge has also been lost, although fragments of the ramp still survive (PRN 47100). The red stone crenellations have been removed in recent years after the stone began to perish, leaving the house with the look of an Ocean Liner.

Plate 1 – South elevation of Dolgarreg house (PRN 19278)

This house is currently in use as a dwelling and is not included in the Tir Gofal agreement.

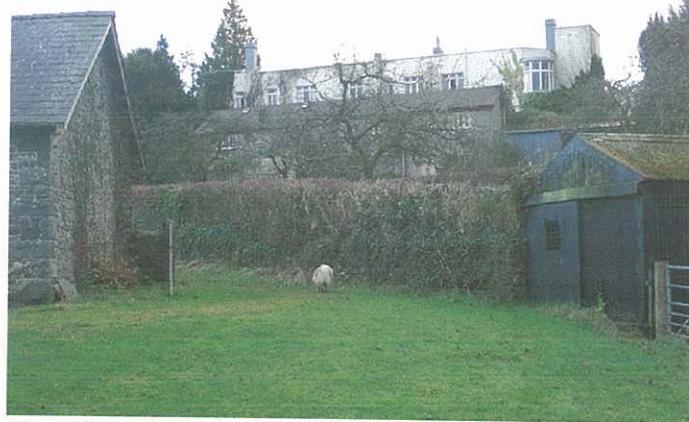
Plate 2 – View from the north of Dolgarreg house (PRN 19278)

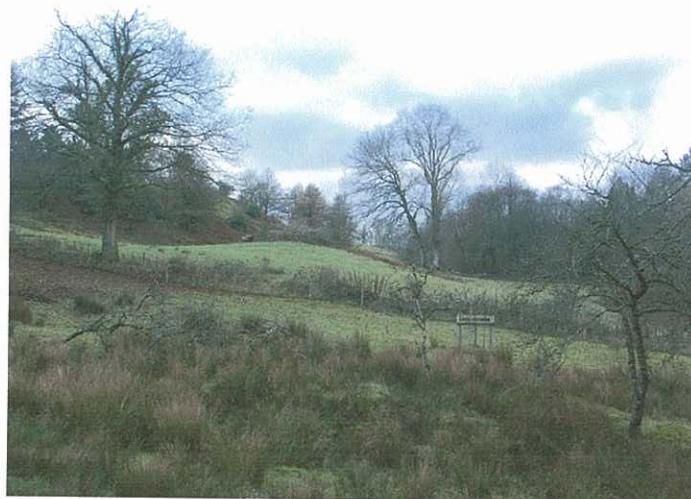
Parkland first (1891) and second (1907) edition Ordnance Survey maps and the 1844 Tithe Map for the parish of Myddfai.

Plate 3 – Dolgarreg parkland (PRN 25595)

Maintain as parkland.

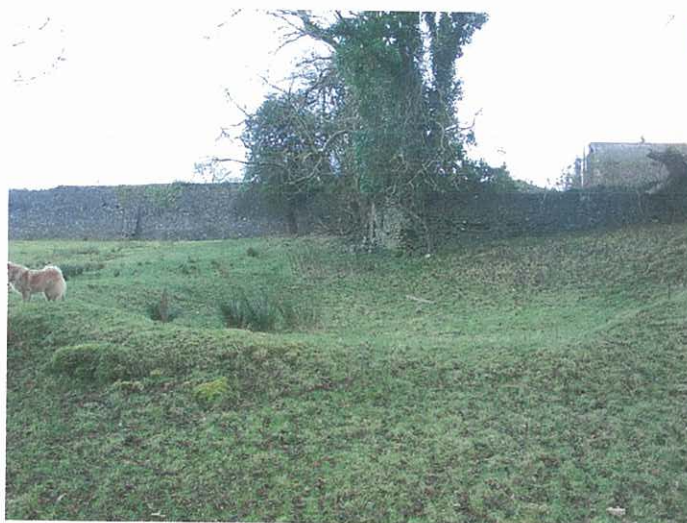
A roughly circular earthwork depression to the north of the main farm complex. It is cut into the slope with banks to its downslope side (north) and sides (east and west). It measures around 12 metres in diameter. According to the farmer this was a cockpit.

Plate 5 – Cockpit (PRN 47083) from the north

No ground breaking should take place within 15 metres of this site, and no animal feeders should be placed on or around this site.

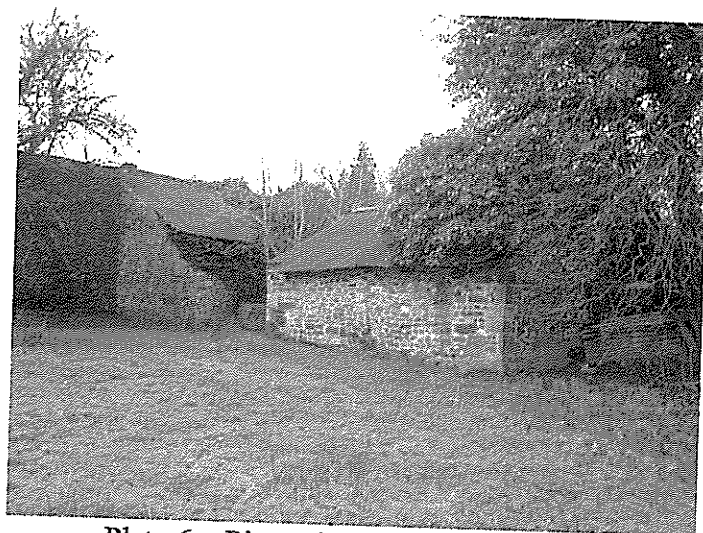
A small pigsty with a corrugated sheet roof. Due to excessive vegetation growth inside the main complex it was not possible to complete an assessment of this building. It dates to the mid or late 19th Century.

Plate 6 – Pigsty (PRN 47084), to right

Remove vegetation growth and repair where necessary any damage to the fabric using traditional materials and methods.

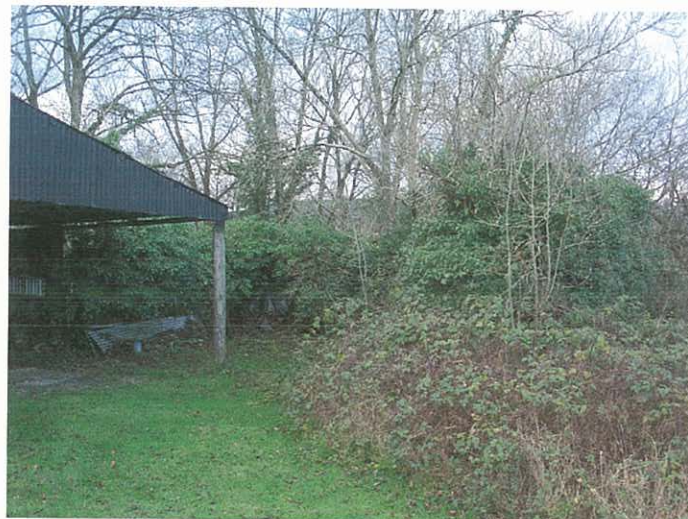
This stone building survives as an overgrown semi-derelict and partially roofed shell. It is shown on the first edition Ordnance Survey map of 1907 as a rectangular building extending along the line of the farm wall (PRN 47081).

Plate 8 – Building (PRN 47088)

The masonry of this building should be stabilised and prevented from becoming damaged any further. The vegetation growth in and around this building should be cut back to allow for an adequate assessment of the building. This will also allow better access to the farm wall (PRN

47081). It is essential for the vegetation covering this building to be cleared prior to any works being undertaken on the farm wall.

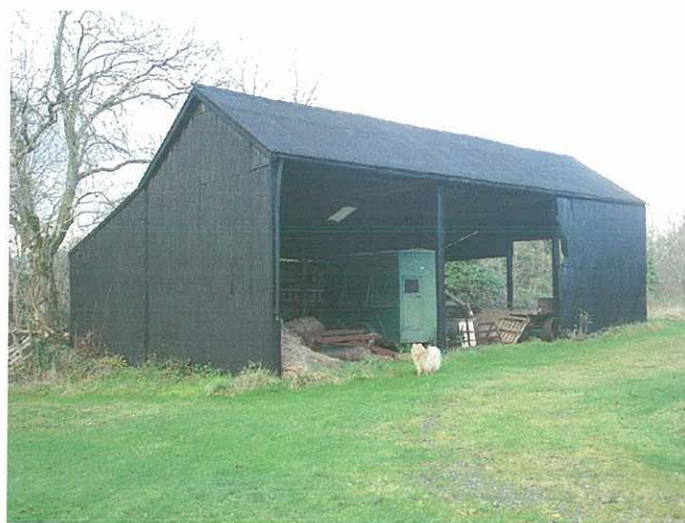
Large corrugated sheet shed sited to the north of the main farm complex, currently used and in good condition. It must have been constructed sometime during the 20th Century and after the production of the second edition Ordnance Survey map of 1907.

Plate 9 – Shed (PRN 47089)

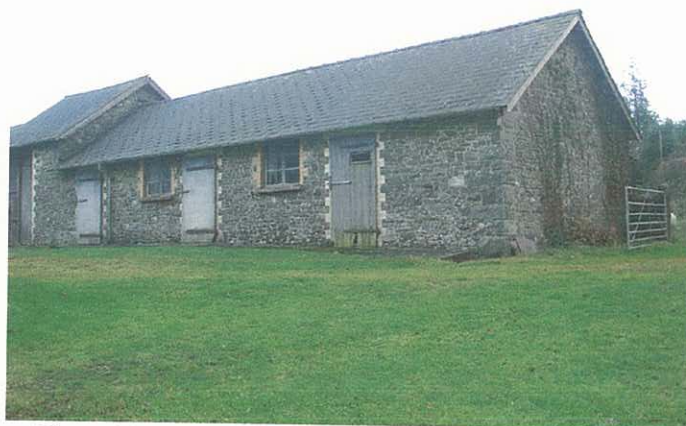
Stone built cow shed, part of a longer northeast – southwest gabled range with to the east (in order): barn (PRN 47091), stables (PRN 47092), and cottage (PRN 47093). It is subdivided into two parts: the main cow shed with two doors and two windows in the north wall and three? windows in the south wall; and a smaller room at the west end with a window in the dividing timber framed wall (?). Like the rest of this range it is built in coursed rubble stonework with yellow / beige brick dressings to each opening. The roofs have cast iron guttering throughout, and the slates are arranged in a 'staggered' pattern. It dates to the mid or late 19th Century.

Plate 10 – North face of Cow shed (PRN 47090)

This building, as with the rest of this range, is in good condition and should continue to be maintained as a usable farm building. Any works that are undertaken on this building should use traditional materials and methods throughout and be in keeping with the architectural character of the range.

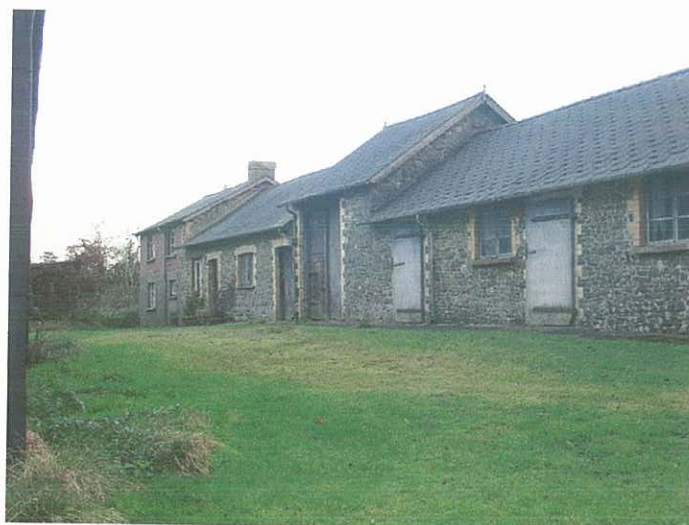
Small barn in the centre of combined range with tall wide doors in both the north and south faces. It has a higher roof line than the buildings to either side (east – cow shed PRN 47090, west – stables PRN 47092) and the apex of each gable is capped by a decorated finial. An internal door allows access with the cow shed to the west and a doorway high up in the west wall allows access to the stable loft. Presumably this provides drive in access of a cart into the barn and direct unloading of hay etc. into the stable loft. It dates to the mid or late 19th Century.

Plate 11 – Barn (PRN 47091)

This building, as with the rest of this range, is in good condition and should continue to be maintained as a usable farm building. Any works that are undertaken on this building should use traditional materials and methods throughout, and be in keeping with the architectural character of the range.

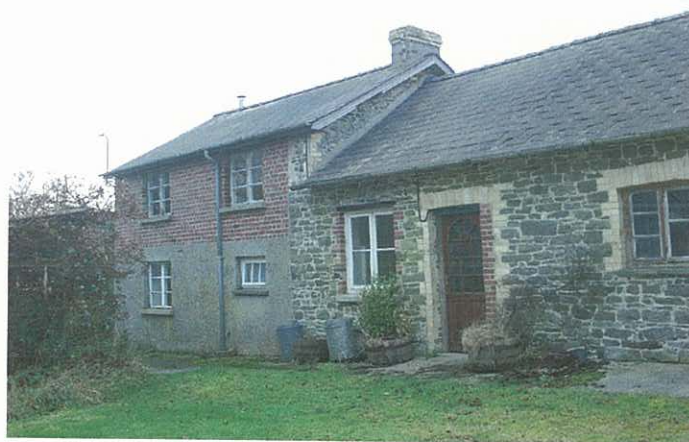
Low two storey cottage at the east end of farm building range, constructed in the 1930s in brick with roughcast to the lower half. The upper floor is served by an external covered stair on the south side and, like the ground floor, has very low ceilings. According to the farmer, Mr. Clement, the Head Bailiff on the Towy occupied this cottage until the end of the 20th century.

Although it is a later addition to the range, its west wall is of stone and has brick quoins, the same as seen on the barn section (PRN 47091), and the chimney in this wall would also appear to be contemporaneous with the rest of the range. It is possible that this cottage replaced an earlier building. It is certainly easy to think of a building with a high roof line balancing the appearance of the barn and the second edition Ordnance Survey map (1907) shows the extent of the range extending further than the limit of the stable section.

Plate 12 – Cottage (PRN 47093)

This building, is no longer used as a dwelling and apparently has been condemned. However, as with the rest of this range, it is in good condition and should continue to be maintained in its current condition. Any works that are undertaken on this building should use traditional materials and methods throughout, and be in keeping with the architectural character of the range.

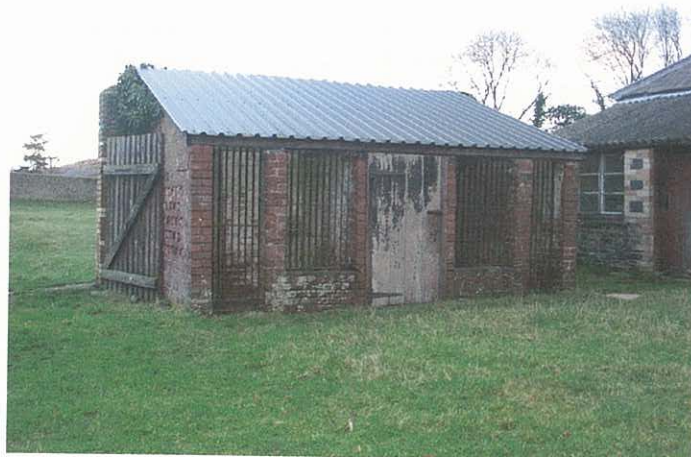
Brick built kennel against the west wall of the walled garden (PRN 47085) and adjacent to the main entry into the garden. Presumably built with the cottage in the 1930s.

Plate 13 – Kennel (PRN 47095)

This building, as with the rest of the farm buildings, is in good condition and should continue to be maintained in its current condition. Any works that are undertaken on this building should use traditional materials and methods throughout, and be in keeping with the architectural character of the farm complex.

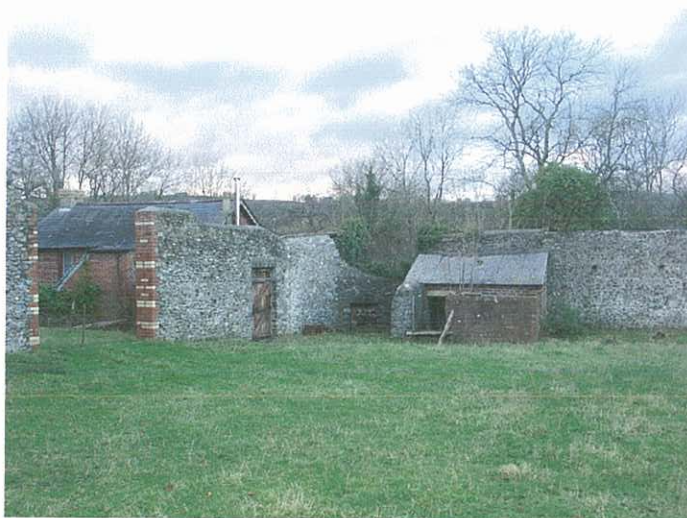
Small building (pig pen?) in the northwest corner of the walled garden (PRN 47085). The remains of a fireplace can be seen within the fabric of the walled garden and the doorway through the wall here would suggest that there was a small building within this corner of the walled garden, possibly a head gardeners cottage / office.

Plate 14 – Building (PRN 47096)

This building should be maintained as an integral part of the walled garden. Any repairs undertaken should use traditional methods and materials.

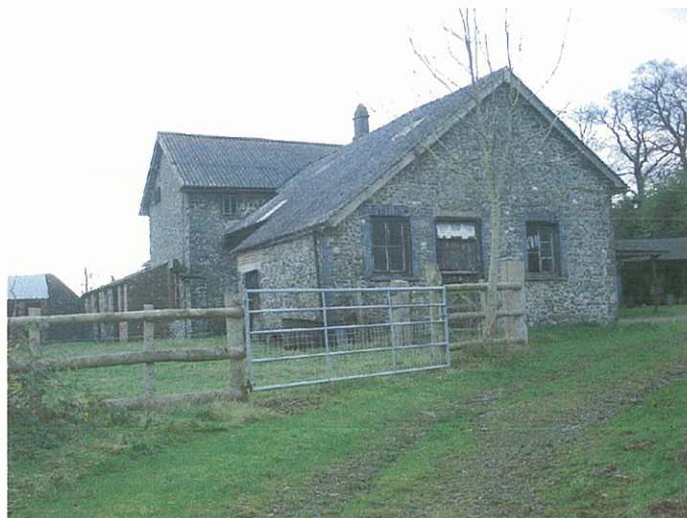
An 'L'-shaped unit comprising briefly: two coach sheds to the east wing, loose boxes and coach house proper in the north wing. It is gabled, the roof now has a corrugated sheet cover, and a low pitched lean to roof has been added to the front of the coach sheds. The roof of the coach house proper is set at right angles to the main roof and it also rises slightly higher interrupting the main roof line. The coach sheds and loose boxes remain in their original uses. However, the coach house has been converted into a separate cottage. There would appear to be a number structural additions and alterations to this building.

Plate 15 – Coach house from the west (PRN 47097)

This building, as with the rest of the farm buildings, is in good condition and should continue to be maintained in its current condition. Any works that are undertaken on this building should use traditional materials and methods throughout, and be in keeping with the architectural character of the farm complex.

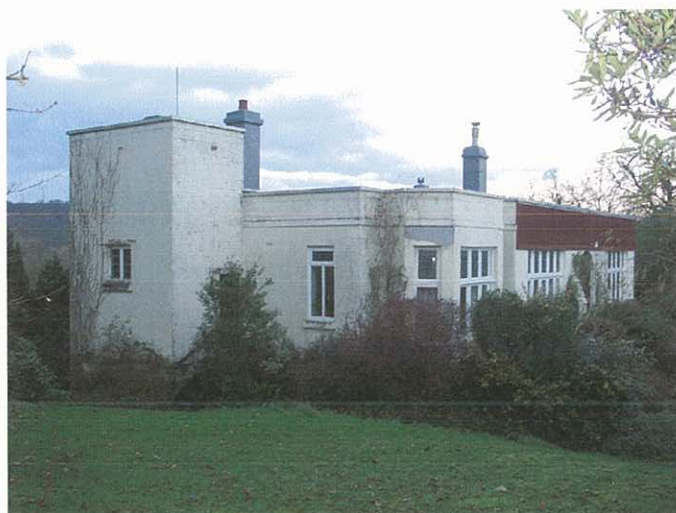
Plate 16 – Dolgarreg house from the south west (PRN 19278)
