Sunnyhill Farm W/13/3237

Tir Gofal Farm Visit Historic Environment Report

REPORT NO. 2003/20
PROJECT RECORD NO. 44263

Sunnyhill Farm
W/13/3237
Tir Gofal Farm Visit Historic Environment Report

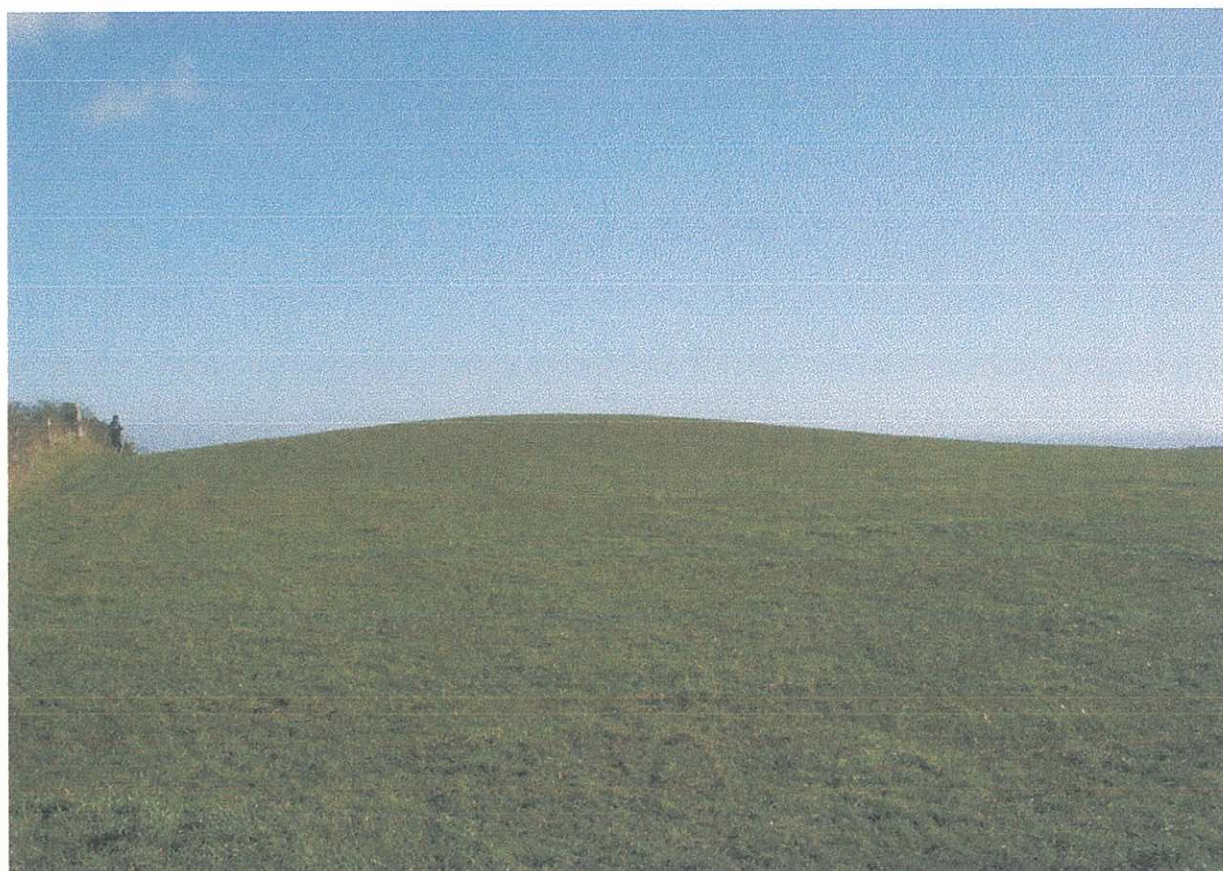
Plate 1: PRN 3532

A circular mound surviving to a height of about 1.0m, with a diameter of approximately 30m. The site has been ploughed in the past but is currently under pasture. This Bronze Age round barrow is one of a group of barrows aligned along the Ridgeway.

The current management of the feature poses no threat. It is recommended that the site is maintained in its present condition. Any further ploughing could damage important deposits associated with this scheduled ancient monument so it is recommended that an area within 5 meters of the tumulus should not be ploughed.

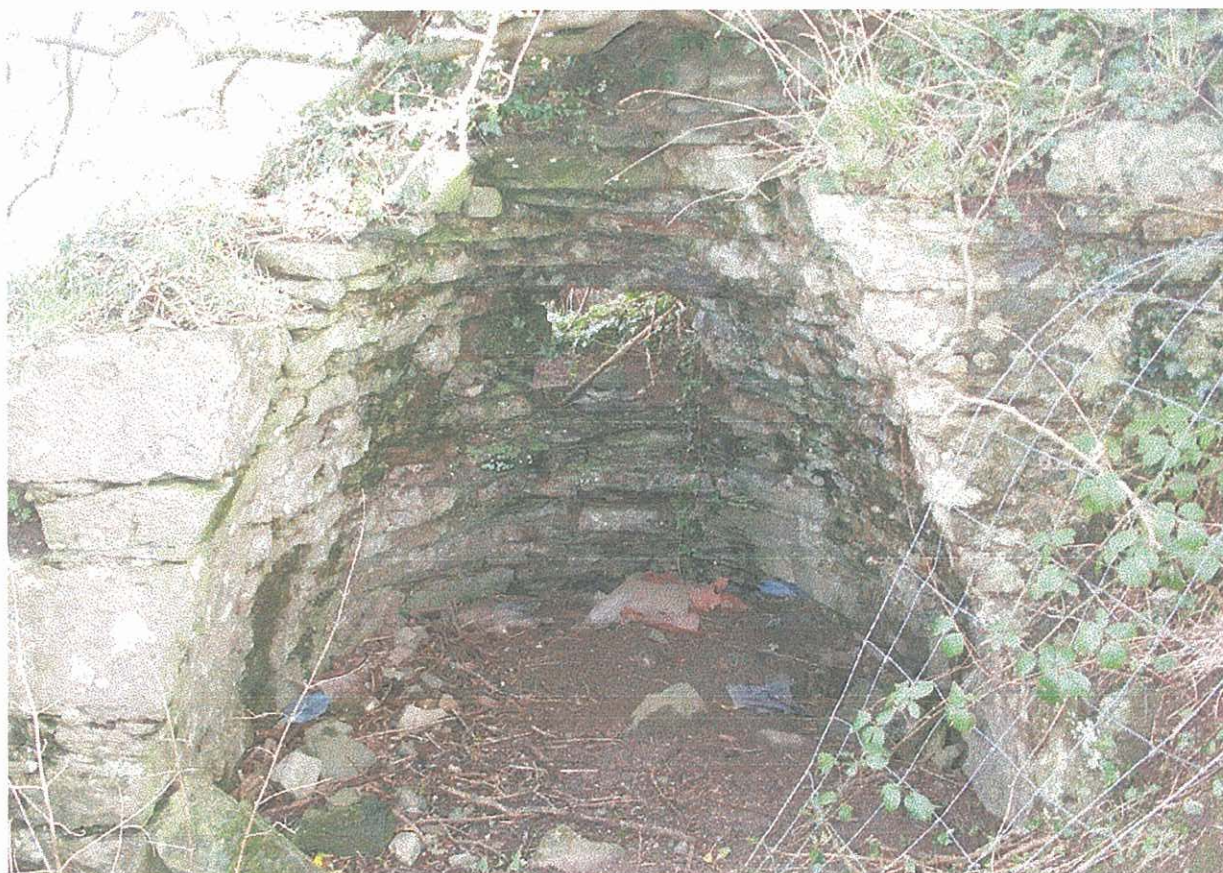
Plate 2: PRN 43272

A three quarter draw kiln constructed from limestone rubble, located on a north facing slope near Slade Farm. Only the west arch and exterior survive. The kiln structure is overgrown with a large hawthorn. The kiln appears to be built at the western end of a possibly artificial raised area between the kiln and the quarry (PRN 47462). This forms the loading ramp for the kiln. To the west of the kiln is an area enclosed with stone walls, within which a structure is depicted on the first edition Ordnance survey map. No visible traces of this survive.

It is recommended that vegetation and saplings growing on the surviving furnace structure and other stonework in the immediate vicinity should be cut back. Stumps and roots should be left in place but treated in order to prevent re-growth and further degradation of the surviving structure.

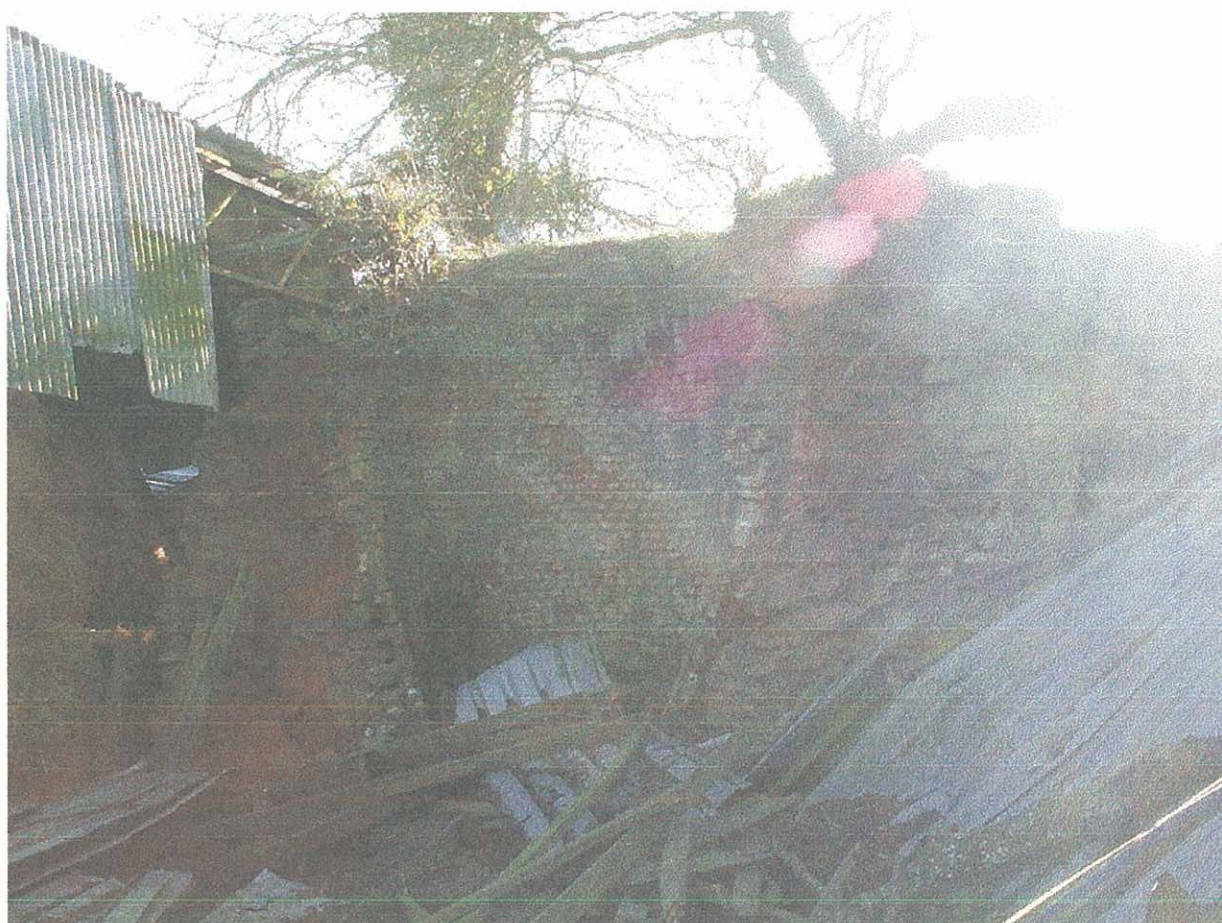
Plate 3: PRN 43274

A lime kiln located at the south side of quarry (PRN47460), built against the quarry face. Half of this lime kiln has been destroyed, presumably when a corrugated shed (now collapsed) was constructed against it. Although the shed previously protected the damaged kiln, it is likely to suffer further damage from exposure to the elements. There is a tree growing from the top of the structure. The cross section through the kiln shows its stone rubble exterior, probable earth and rubble filled core, and yellow brick lining .

In its present condition, the lime kiln is a potential safety hazard, and is liable to further deterioration. If possible, it is recommended that the tree and any other vegetation is cut back and the tree stump treated to prevent re-growth. The remains of the collapsed shed should be removed, and consolidation of the surviving remains of the kiln should be considered.

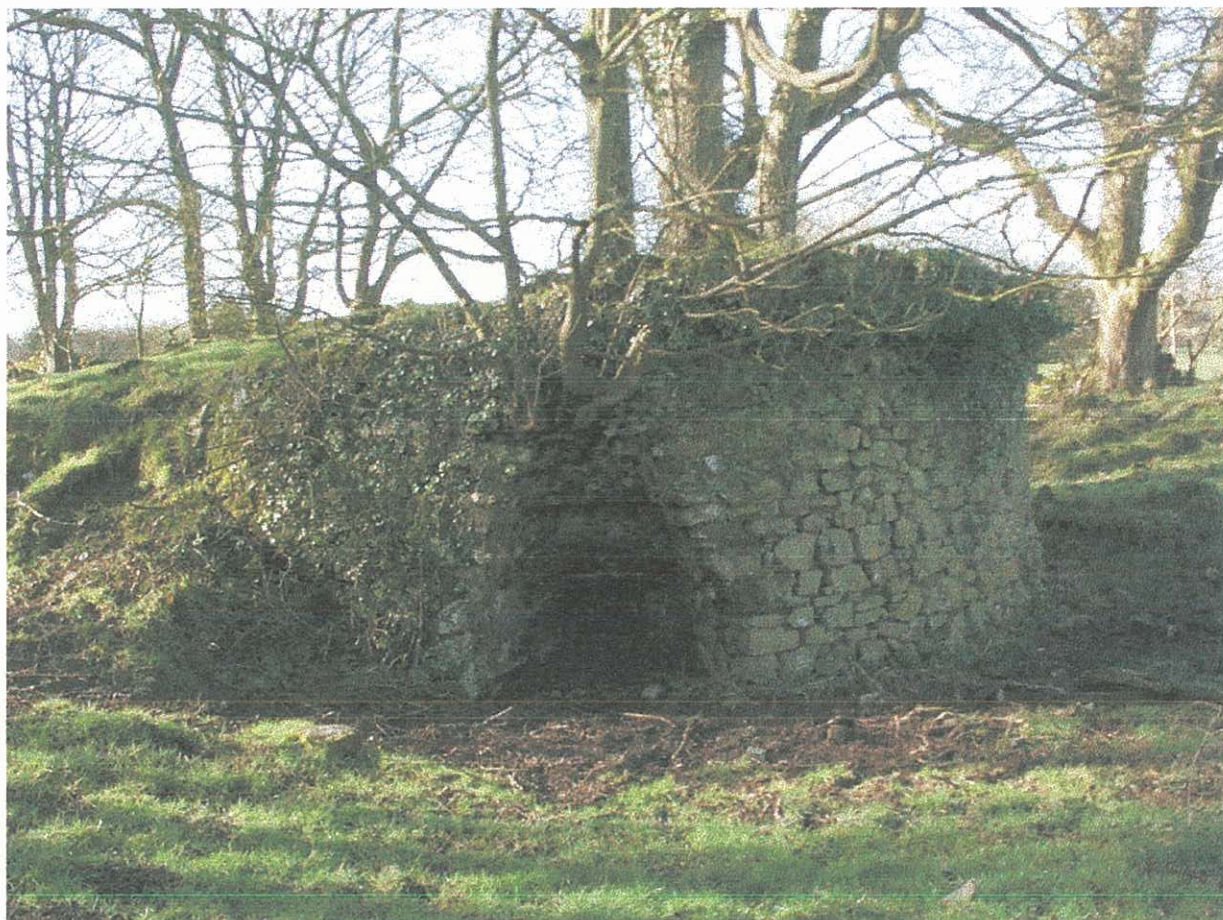
Plate 4: PRN 43275

A three quarter drawn kiln located near a small quarry to the west of Green Acres. Two drawing arches are visible to the south west and east. Part of the eastern arch is beginning to collapse. Several large trees are growing out of the structure at present. The kiln is associated with extensive quarrying immediately to the south (PRN47459).

The vegetation should be cut back and cleared from the structure, with larger trees cut to ground level and treated to prevent re-growth.

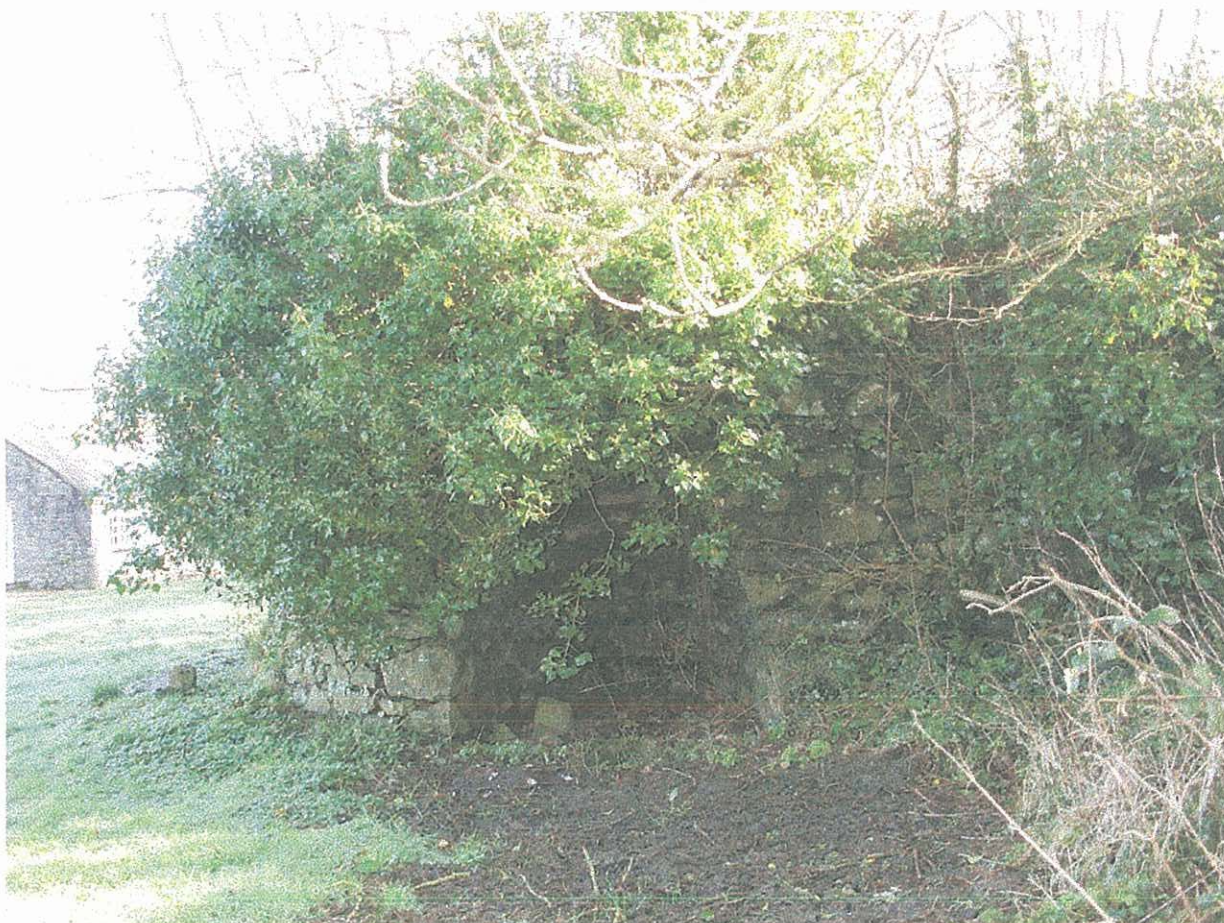
Plate 5: PRN 43277

A limestone rubble lime kiln situated at the southern end of the yard of Rock Farm built against a probable quarry face (PRN47458). A three quarter circle draw kiln with two drawing arches to the east and west. Rear arch vault and crucible collapsed. The structure is overgrown with ivy and a large sapling.

In order to slow further deterioration of the feature, the vegetation including saplings should be cut back and treated to prevent re-growth.

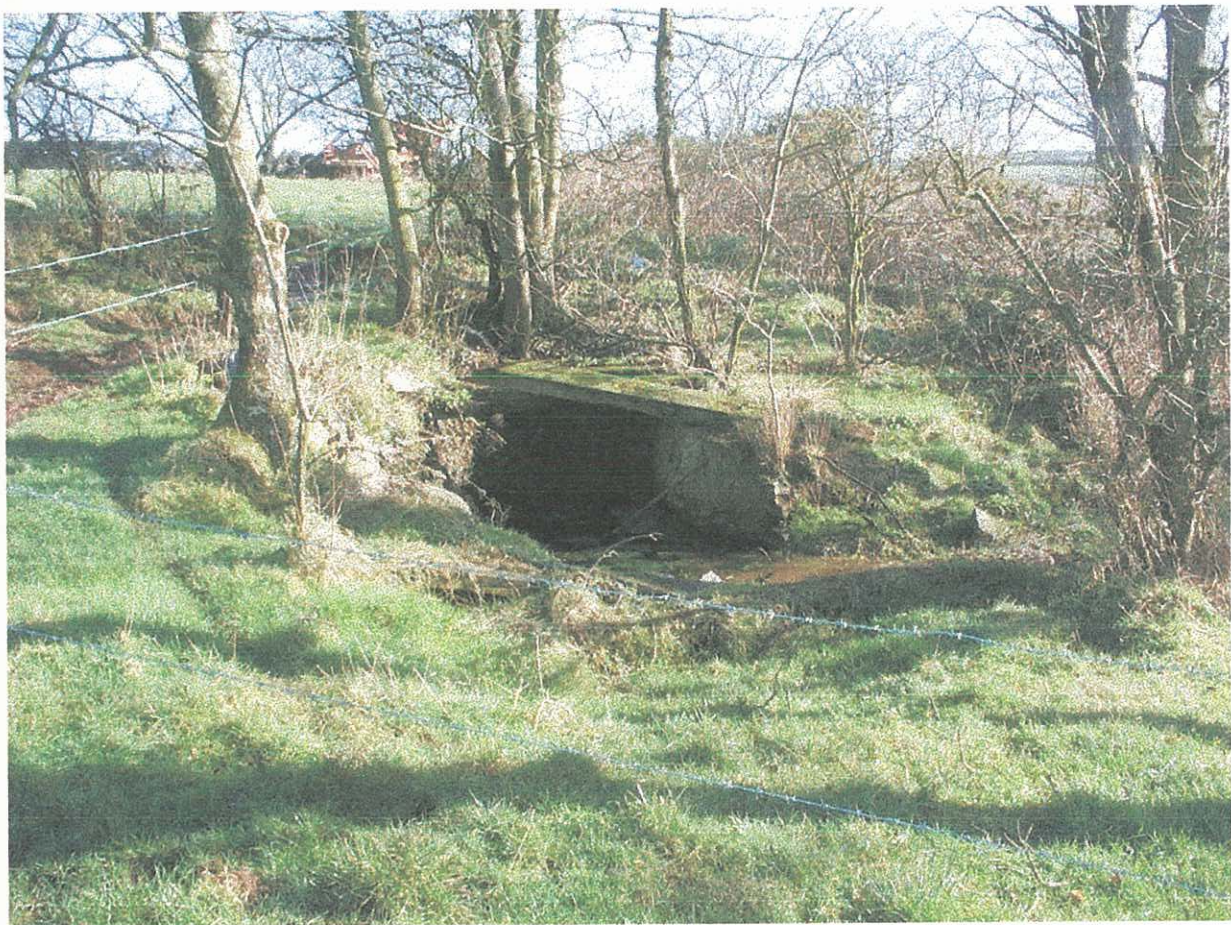
Plate 6: PRN 47456

A spring rises at this location. A low masonry wall forms a pool that may originally have been covered. Well structure presumed to be contemporary with the farm buildings.

It is recommended that any tree growth that threatens the structural integrity of the walls be removed and treated to prevent re-growth.

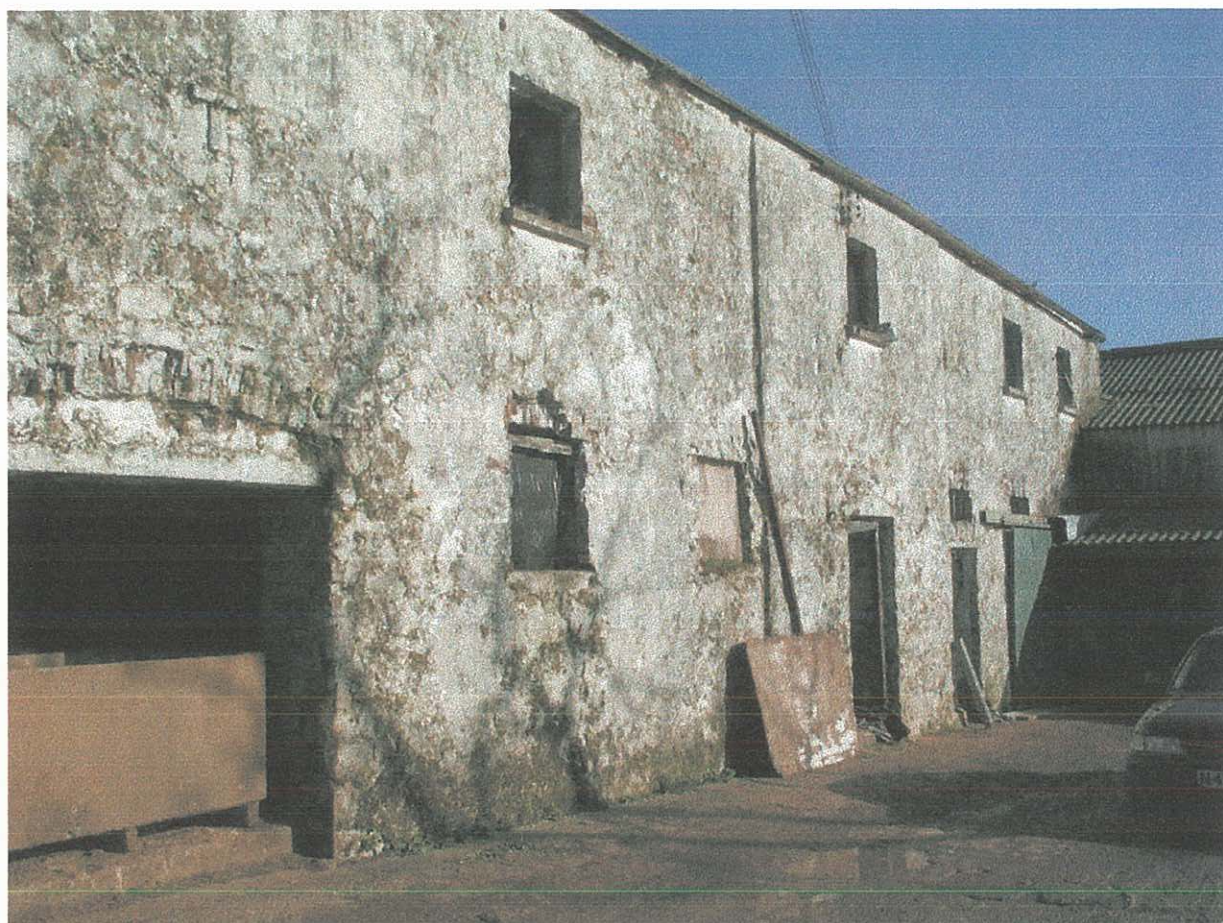
Plate 7: PRN 47457

This farm building is of two storeys aligned east-west and terraced into the south facing hill slope. Access to the first floor is from the rear. It is constructed of local stone rubble and is rendered on the south and west elevations only. Access to the interior of the building was limited but it appears to be generally structurally sound. Ground floor archways and windows have flat brick arches.

The building consists of three units the central unit extending out slightly in the southern elevation. The central unit has a single doorway with a single window above (first floor). The Right (east) unit consists of cow stalls on ground floor, accessed by two doorways with window lights above and possibly an archway (obscured). There are three windows on the first floor. The westernmost is blocked. The western unit has an archway and two windows (possibly formerly doorways) on the ground floor, with three windows on the first floor only the central window remains unblocked. The west elevation has three window openings on the first floor and a ground floor doorway. There are wall scars in the render indicating rooflines of former sheds against this wall. There is a crack in the gable wall above the first floor window. The rear elevation shows scars of a projecting wing (now absent) at the west end.

The roof is mostly intact but slates and guttering are being lost. Internally some roof tie beams have been sawn through but there is no apparent movement in the exterior walls. Wooden pegged trusses remain.

This farm building appears at present to be generally structurally sound. Repairs to roof and guttering will help to maintain the building in its current condition, but there is good potential for it to be more extensively renovated into a useful farm building. Any repair or renovation work should be carried out using traditional methods and materials. If work is to be carried out please inform Cambria Archaeology so that a photographic record of the building can be made.

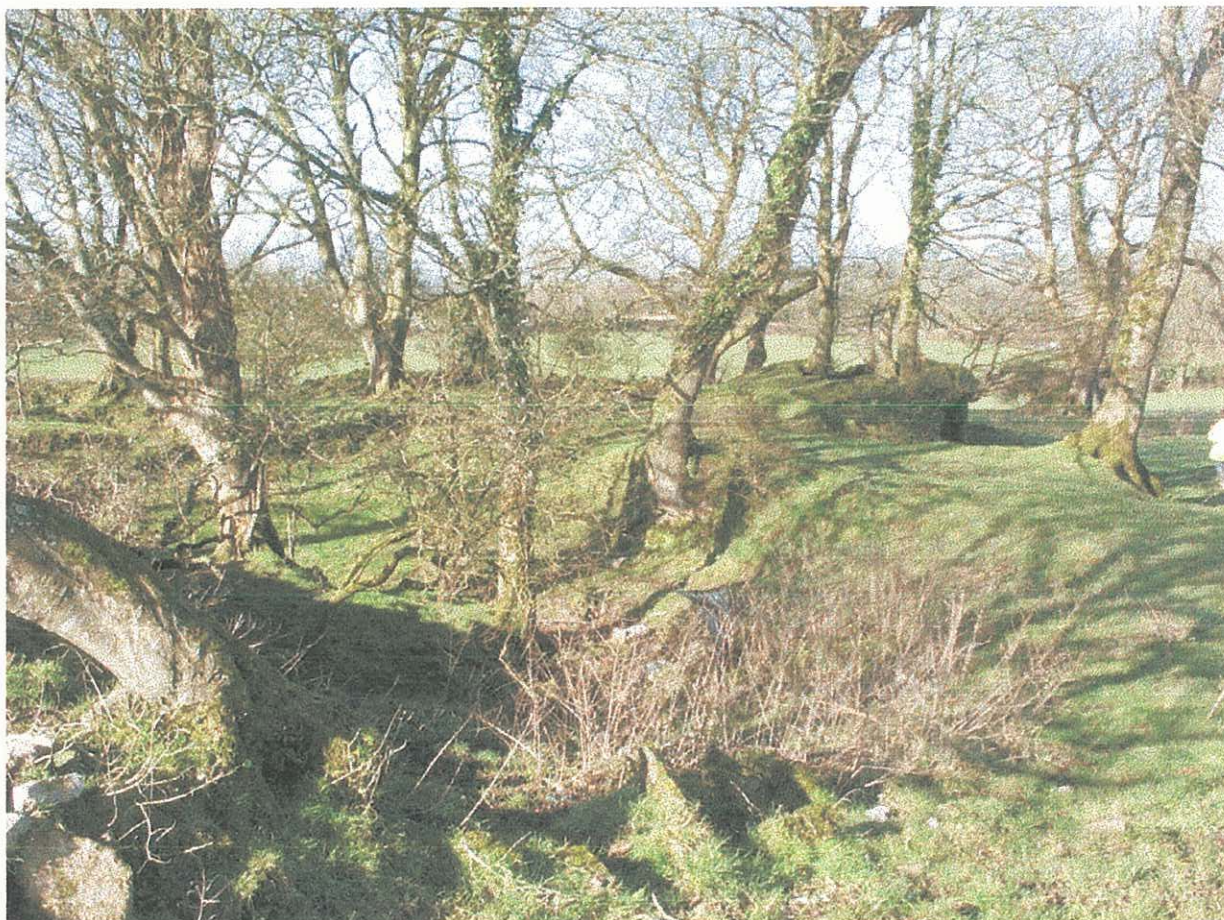
Plate 8: PRN 47459

Area of quarrying associated with lime kiln PRN43275. The site is overgrown with mature trees, but with little undergrowth, and is at present an attractive site in good condition.

Maintain in current condition.

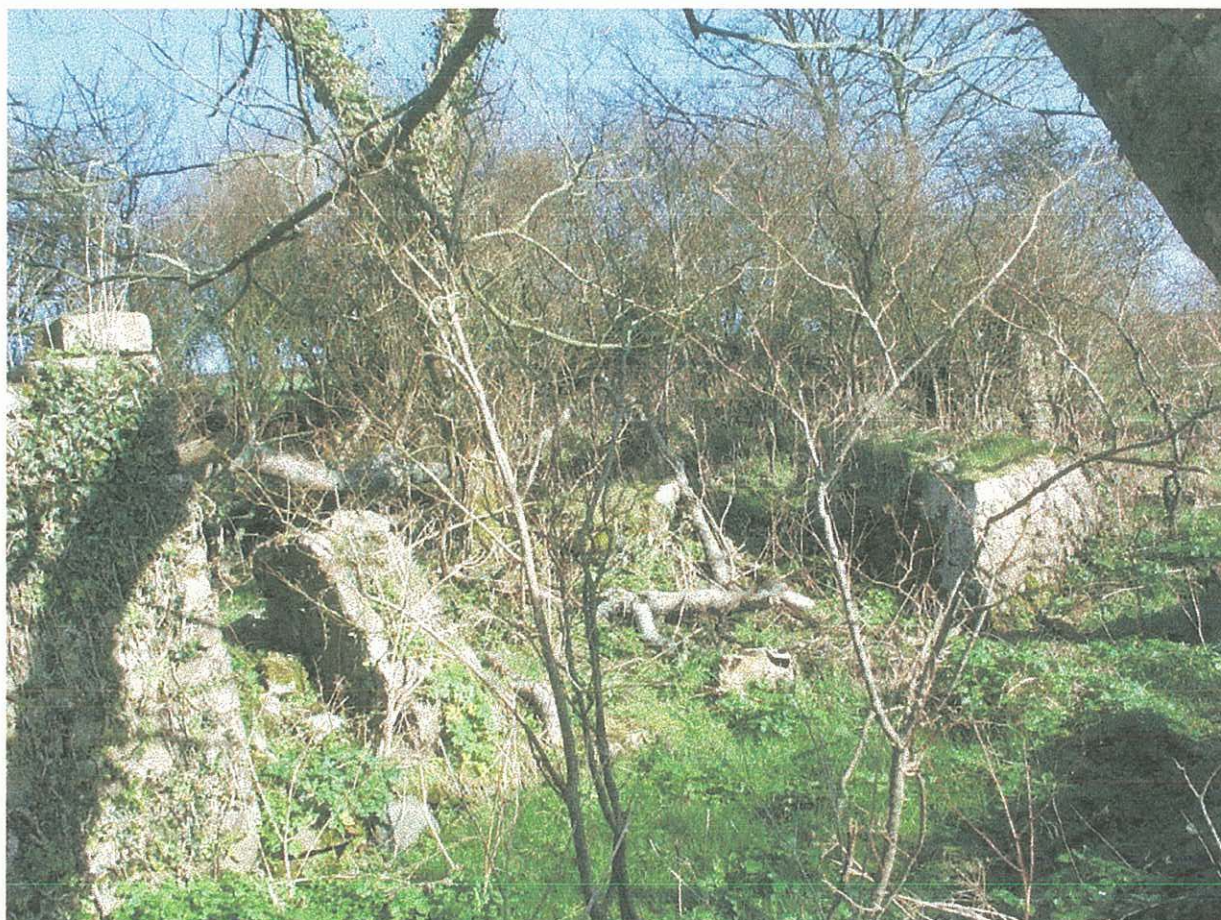
Plate 9: PRN 47461

Site of derelict cottage shown on the first and second edition Ordnance Survey maps (1891 and 1908) and the tithe map of 1840. Now collapsed and very overgrown with trees and undergrowth. Ground plan unclear but includes pigsty to west, two rooms to south and possible fireplace and steps (?) in central part.

Removal of trees and saplings likely to cause further damage to upstanding masonry, and treatment to prevent re-growth.

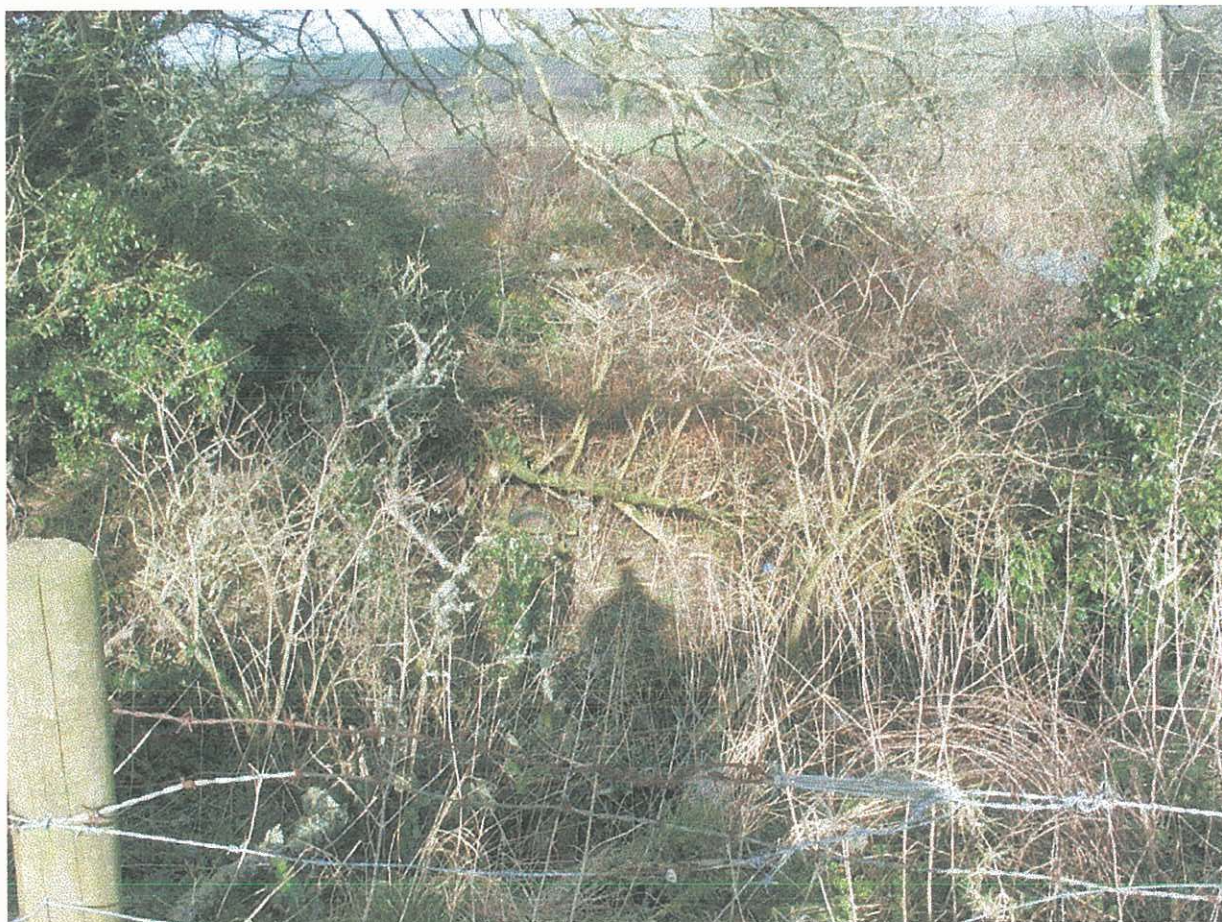
Plate 10: PRN 47462

Extensive quarrying to east of Lime kiln PRN 43272 on an east-west alignment. Indicated on OS maps first and second editions, but not on tithe map. The quarry is fenced off, very overgrown and has been used as a dump.

The removal of recently dumped materials is recommended, but any spoil heaps should be retained.
