AMMANFORD CASTLE, TIR-Y-DAIL

ARCHAEOLOGICAL EVALUATION, MAY-JUNE 2002

Report No. 2002/49

REPORT NO. 2002/49 PROJECT RECORD NO. 44889

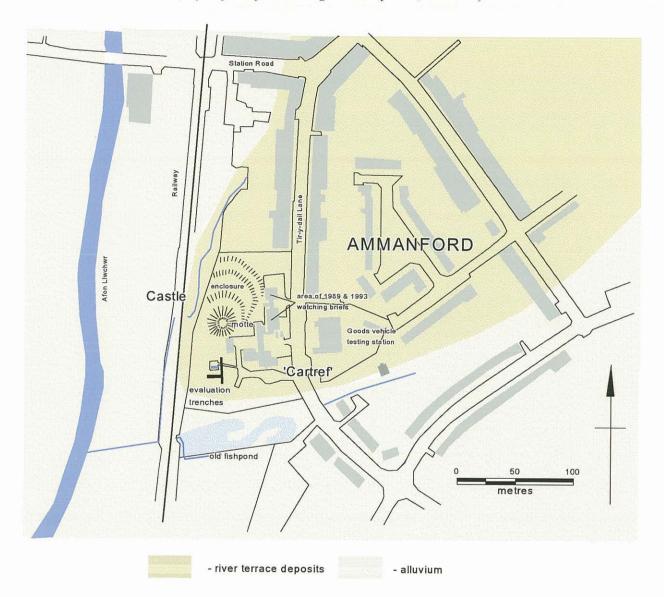
Fig. 1 – The Tir-y-dail area of Ammanford showing the castle and evaluation site (drift deposits from Geological Survey 1977, Sheet 230)

Ammanford Castle (PRN 831; SAM CM067) occupies the edge of a bluff or glacial terrace, lying some 4m above the floodplain on the east bank of the Afon Llwchwr (Fig. 1), at NGR SN 6241 1247. The solid geology is represented by the Coal Measures but, in Ammanford, these are overlain by undifferentiated river terrace deposits (Geological Survey 1977, Sheet 230). These drift deposits, glacial in origin, form a 'tongue' beneath the castle site itself which extends a short distance southwestwards of the castle into the alluvium of the Afon Llwchwr, accounting for the sharp downhill terrace 50m south of the castle.

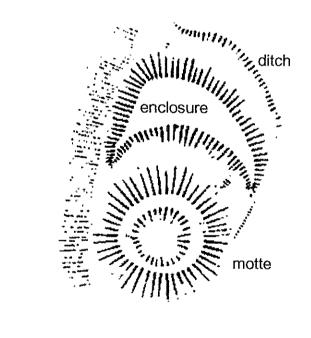
Fig. 2 - Paul Davis' plan of Ammanford Castle (reproduced, with the author's permission, from Davis 2000, 21)

The most visible feature on the site is the large tree-covered earthen mound immediately northwest of the Day Centre (Figs. 1 and 2). The mound is c.6.5m tall, with a basal diameter of c.35m, and there is a hollow in the summit measuring 15m in diameter and 2m in depth. Possible traces of a ditch around the mound can be seen in the overgrown area on the south side, where it may have been deliberately filled in.

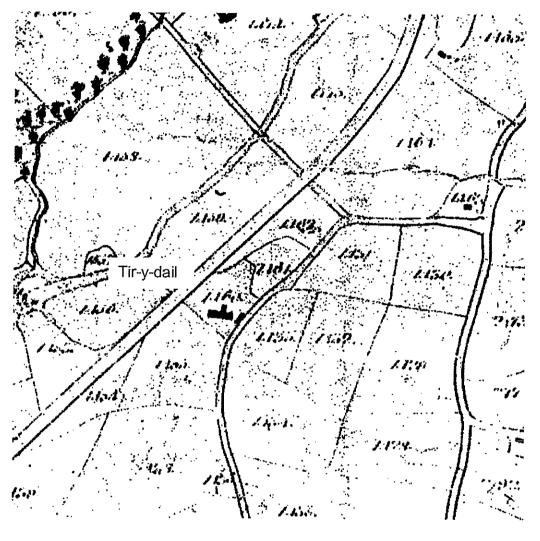
Fig. 3 - part of Parish of Llandybïe, Tithe Map and Apportionment, 1841.

Tir-y-dail was, by 1841, under lease or rental to Thomas W. Lawford (Locksmith 1999, 242), the son of an influential nabob and member of the Drapers Livery Company, London, who had acquired Carreg Cennen House in c.1806 (Nigel Lawford, pers. comm.). It was depicted on the tithe map of Llandybie parish, in 1841, when the holding occupied most of modern Ammanford - which was then entirely rural. A large house is shown on the map, but is in an entirely different location than any of the subsequent buildings, lying NE-SW across the southeastern corner of the present 'Cartref' site, in the area of the present driveway (Fig. 3). A second building lay on frontage of the roadway (the present Tir-y-dail Lane), again depicted roughly on the site of the present drive entry. The railway was newly-constructed in 1841 (Morgan 1958) and is shown running along the west side of the site.

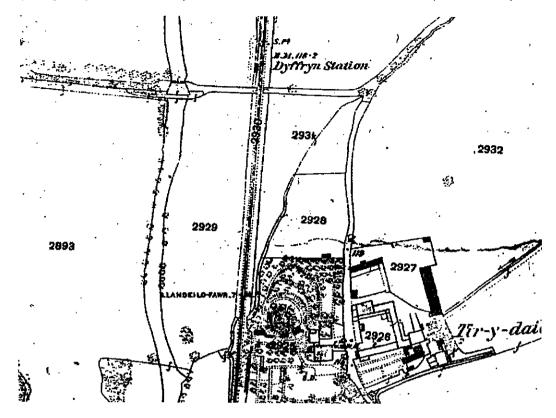
Fig. 4 - part of Ordnance Survey, 1:12500, Carmarthenshire Sheet XLVIII.11, First Edition, 1875.

To the north of the mound is a small, triangular or crescentic enclosure measuring some 38m east-west and 15m north-south, and also tree-covered. It forms a level platform, steeply scarped, c.3m higher than its surroundings. However, there is no clearly defined ditch from which the earth that it is made from could have been quarried, apart from a shallow depression, c.14 metres wide, on the north side. It has been suggested that the west side of the enclosure may have been damaged or truncated by the construction of the railway (Cadw SAM file, 1986), but any damage is unlikely to have been significant—the present west side lies on the scarp down to the Afon Llwchwr floodplain. The earliest map that shows the castle was drawn after the railway had been constructed (see Fig. 4).

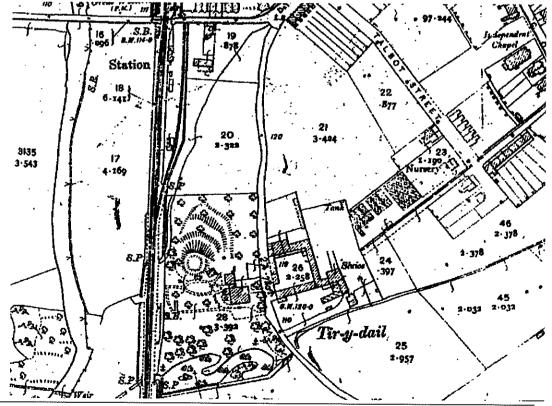
Fig. 5 - part of Ordnance Survey, 1: 12500, Carmarthenshire Sheet XLVIII.11, Second Edition, 1906.

Tir-y-dail is shown more-or-less unchanged from 1875 on the Ordnance Survey 25" maps of 1906 (Fig. 5), and 1916. At a subsequent date, the 19th century house was demolished and the present stone building (now Cartref Day Centre) was constructed. The exact date is not known - in 1937 the house was occupied by David Richards JP, owner of the local Dynevor Tinplate Works, while it was requisitioned by the army during the 1940s, and was again occupied in 1946 (ibid.).

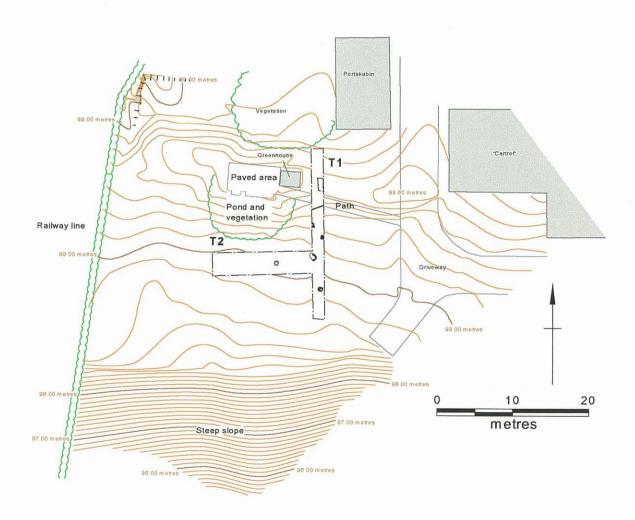
Fig. 6 – Topographic survey of site showing evaluation trench locations (levels based on survey by Carmarthenshire County Council)

The natural horizons reflect the present surface topography (Fig. 6), ie. a level 'platform' representing the river terrace, which dropping down to the south and west beyond the evaluation trenches. A linear, eastwest area of higher surface levels, which can be seen towards the north end of the trench in Figs. 6 and 8, was thought to perhaps represent the counterscarp bank of the motte ditch. However, these higher levels are also represented by the natural profile and represent a natural topographic feature.

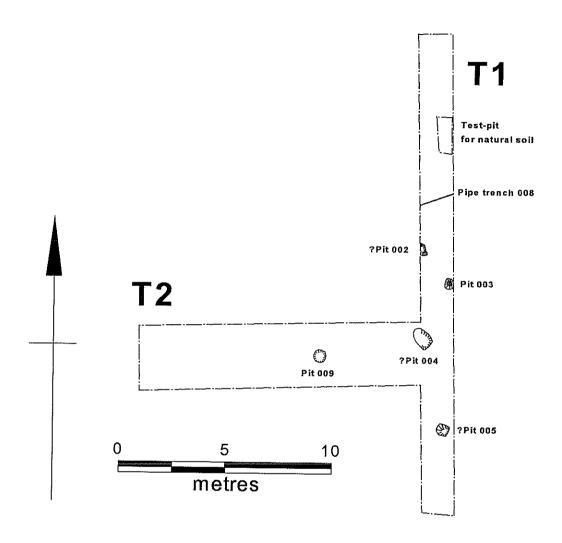
Fig. 7 - Detailed plan of evaluation trenches

Cut through boulder-clay horizon 006 were up to four possible features (Figs. 7 and 8), although only two of these features are entirely convincing. The four are described below, from north to south (see Fig. 7).

Cut through the natural boulder-clay 006 was a single archaeological feature (Fig. 7). The feature, 009, was a shallow pit measuring 0.60m in diameter and 0.15m deep. It was a definite man-made feature with a fill of charcoal and burnt soil. The fill contained no artefactual evidence, but sample of the burnt material were taken and may be available for future analysis. The feature appears to be a pit, of unknown function but possibly deliberately cut to receive the burnt fill.

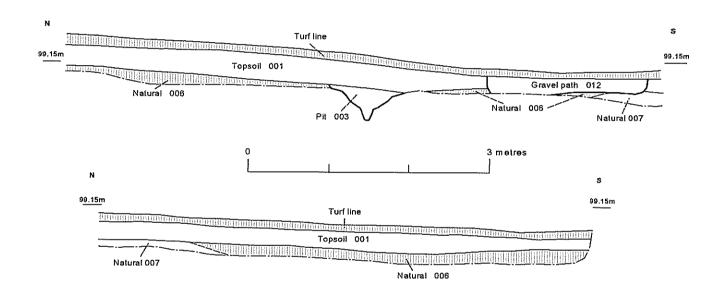
Fig. 8 – Running section of trench T1, east side (levels based on survey by Carmarthenshire County Council)

A similar, but earlier path (012) was observed cutting the topsoil 6m further south (Fig. 8). It occupied a shallow cut, averaging 0.2m in depth and measuring 2m in width (north-south), cut from beneath the present turf line and containing small cobbles and cinders. This would appear to be the path shown on the Ordnance Survey 25" map of 1875 (see Fig. 4), and again in 1906 (see Fig. 5), which is probably mid 19th century in origin.

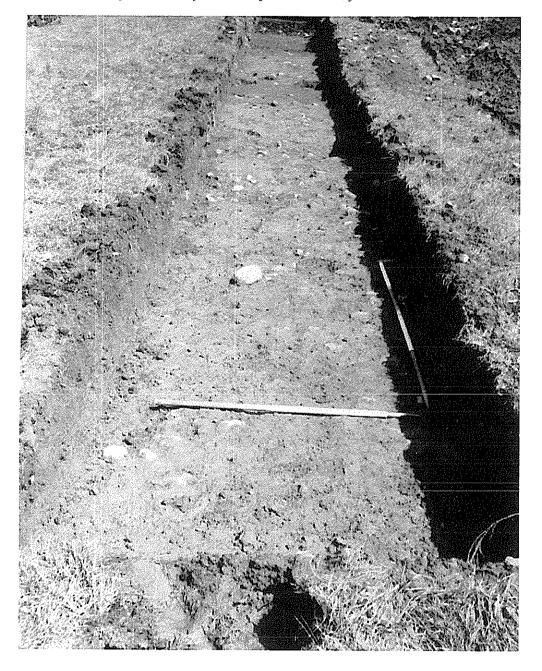
Fig. 9 - Photo of Trench 1 after excavation, from the south

Trench 1 was located north-south through the proposed development area. It was 22.75m long and 1.8m wide. It was excavated to an average depth of 0.5m, the level of the uppermost archaeological features – which were cut through the natural soil.

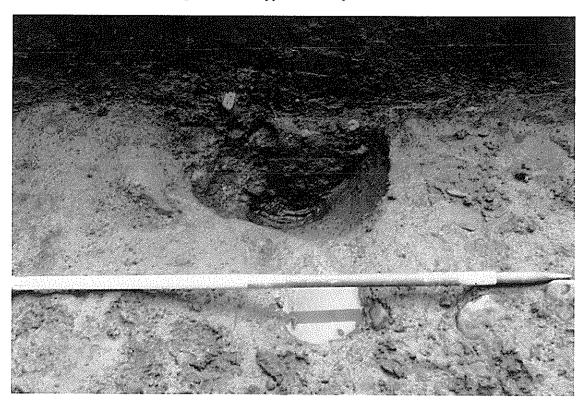
Fig. 10 - Photo of feature 003, from the west

Feature 003 was a definite man-made feature, being a pit measuring 0.60m in diameter and 0.40m deep. Its profile was stepped, being shallow in the upper half and steep in the lower, terminating as a 'V'-shaped bottom (see Fig. 8). It was cut directly into 006, from below the topsoil 001, and filled by a clay-loam similar to 006. Its profile suggests that it was possibly a small post-pit, or a stakehole widened in its upper half when the stake was forcibly removed. The fill contained no artefactual material.

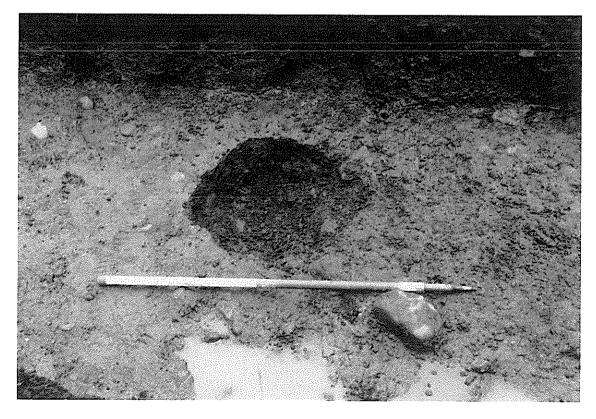
Fig. 11 – Photo of feature 005, from the west

Feature 005 was, in contrast, a definite man-made feature but of uncertain form. It appeared as a small soilmark of charcoal and burnt soil, measuring approximately 0.15m in diameter, which, when excavated, was found to be an amorphous fill. Eventually an area measuring 0.60m in diameter was excavated to a depth of 0.10m was excavated, but no well-defined edge was encountered. The feature thus remains of unknown form or function. Again, the fill contained no artefactual evidence, but sample of the burnt material were taken and may be available for future analysis.

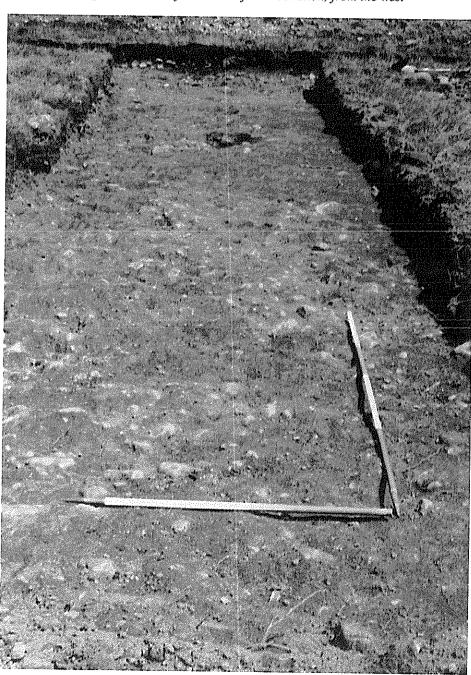
Fig. 12 - Photo of Trench 2 after excavation, from the west

Trench 2 was located east-west at a right-angle to, and adjoining, the west edge of T1, between 6m and 9m from its southern end. It measured 13m by 3m and was similarly excavated to an average depth of 0.5m, the level of the uppermost archaeological features — which were cut through the natural soil.
