# **PENNAR POINT, PEMBROKE DOCK, PEMBROKESHIRE**

**AN ARCHAEOLOGICAL DESK-BASED ASSESSMENT  
AND WALK-OVER SURVEY**

Report No.  
2002/47

Report Prepared for:  
ACHILLION PROPERTY AND DEVELOPMENT LTD

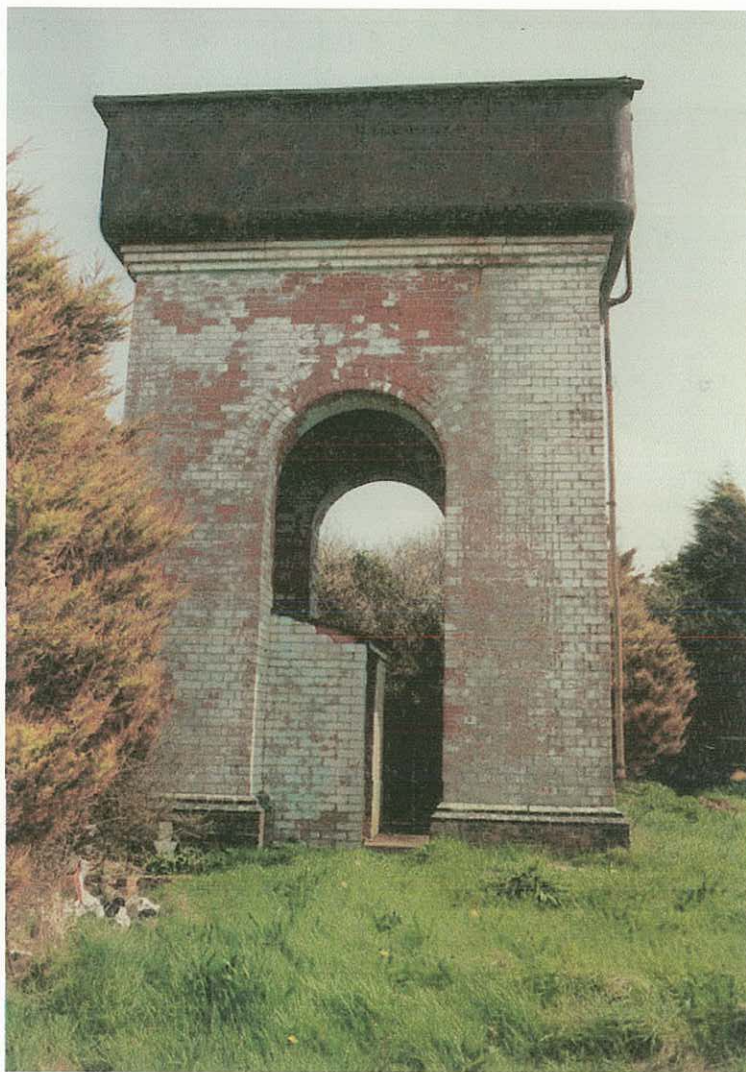
Just inside the present day entrance to the site stand the brick supports for a large water tank (PRN 26254) (Photo. 1). The tank itself, dated 1901 was removed at some time after 1995. This tank, fed by a nearby spring was presumably the main water supply for the barracks.

**Photo. 1:** The Water Tank (PRN 26254). From unknown Receivers photographs held in SMR

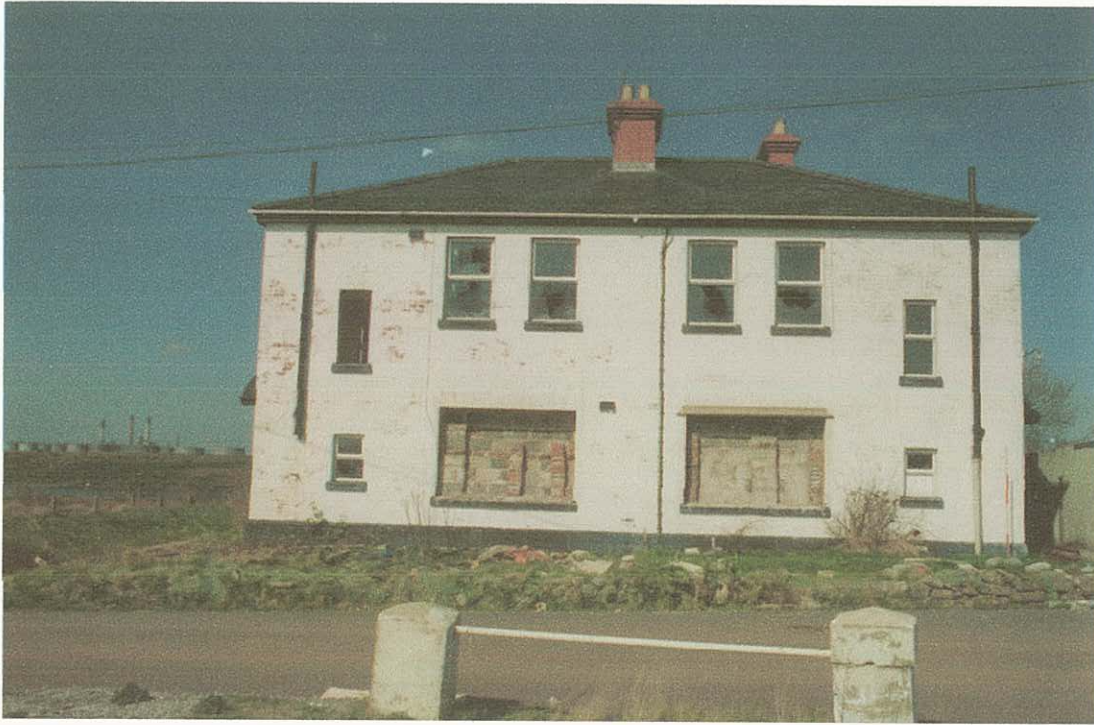
Close by stood the Guard House (PRN 45079) at the eastern end of the Parade Ground, and two two-storey dwellings designated Married Quarters (PRN 26255) (Photo. 2). Proceeding westward along the north side of the Parade Ground was a terrace of eight two-storey houses (PRN 26256) (Photo. 3), also Married Quarters.

**Photo 2:** Married Quarters (PRN 26255). From unknown Receivers photographs held in SMR

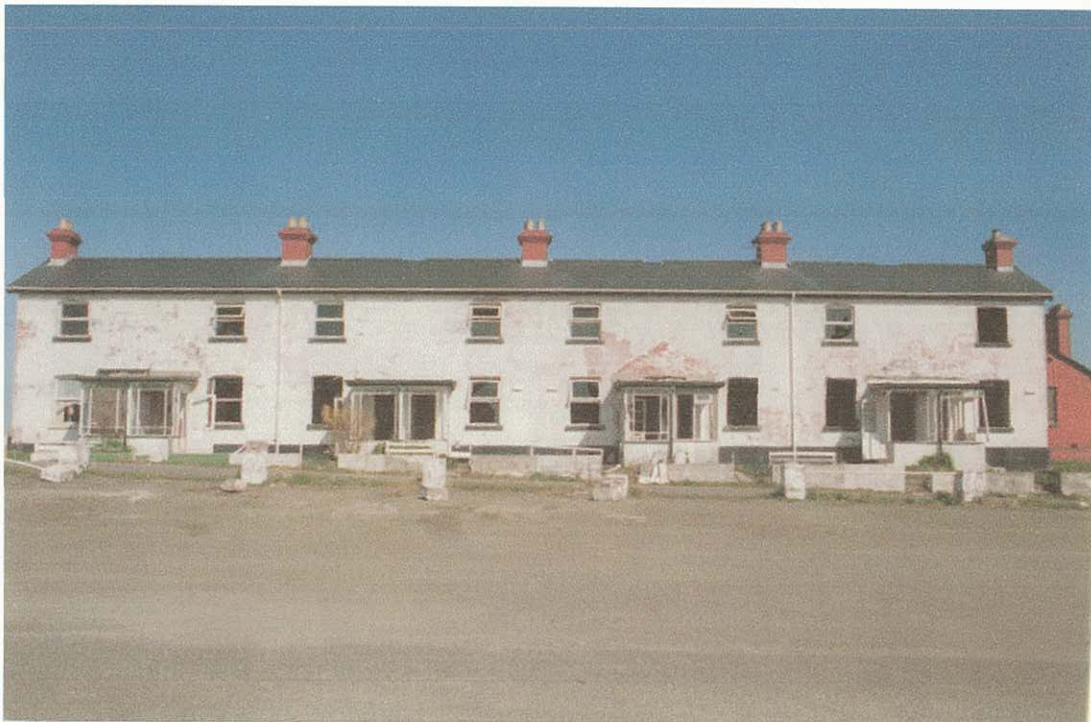
**Photo 3:** Married Quarters (PRN 26256). From unknown Receivers photographs held in SMR

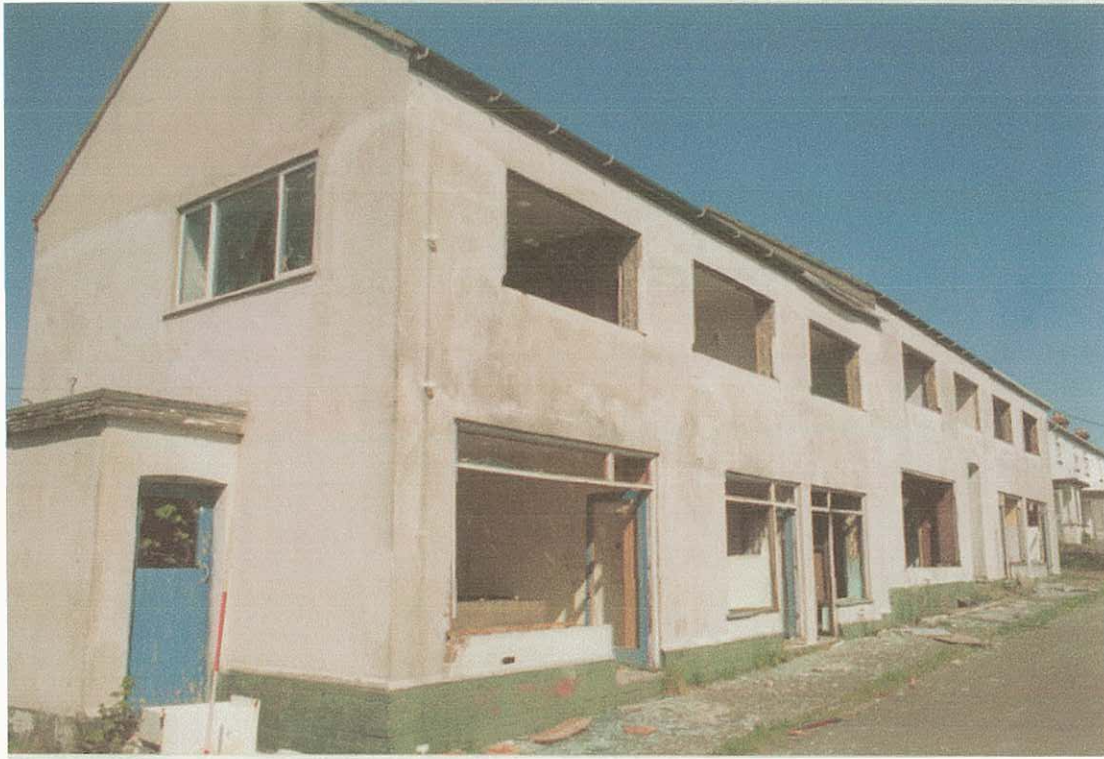
PRN 26257 (Photo. 5) was probably originally a barrack block, but was considerably altered or re-built to provide shop units and accommodation when the Barracks were used as a Holiday Camp after WWII. PRN 26258 (Photo. 6) was likewise extensively re-modeled, and its original function is uncertain. To the north of these buildings is a Laundry building (PRN 26259) (Photo. 4).

**Photo. 5:** Former Barracks? (PRN 26257). From unknown Receivers photographs held in SMR

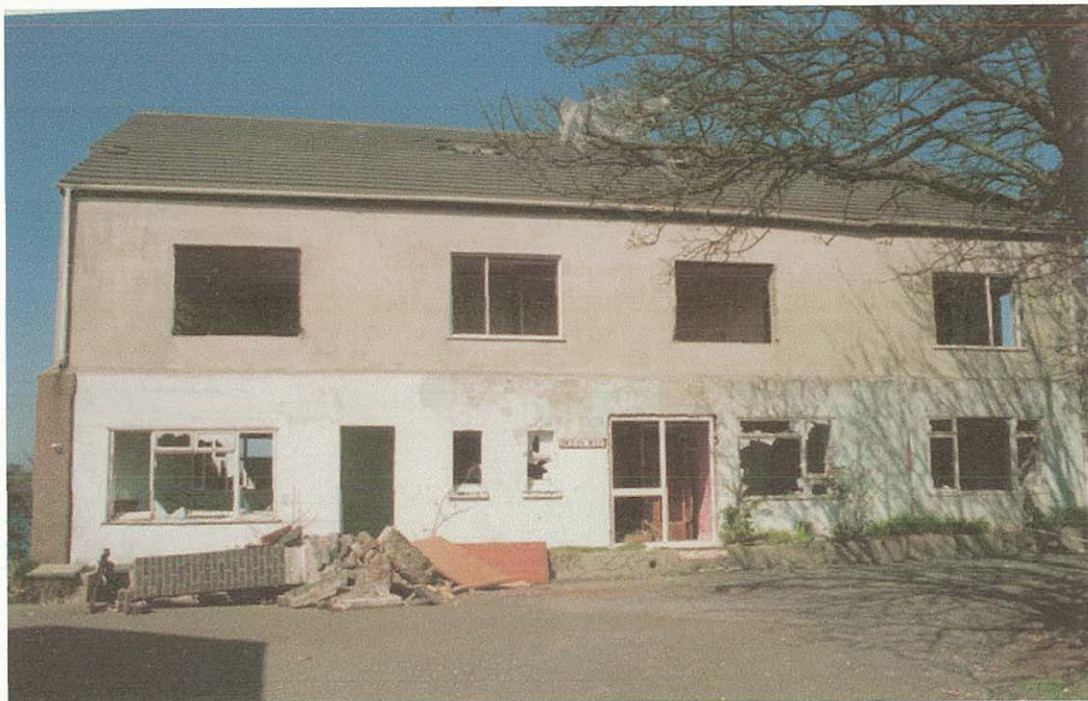
**Photo. 6:** Former Quarters (PRN 26258). From unknown Receivers photographs held in SMR

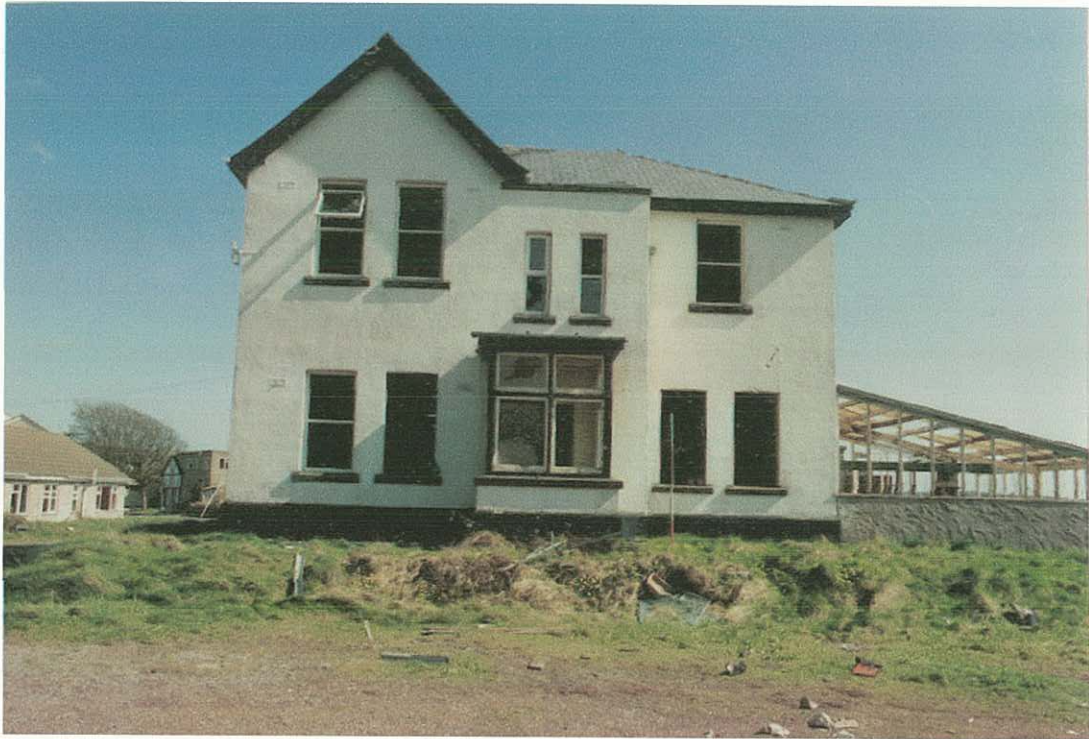
The Officers Mess (PRN 26261) (Photo. 8), and another Married Quarters building (PRN 26260) (Photo. 7) are situated further to the west.

**Photo. 7:** Married Quarters (PRN 26260). From unknown Receivers photographs held in SMR

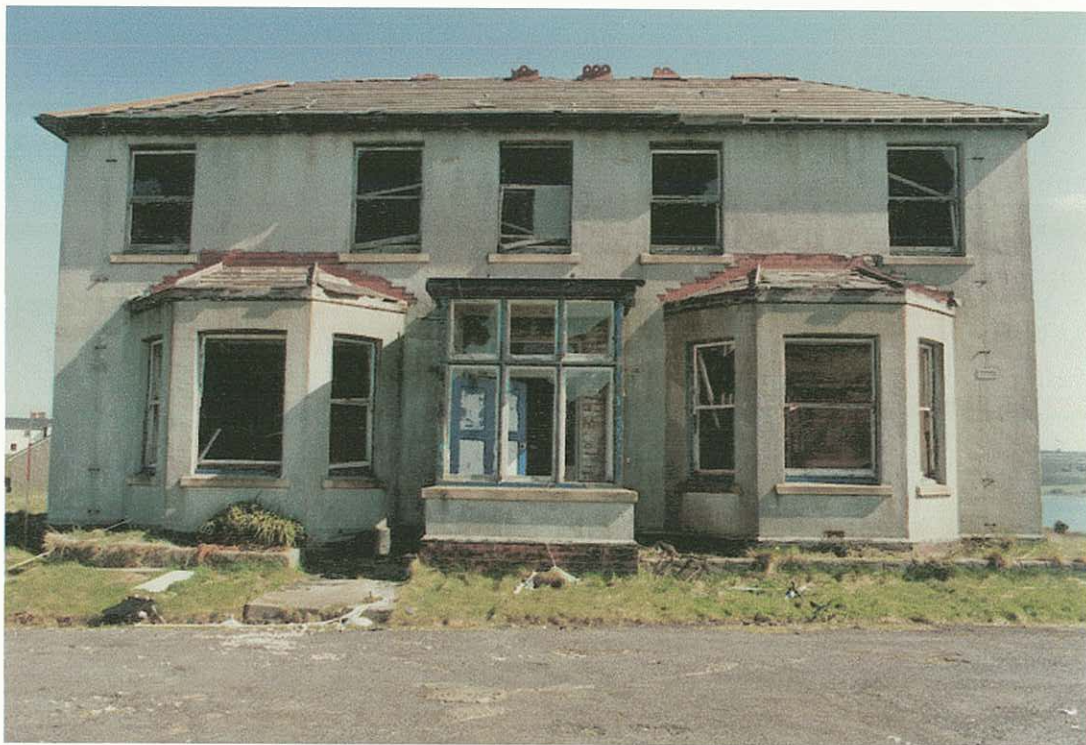
**Photo. 8:** Officers Mess (PRN 26261). From unknown Receivers photographs held in SMR

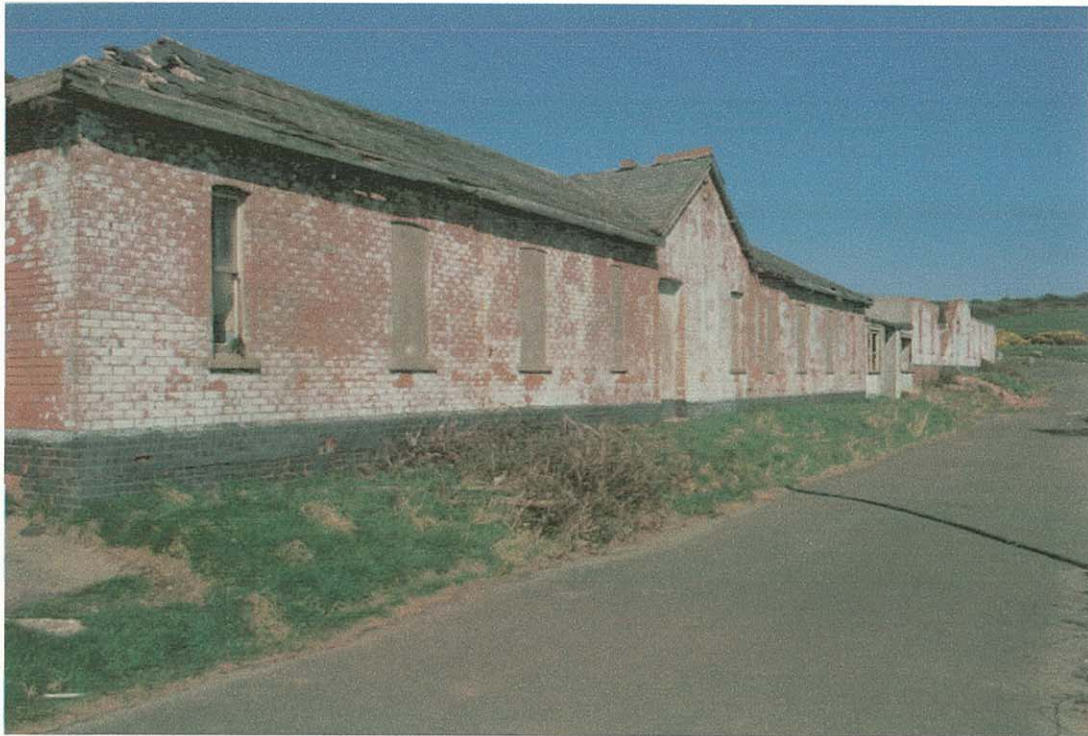
At the west end of the Parade Ground is situated the Head Quarters Building (PRN 26262) (Photo. 9). The south side of the Parade Ground is bordered by two Barrack Blocks (PRN 26263 and 26264) (Photos 10 and 11). To the south of these are a Latrine block (PRN 26268) (Photo. 26 268) and an Ablutions Building (PRN 26265) (photo. 12).

**Photo. 10:** Barracks (PRN 26263) . From unknown Receivers photographs held in SMR

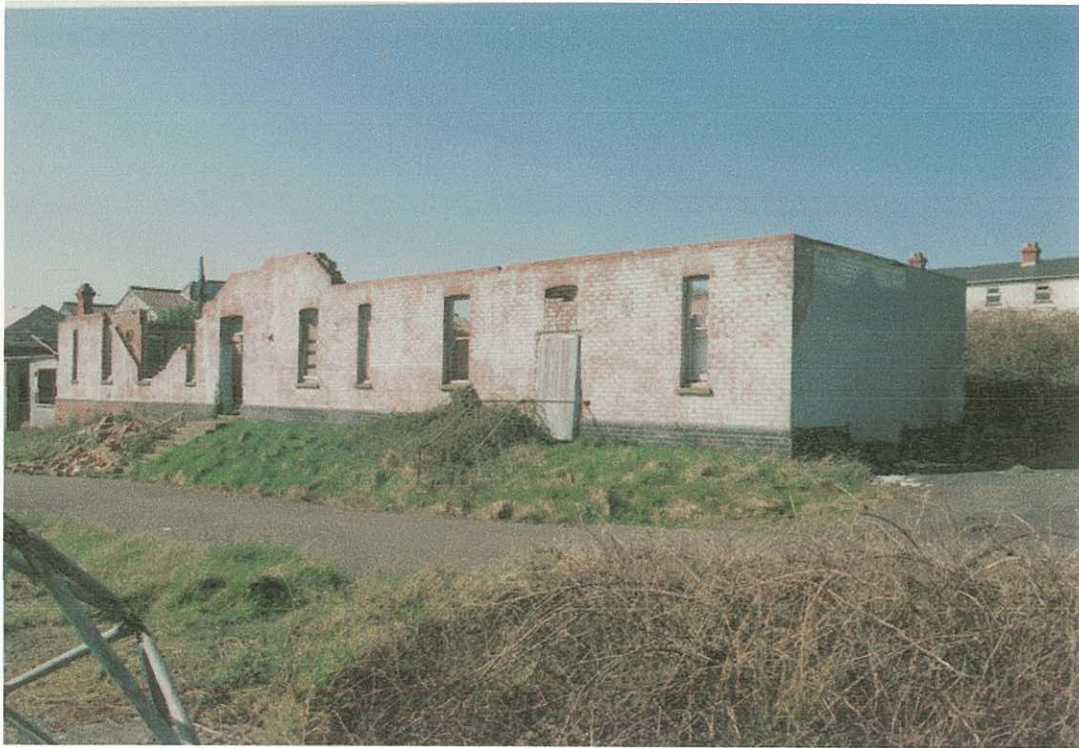
**Photo. 11:** Barracks (PRN 26264). From unknown Receivers photographs held in SMR

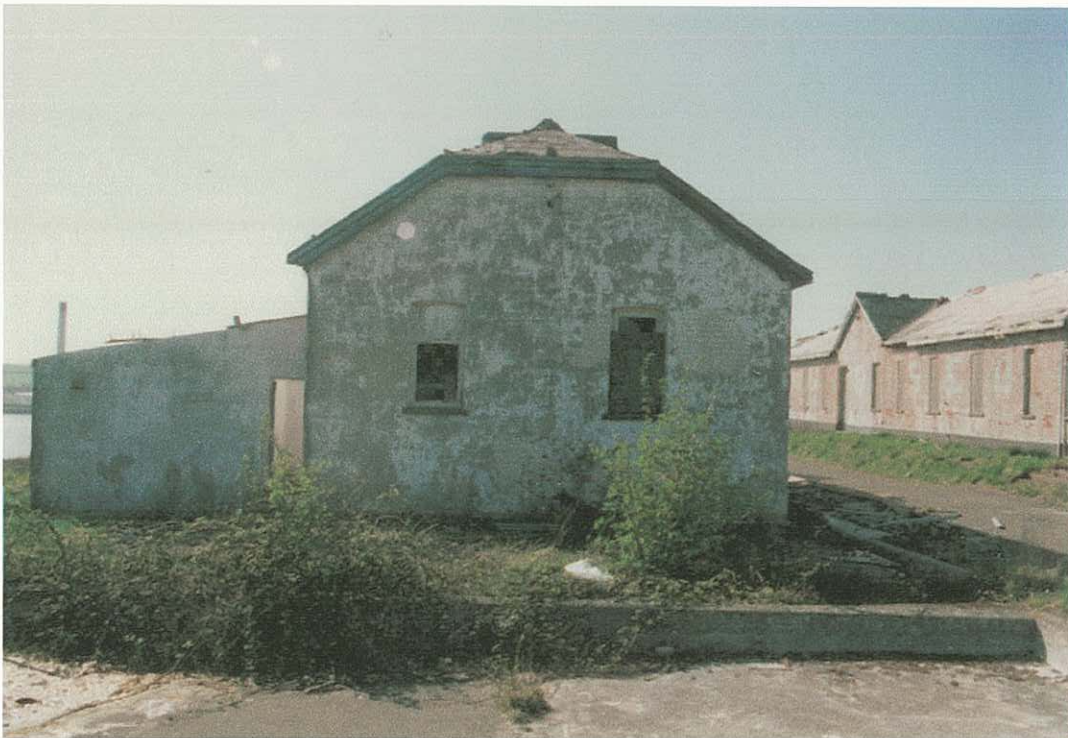
**Photo. 12:** Ablutions Building (PRN 26265). From unknown Receivers photo held in SMR

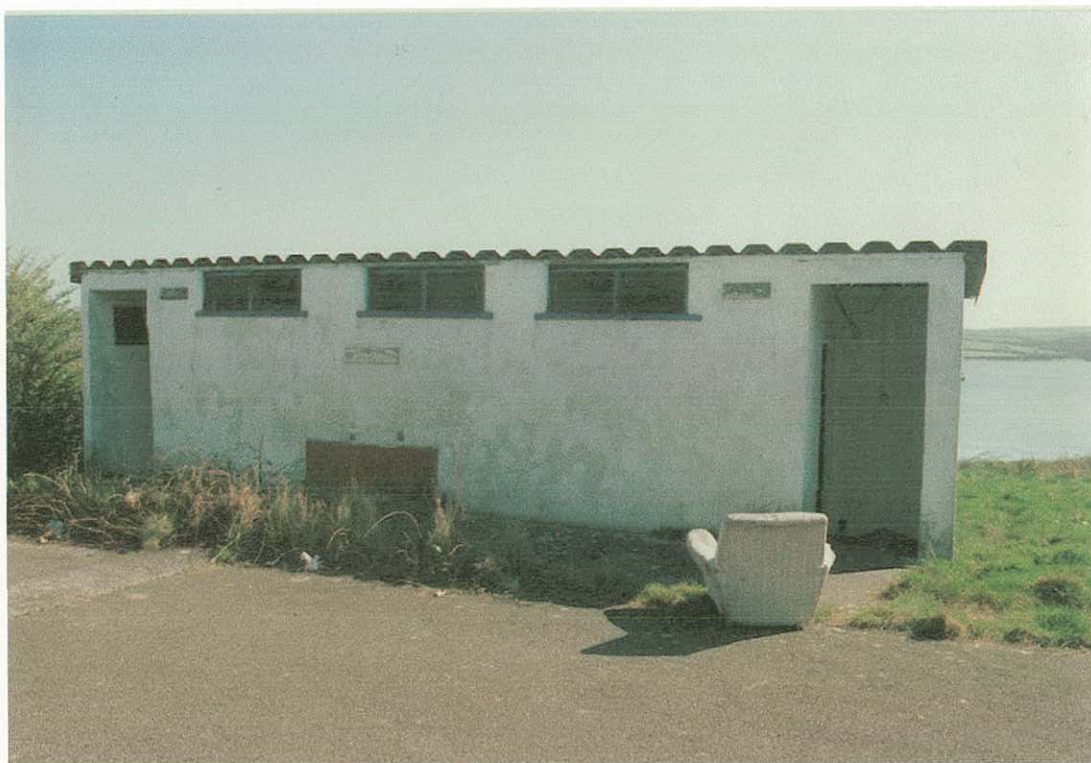
**Photo. 13:** Latrine Block (PRN 26268). From unknown Receivers photographs held in SMR

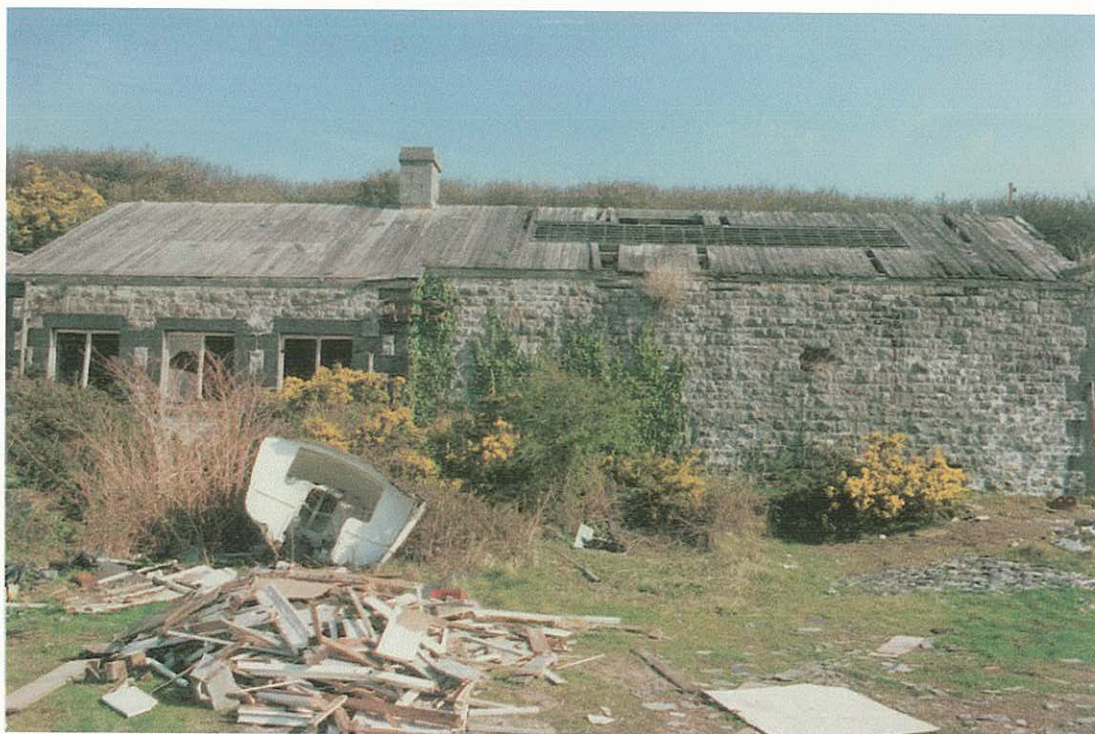
**Photo. 17:** Loaded Mine Store and office? (PRN 26273 and PRN 26274). From unknown Receivers photographs held in SMR

Single storey, rectangular plan, coursed rubble with ashlar quoins cladding interior of red brick construction, gabled slate roof. Large depressed arched double doorway in E gable permits access for 18 inch gauge tramway, concrete foundations for generator (?) on floor but no other internal features. Circular ventilator in gable above the doorway. Internal door in west wall leads to adjoining room PRN 26274, of same construction.

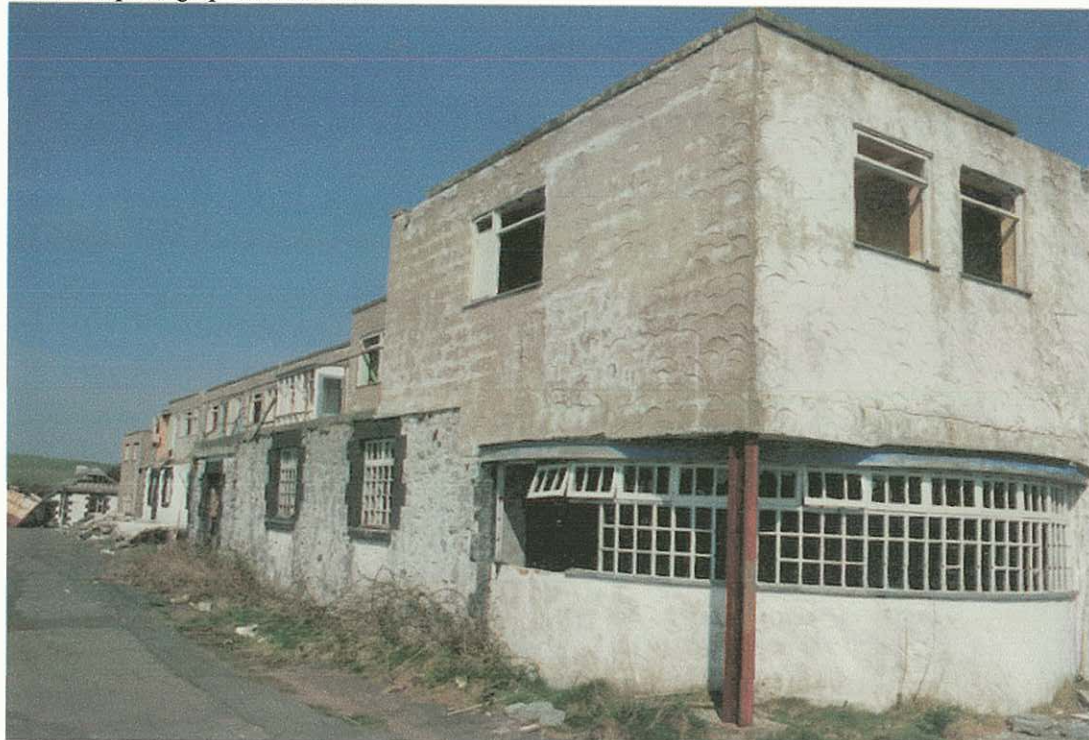
PRN 26275 (now demolished) was originally a range of buildings, identified by Roger Thomas as a 'Drill Shed' of the same construction as the other original establishment buildings, with a gabled slate roof, depressed arched doors in each gable end through which a tramway ran the length of the building, and with eight windows and a central door in the south elevation. The drill shed was where training in the assembly of mines was carried out, and where strings of mines were linked up. Two circular features at the eastern end of the Drill Shed were possibly tanks in which cable was stored. The building was later heavily modified circa 1968 (Photo. 18).

**Photo. 18:** Former Drill Shed (PRN 26275). From unknown Receivers photographs held in SMR

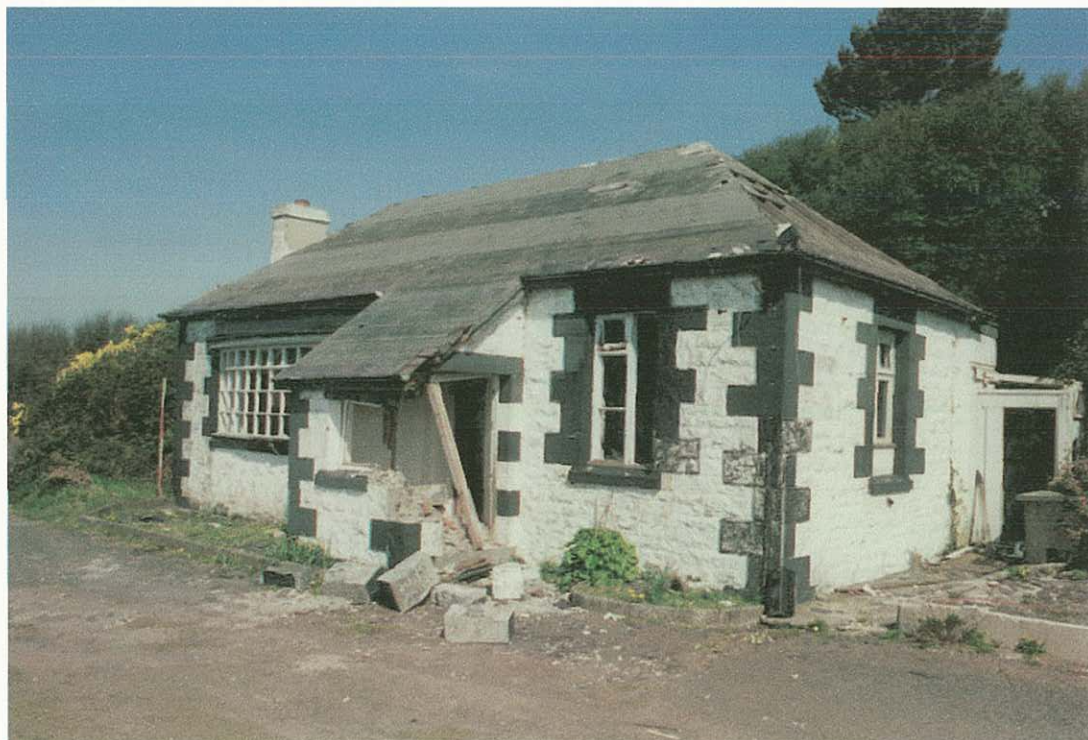
PRN 26277 (now demolished), is identified by Roger Thomas as an Office (Photo. 20). It was built in the same manner and style as other buildings in the complex, with a limestone exterior cladding and red brick internal construction.

**Photo. 20:** Office (PRN 26277). From unknown Receivers photographs held in SMR

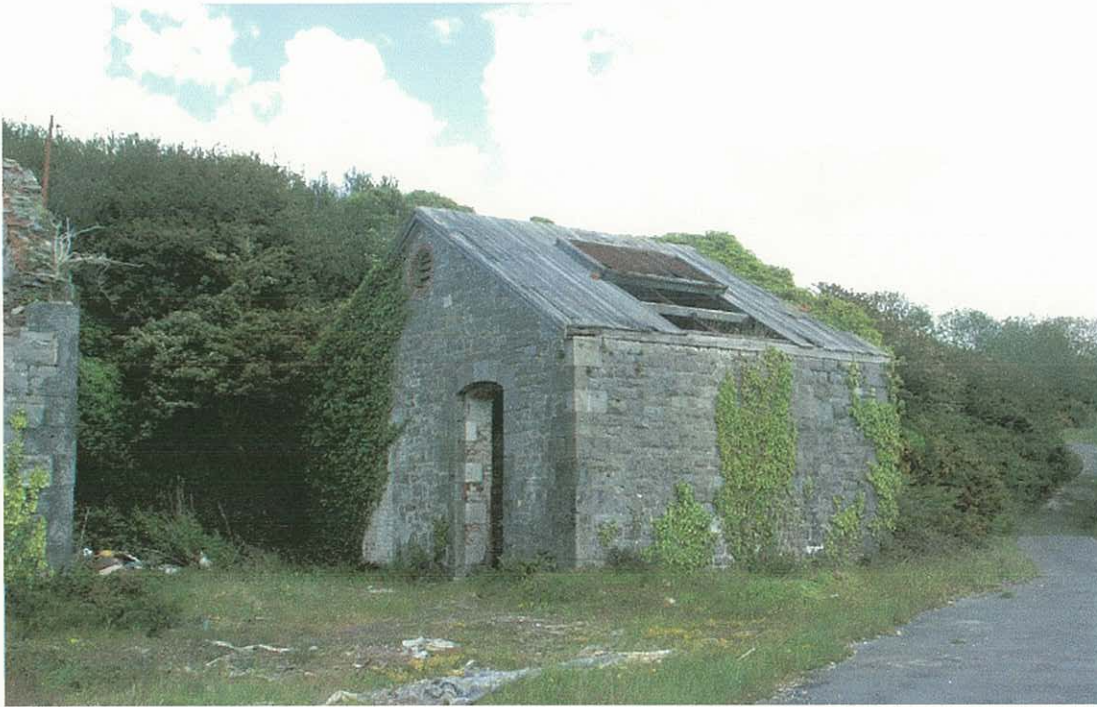
Set back from the Drill Shed, and on a different branch of the tramway network was another range of buildings. PRN 26272 (Photo. 21) was the Loading room, where explosives were loaded into the mines. This building has no windows, but two skylights in the roof. From the Loading Room the tramlines led to the Loaded Mine Store (PRN 26273) where mines were temporarily stored before being linked together into strings in the Drill Shed (Photo. 17). Attached to the loaded mine store was another room (PRN 26274) of uncertain function, but which may have been administrative (Photo. 17). A small detached building immediately to the west (PRN 45090) is also of uncertain function. It is of brick construction but is not stone clad, has no windows but has a central skylight in the roof.

**Photo. 21:** Loading Room (PRN 26272).

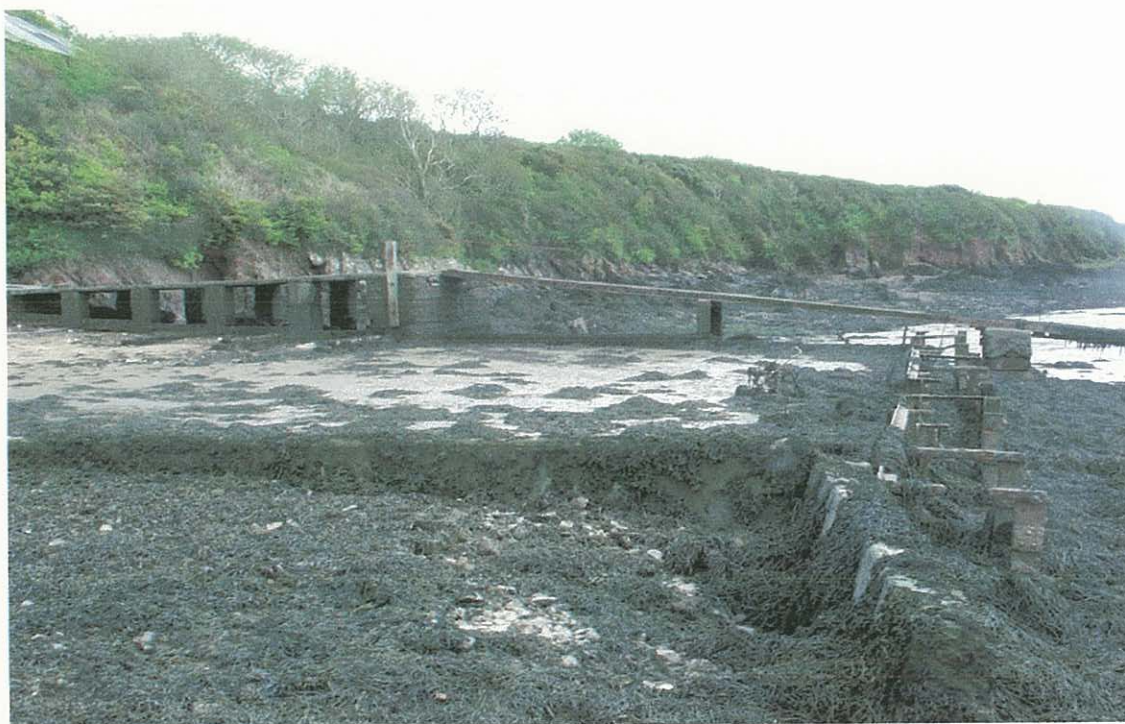
**Photo. 23:** Jetty (PRN 34993) . From unknown Receivers photographs held in SMR

Concrete and steel pier/jetty and concrete sea defence and other steel stanchions. The jetty is attached to a stone built sea wall/pier base. Some of the stonework is late nineteenth century in origin but re-built and now appears to be mostly twentieth century. The jetty slopes into the water.

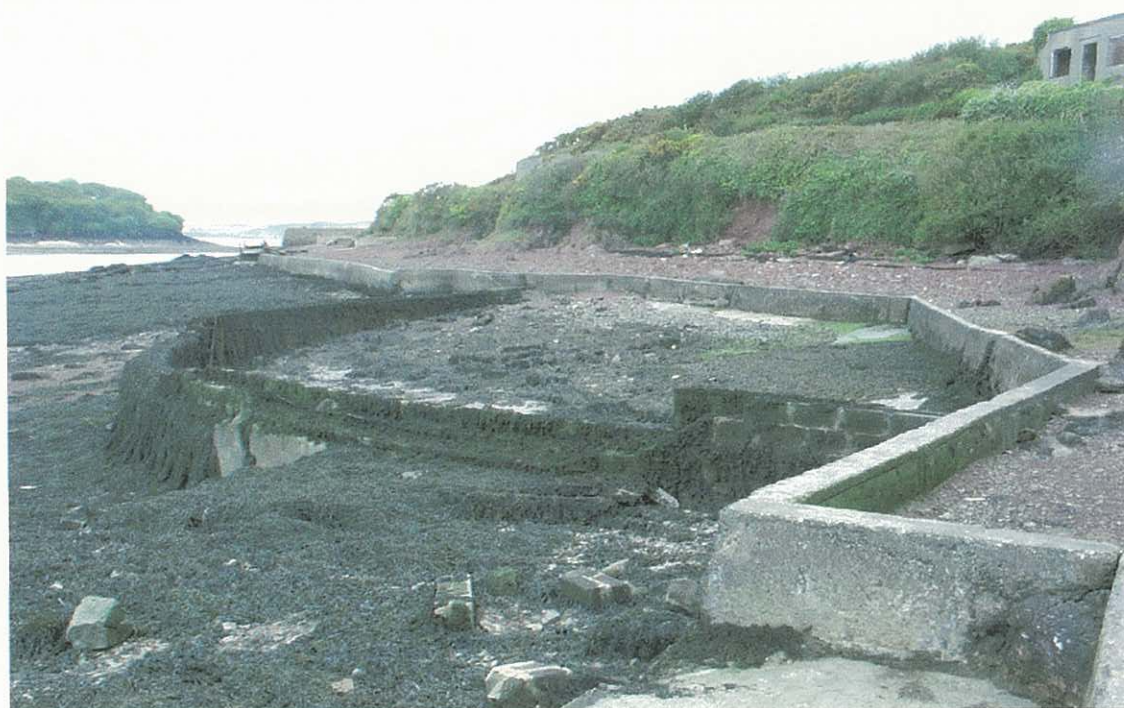
**Photo. 24:** Swimming Pool (PRN 45084)

A sub-circular probable swimming pool constructed from cement rendered breezeblocks, presumed to be associated with the Holiday Park.

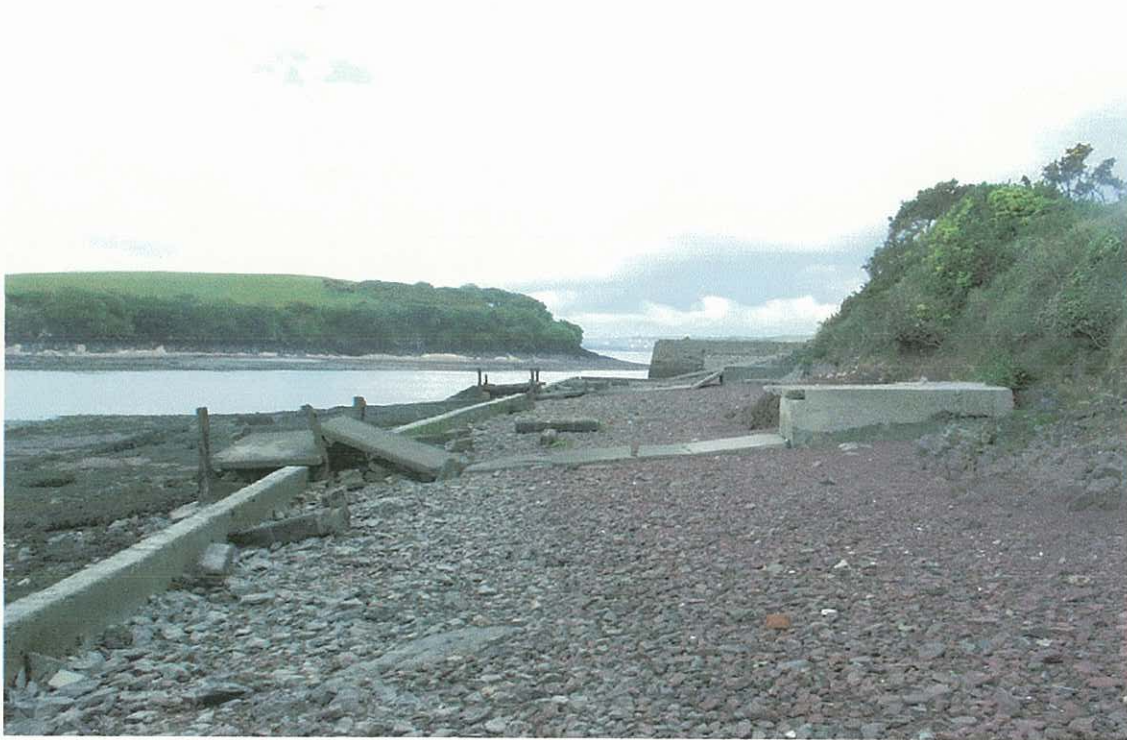
**Photo. 25:** Jetty (PRN 45082)

A jetty approximately 1m wide, 30m long now collapsed accessed from shore by a flight of concrete steps. Constructed from concrete slabs with a steel frame. Not visible on WWII aerial photographs, so presumably associated with the Holiday Park.

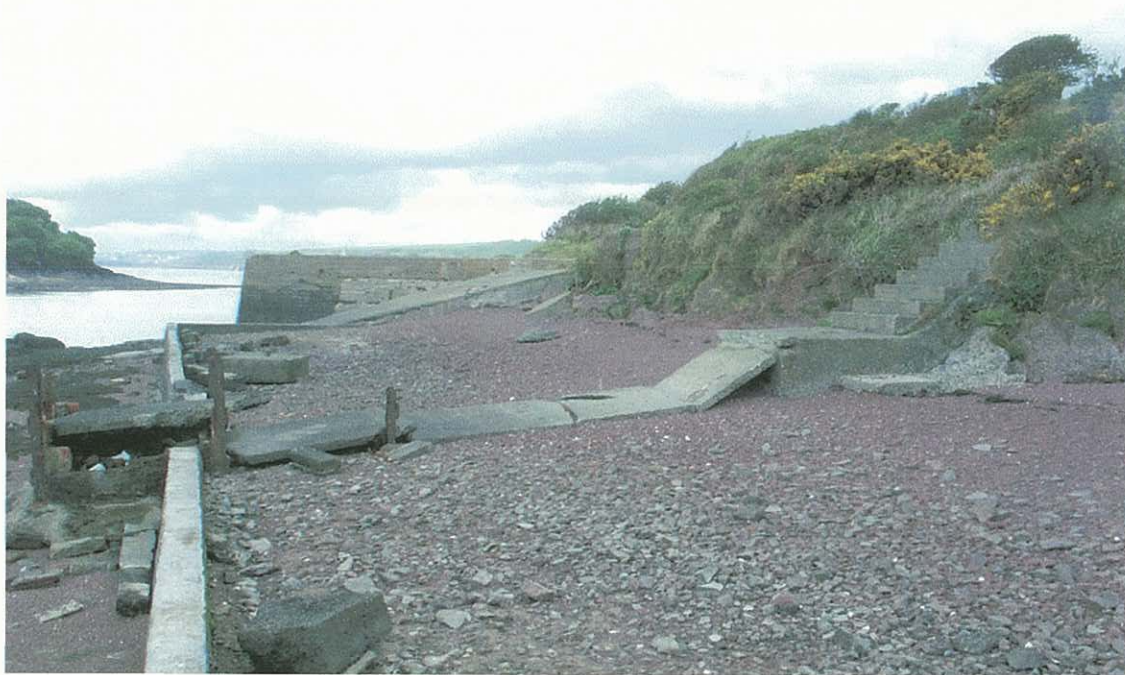
**Photo. 26:** Jetty (PRN 45081)

A jetty approximately 1m wide, 30m long now collapsed accessed from shore by a flight of concrete steps. Constructed from concrete slabs with a steel frame. Not visible on WWII aerial photographs, so presumably associated with the Holiday Park.

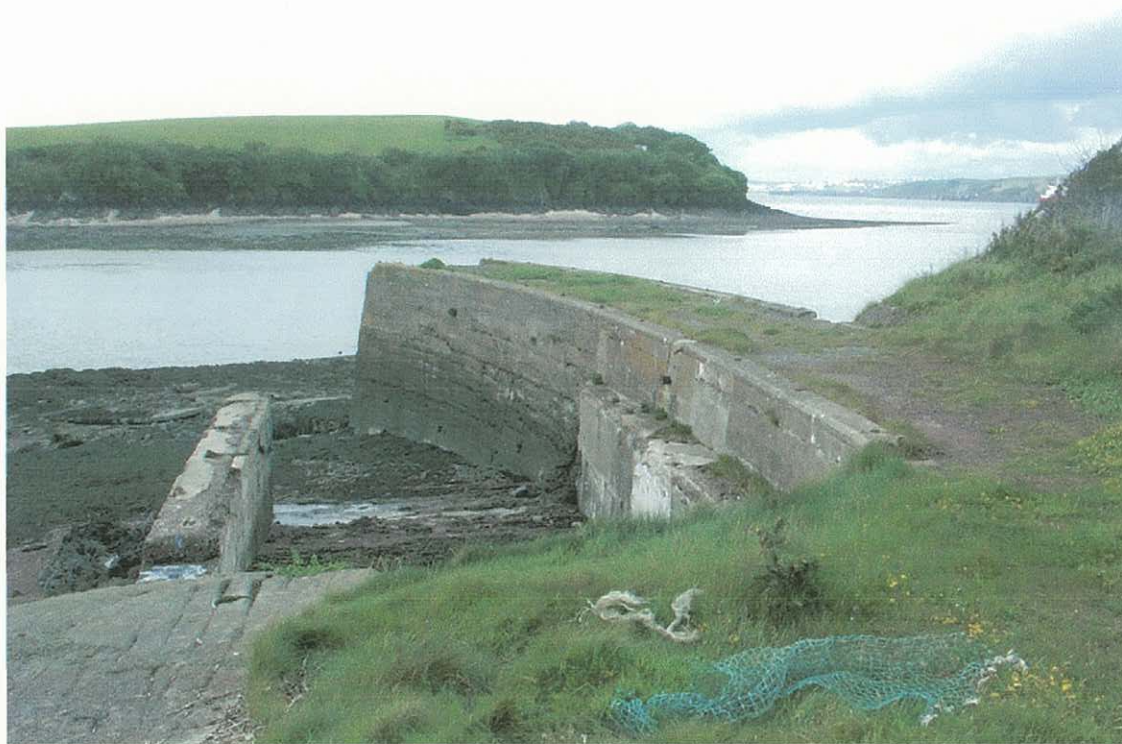
**Photo. 27:** Tank and Pier (PRN 45083 and PRN 26278)

A rectangular pool or tank associated with Pier 26278. Possibly held seawater in which mining cables were stored to prevent corrosion. The end wall has been removed so that it can no longer hold water.

PRN 45083 (Photo. 27), located besides the pier (PRN 26278) was probably a tank containing seawater in which cable used for linking the mines was stored. This was necessary to prevent the excessive corrosion that would occur if the cables were frequently immersed in seawater then stored on dry land. The group of small buildings immediately to the north of this tank are of unknown function and no trace of them is visible today as a pillbox (PRN 45080), also now demolished, was constructed in the same location during WWII.

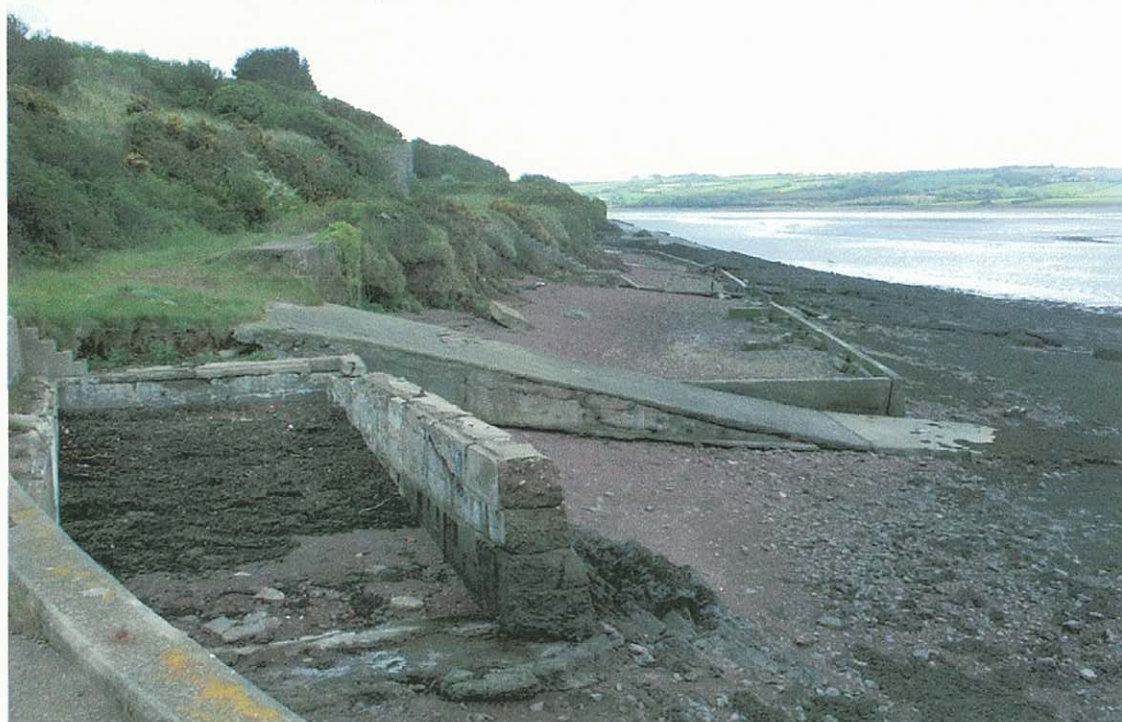
**Photo. 28:** Tank and Slipway (PRN 45083 and PRN 45088)

(used to link mines in strings) was stored to prevent corrosion. Adjacent Slipway PRN 45088 does not appear on the WWII aerial photographs and so is presumed to be associated with the Holiday Camp phase.

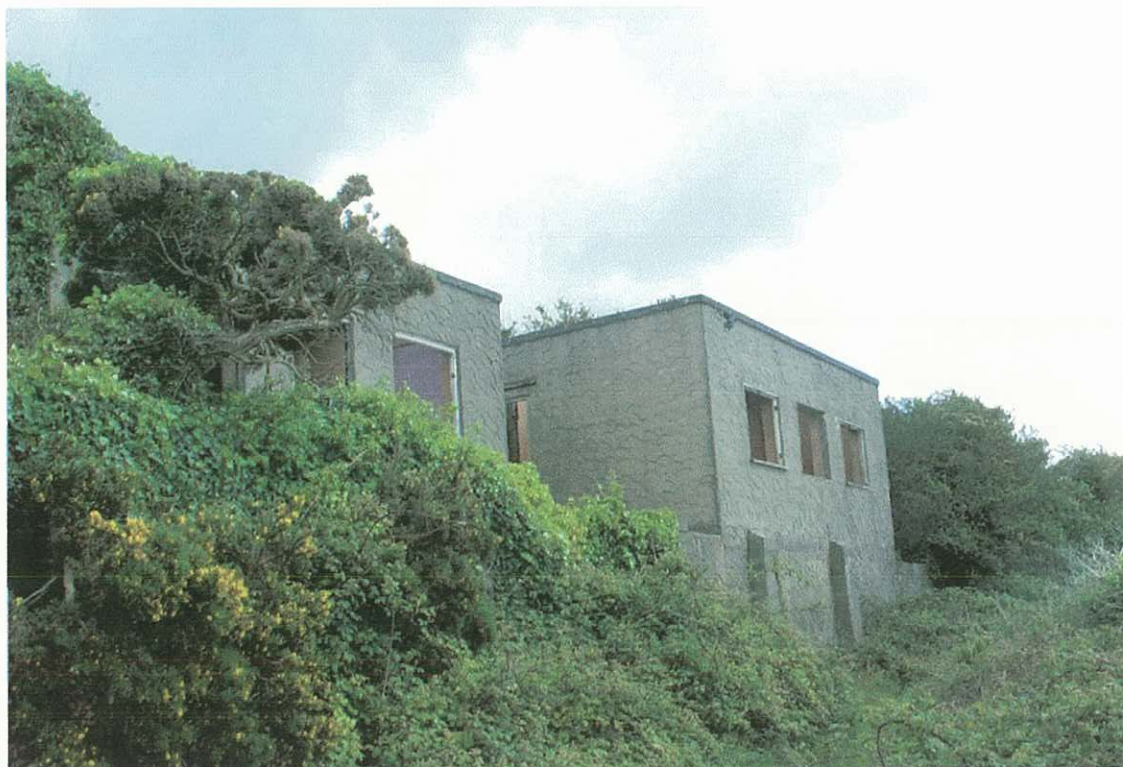
**Photo. 29:** Unidentified Building (PRN 34990)

A modern building constructed from breezeblocks, probably Holiday Park accommodation. Now becoming derelict. Built on top of a brick built and cement rendered structure with a flat concrete roof supported on iron girders (visible in post WWII aerial photographs. Now forming a basement below the existing building. Accessed via manhole outside house. This is probably of early 19<sup>th</sup> century origin, but may have been altered during WWII. A revetment runs between this structure and PRN 45086.
