PENYGARN ROAD, TYCROES

ARCHAEOLOGICAL WATCHING BRIEF,
JULY 2002

Report No. 2002/61

REPORT NO. 2002/61
PROJECT RECORD NO. 45242

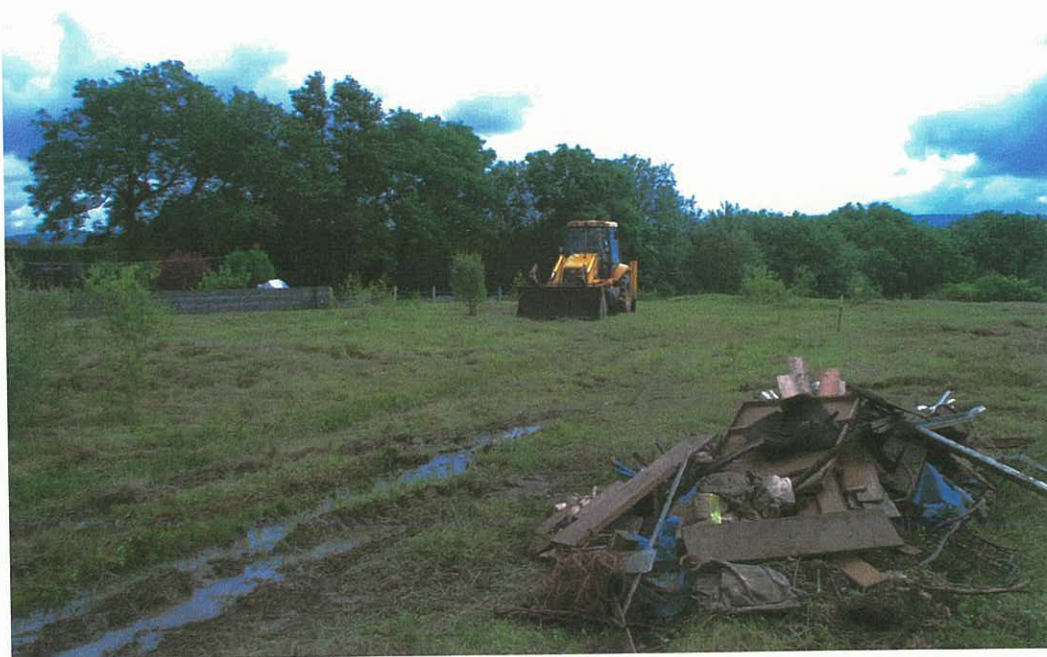
Fig. 2 - The site before excavation, looking east-northeast

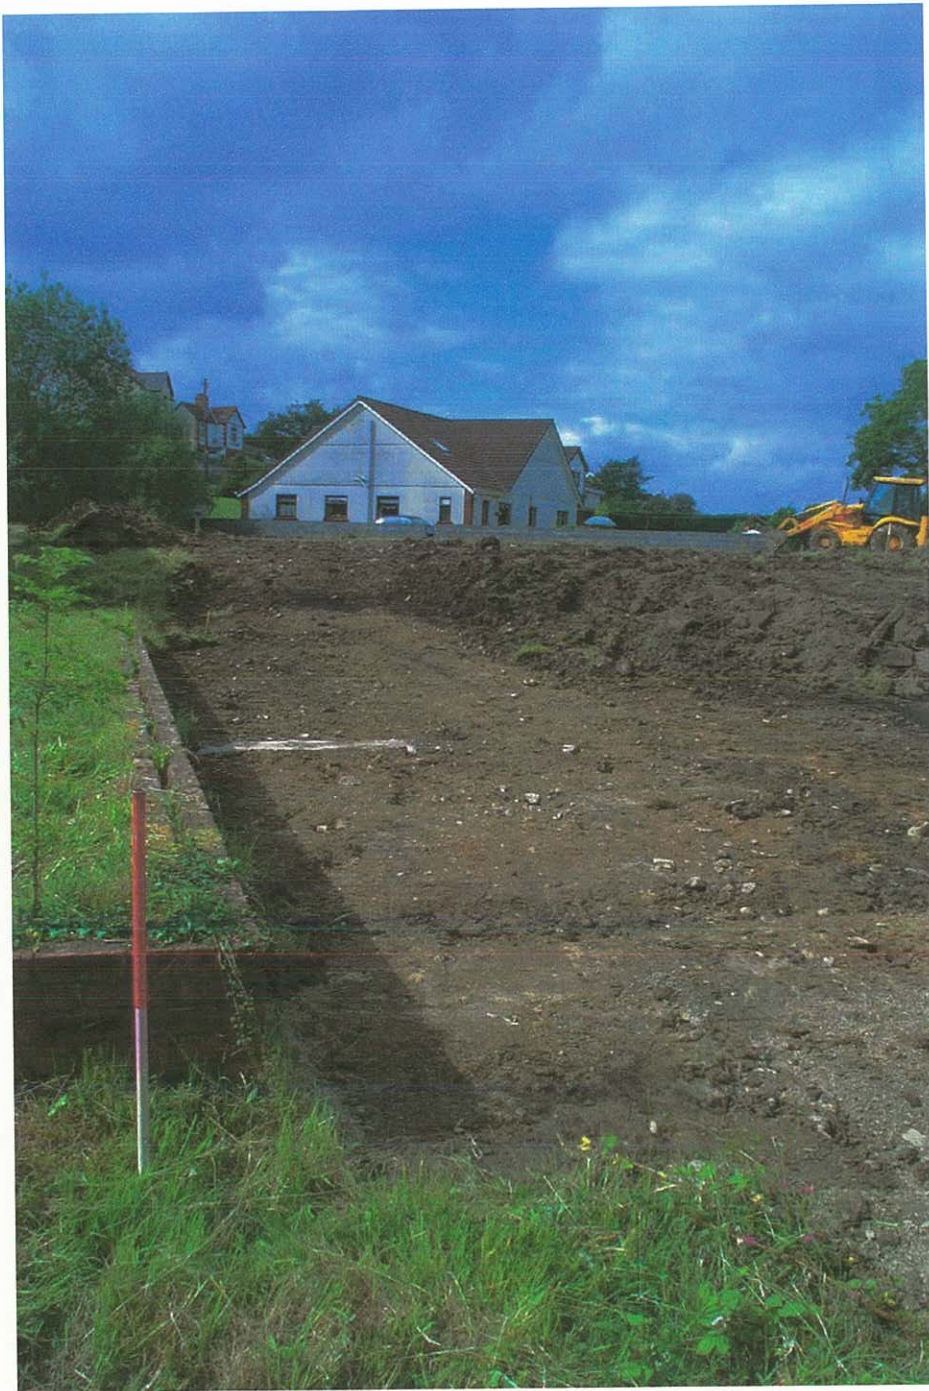
An area measuring approximately 70m N-S by 25m E-W was mechanically stripped, to a varying depth of 0.20m - 0.25m, using a JCB with a 1.8m wide toothless grading bucket.

Fig. 4 - The site during excavation, looking north

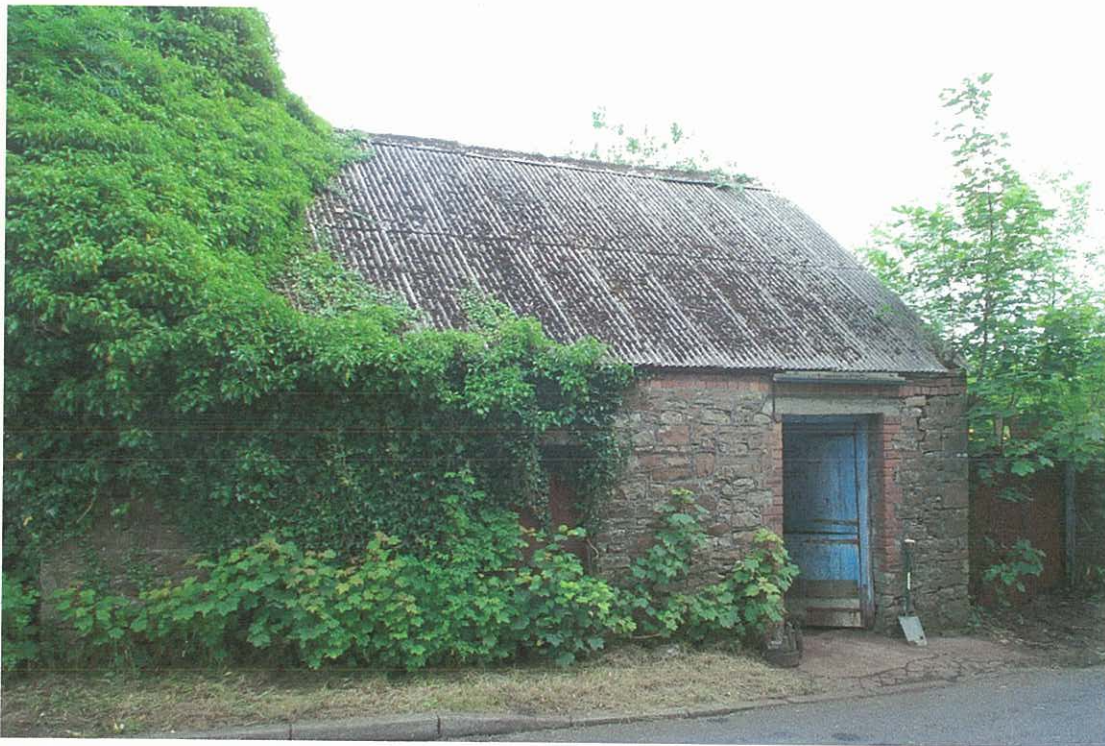
The smithy (PRN 45239; NGR SN 60518 09923) is a rectangular, gabled building of a single storey, aligned NW-SE and measuring 9.0m x 7.0m. At its southern end is an adjoining lean-to annexe set back from the western side by 1.0m and measuring 4.0m x 6.0m. It is constructed from medium, angular, random shale rubble with red-brick surrounds. Much of the building is under a heavy external growth of ivy.

Its western side wall fronts onto Pen-y-garn Road, and is pierced by a non-vehicular doorway at its southern end. The entry has a brick surround and probably therefore secondary, with a concrete lintel that is may be later still. To the north, this wall is pierced by a window with a simple rubble surround, probably primary, and a timber lintel. The present timber frame is ?later 20th century. The forge occupies the north, gable wall and has a projecting rubble-masonry hood, sloping back, with an intervening string-course, to a slightly projecting, square stack which, externally, lies beneath heavy ivy. All appear to be primary features and the presence of red brick in the hood is probably due to repair rather than rebuild.

Fig. 5 - The smithy from the west

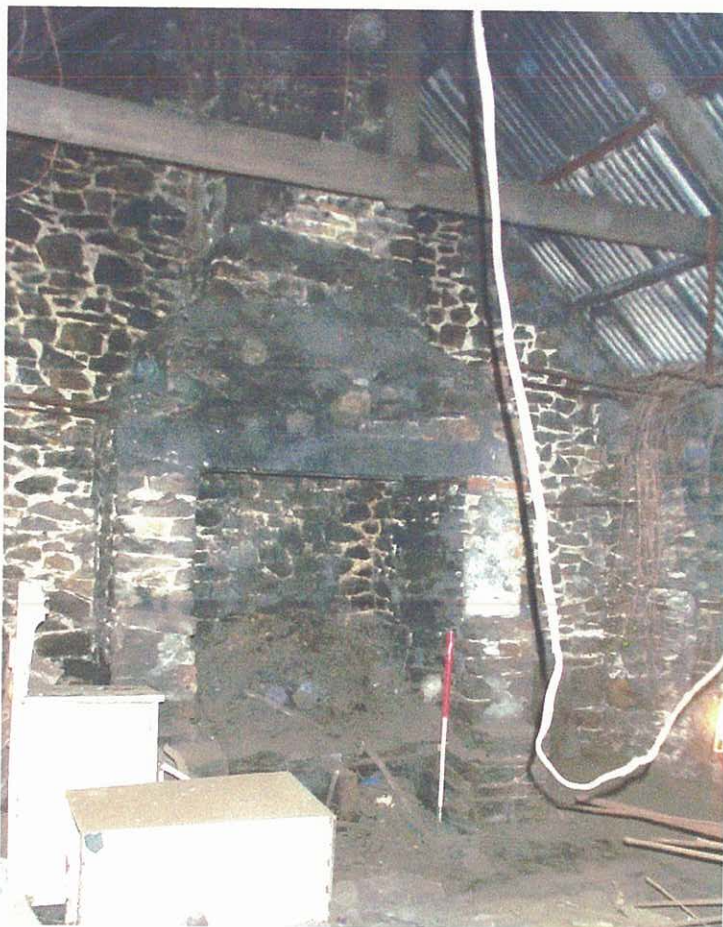
The present roof is in corrugated asbestos sheeting, on A-frame trusses (some with 'king-posts') which may be contemporary with the raising of the eaves-line in red brick. The southern half of the building has a plank-floored loft in the roof-space. The floor lies beneath a mass of scrap metal and fittings, not all of them derived from the forge, and its nature could not be determined but is probably concrete as is the floor of the lean-to annexe.

Fig. 6 - The interior of the smithy north wall

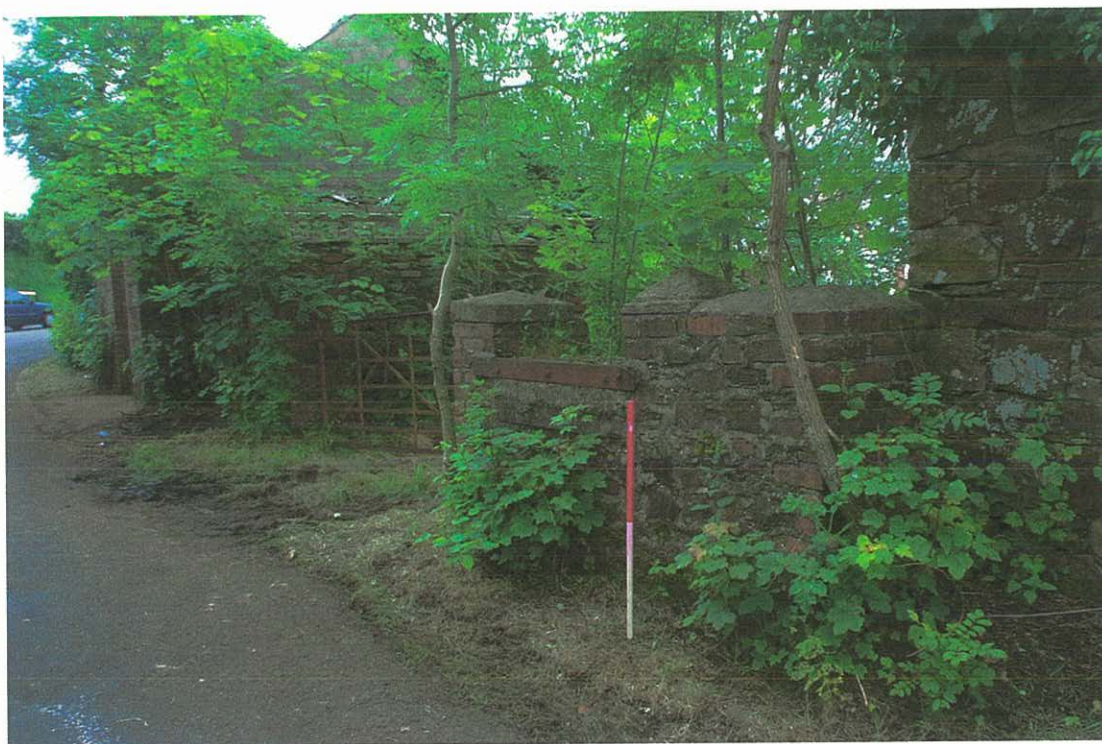
A roadside wall leads SE from the SW corner of the smithy. Its north end butts against the smithy annexe as one of a pair of red-brick gate-posts, with pyramidal concrete caps, either side of a simple entrance gap into the site. It continues south for 2m as a shale-rubble and red-brick and the whole may be contemporary with the red brickwork in the smithy ie. early 20th century.

Fig. 7 - The smithy, ancillary building, and roadside wall from the south

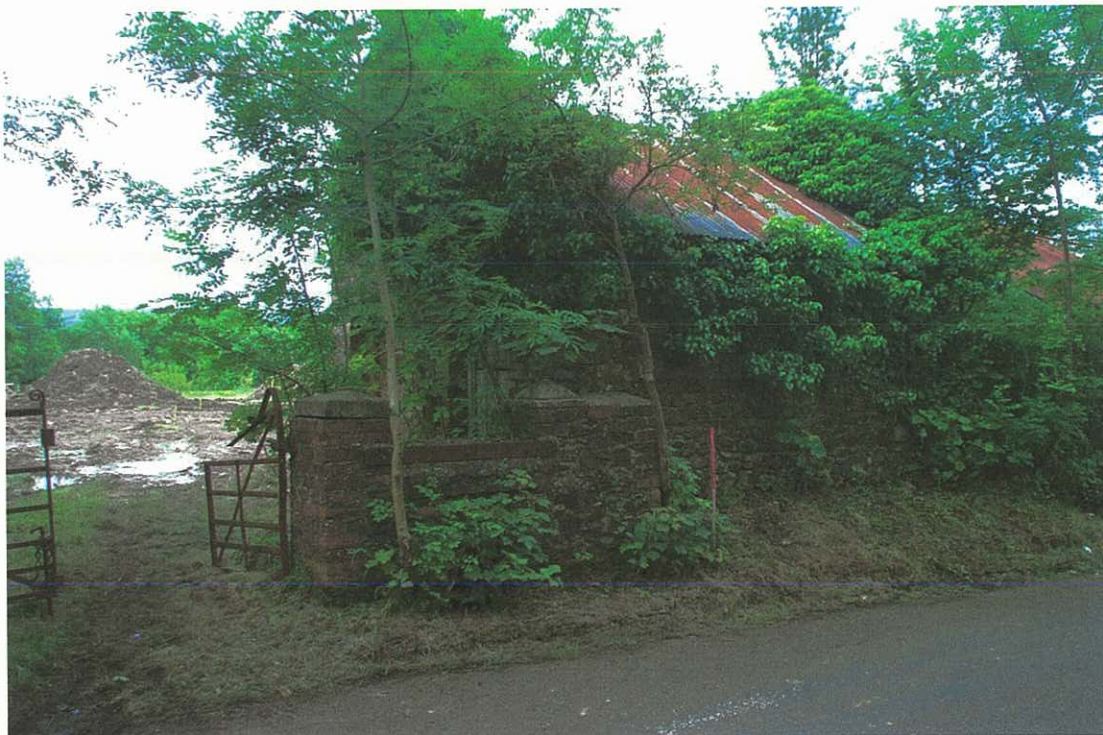
Fig. 8 – The ancillary building from the northwest

The ancillary building (PRN 45240; NGR SN 6052 0990), like the smithy, is a rectangular building constructed from medium, angular, random shale rubble with red-brick surrounds. It is set back slightly from the roadside wall, which butts against its NW corner. The building is aligned NW-SE and measures approximately 5.0m by 4.0m. It is constructed from medium, angular, random shale rubble which may be primary ie. early 19th century, but is not shown on any maps. It lies under a heavy external growth of ivy. The north gable end is pierced by two doorways and the present roof is of corrugated iron. Ivy growth prevented description of any other architectural features and access was not gained to the interior.

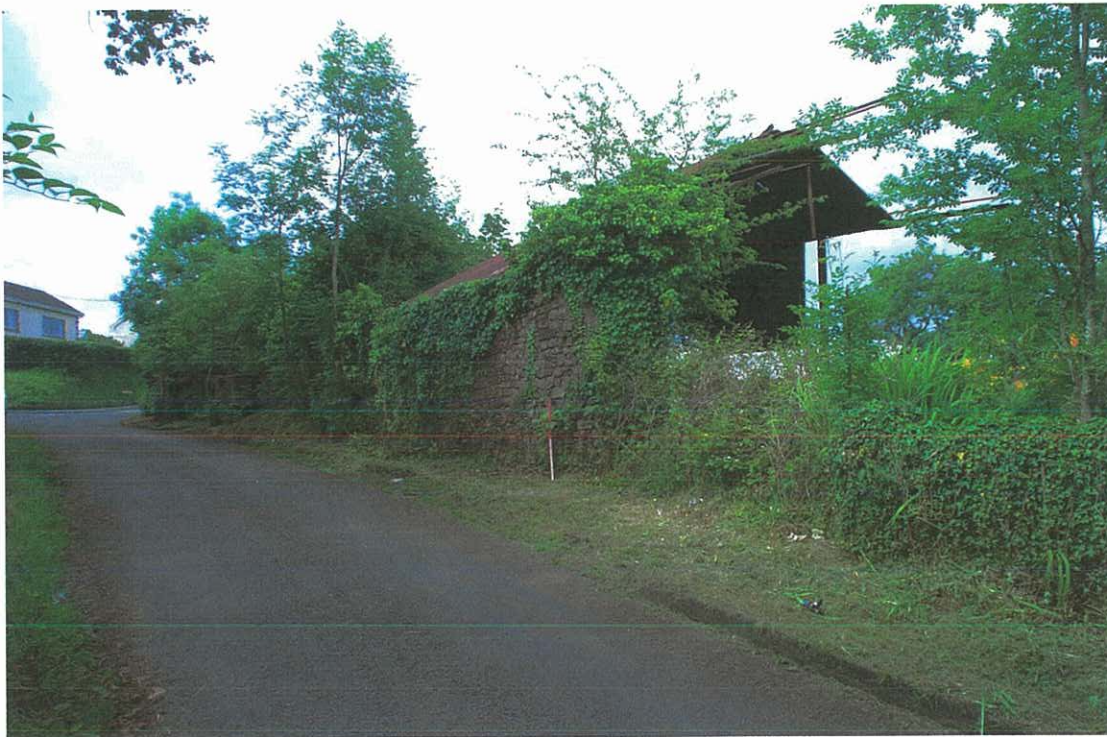
Its west (ie. roadside) wall-line continues southwards and now forms the west wall of the Dutch barn. The remainder of this barn comprises steel girders with a sheet-metal covering, all from the 20th century. It measures approximately 7m by 7m and abuts the north end of Banc-y-ffynnon.

Fig. 9 - The Dutch barn from the southwest, showing its ?earlier west wall

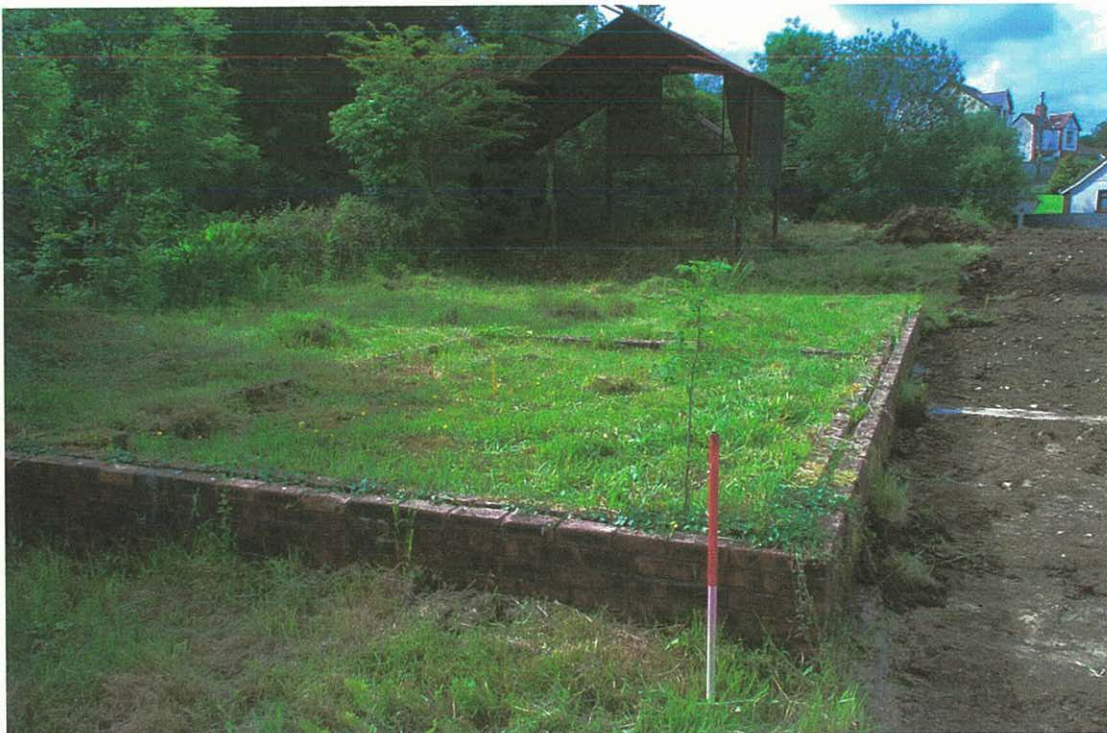
Fig. 11 – Banc-y-ffynnon footings from the southeast, with the Dutch barn in the background

Banc-y-ffynnon (PRN 45241; NGR SN 6053 0988) is marked on the tithe map of 1841. However, the building is now only represented by the lowest 7 courses of a brick cavity wall from the mid-late 20th century, which define a rectangular area measuring 14m N-S by 10m E-W. The remains of internal walls divide the area into 4 rooms, but the interior is now under grass which is level with the uppermost course. The ground works revealed part of the concrete foundations and showed these to have been dug into the subsoil. In addition the topsoil strip revealed evidence, in the form of discrete *in situ* patches of cobbling, for either a courtyard or hard standing frontage to the east side of the building. although the limited excavation did not reveal the extent of this.

The building was clearly a dwelling. The name 'Banc-y-ffynnon', used on the 1891 OS map, suggests that its predecessor was also a dwelling. It was largely rebuilt in brick in the mid-late 20th century, and largely demolished in the late 20th century.
