Rhos-y-Bedw Mill

Tir Gofal Farm Visit Historic Environment Report

REPORT NO. 2003/9
PROJECT RECORD NO. 45592

January 2003

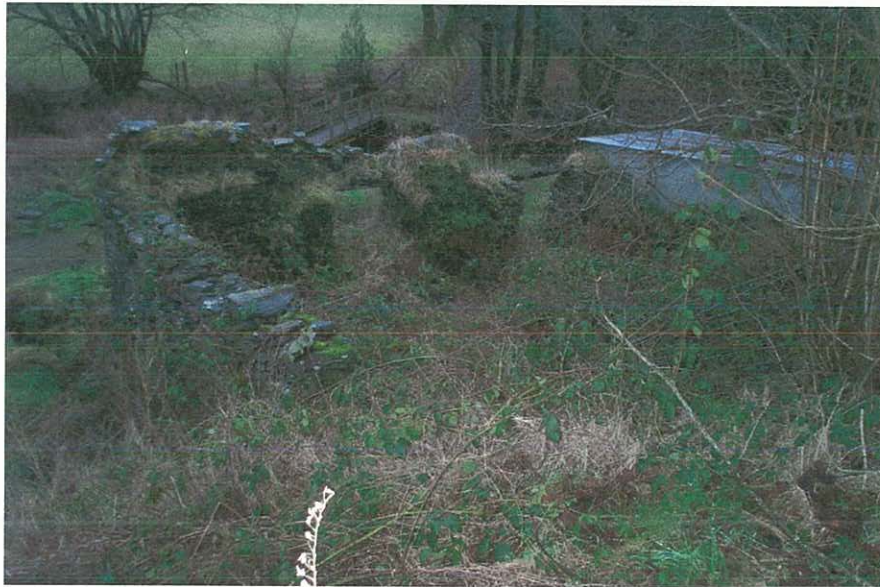
The mill is likely to be of 18th century date and was operational until the first half of 20th century. It is shown as a working corn mill on a 1906 Ordnance Survey map although was out of use by the time of Gardiner’s visit in 1951. The mill is now in a ruinous condition and only the building shell remains.

Plate 1- the remains of the cornmill looking southeast.

The mill building requires stabilisation if it is to be preserved. Only the shell of the structure survives. The walls are now self supporting, no longer benefiting from the binding influence of floor joists or a roof structure. Added to this is the problem of water ingress into the masonry structure, which is washing away the lime mortar bonding and promoting instability.

Restoration of the mill building is feasible and should be encouraged, although this will require considerable rebuilding and renewal. A thorough understanding of the history and characteristics of the building is necessary before any repair work can be carried out. The notes and photographs taken by Miss E.M. Gardiner in 1951 provide a useful record of the mill's original appearance and should be used to inform the sensitive restoration of the mill building using traditional materials and techniques. The Royal Commission on the Ancient and Historic Monuments of Wales also hold information on the mill, which could be used to inform a sensitive restoration programme. Any restoration works should be compatible with existing materials and methods of construction.

In the event that building restoration is not pursued, masonry should be consolidated and wall tops capped with a lime mortar mix in order to prevent further collapse. Intrusive vegetation growth should also be kept to a minimum.

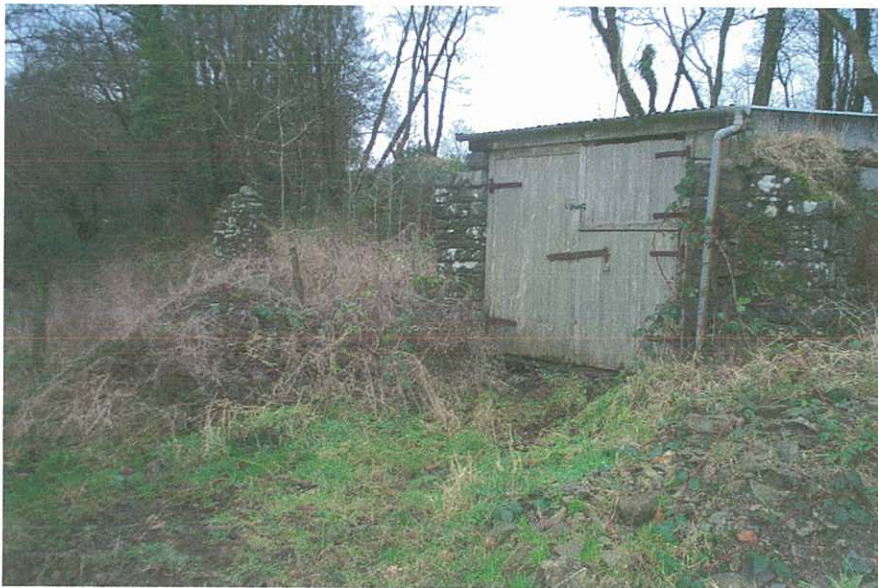
The two units at the west end of the building are almost entirely collapsed, although part of the southern lateral wall survives. Building debris remains in these two bays where the walls have collapsed inwards. The former extent and plan of these two units can still be made out. It is not clear to what height this section was built or how it was roofed. The present condition makes it difficult to ascribe a function.

A cartshed bay is situated between these units and the mill. Only the doorway dressings survive, although the structure has been rebuilt out of breeze blocks with a corrugated iron roof.

Plate 2- the cartshed and remains of the southern lateral wall looking west.

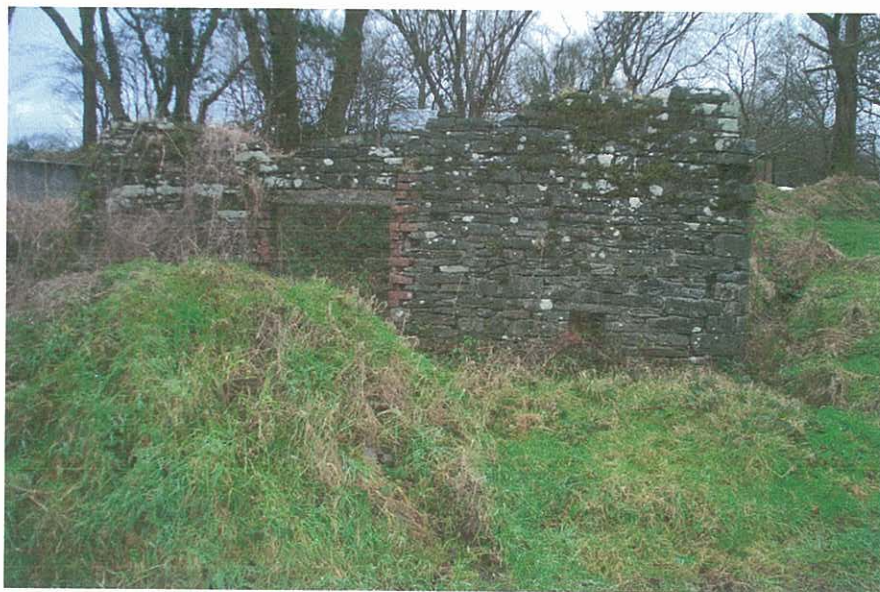
The mill itself forms the east bay of the range and is the best preserved element, although only the shell remains. The front (southern lateral) wall and eastern gable walls survive albeit in an eroded and unstable condition. The northern lateral and western partition walls have been lost (the former having collapsed inwards sometime since 1953, whilst the latter has been replaced by a breeze block wall).

Access was provided in the front wall by either a wide entrance, now with a displaced wooden lintel, or a narrow doorway positioned in the centre of the building with a red brick dressing and concrete lintel.

Plate 2- southern elevation of the cornmill

The eastern gable wall would formerly have supported the mill wheel, although the mill axle fitting is no longer visible, the central section having been rebuilt with coarse rubble.

A rectangular opening c.0.5m with stone lintel in the front wall may have supported the hurst beam. None of the mill apparatus supporting structure or internal building fabric remains to confirm this; the building interior being much overgrown and possibly with as much as 1.5 metres depth of building debris.

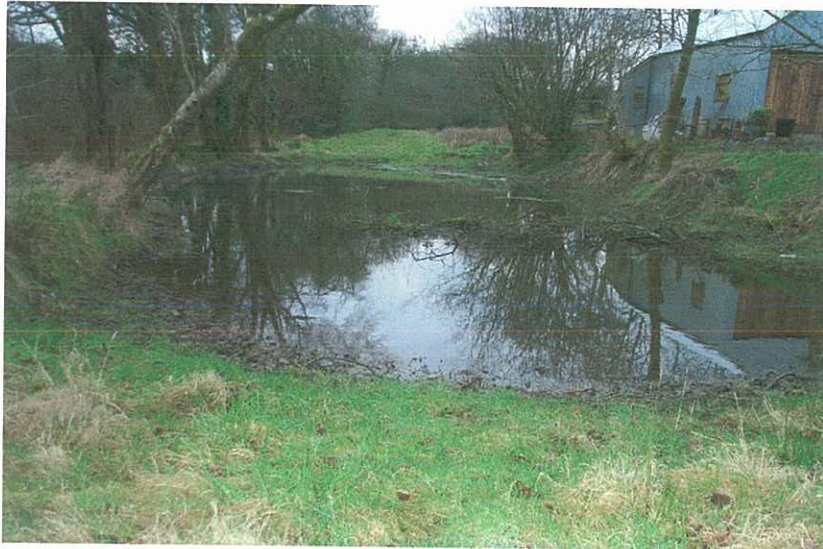
Plate 3- the millpond looking west

The original extent of the millpond, as shown on historic maps exceeds the current outline. The owners propose to clear the west end of the pond to reinstate it to its full extent. Mr. Ward had learned from a previous occupant that there had once been a tap for domestic use in the east bank. No traces of this tap remain visible.

The restoration of the millpond is to be encouraged, and should as far as possible attempt to follow its original extent. Care should be taken during any restoration works not to damage or remove the original clay lining or any water management structures which may survive within the millpond. It is recommended that an archaeological record is carried out during pond restoration works. It is hoped that any features could be recorded and used to inform sensitive restoration. Please contact Cambria Archaeology in advance of any pond restoration works for further advice.
