## **Graig Farm W/12/2802**

### **Tir Gofal Farm Visit Historic Environment Report**

Report No. 2002/72

REPORT NO. 2002/72  
PROJECT RECORD NO. 45600

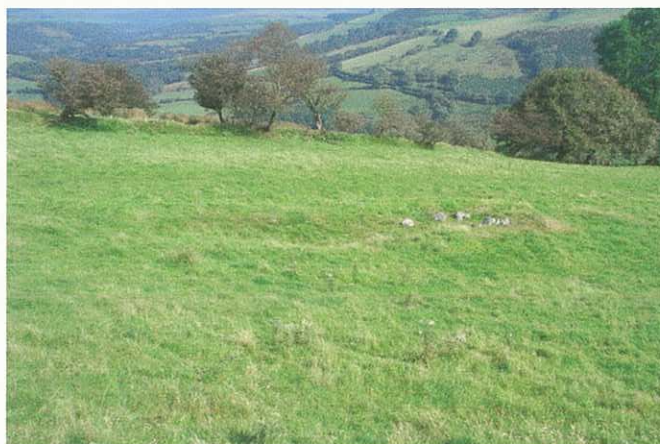
Plate 1 – Long Hut from the south west (PRN 40389)

Two-celled long hut located in improved pasture field. Overall dimensions are 11m east-west x 5m; the western cell is 6m long, the eastern 5m. The structure stands on a slight platform, cut into a gentle slope at the western end of the long hut, with a positive platform to the eastern end. The interior of the hut is slightly sunk into the surface of the field. Some drystone walling is seen in the eastern gable end wall. Wall bases are generally less than 0.3m high.

Maintain as a visible landscape feature. No ground breaking works should take place on or within 15 metres of this site. Stocking levels need to be kept at a level which will not cause erosion to the site, and stock feeders should not be located on or within 15 metres of this site.

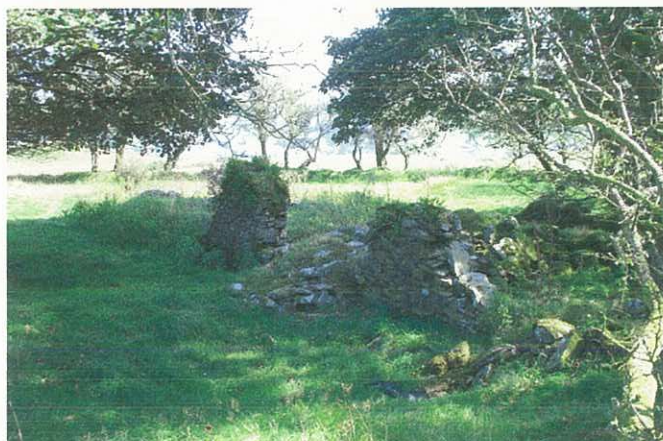
Plate 2 – North face of farmstead (PRN 4039) from the west

A Post Medieval farmstead complex. Not shown on the parish tithe survey and probably dating to the mid 19th century in origin. The complex includes the foundations of a 4-celled dwelling/byre, on a north east – south west axis, measuring 22m x 6m overall. It was well-built of large, local stone slabs, but the drystone walls now stand to a maximum of 0.5m in height in general, with parts of the northern side still standing to c.2m high and incorporating some former structural openings. The rectangular parcel which encloses the whole complex is defined by earth and stone banks topped with planted blackthorn hedging. A smaller garden plot attached to the south west corner of the dwelling has mature sycamore and ash trees growing on its banks which may give some indication of the age of the settlement. A grave (PRN 45722) is located within the garden plot.

This deserted farmstead should be maintained as a visible landscape feature. The surviving masonry elements should be protected from damage and erosion by controlling stock levels, as well as ensuring that stock feeders are not placed within 15 metres of the enclosure surrounding the whole farmstead. Also in order to maintain the upstanding structural elements vegetation growth should be regularly cut back and prevented from taking over the surviving structural elements.

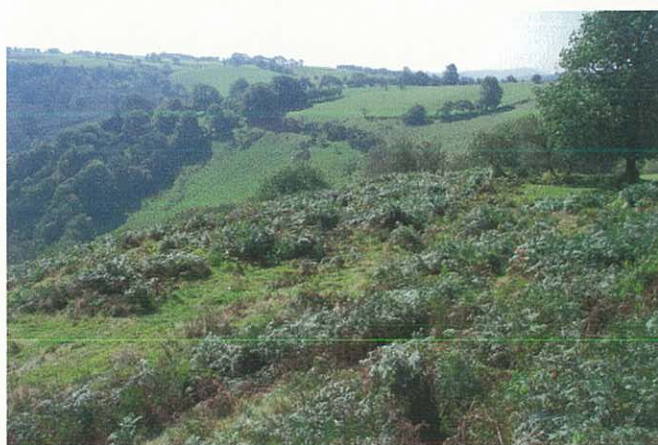
Plate 3 – Long Hut (PRN 40391) from the north east

Long hut which is now only identifiable by low earth and stone wall bases, up to 0.3m high,

defining a structure 11m NNE-SSW x 4m. The SSE end is badly damaged and indistinct. It comprises of two cells, the western cell is c.3m in length and contains possible entrances in the northern face. Located on a natural terrace on otherwise steeply sloping ground.

Ideally this site should be maintained as a visible landscape feature. Any bracken control should take into account the extensive archaeology in the area and techniques should not be used that will cause damage to above or below ground archaeology. No ground breaking works should be undertaken within 15 metres of this site.

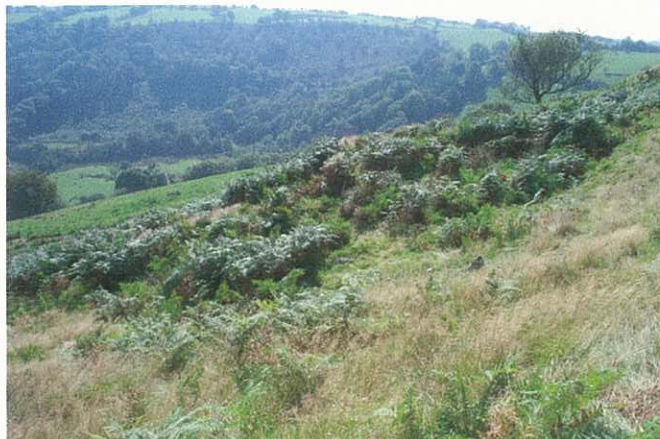
Plate 4 – Long Hut (PRN 40392) from the north east

Single cell long hut which is defined by low earth and stone wall bases. The structure measures 11m east-west x 5m. No internal features are apparent on the surface. It is located on a natural east sloping terrace on top of a steep slope, around 30 metres down from the main beak of slope.

This site should be maintained as a visible feature. Any bracken control should take into account the extensive archaeology in the area and techniques should not be used that will cause damage to above or below ground archaeology. No ground breaking works should be undertaken within 15 metres of this site.

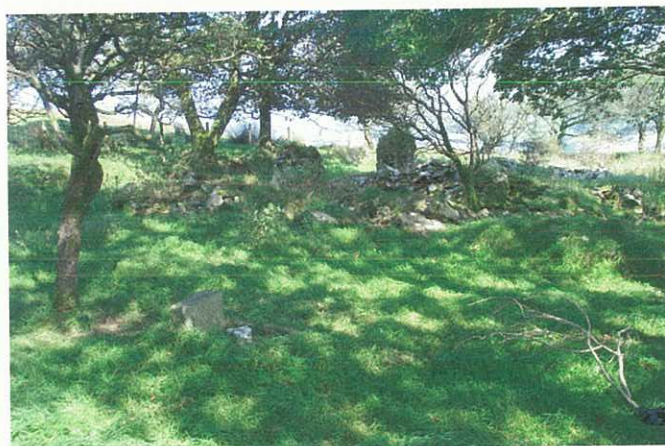
Plate 5 – Inhumation (PRN 45722) with farmstead beyond

Stone edged north - south grave measuring 0.75 metres long by 0.5m wide. Located in the garden of farmstead (Prn 40390) it has a regular undressed stone slab headstone at its north end. It could probably be the grave of a pet.

Maintain as Prn 40390.

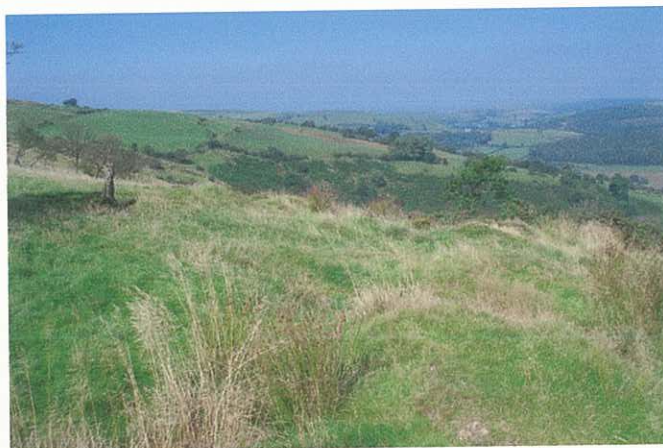
Plate 6 – Double banks (PRN 45723)

Two parallel earth banks measuring around 2 metres wide and less than 0.5 metres high and 11 metres apart. They run downslope to the north and appear to be aligned with a break in the north east corner of the boundary surrounding the nearby farmstead (Prn 40390). They are probably an integral part of the enclosure system related to the farmstead, and could form a trackway leading from the farm down off the hill to the north

Maintain as a visible landscape feature. No ground breaking works should take place on or within 15 metres of this site. Stocking levels need to be kept at a level which will not cause erosion to the site, and stock feeders should not be located on or within 15 metres of the site.

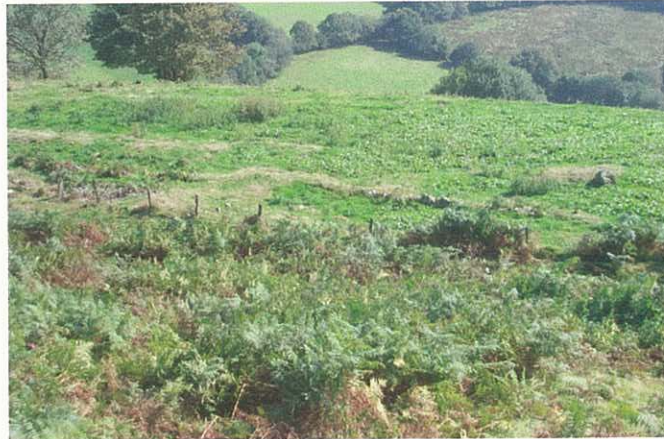
Plate 7- Barn (PRN 45724)

Low stone and earth banks forming an east – west enclosure on a gently sloping area of ground immediately to the south of a field boundary. The enclosure measures 13 by 5 metres, the banks measuring around 1 metre in width, and has a 4 metre wide opening in its north face, suggesting that it is a former field barn.

Maintain as a visible feature. No ground breaking works should take place on or within 15 metres of this site. Stocking levels need to be kept at a level which will not cause erosion to the site, and stock feeders should not be located on or within 15 metres of the site.
