# **Treiago** W/13/3258

# Tir Gofal Farm Visit Historic Environment Report

# REPORT NO. 2002/74 PROJECT RECORD NO. 45603

Treiago Tir Gofal Farm Visit Historic Environment Report

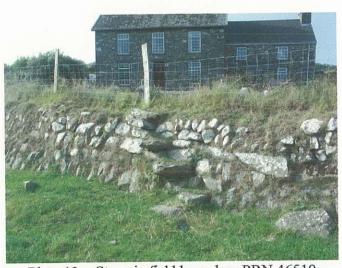
Plate 13 - Steps in field boundary PRN 46519

A set of four projecting (by 30cm) stone steps built into the south face of the roadside field boundary at Treiago farmstead.

Maintain as a feature within the fabric of the field boundary. Any work that is done on the field boundary should preserve the form and nature of these steps.
