Pantglas W/12/3123

Tir Gofal Farm Visit Historic Environment Report

REPORT NO. 2003/35
PROJECT RECORD NO. 45605

Pantglas
Tir Gofal Farm Visit Historic Environment Report

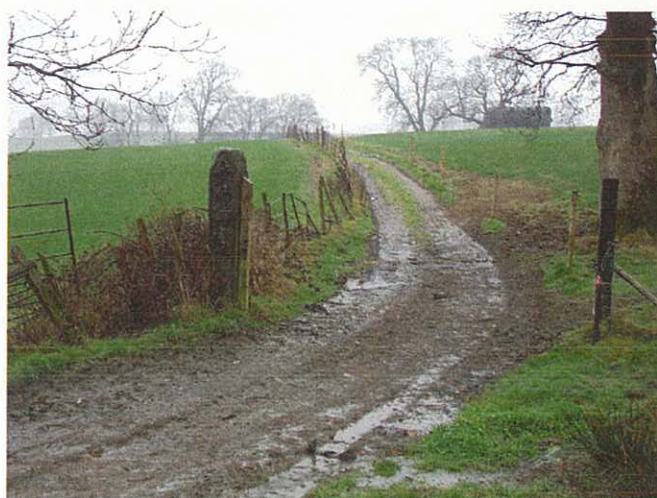
Plate 1 – Pantglas drive PRN 47175

This is the original main, grand entrance drive to Pantglas house only part of which survives within the holding of Pantglas home farm. It would have originated at the Lodge at SN53632446 and then wound its way up the valley through a section of woodland and then into the parkland to the south of the house and eventually approaching the house from the south east.

The section of drive within the parkland (and farm holding) survives as a well preserved trackway with iron railings and gateways (PRNs 47177, 47178 and 47605) along its western side.

This is an important part of the parkland landscape of Pantglas. It is clearly still in use as an access track within the farm holding, and ideally it should continue to be used as such without causing excessive levels of erosion or damage. Also the iron railings are clearly beginning to suffer from deterioration and in some instances are no longer fully stockproof, these should be maintained and where necessary repaired using good quality matching material.

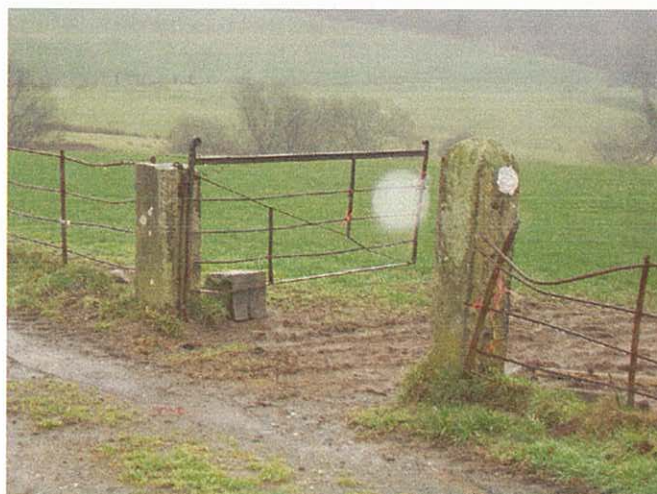
Plate 2 – Gateway PRN 47177

Gateway in the iron railings bordering the Pantglas house drive (PRN 47175) and near to barn PRN 47176. It consists of two large stone gateposts around 0.35m square and 1.6m high and an iron gate opening onto the field to the west.

Ideally this gateway should be maintained inline with the rest of the parkland railings as essential elements of the historic landscape of Pantglas. The iron work of the gate and the stonework of the gateposts are beginning to suffer from deterioration and where necessary they should be repaired using good quality matching material.

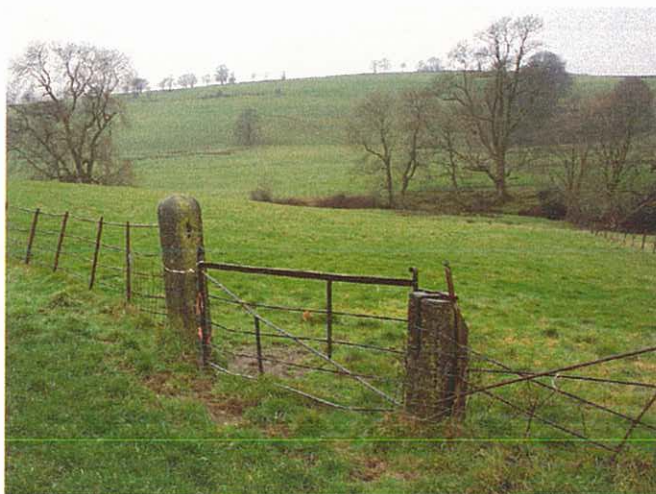
Plate 3 - Gateway PRN 47605

Gateway in the iron railings bordering the Pantglas house drive (PRN 47175). It consists of two large stone gateposts around 0.35m square and an iron gate opening onto the field to the north.

Ideally this gateway should be maintained inline with the rest of the parkland railings as essential elements of the historic landscape of Pantglas. The iron work of the gate and the stonework of the gateposts are beginning to suffer from deterioration and where necessary they should be repaired using good quality matching material.

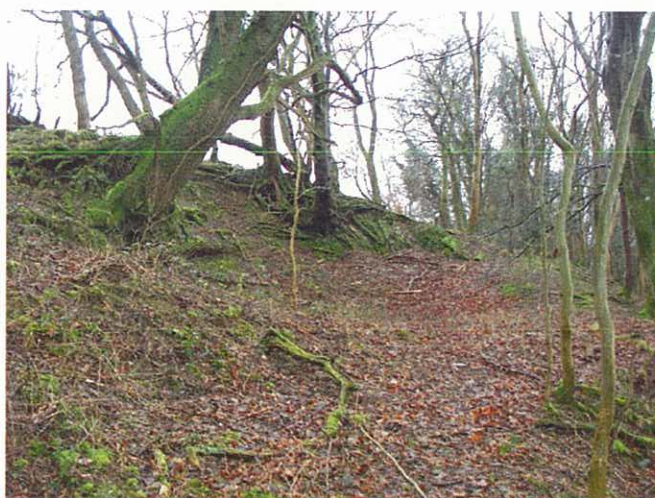
Plate 4 – Quarry (PRN 47607)

A quarry is shown on the 1891 first edition Ordnance Survey map. The site of this quarry is now marked by 20 metre long cut into the hillside within an area of woodland. The line of a trackway linking the quarry with the nearby kennels (PRN 47606) and shown on the first edition Ordnance Survey map is still partially visible.

Maintain as existing. In order to protect any buried archaeological remains no ground breaking works should be undertaken within 15 metres of this site.
