# **Abergwenlais W/12/3198**

## **Tir Gofal Farm Visit Historic Environment Report**

Report No. 2003/68

CAMBRIA ARCHAEOLOGY

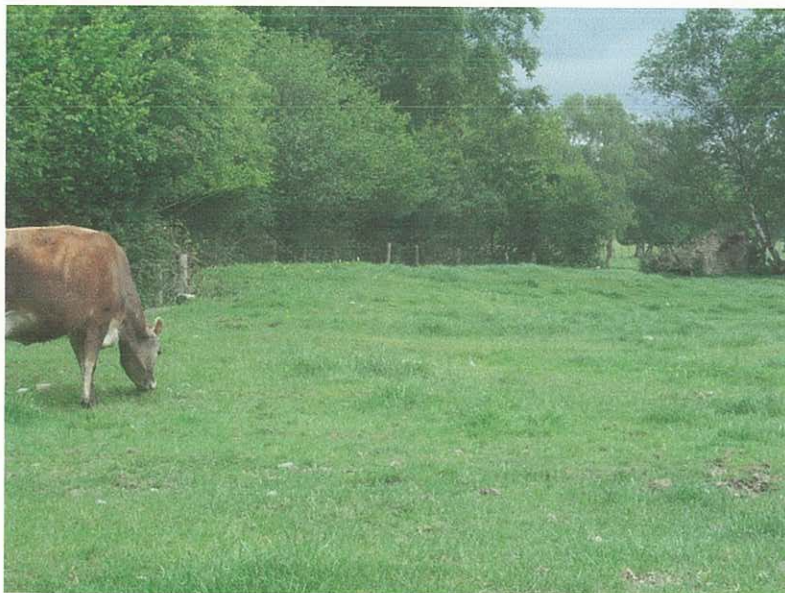
A burnt mound, roughly crescent shaped. The mound was augured in 1994, and burnt soil and stones were found. The mound measures about 18m x 9m, and stands up to 1m high at its highest point. It lies only a few metres away from a watercourse. In general, the site is in good condition, and under pasture, but some cattle trampling is evident on the side nearest the river.

**Plate 1.** The burnt mound (PRN 13990), just visible in the corner of the field. The side nearest the river is suffering from some cattle trampling.

The site should continue to be kept under pasture, and no ground intrusive activities should take place within 5m of the edge of the site. At present the cattle trampling is not severe but it needs to be monitored. If the poaching gets worse or the grass cover is substantially reduced, then the mound should be temporarily fenced out to allow the vegetation to recover. It may be necessary to restrict winter grazing to short periods on this site to prevent further erosion in wet weather.

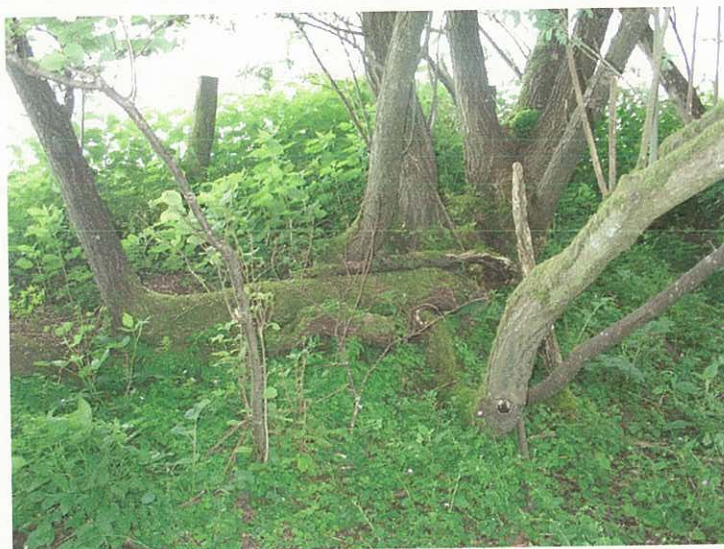
The site of a cottage which was marked on the 1844 tithe map and not seen on the 1891 Ordnance Survey map. There are no standing remains of the building, but the enclosure which surrounded it survives. It is roughly rectangular, around 35m x 20m, and bounded on the southwest by a stream, and on the northeast side by a substantial hedgebank which stands up to 1m high. Trees growing along the hedgebank clearly show the traces of having been a laid hedge. Some scattered large stones around the enclosure may be all that remains of the cottage itself.

**Plate 2.** One of the trees in the hedgebank which surrounds the site of Rhos Cottage (PRN 48064). This clearly shows traces of being deliberately laid as a hedge.

At present, the site is in a stable condition. The surviving hedgebank should be left in place, and no ground intrusive works should be undertaken within the enclosure.

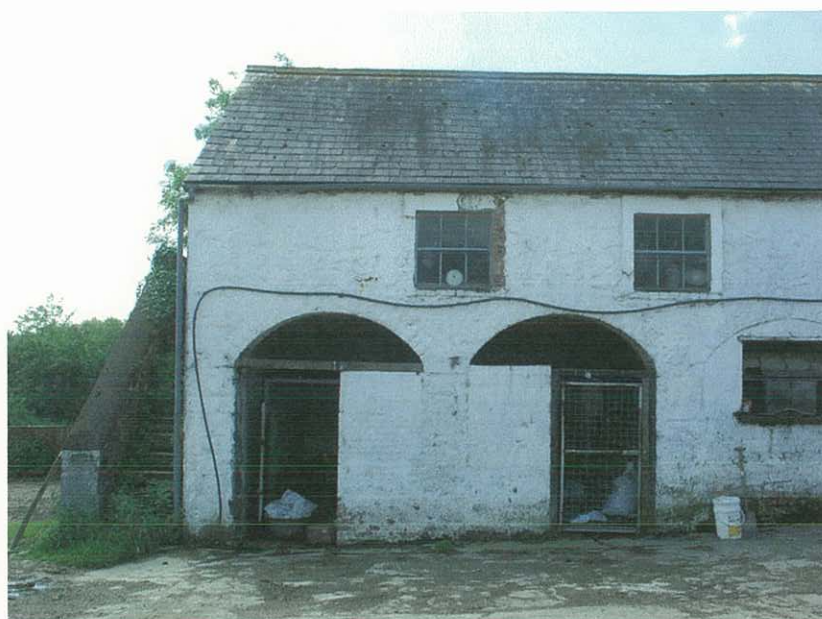
A three-bay cartshed with granary over. The western bay is now completely blocked, the other two are partially blocked and in use as animal shelters. Access to the granary is via a set of steps which run up the east gable end. These are still useable, but are becoming very overgrown. The upstairs seems to be in use only for light storage and for the dumping of farm waste, and seems to be in a stable condition.

**Plate 3.** *The cartshed (PRN 48069) with steps up to the granary. The building displays a number of modifications from a variety of periods. It originally had three arches, one of which is now blocked in (visible on the right of the picture). Later windows with brick surrounds are visible in the upper storey, and the modern, partial blocking of the lower arches allows them to be used as animal stalls.*

In general the building is in a stable condition. However, one upper-storey window at the west end is only blocked with polythene, and the glass in this should be replaced in order to ensure that the upstairs of the building remains dry and weatherproof. The steps up to the granary are also becoming very overgrown, and this needs to be addressed before the upper storey becomes inaccessible. Vegetation should be cut back flush with the stonework, and, if necessary, treated to prevent re-growth.

Future maintenance and repairs should use materials and techniques which are sympathetic to the original construction of the building.

Some consideration needs to be given to the future of this building. It is an integral part of the farmstead, and is all the more significant since it is one of the earlier buildings. A use should be found for the upper storey of this building in order to secure its long term future.

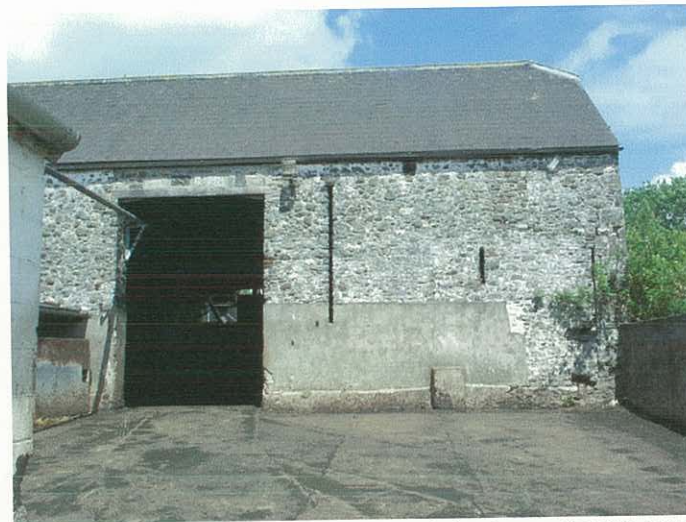
**Plate 5 (above).** *The impressive southwest elevation of the barn (PRN 48072) showing one of the large doors into the threshing floor.*

The barn is in good condition, and is stable and weatherproof. No further alterations should be made to this building, beyond routine maintenance and repairs. These should be carried out using materials and techniques which are sympathetic to the construction of that part of the building.

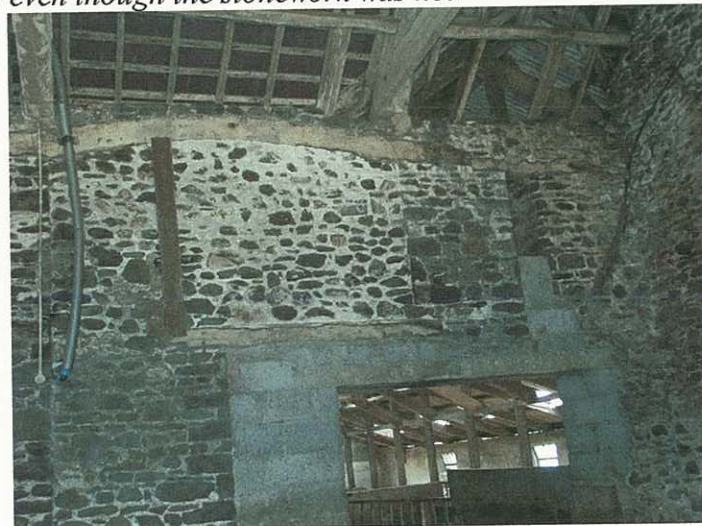
The inside of the southwest elevation shows most clearly the various alterations which have taken place. At present, the barn has one pair of large double doorways, which stand the full height of the building and form a cross passage. Another pair of doorways, of the same size, were situated to the west, but one is now blocked in, and partially hidden by the cowshed (PRN 48071). On the inside, the doors have large, curved wooden lintels above them.

**Plate 6 (below).** *The interior of the southwest elevation shows clearly the amount of modification the barn has undergone. Here the curved wooden lintel at the top of the wall marks the site of another large door. The wooden lintel below represents a door which gave access into the cowshed (PRN 48071) and has been replaced by the modern door with breeze-block surrounds. In the top right hand corner of the picture it can be seen that the roofs of the barn and cowshed were tied in together, even though the stonework was not.*
