# **Llwynrebol W/12/2831**

## **Tir Gofal Farm Visit Historic Environment Report**

Report No. 2004/34

REPORT NO. 2004/34  
PROJECT RECORD NO. 45630

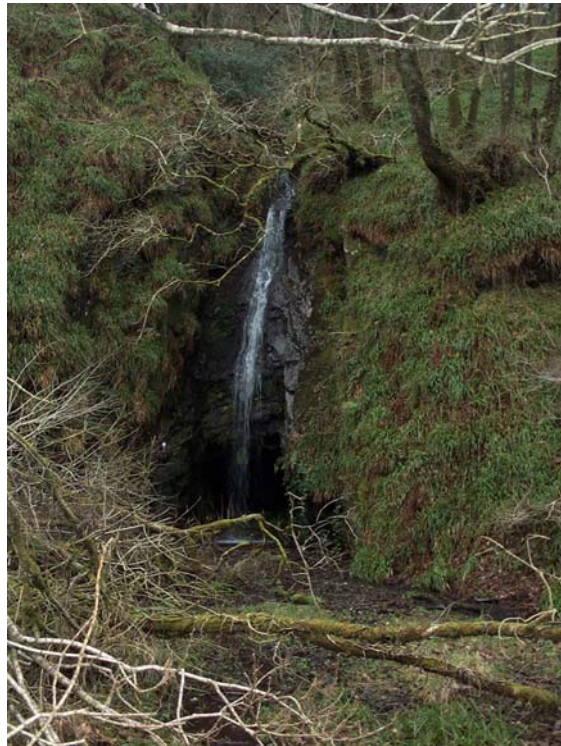
*A waterfall in the quarry workings (PRN48749) beside the Eastern Cleddau*

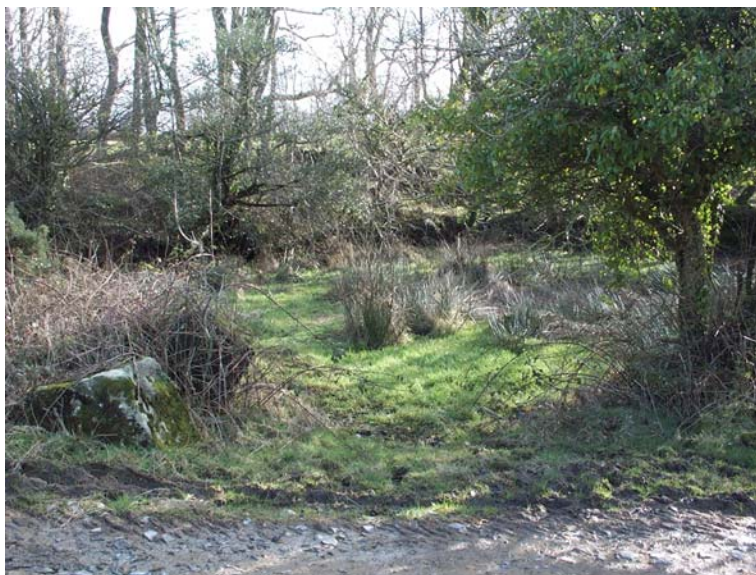
A large pond is situated to the north of the farmstead of Llwynrebol. It does not appear to be marked on the tithe map of 1840, but is clearly defined on the 1<sup>st</sup> edition Ordnance Survey map of 1891.

The pond is approximately 20 metres in diameter, it has been constructed with stone banks to the sides and a straight revetment bank to the west where the farm track approaches the gateway to the farmstead. Built into this revetment bank is a sluice to control the water to the water wheel (Prn 48739).

The pond is holding water and is apparently over 1.5 metres deep in the centre, however it has become very silted up and clogged with reeds and vegetation. A number of trees overhang the sides of the pond.

*The pond which lies to the north of the farmstead and supplied water to power a water wheel*

It is hoped that the pond can be restored, removing the excess silt and vegetation and allowing it to fill with clear water. This would be a very worthwhile undertaking and would restore the visibility of the pond which is an integral feature of the farmstead. Clearance of the pond must be done with extreme care to avoid causing any damage to the stone sides and the revetment banks. Please inform Cambria Archaeology when the work is to be undertaken to discuss the details of the restoration.

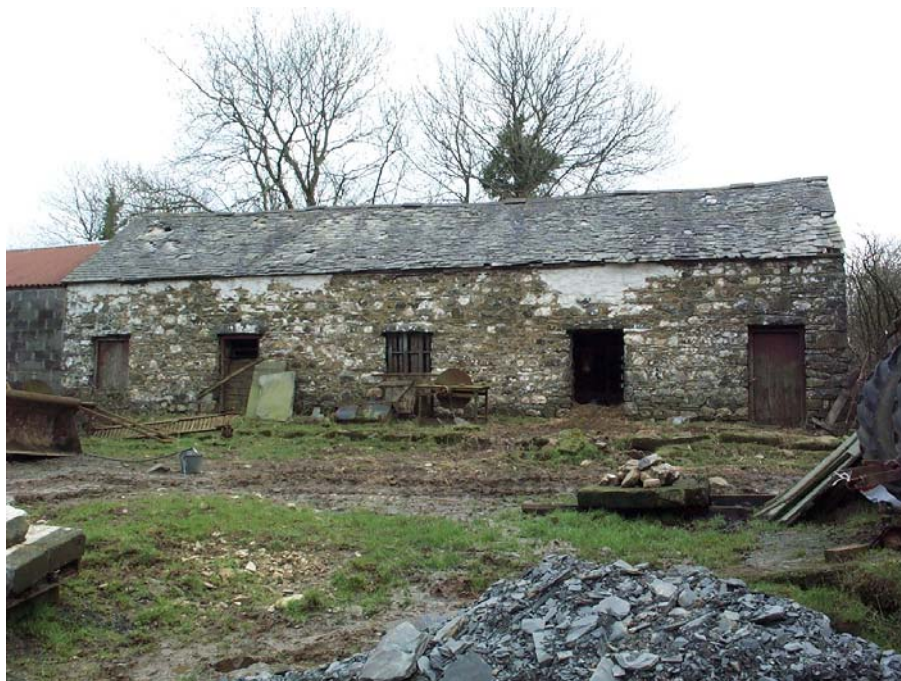
The cow shed is constructed with alternate layers of coursed rubble stone with slate levelling courses which give the building a very distinctive appearance. Within the northwest elevation are five evenly spaced doorways with stone lintels, to the rear of the building is one central doorway and a single window to either side. The arrangement of openings indicate that the cattle were tied across the building, with two feeding passages and three manure passages. The front elevation of the building has been limewashed in the past.

Although it is still in use, the cow shed is in a very vulnerable condition at present, many of the slates have become loose and uneven allowing water into the building. The masonry itself appears to be in a reasonable state although a lintel over one of the rear openings is collapsing and the stonework above is becoming unstable.

It is uncommon to find a cow shed with so much of the historic fabric surviving.

*This cow shed is a fine example of its type with an original slate roof, pegged with wooden dowels*

It is very important that the building is made watertight as soon as possible. If the water continues to come in through the roof the structural timbers will rot and the roof itself could quickly be lost. In the short term a temporary cover should be put over the existing roof in order to prevent further water damage to the structural roof timbers. Also as a short term measure a prop should be inserted into the window opening to the rear in order to prevent the stonework above collapsing.

Ideally the roof should be restored using the same methods that have been employed on the

original construction ie. the slates should be replaced using wooden dowelling pegs and the undersides of the slates should be mortared. The failing lintel should be repaired or replaced and the stonework above should be consolidated using the same coursing pattern and lime mortar mix.

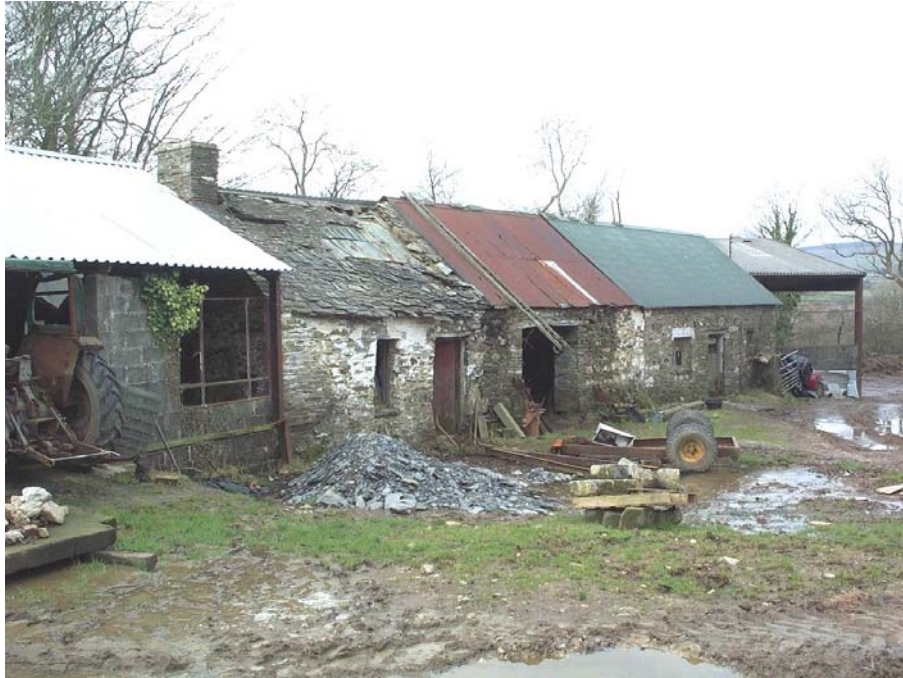
The building is constructed with uncoursed rubble and slate. The roof is still slated on the northeast facing side, to the southwest the roof has recently been re-covered with box sectioned corrugated iron sheeting and some of the roof timbers on this side are also replacements. Some of the roof slates have been grouted on the exterior. There is a chimney on the gable end, and the underside of the remaining original roof is smoke blackened. A window has also been inserted into the gable end of the building, beneath the chimney, suggesting that it no longer functioned as a kiln drier or mash house latterly. It is now in use as low level storage.

This building is an interesting feature of the historic farmyard and quite unusual. The condition of the building is currently poor, the roof slates which remain on the northeast side have slipped and there are significant holes allowing water access onto the structural elements of the roof.

*A long low range including the corn drying kiln, cart house and stable beyond  
(PRNs 48742, 48743 & 48744).*

This building forms an interesting and unusual survival. It is important that the building is made watertight as soon as possible in order to prevent further water damage to the structure. In the short term a temporary cover should be put over the existing roof in order to prevent water ingress.

Ideally the roof should be restored using the same methods that have been employed on the original construction. Any restoration work should endeavour to retain as much of the historic fabric of the building as possible and where elements have to be replaced new materials and methods should match the old and existing.

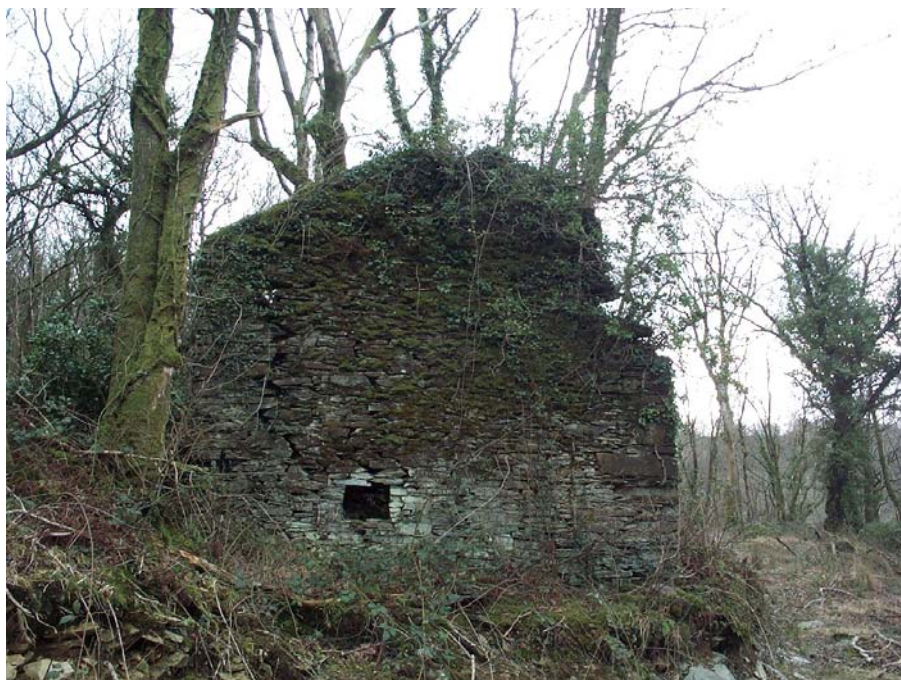
It is situated within woodland and in part the ruined the walls almost survive almost to full height (two stories). The walls are covered with some ivy growth and there is the potential for damage from tree fall.

*A quarry building which lies in the quarry complex, its function is unknown, but it may have been a quarry office.*

Any woodland management within this area should take account of the fragility and vulnerability of features such as this and management should endeavour to prevent damage from tree fall.

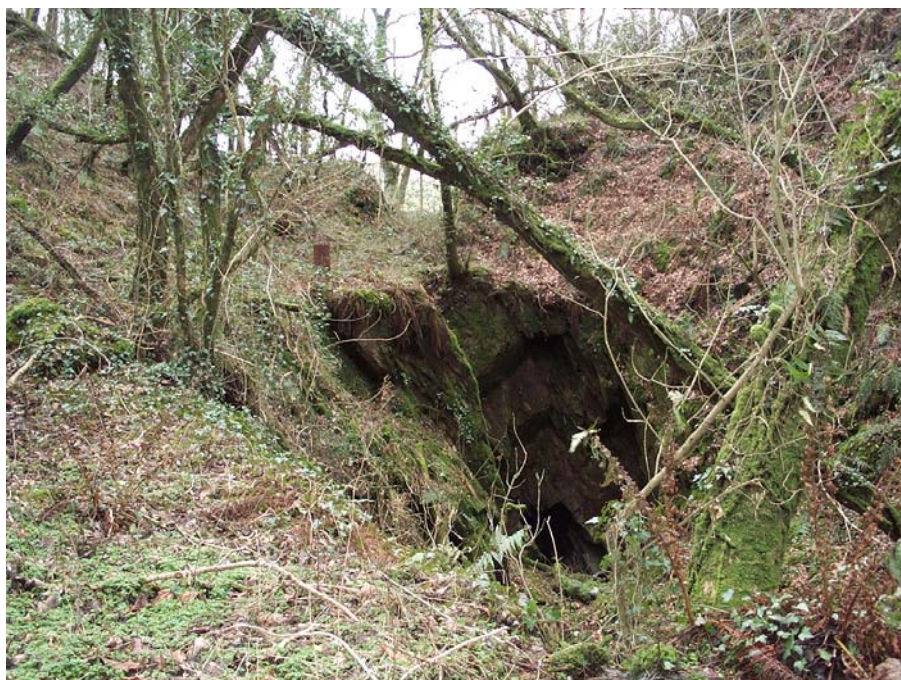
*The quarrying remains include this enormous excavation and a rock cut tunnel*

Any waste or dumped materials should be removed from the quarry where it is practical and safe to do so. No further dumping should take place.

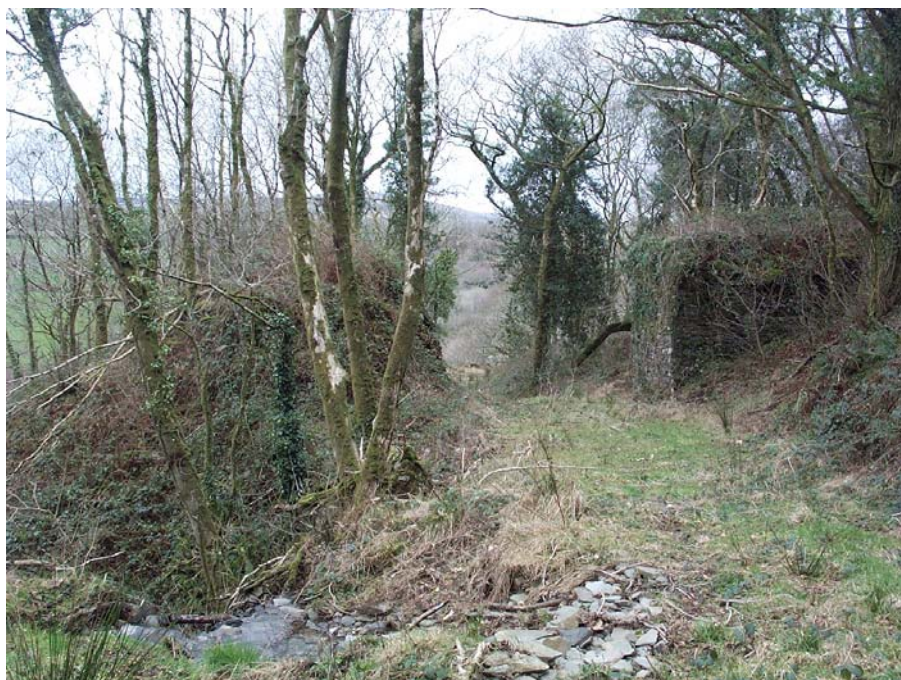
*This embankment or loading platform lies immediately to the south of the large quarry workings PRN 48749*

The embankment or loading platform appear to be in a stable condition at present. However, future management of the woodland within which it is located should endeavour to ensure that the structure is not threatened by tree fall.

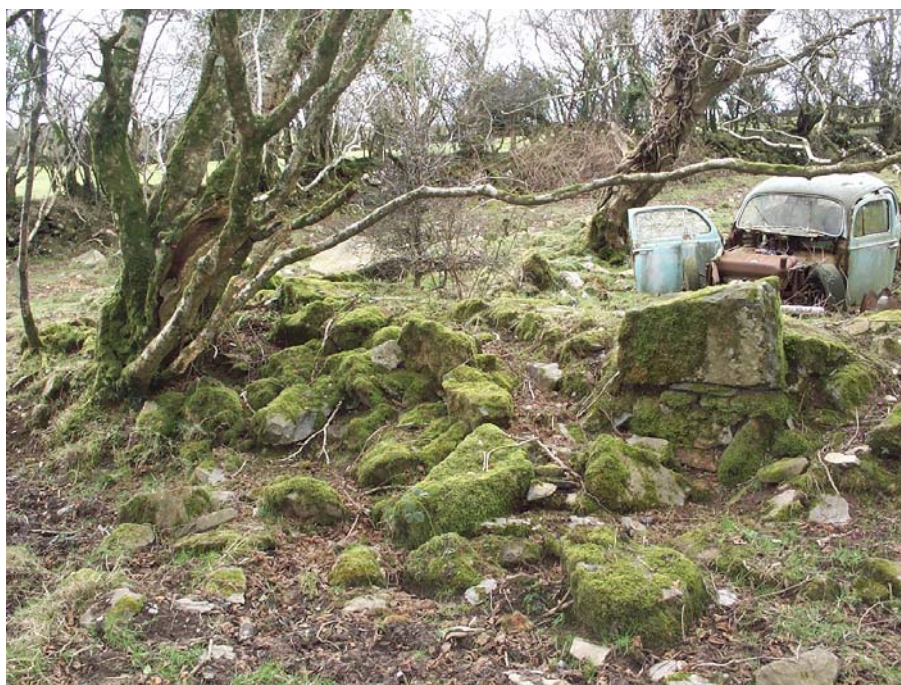
A cottage and garden is marked on the 1840 tithe map and is named on the 1<sup>st</sup> edition Ordnance Survey map of 1891 as 'Teg Pistyll'. It appears to be disused on the 2<sup>nd</sup> edition Ordnance Survey map of 1907. The site of the cottage lies within an area of unenclosed woodland. The stone footings of the cottage remain and much loose stone lies about. The woodland trees are quite insubstantial and appear liable to fall. The decaying body of a car also lie within the cottage remains.

*The remains of Teg Pistyll cottage, here the wall footings are clearly visible.*

The remains of the building may suffer damage when the trees within it fall. Ideally the management of this area should endeavour to remove the trees if it is practical and safe to do so and if it is possible without causing further damage to the cottage remains.
